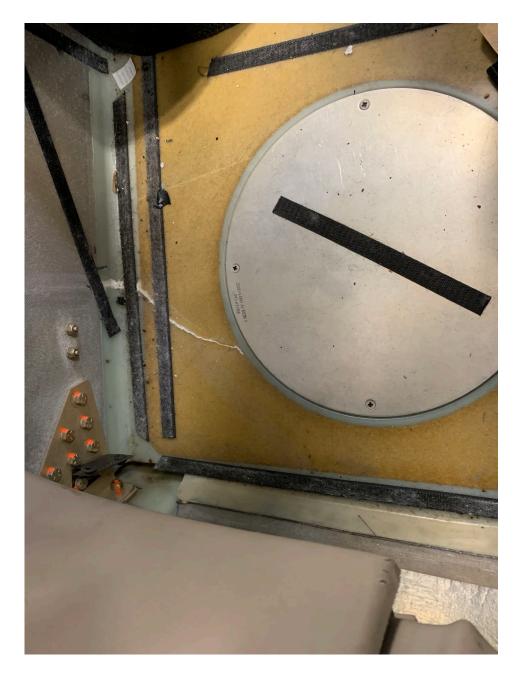
Photo 1 – Crack to composite fuselage structure (photo provided by FAA)

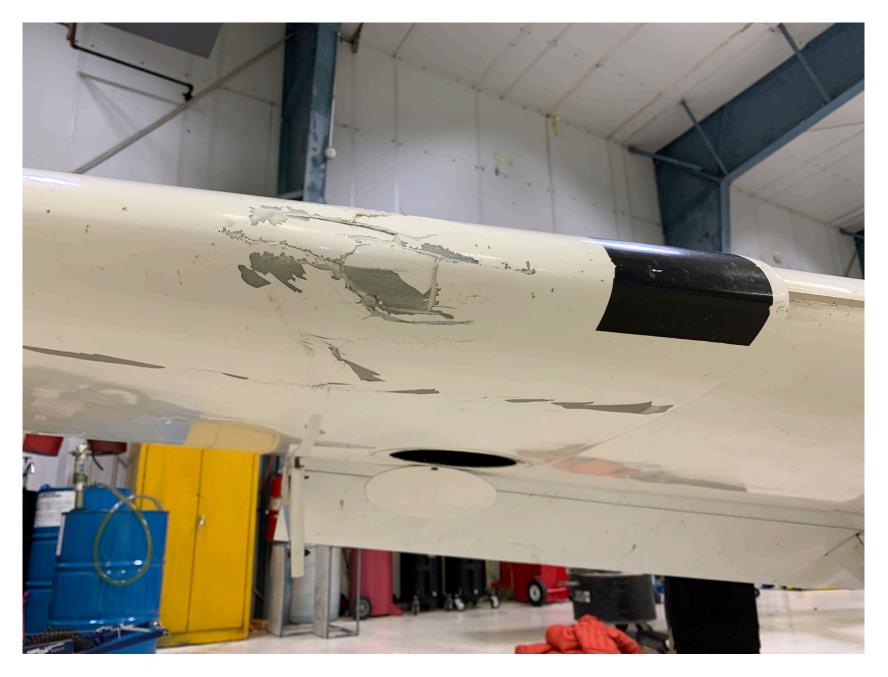
Photo 2 – Right wing and leading edge damage (photo provided by FAA)
