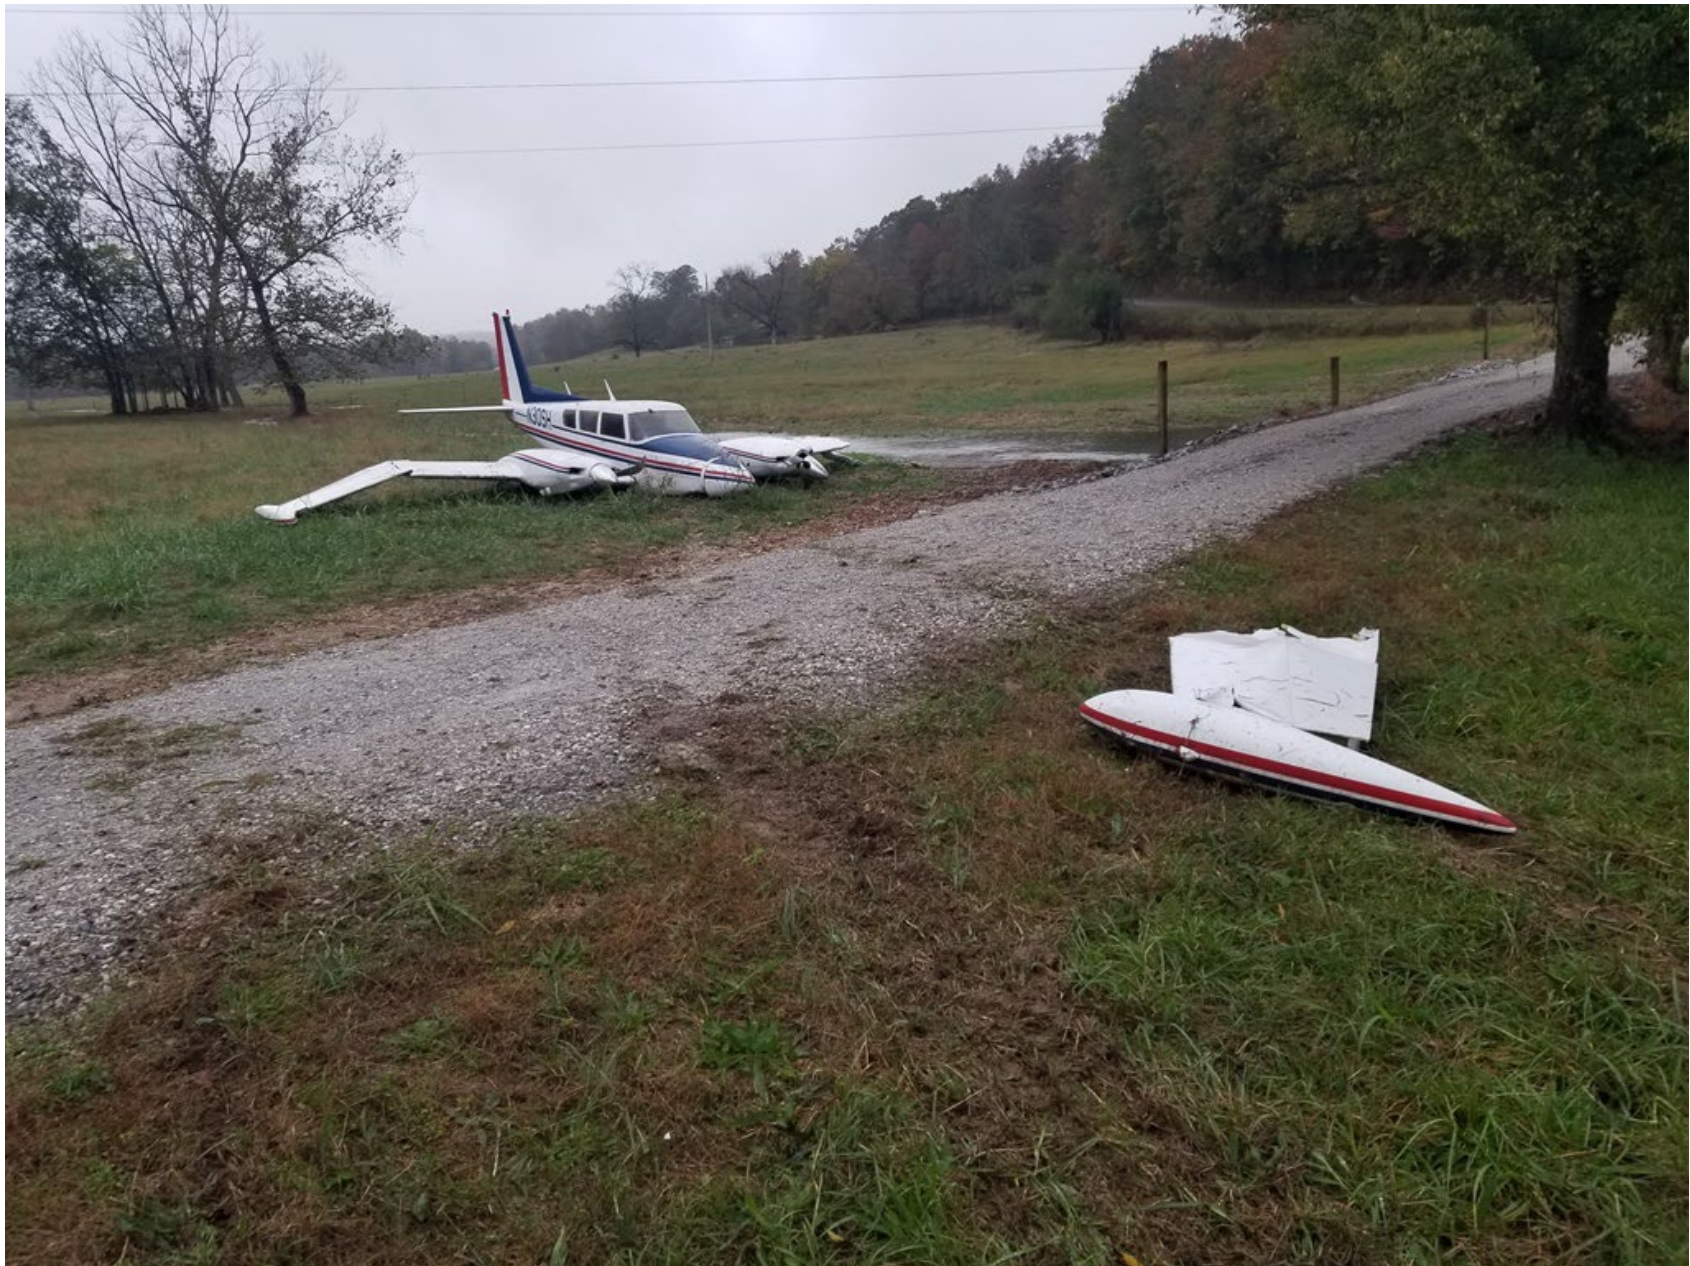
Photo 1 – Picture of Airplane at Accident Site (FAA)

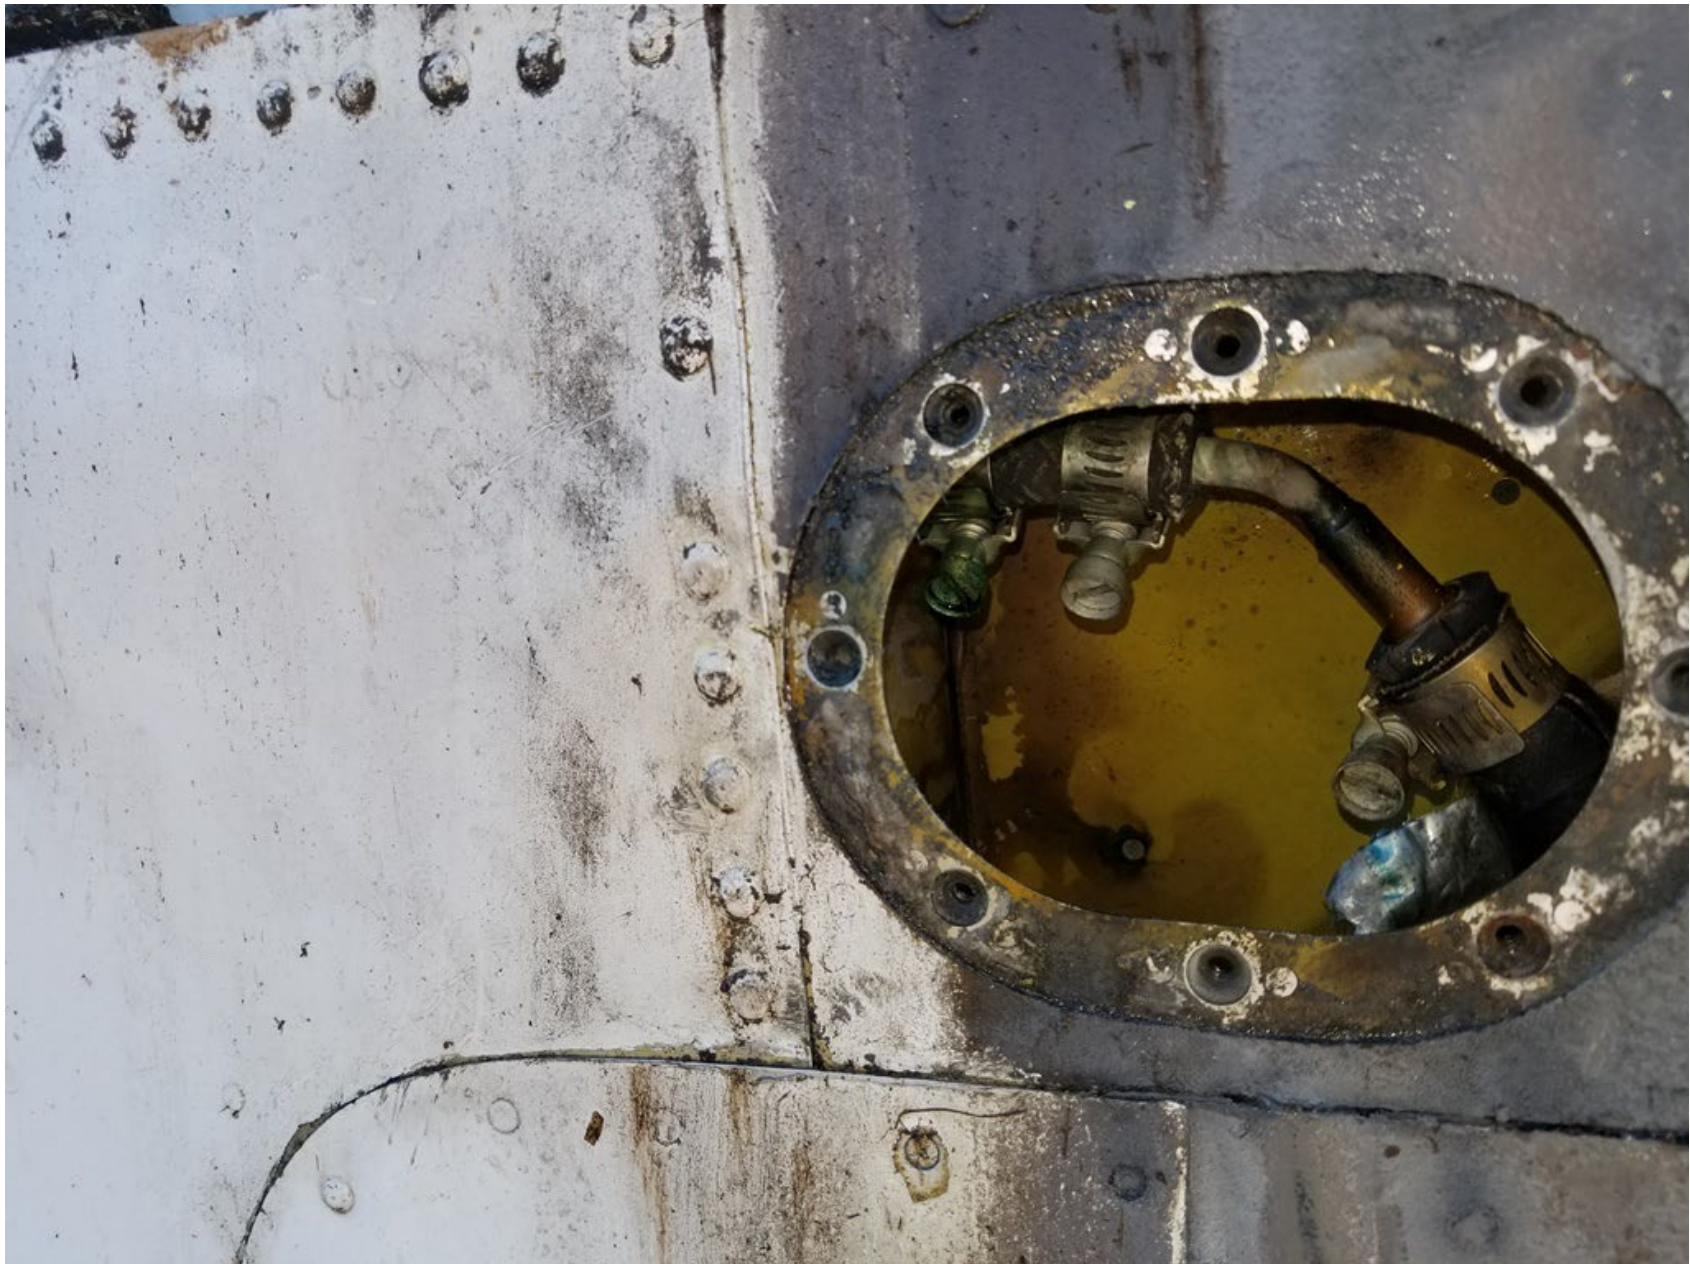
Photo 2 - Loose Aux Fuel Tank Fitting in RH Wing (FAA)

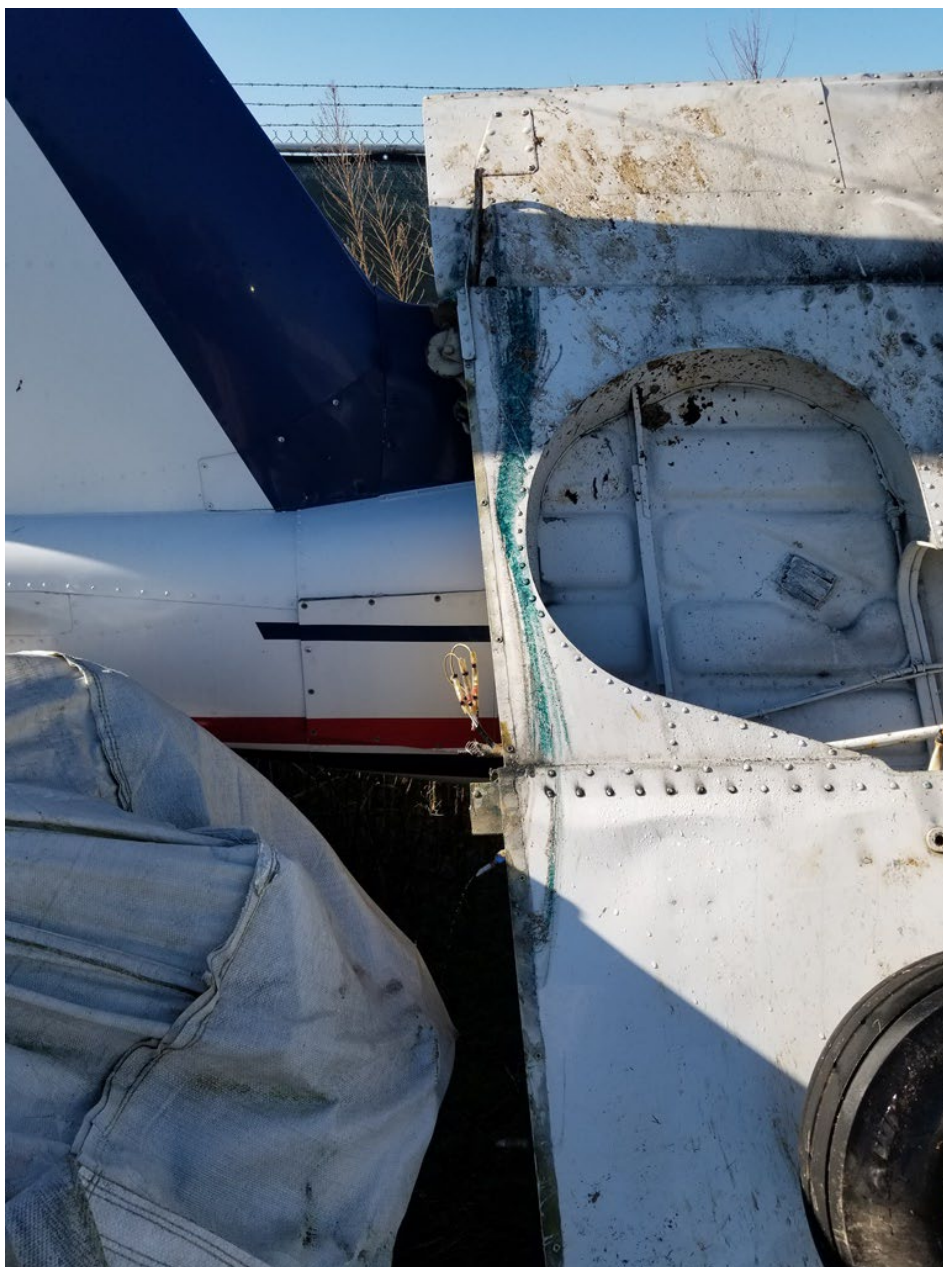
Photo 3 – Fuel Stain at Root of RH Wing (FAA)
