**NATIONAL TRANSPORTATION SAFETY BOARD**

**Photo Array**

**ERA23LA118**

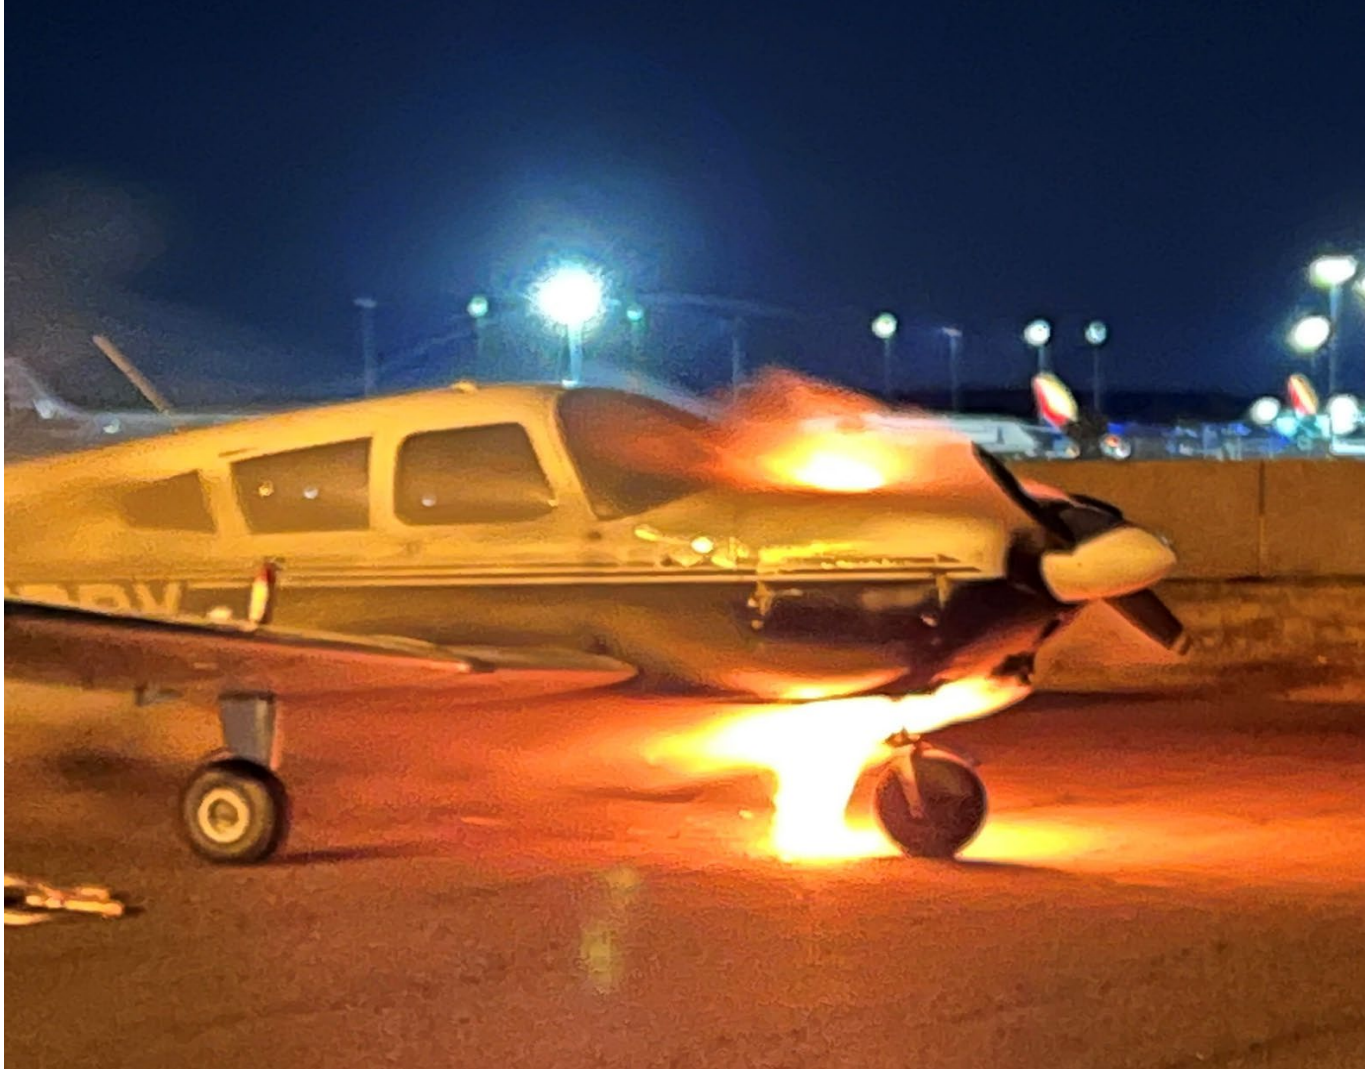
**Photo 1 – View of airplane from right wing with engine on fire (Photo courtesy of Mark Chemacki)**

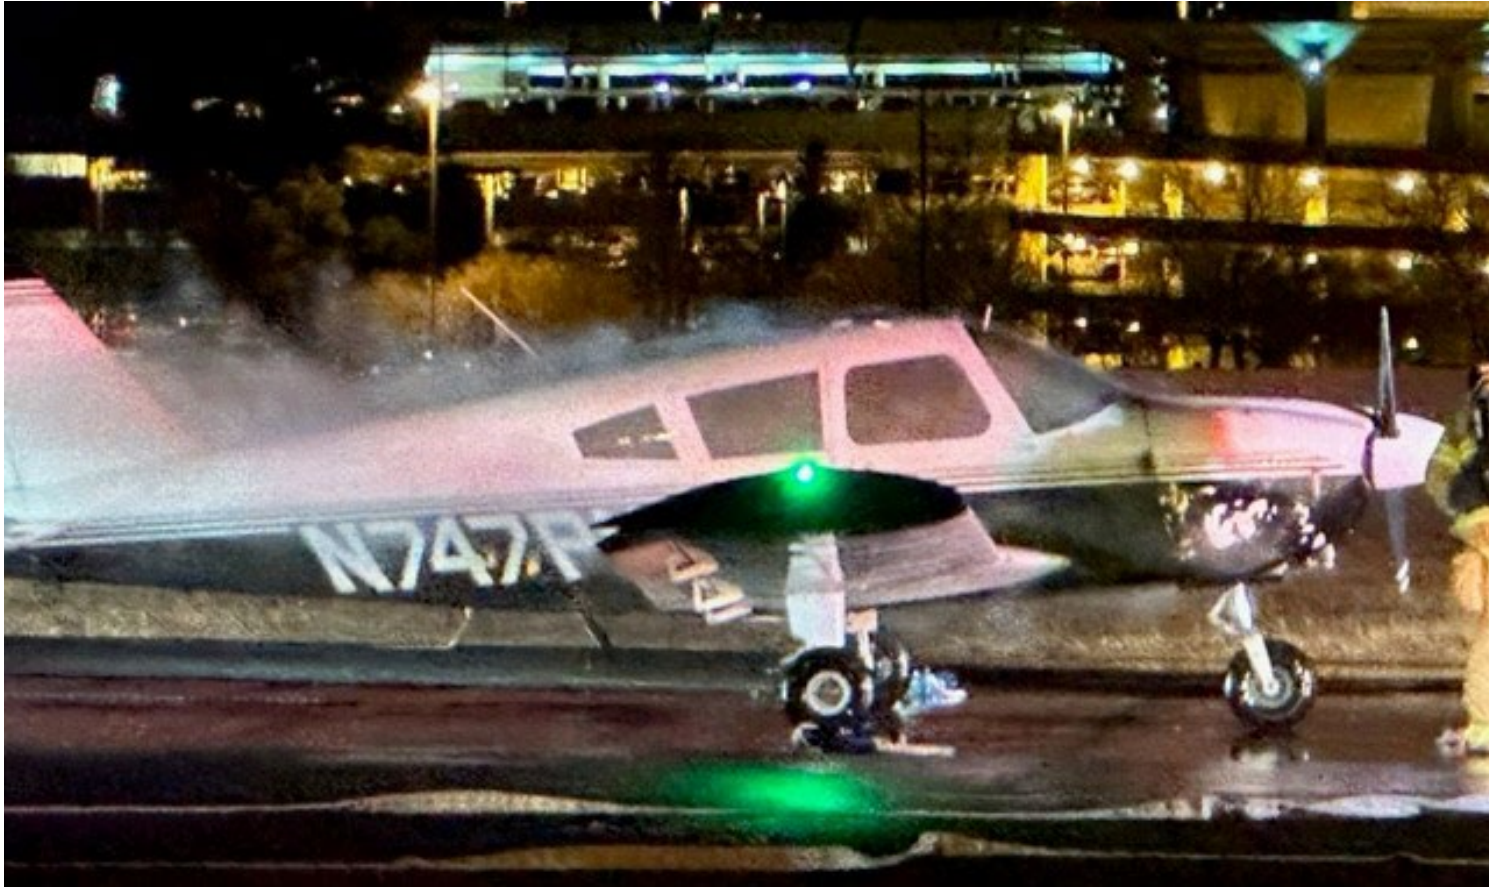
**Photo 2 – View of airplane after fire extinguished (Photo courtesy of RDU Airport Operations)**

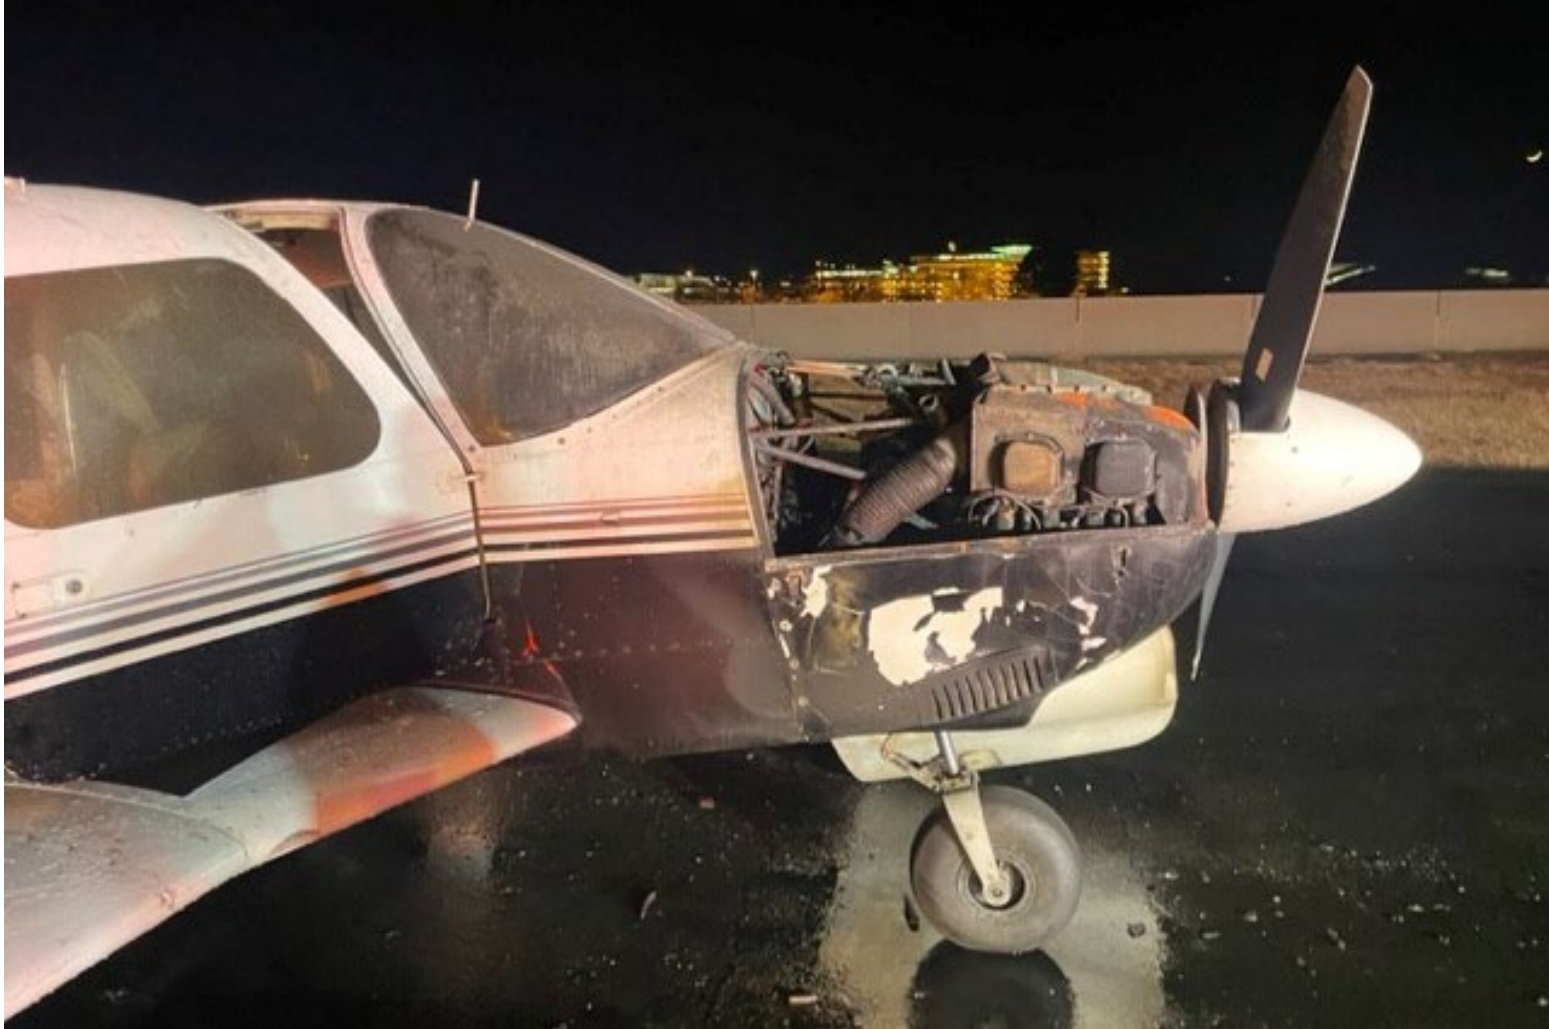
**Photo 3 – Close-up view of damage after fire extinguished (Photo courtesy of RDU Airport Operations)**

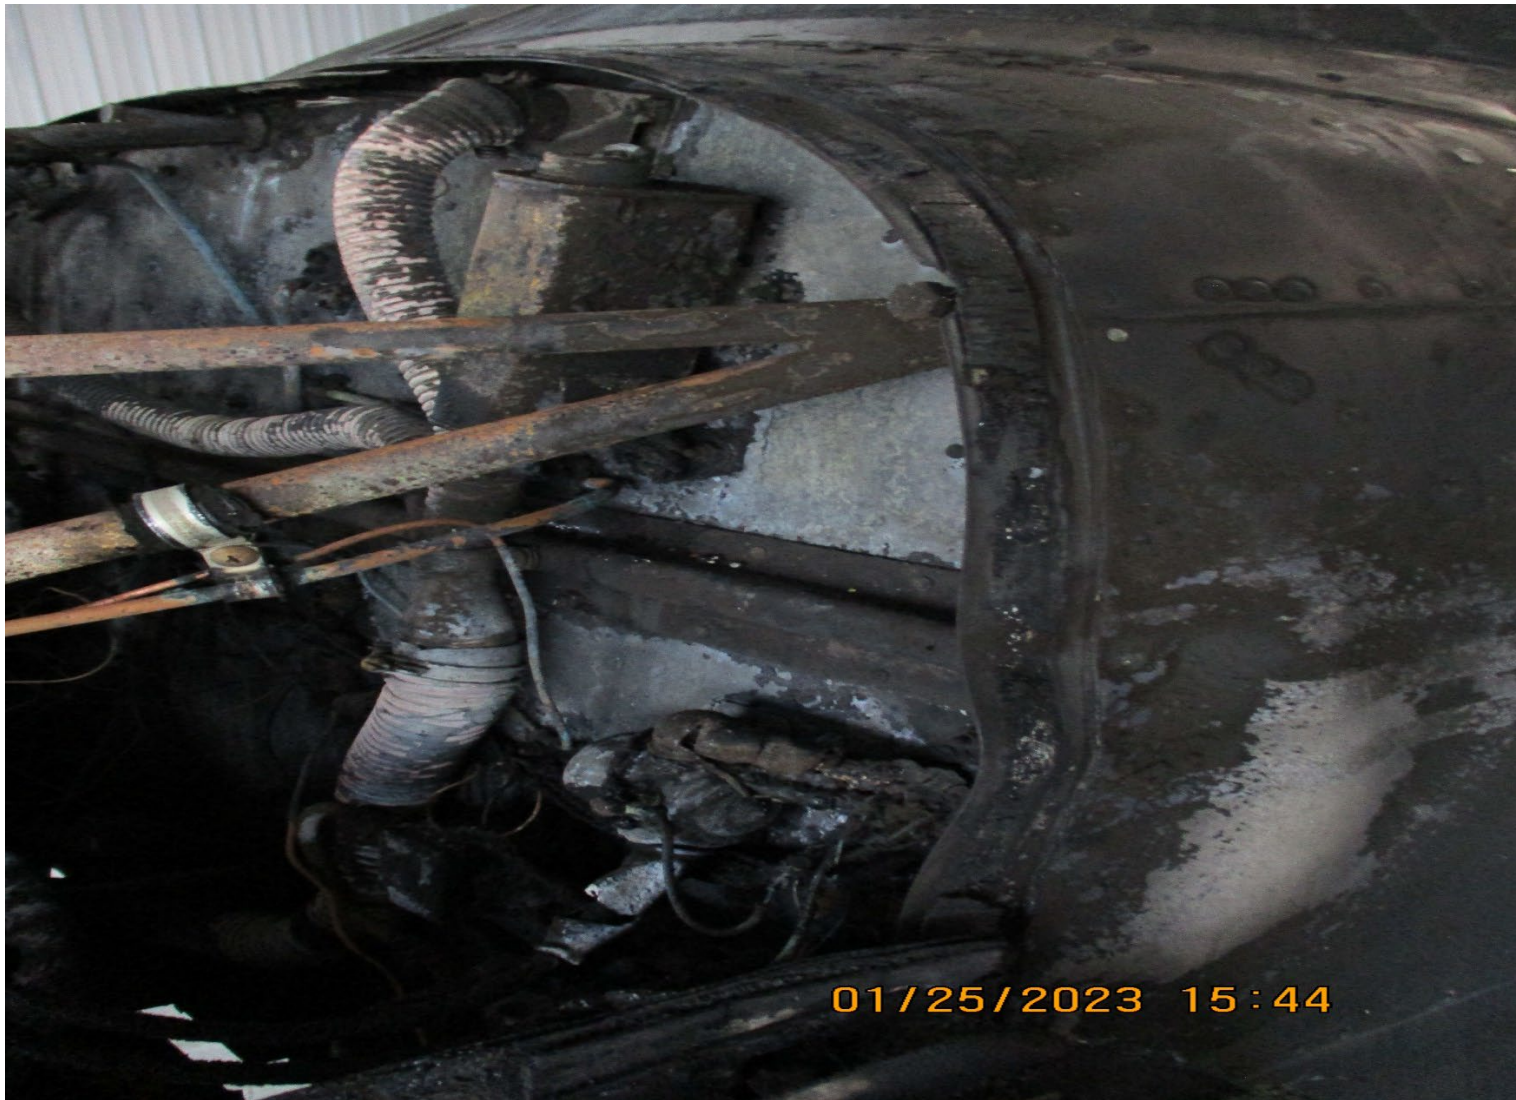
**Photo 4 – View of fire damaged engine mounts and firewall (Photo courtesy of FAA)**
