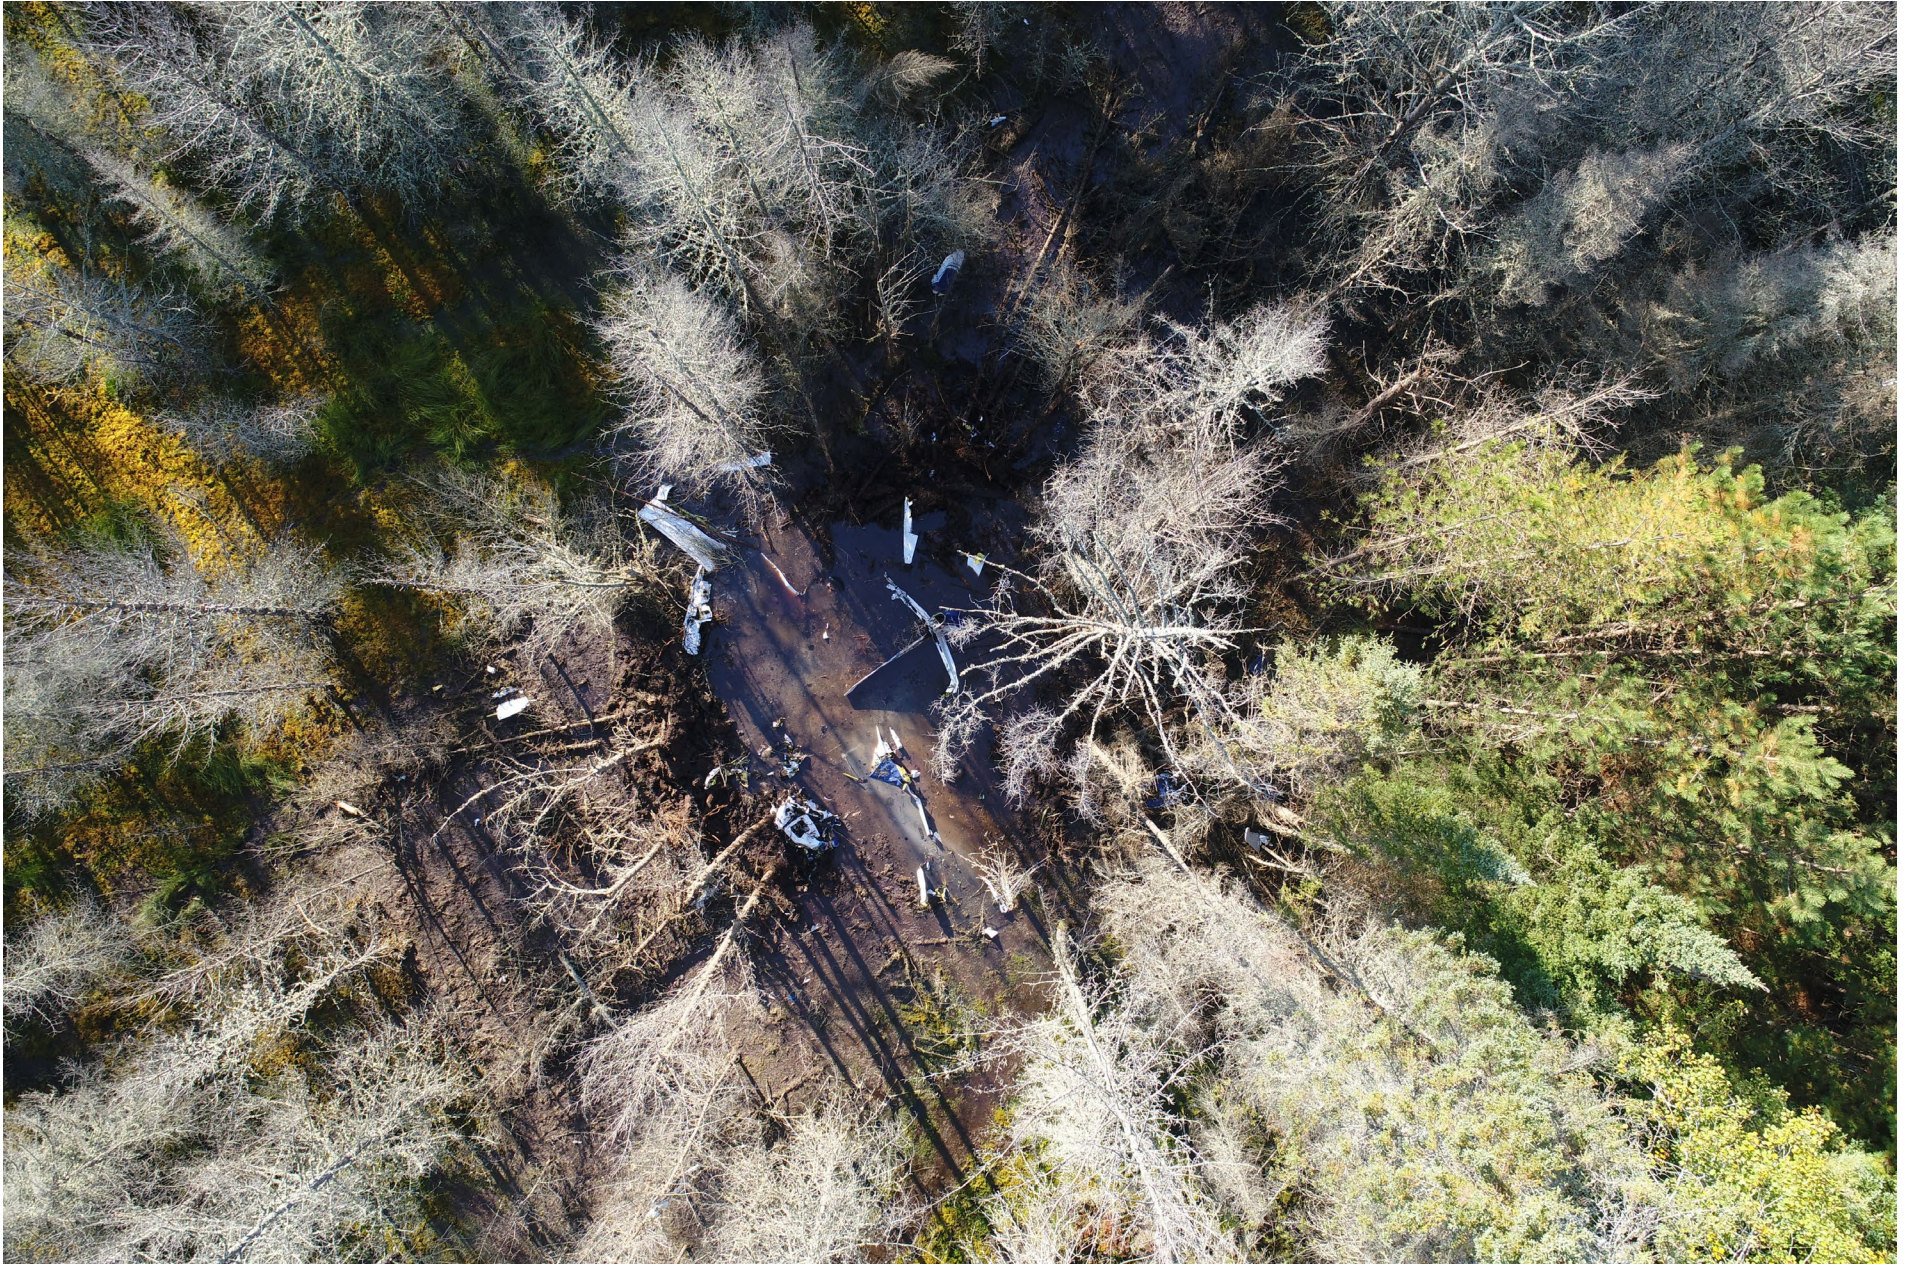
Photo 1 – Aerial image of accident site

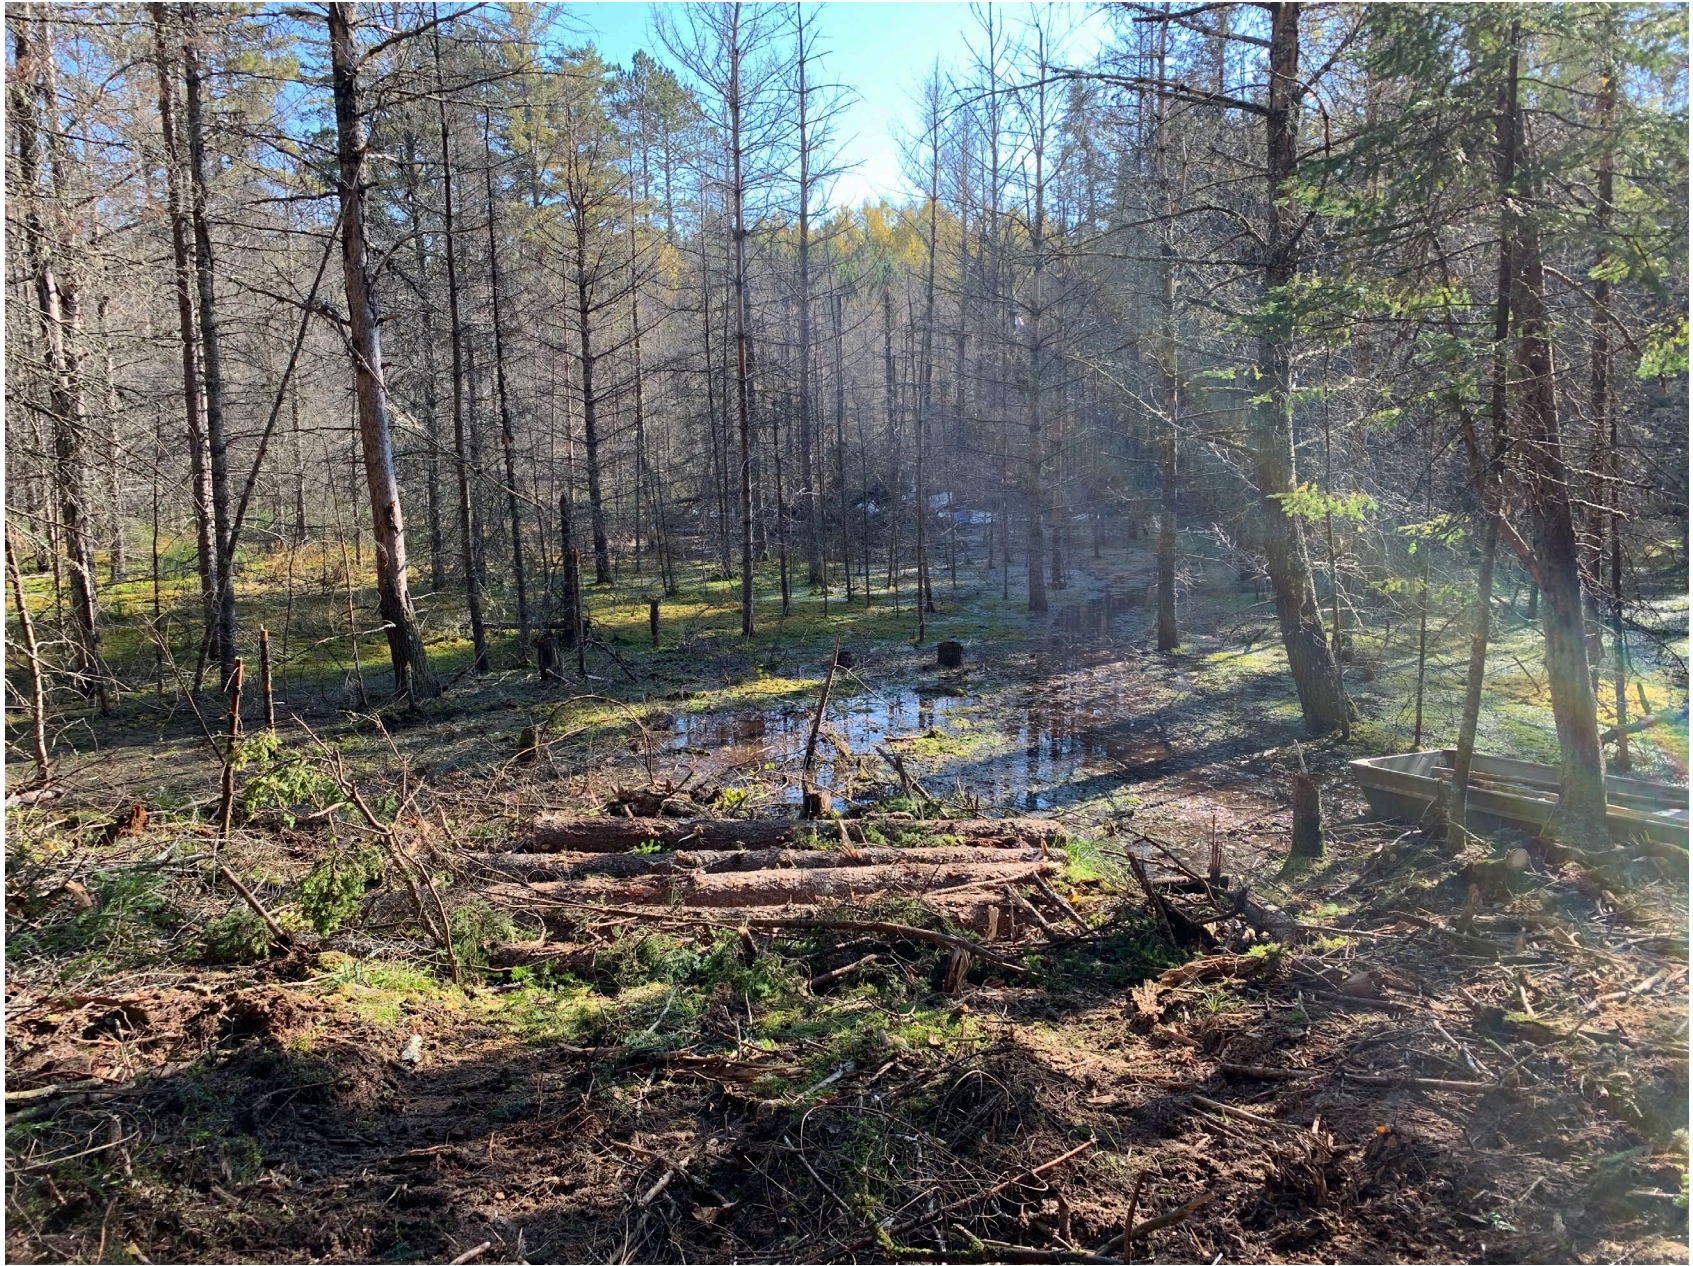
Photo 2 – Main wreckage

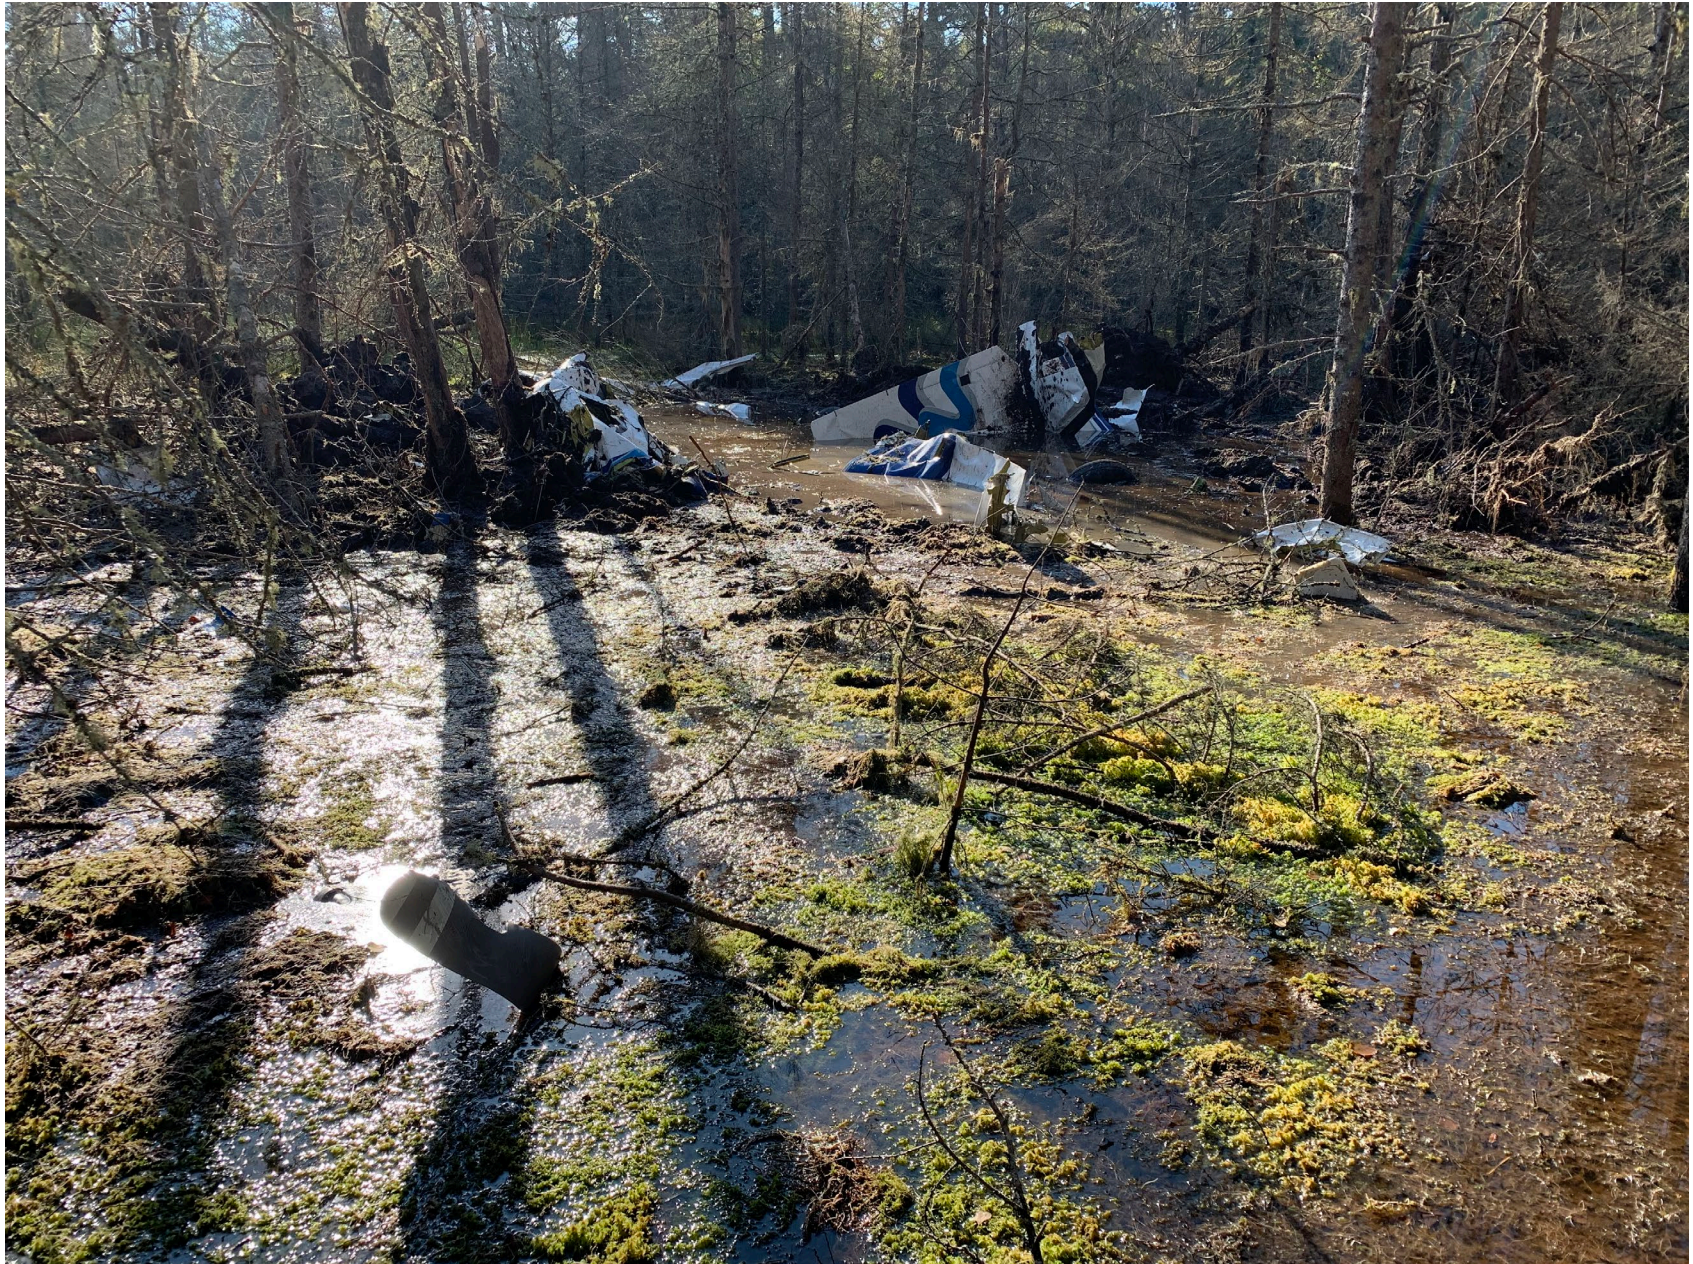
Photo 3 – Main wreckage

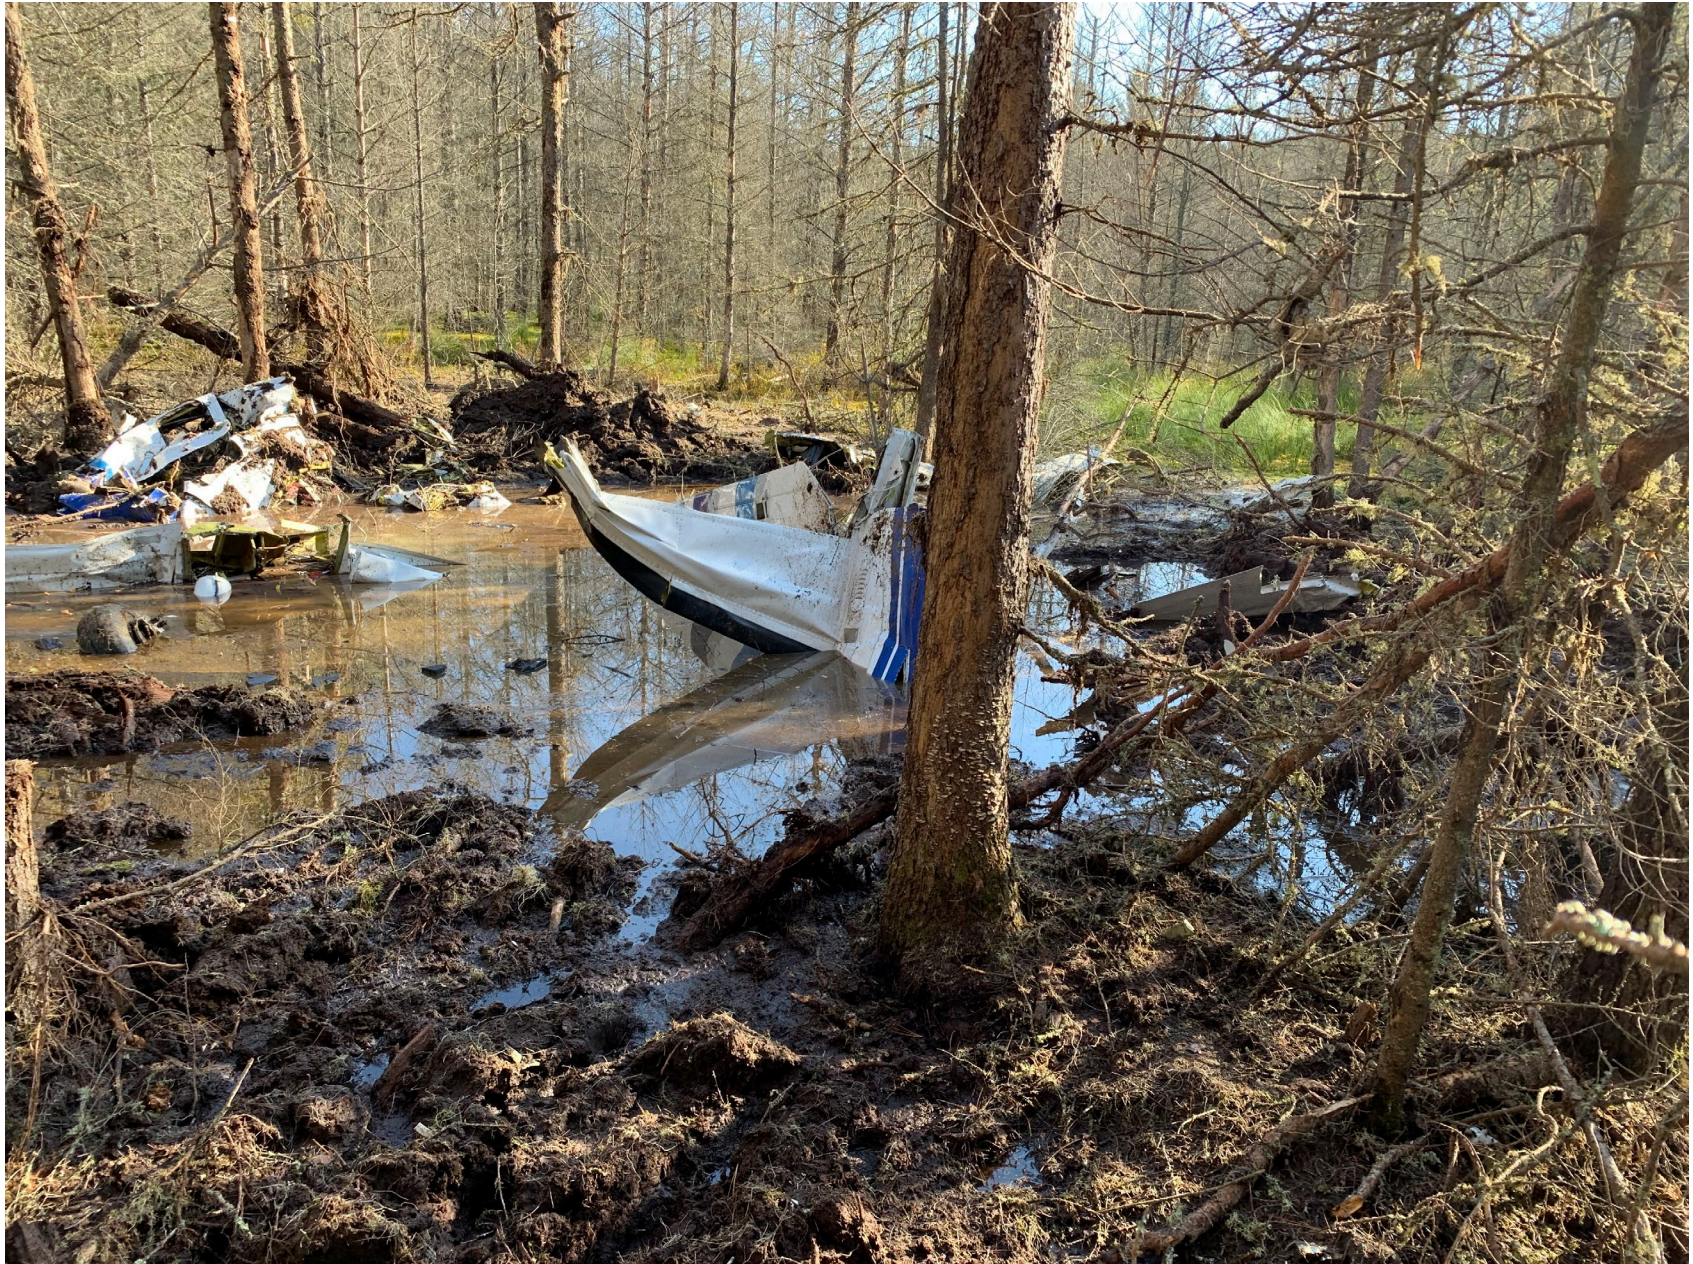
Photo 4 – Main wreckage

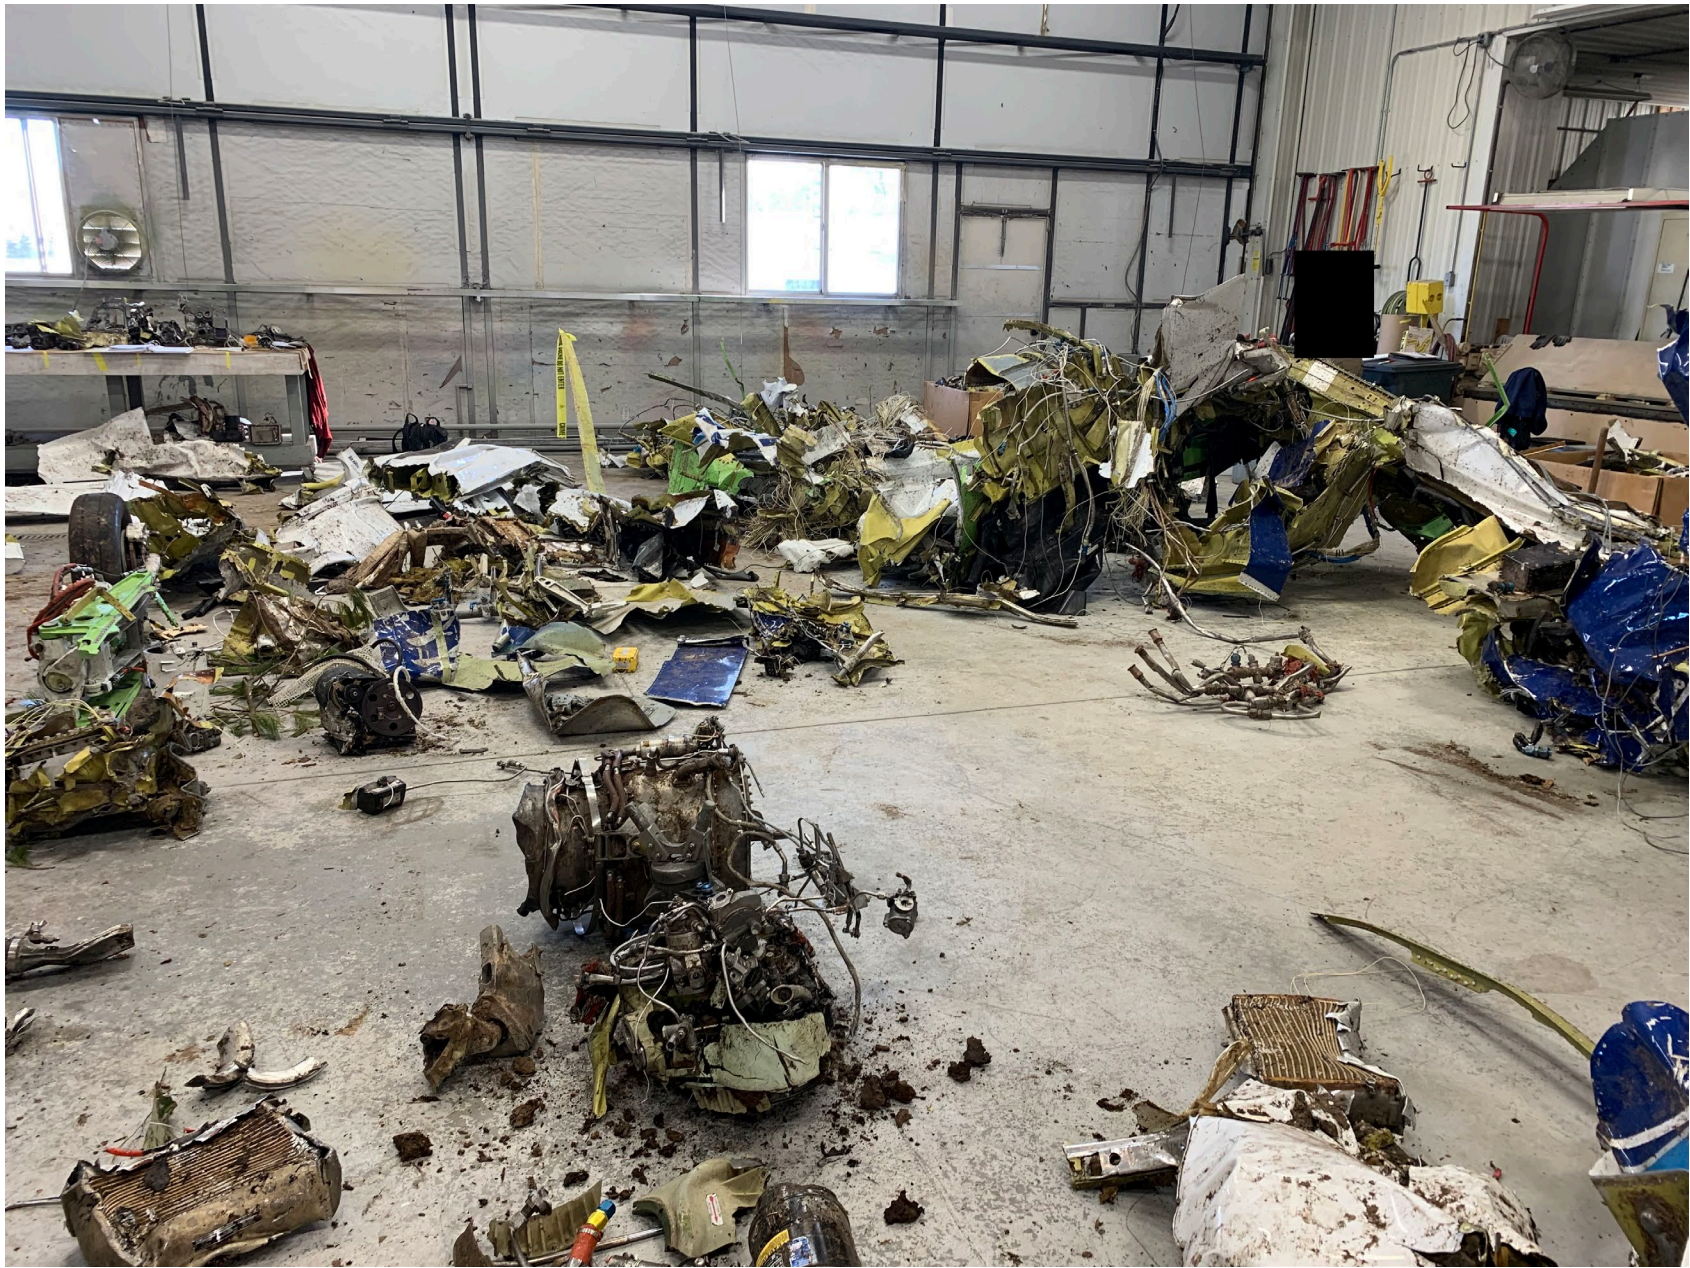
Photo 5 – Main wreckage

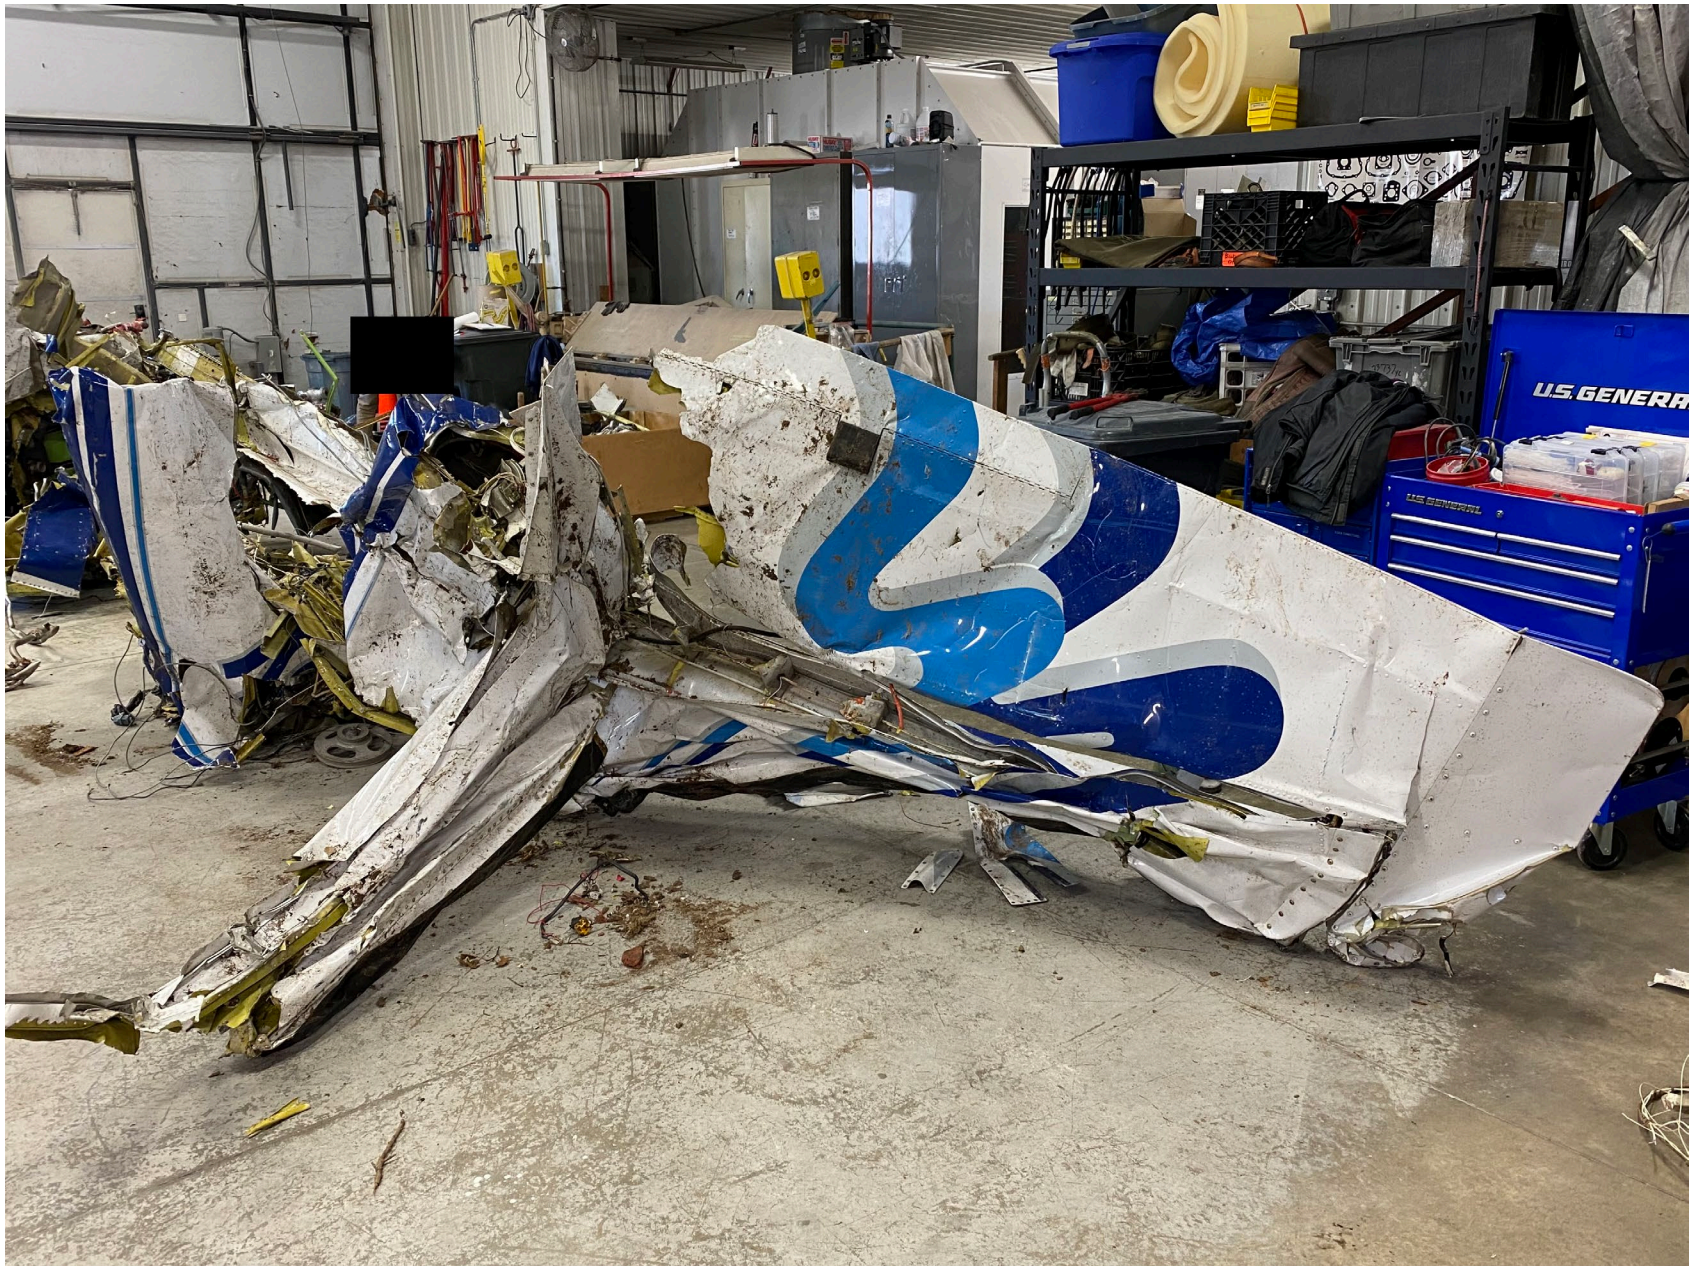
Photo 6 – Empennage (Source: Twin Commander LLC)
