ERA23FA194

INVESTIGATION PHOTOGRAPHS

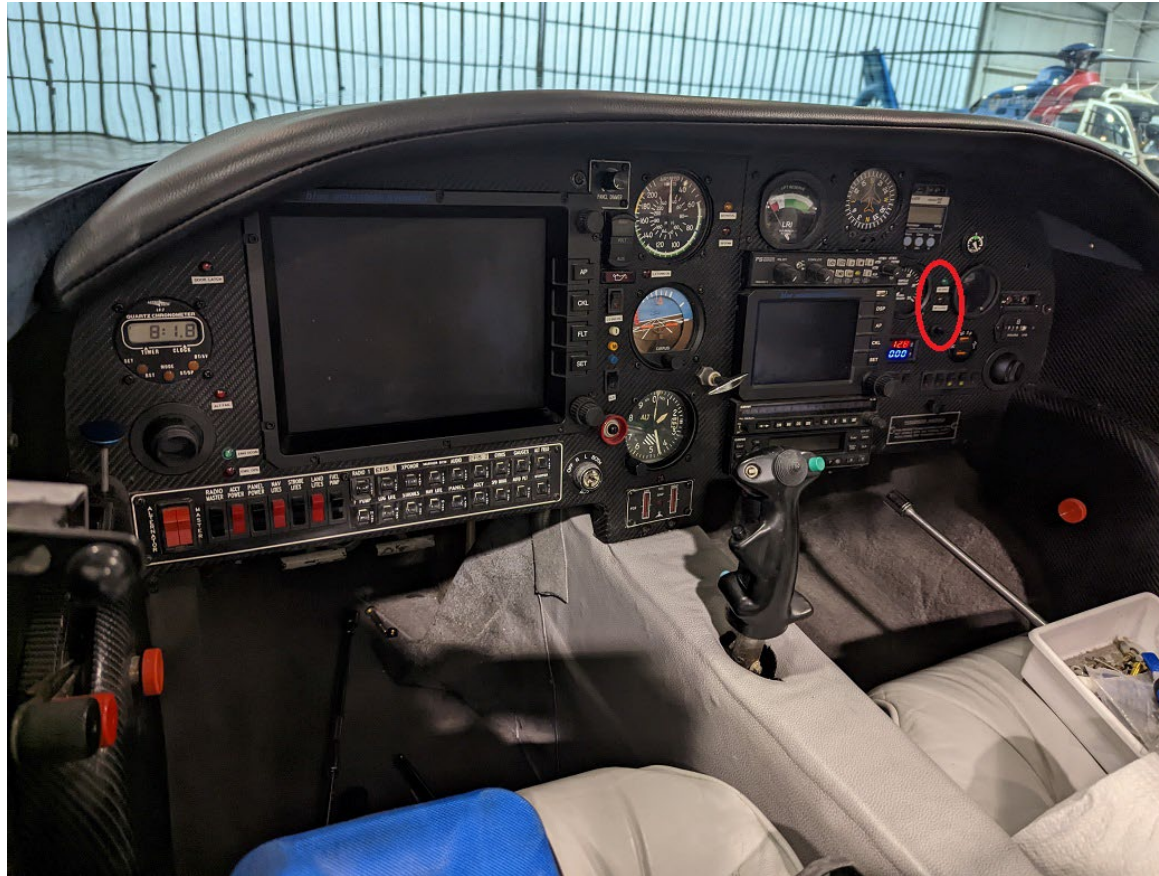
Photograph - Turbocharger Switch in Cockpit (Courtesy of Owner)
