CEN23LA062

INVESTIGATION PHOTOGRAPHS

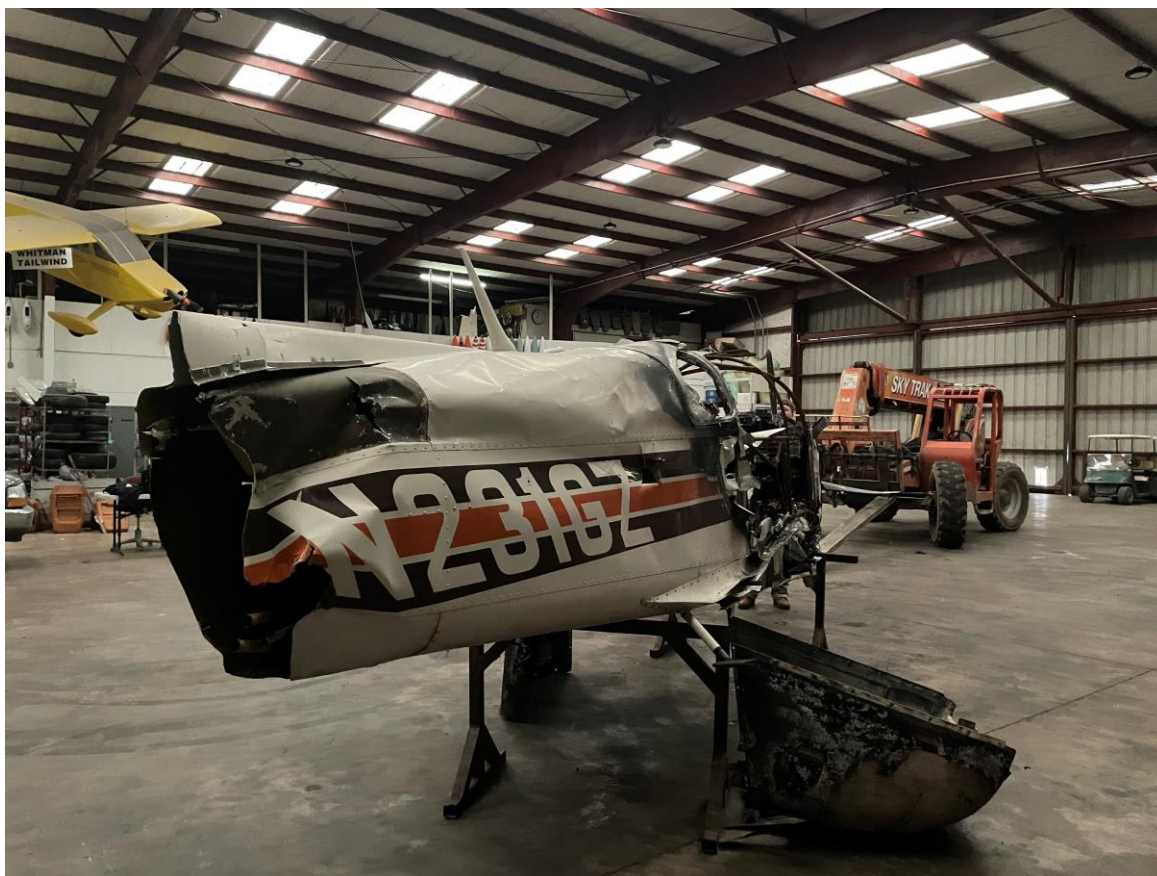
Photograph 1 - Substantially Damaged Airplane (Courtesy of FAA)

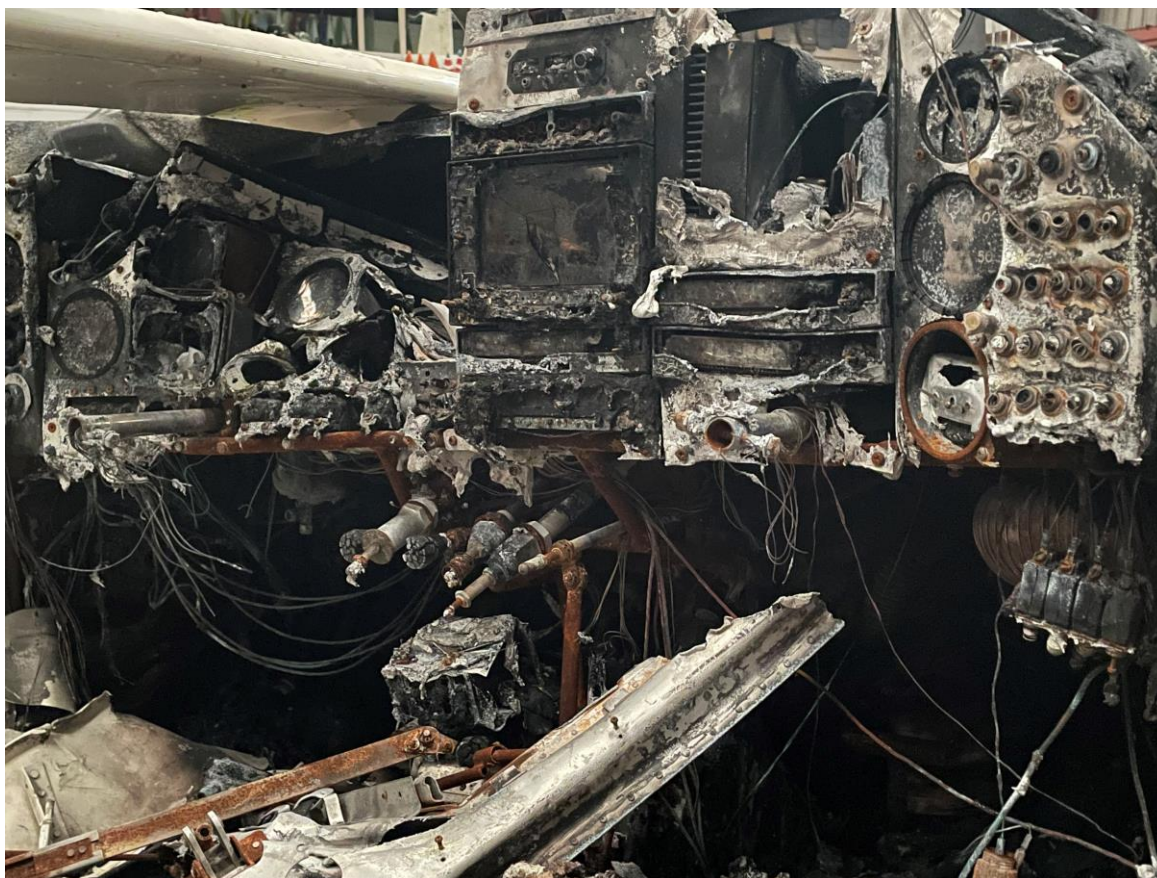
Photograph 2 - Burned Airplane Instrument Panel (Courtesy of FAA)

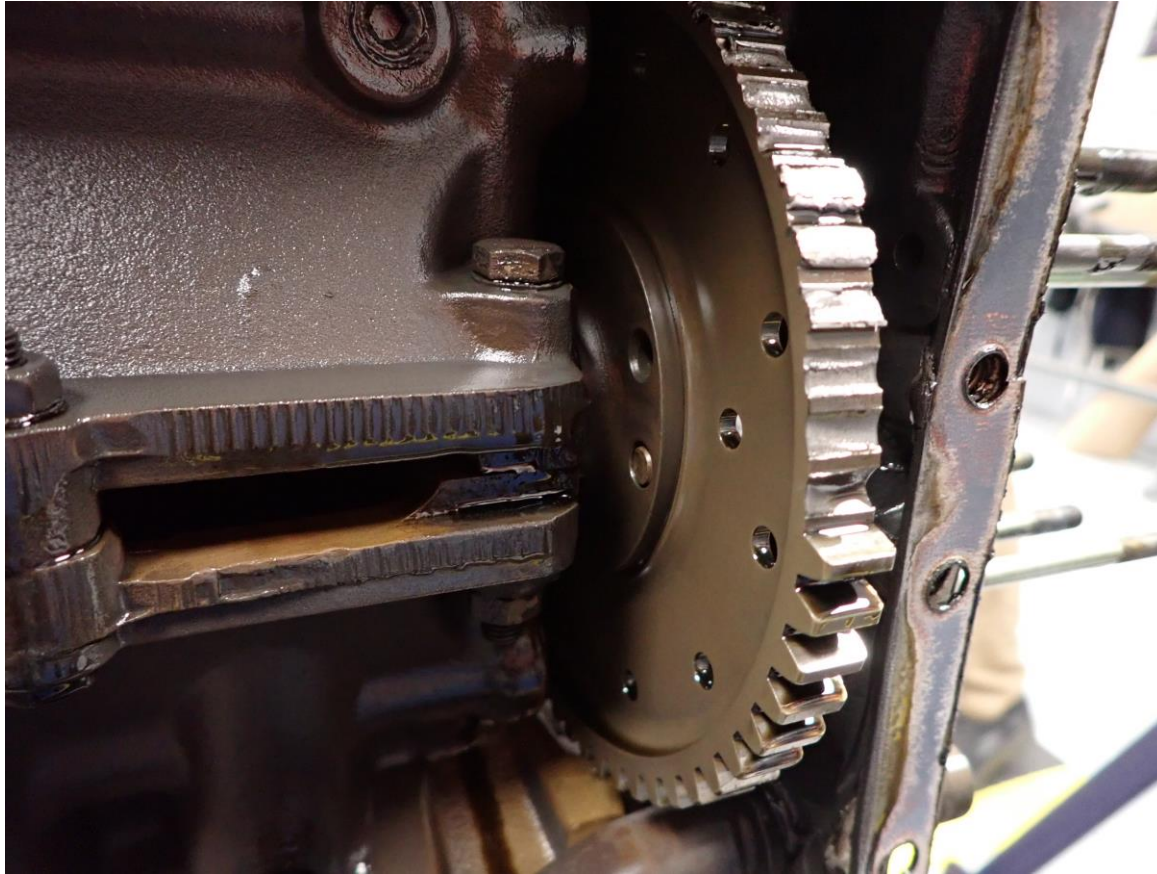
Photograph 3 - Missing Teeth on Camshaft Gear

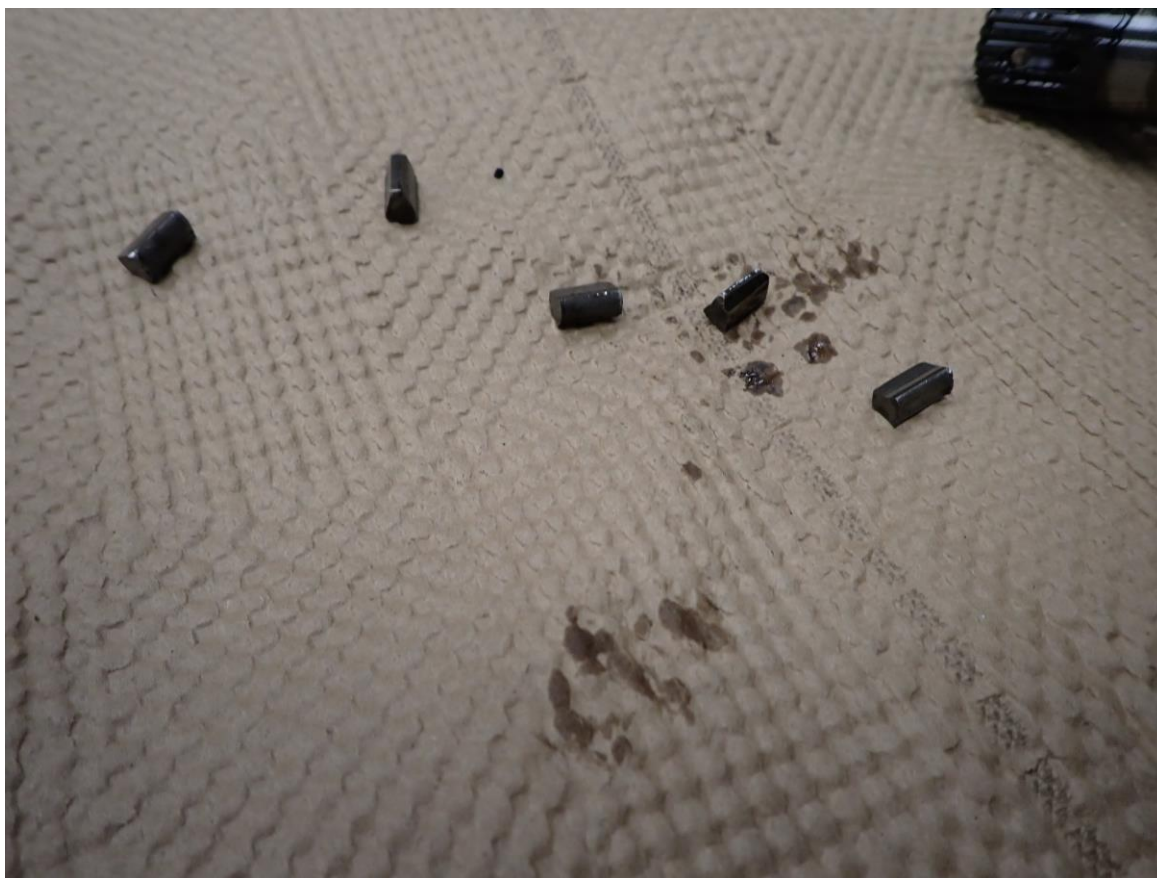
Photograph 4 - Camshaft Teeth Found in Oil Sump

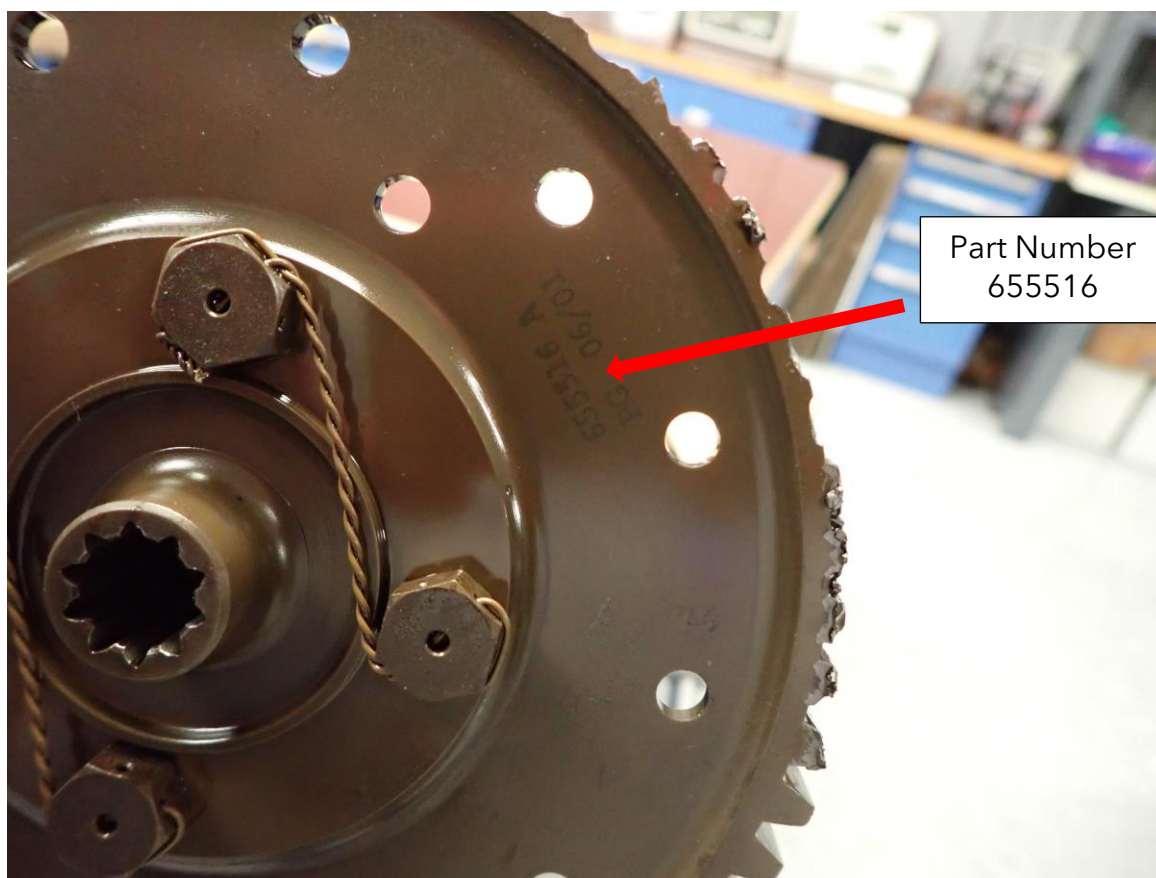
Part Number
655516

Photograph 5 - Camshaft Gear Highlighting the Part Number
