CEN24LA127

INVESTIGATION PHOTOGRAPHS

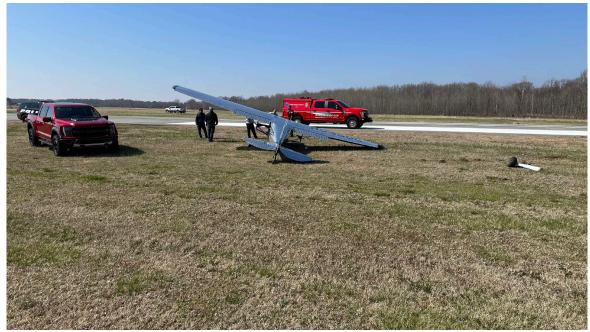
Photograph 1 - Right main landing gear separated (Courtesy of Pilot)

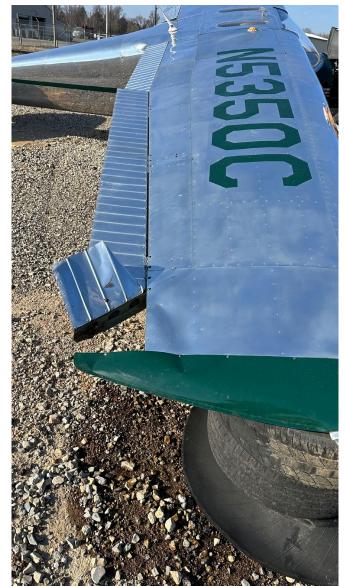
Photograph 2 - Deformation noted to the right aileron (Courtesy of Pilot)

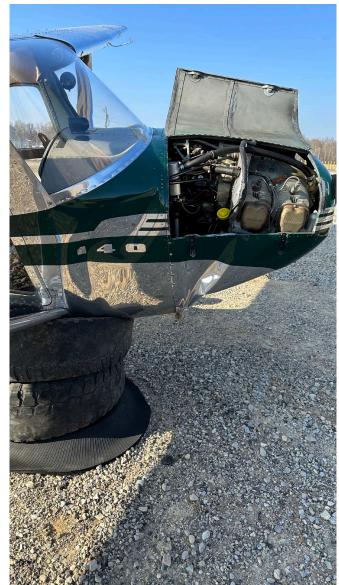
Photograph 3 - Deformation noted to the fuselage (Courtesy of Pilot)
