ERA24LA146

## INVESTIGATION PHOTOGRAPHS

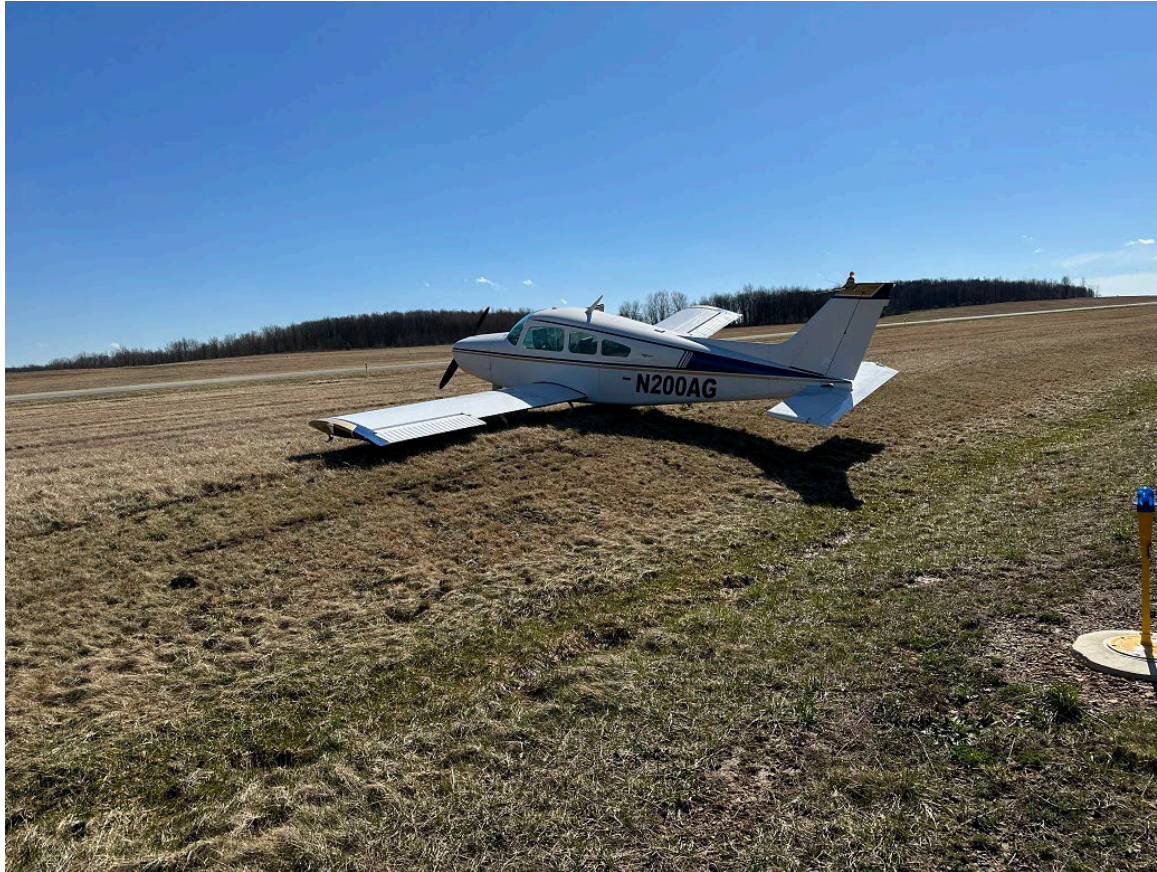
**Photograph 1 - Main Wreckage (Courtesy of FAA)**

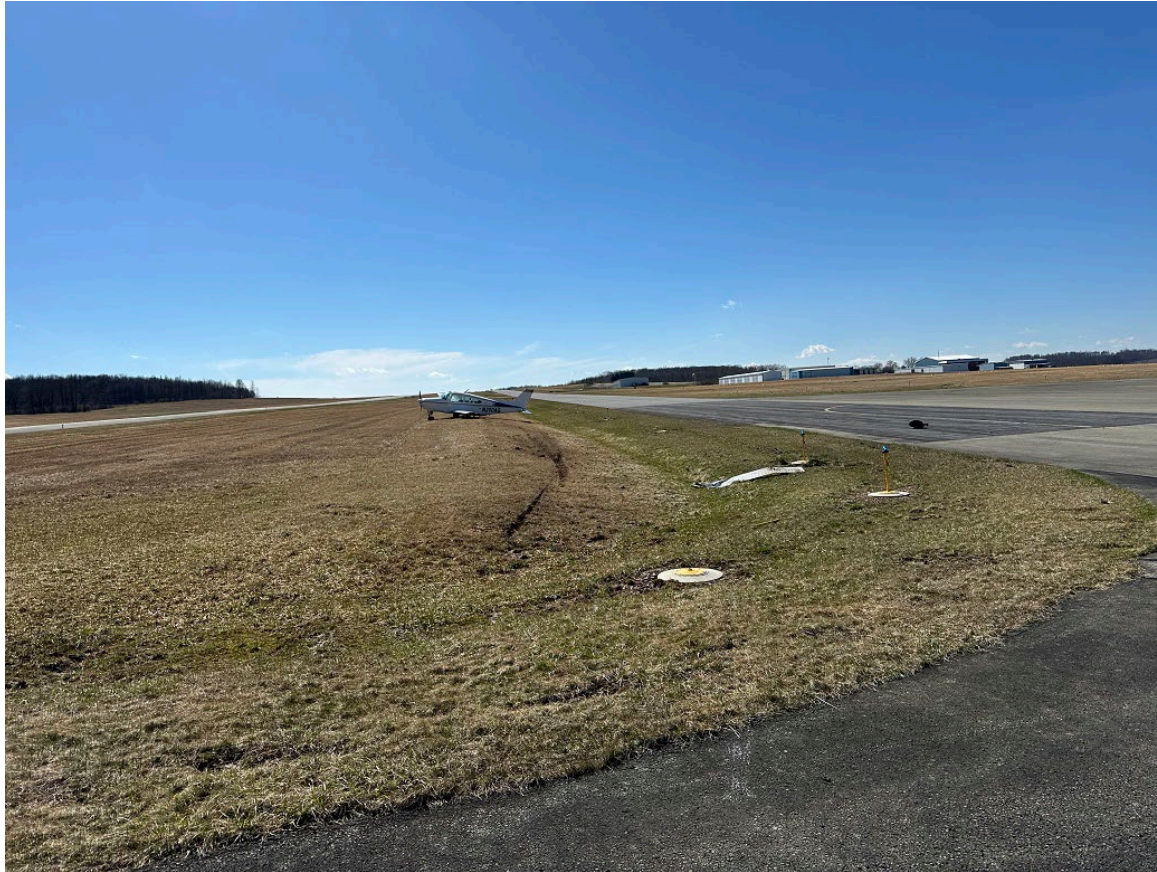
**Photograph 2 - Debris Path of Left Flap And Left Main Landing Gear (Courtesy of FAA)**

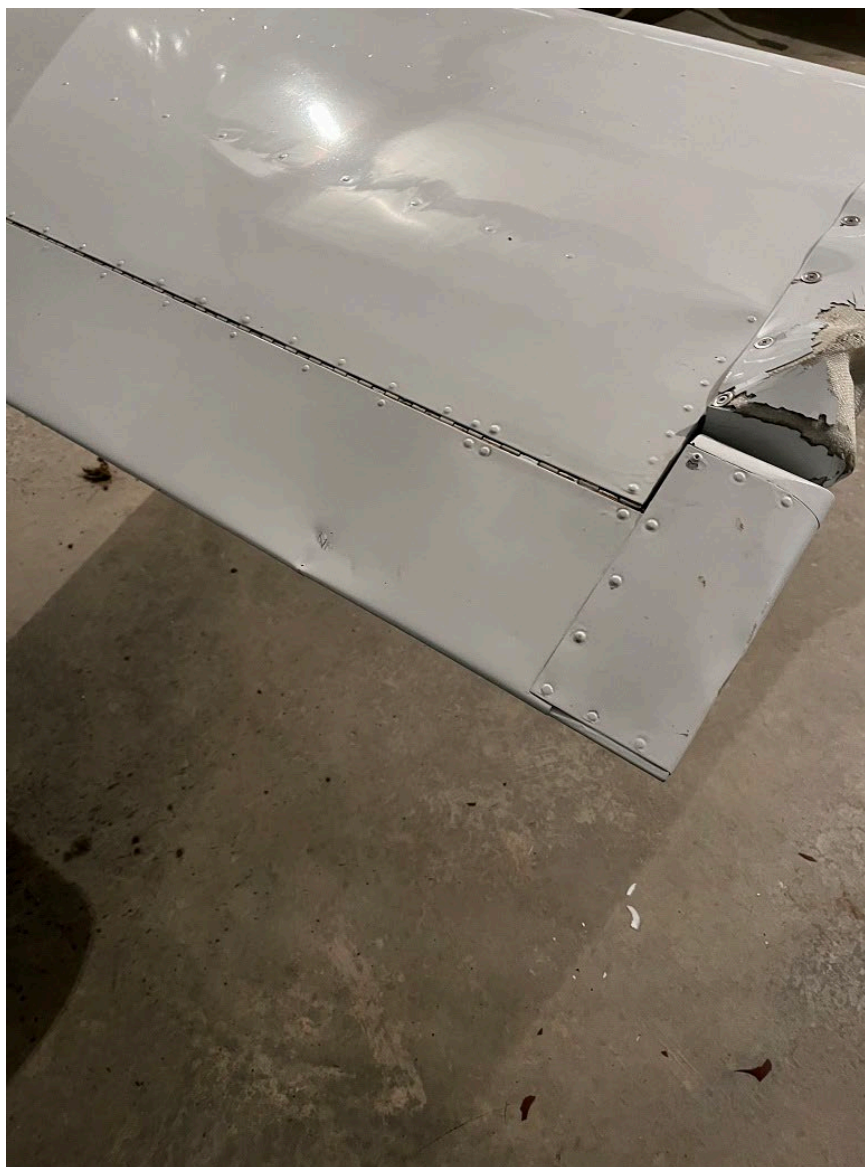
**Photograph 3 - Right Elevator Damage (Courtesy of FAA)**
