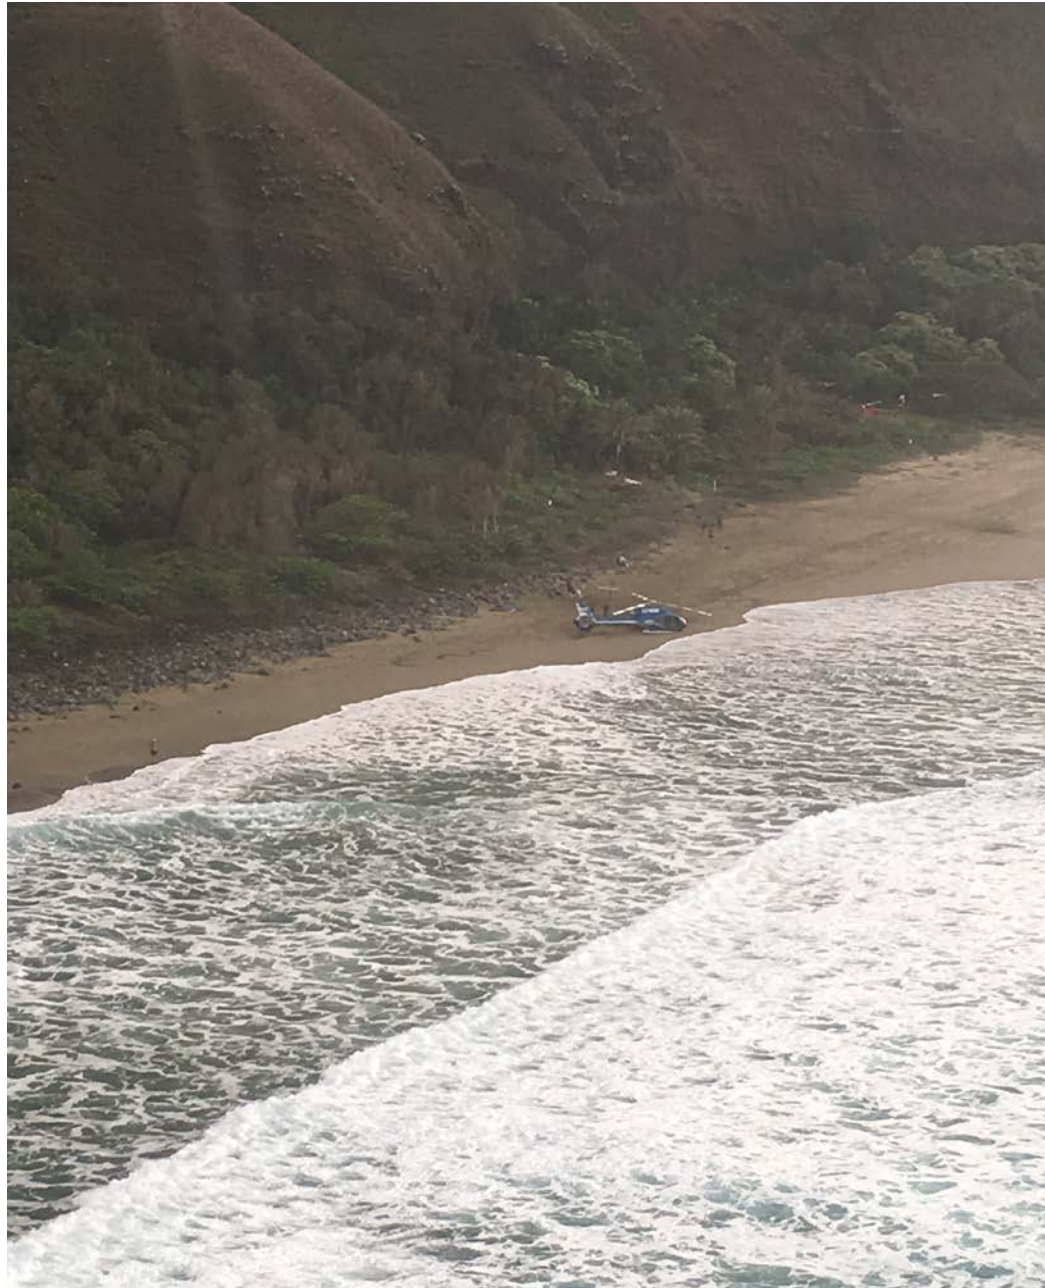
Photo 1 – Aerial view of the helicopter landing area.

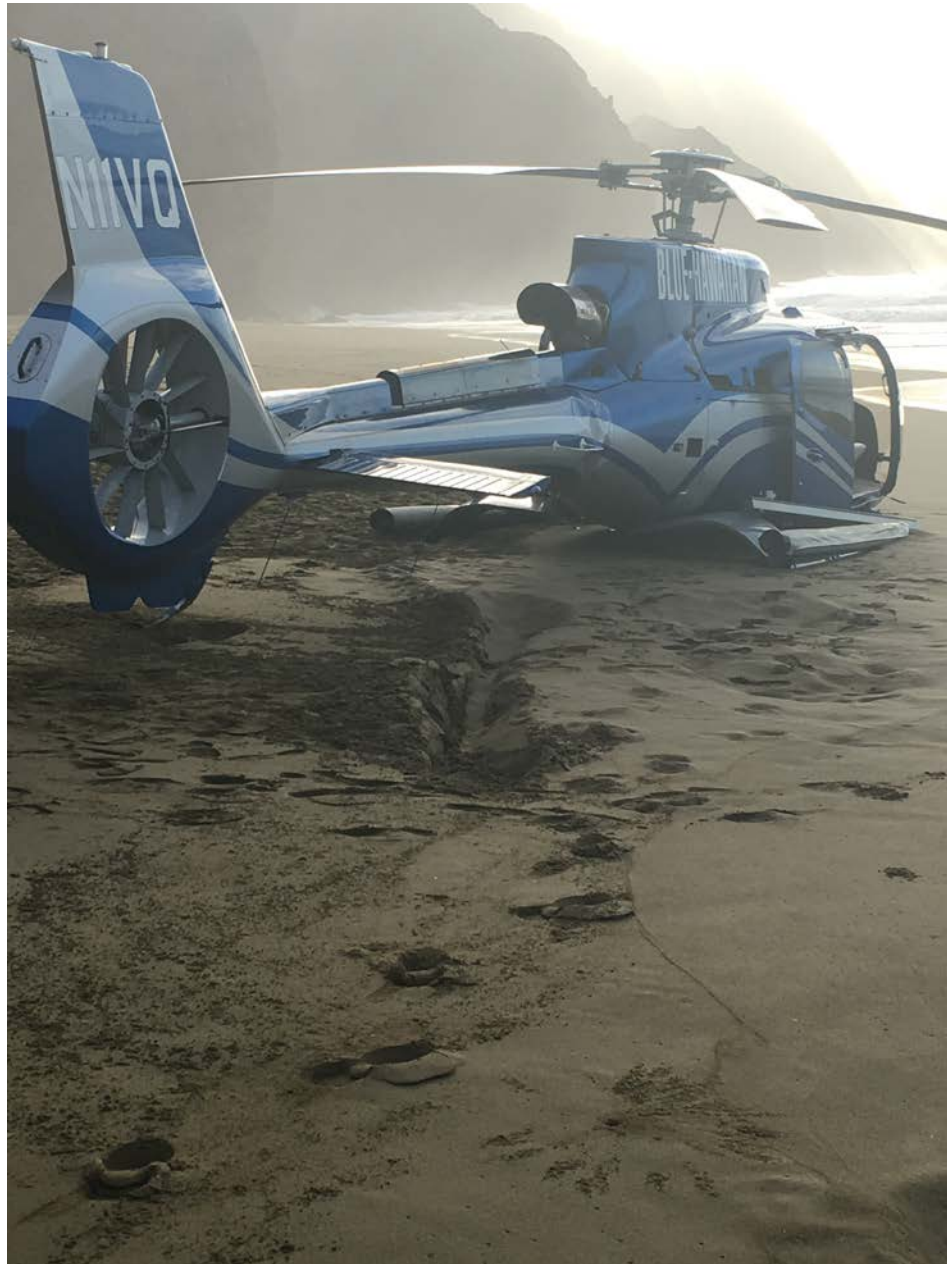
Photo 2 – On-scene view of the helicopter, right rear side.

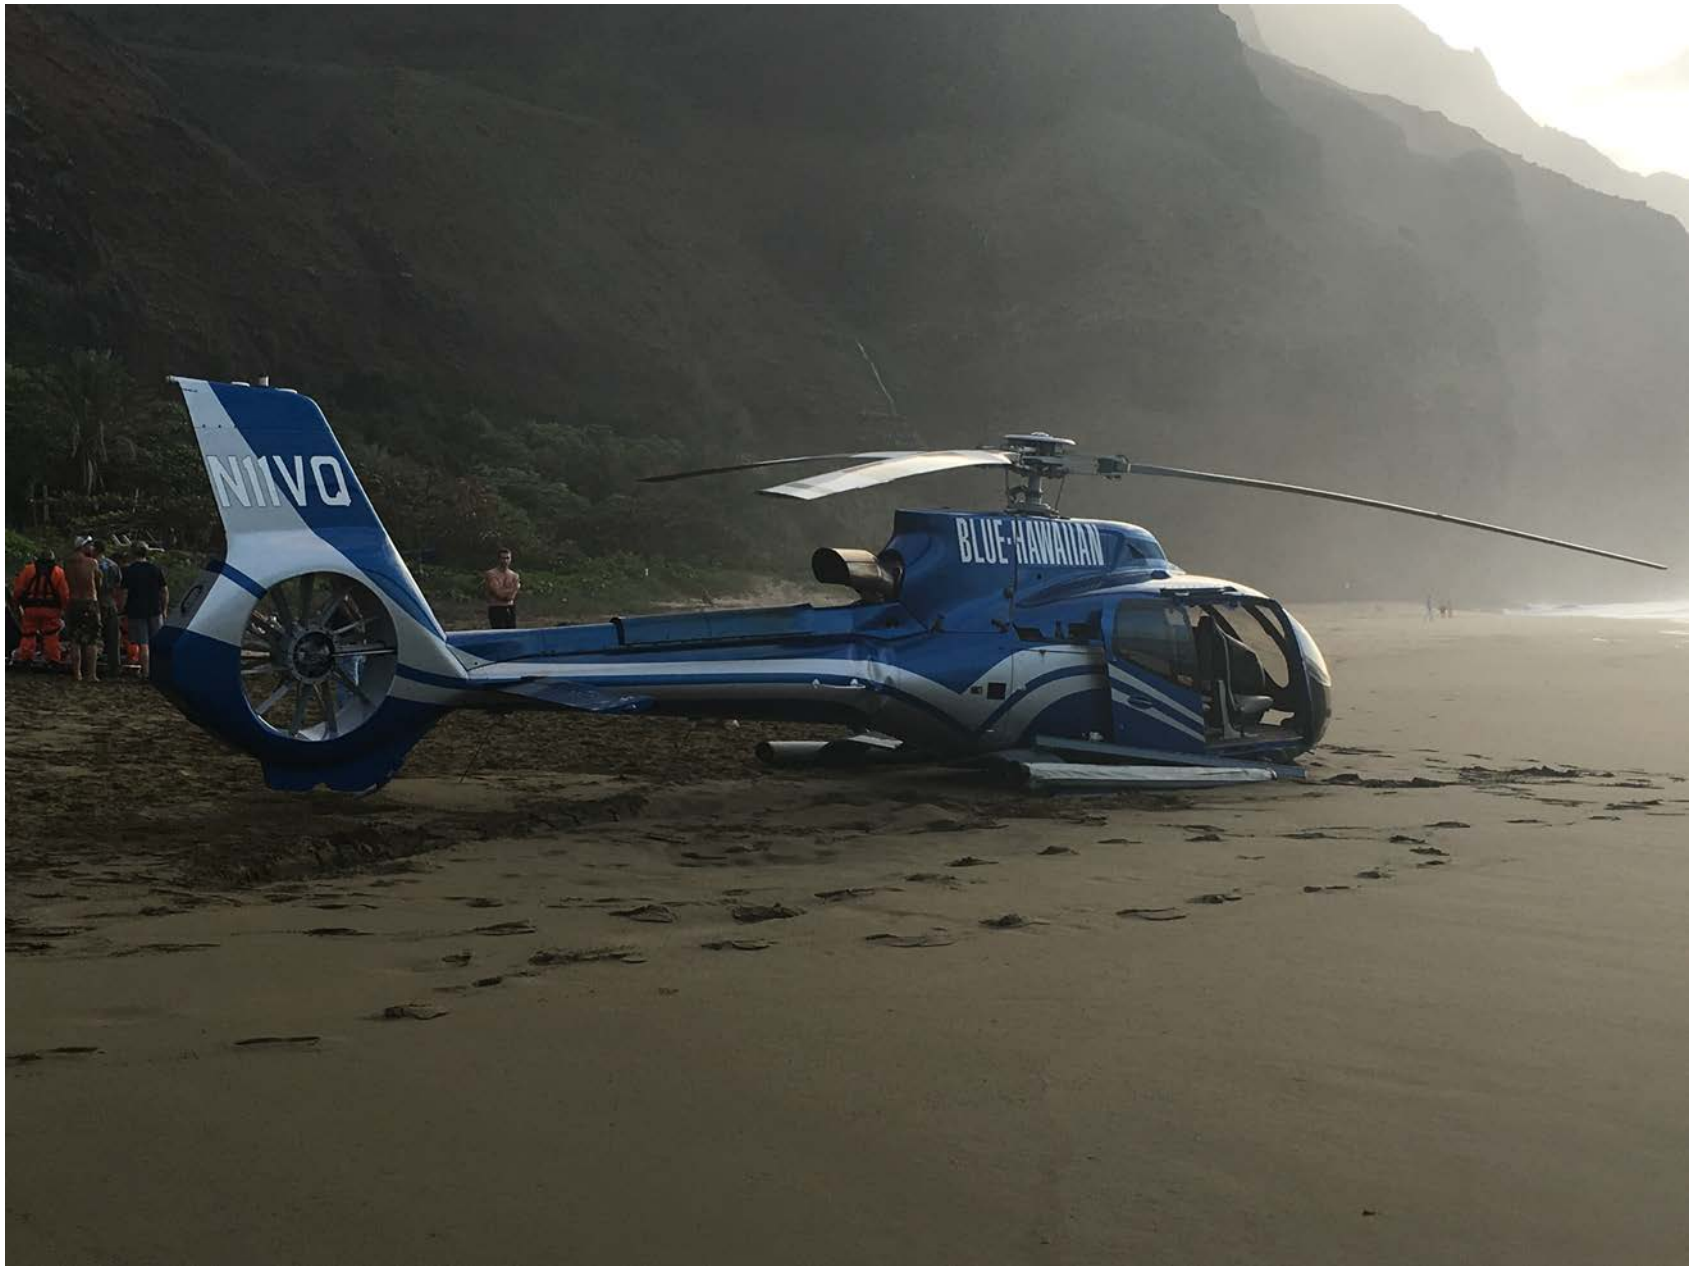
Photo 3 – On-scene view of the helicopter, right side.

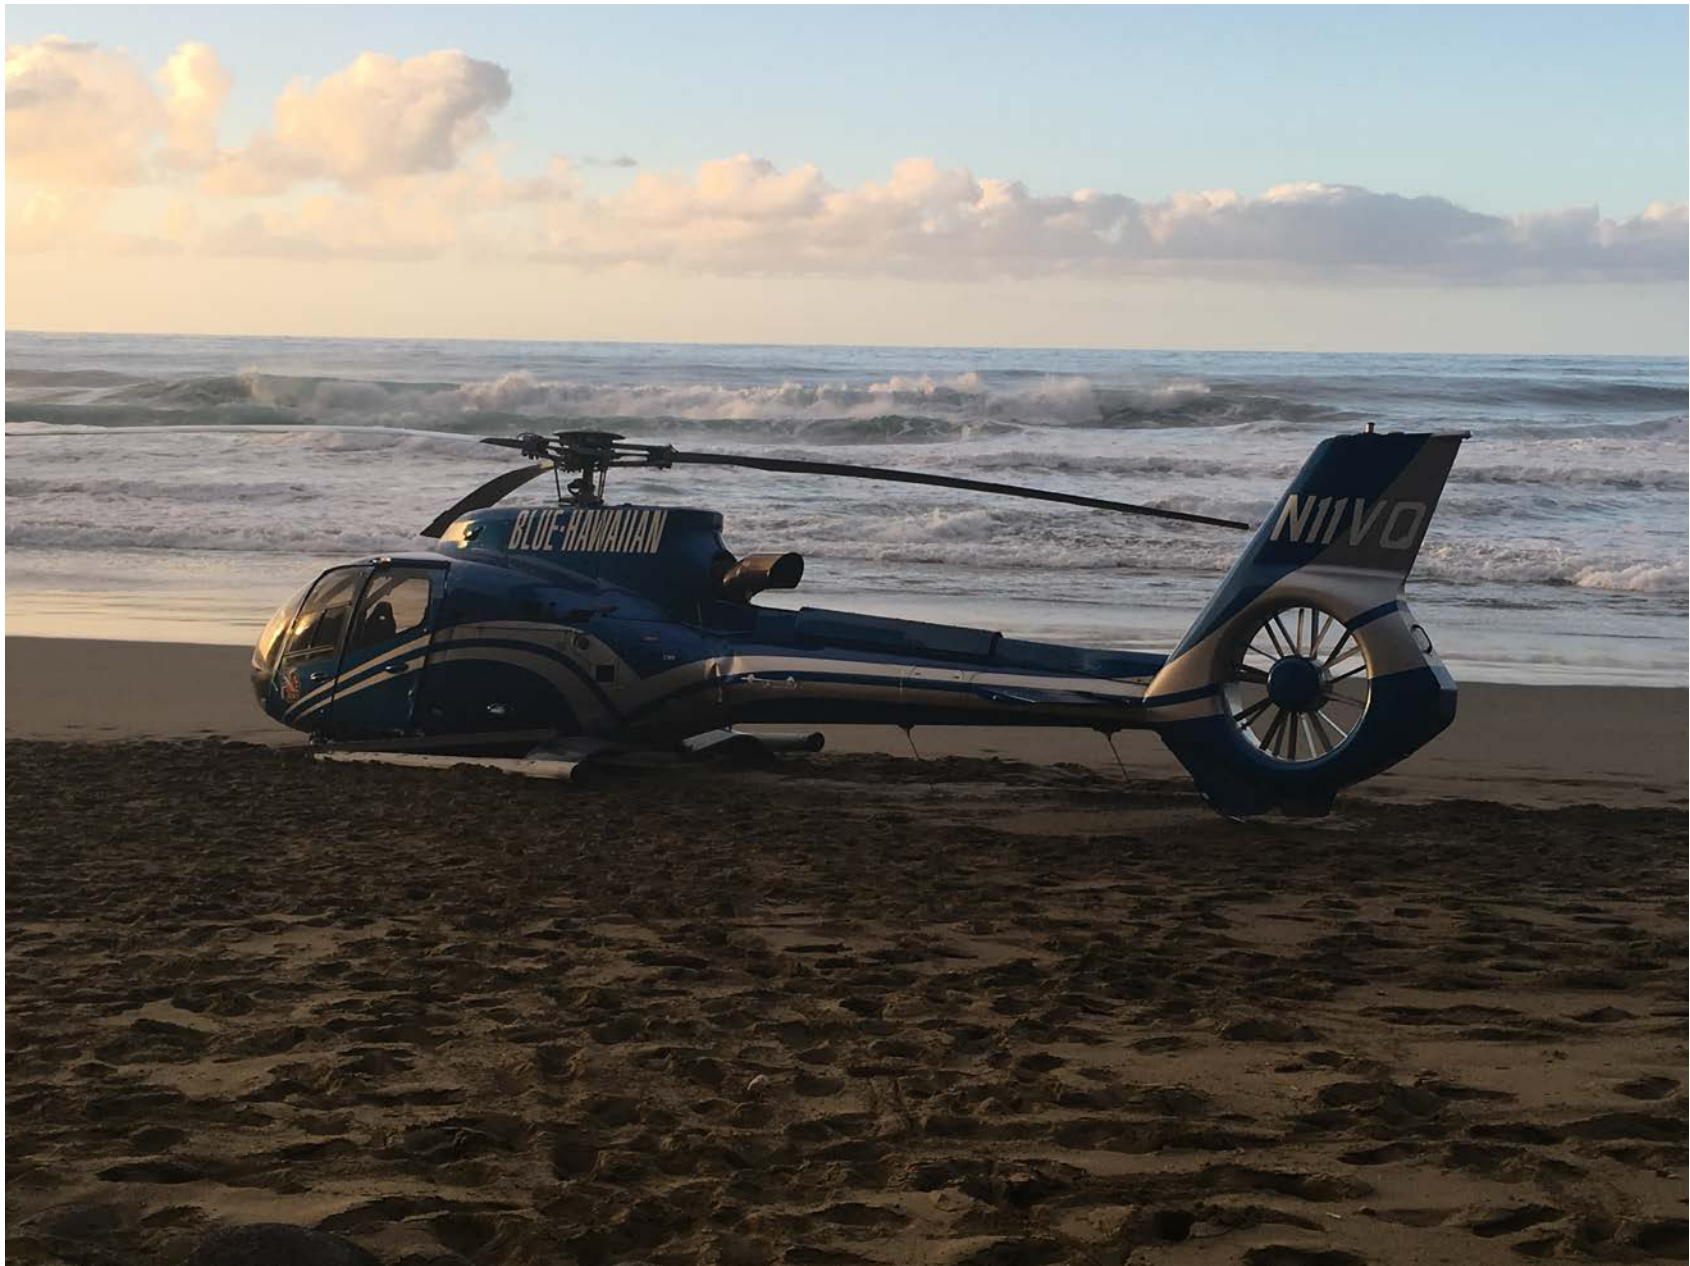
Photo 4 – On-scene view of the helicopter, left side.

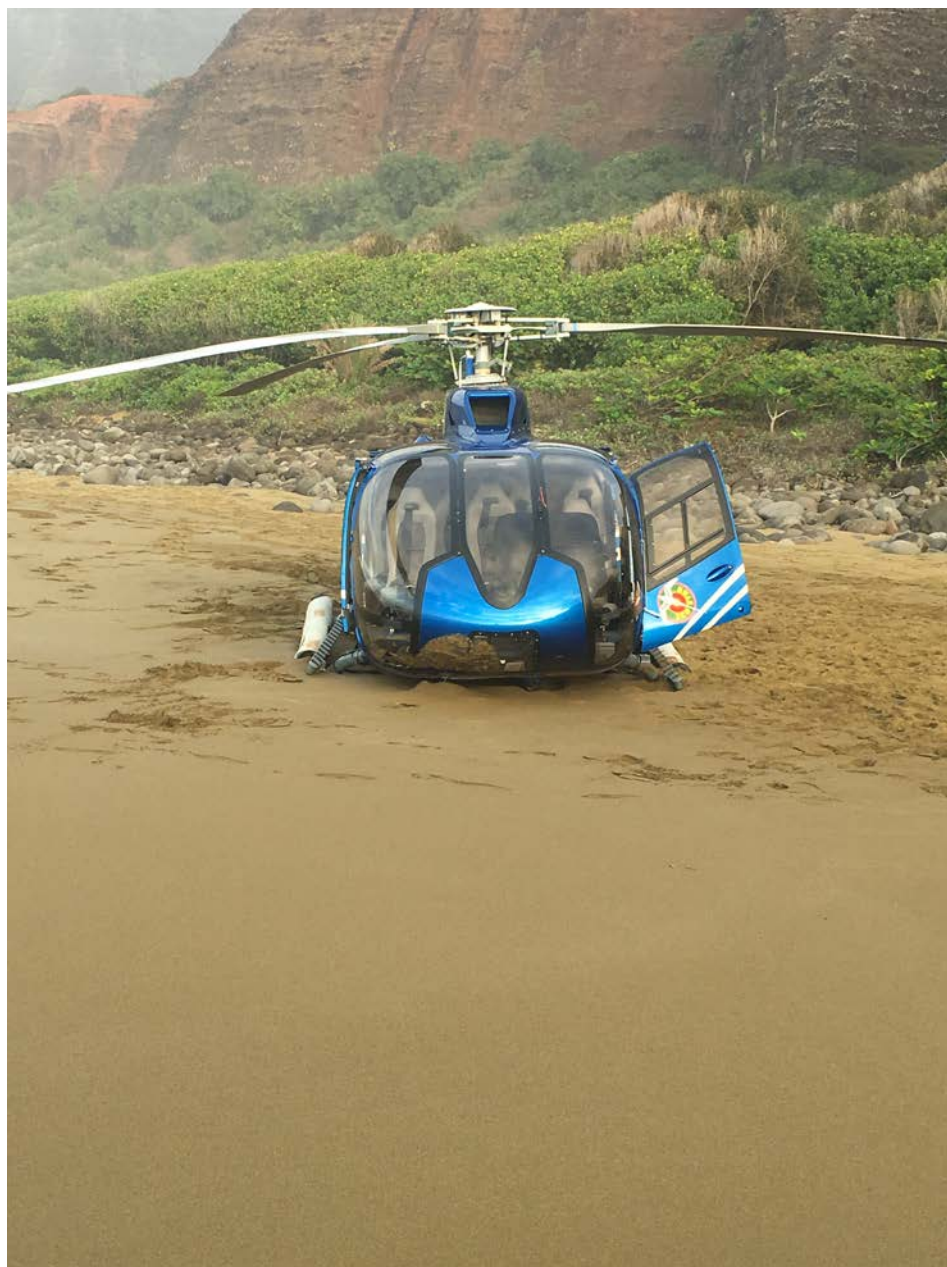
Photo 5 – On-scene view of the helicopter, front view.

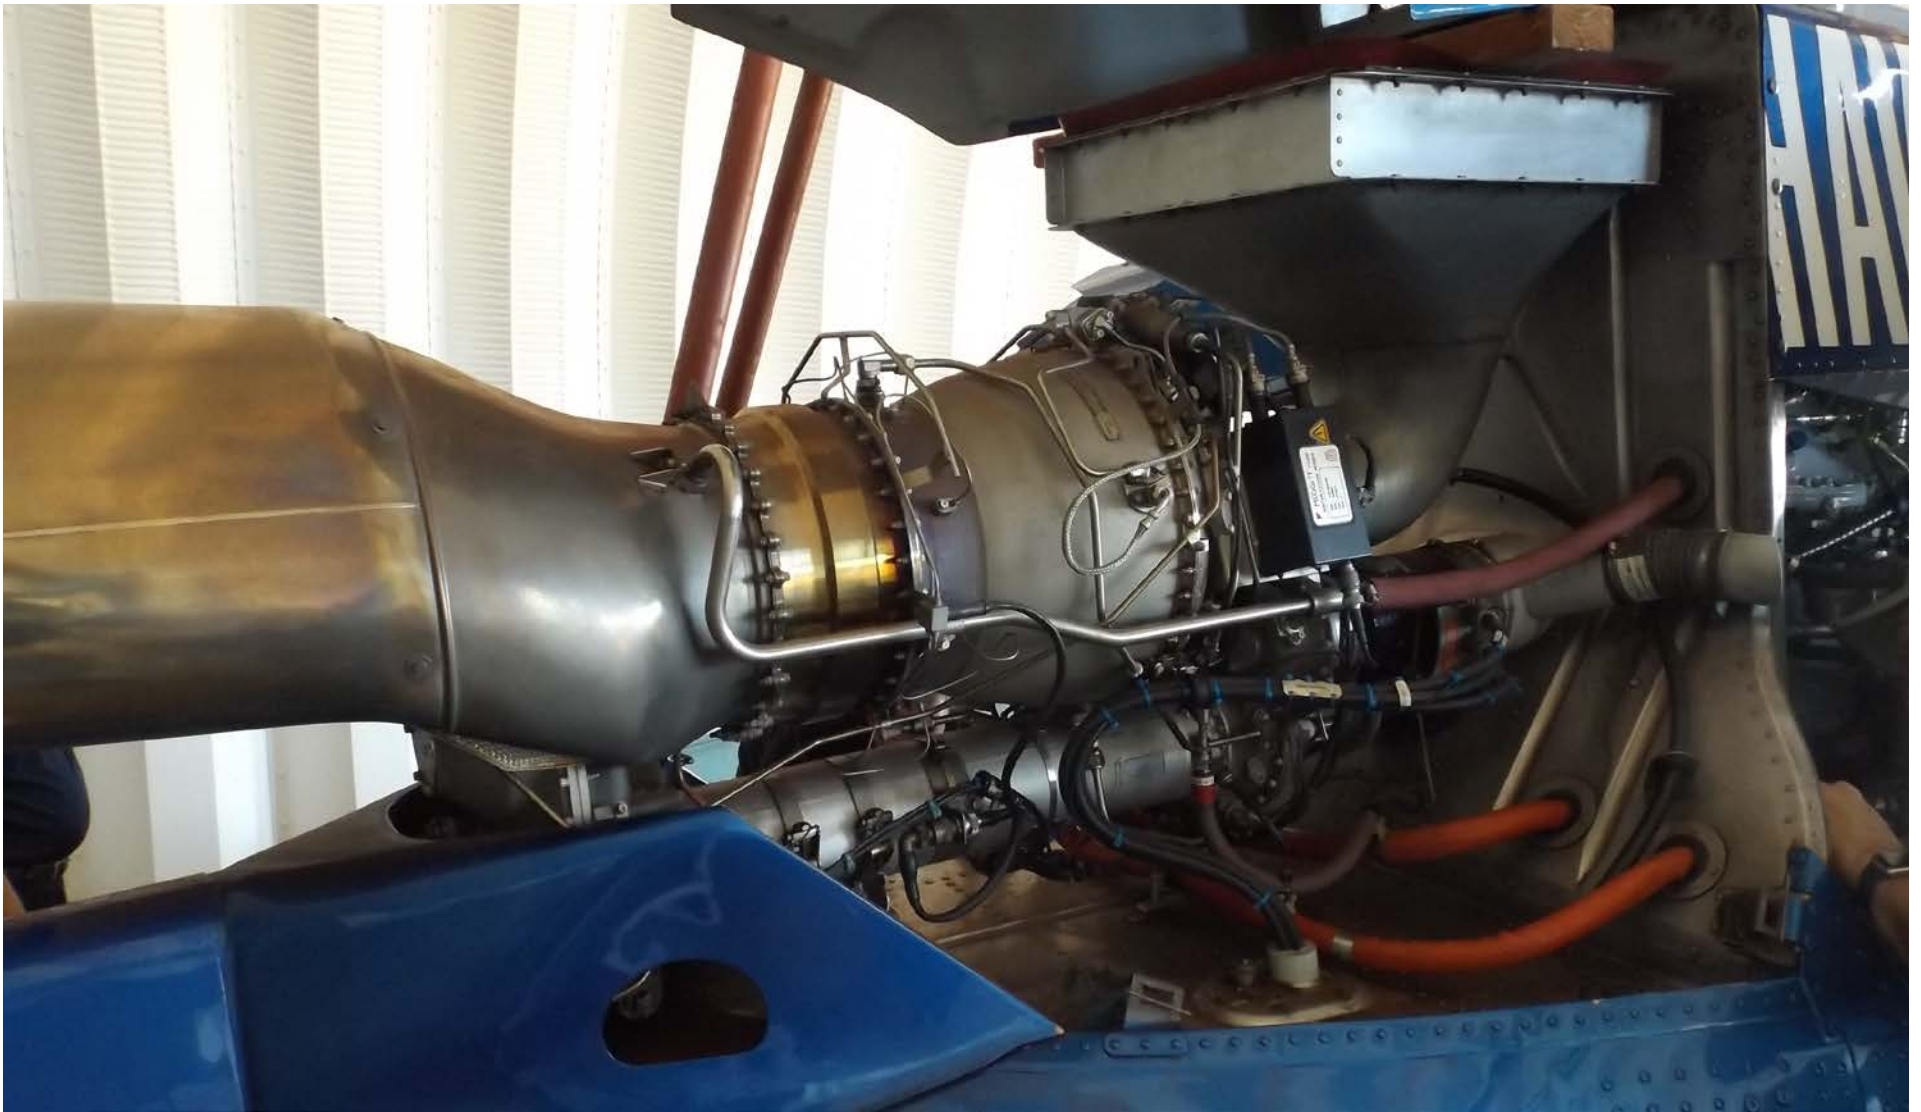
Photo 6 – View of engine during initial examination after the accident.

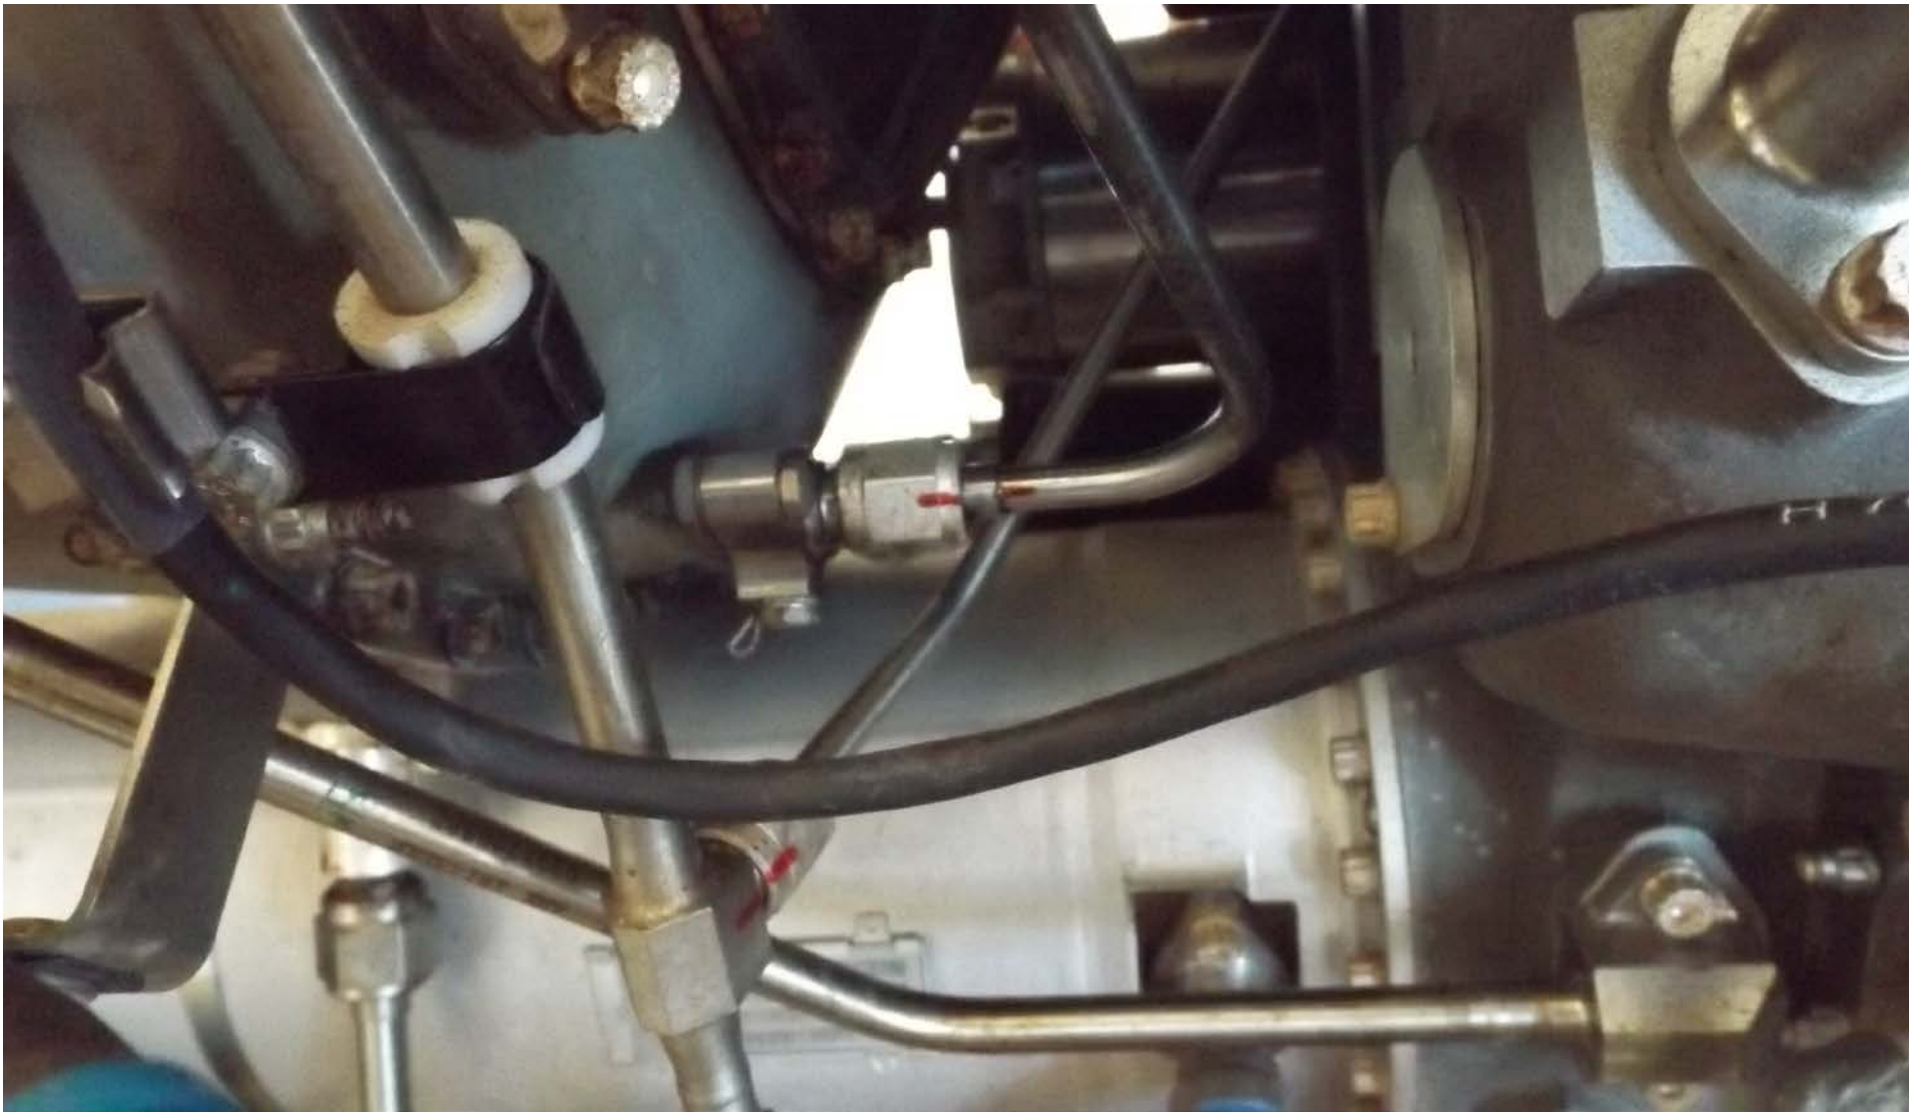
Photo 7 - Engine fuel pipe as found after the accident, with b-nut secured to manifold.

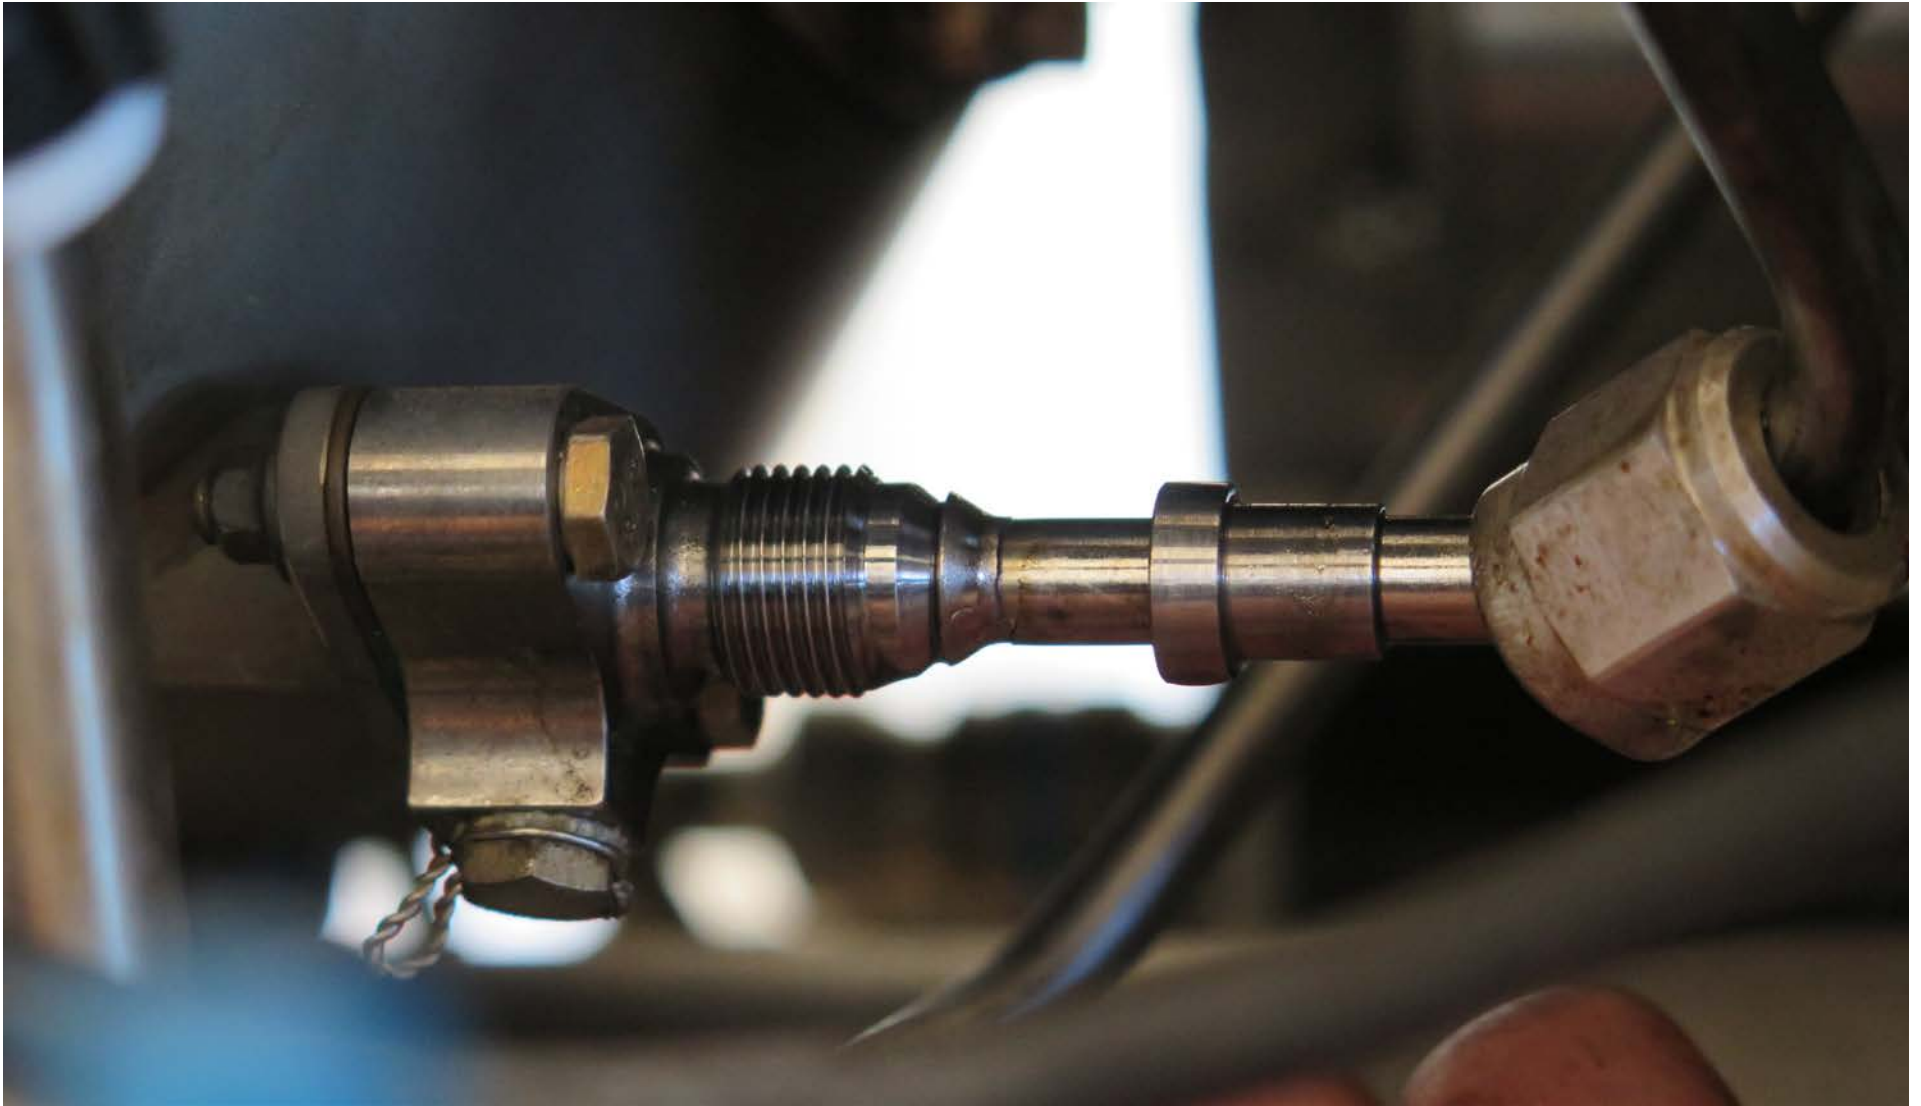
Photo 8 – Fuel pipe shown after the b-nut had been backed off by investigators, showing cracked fuel pipe flared end.

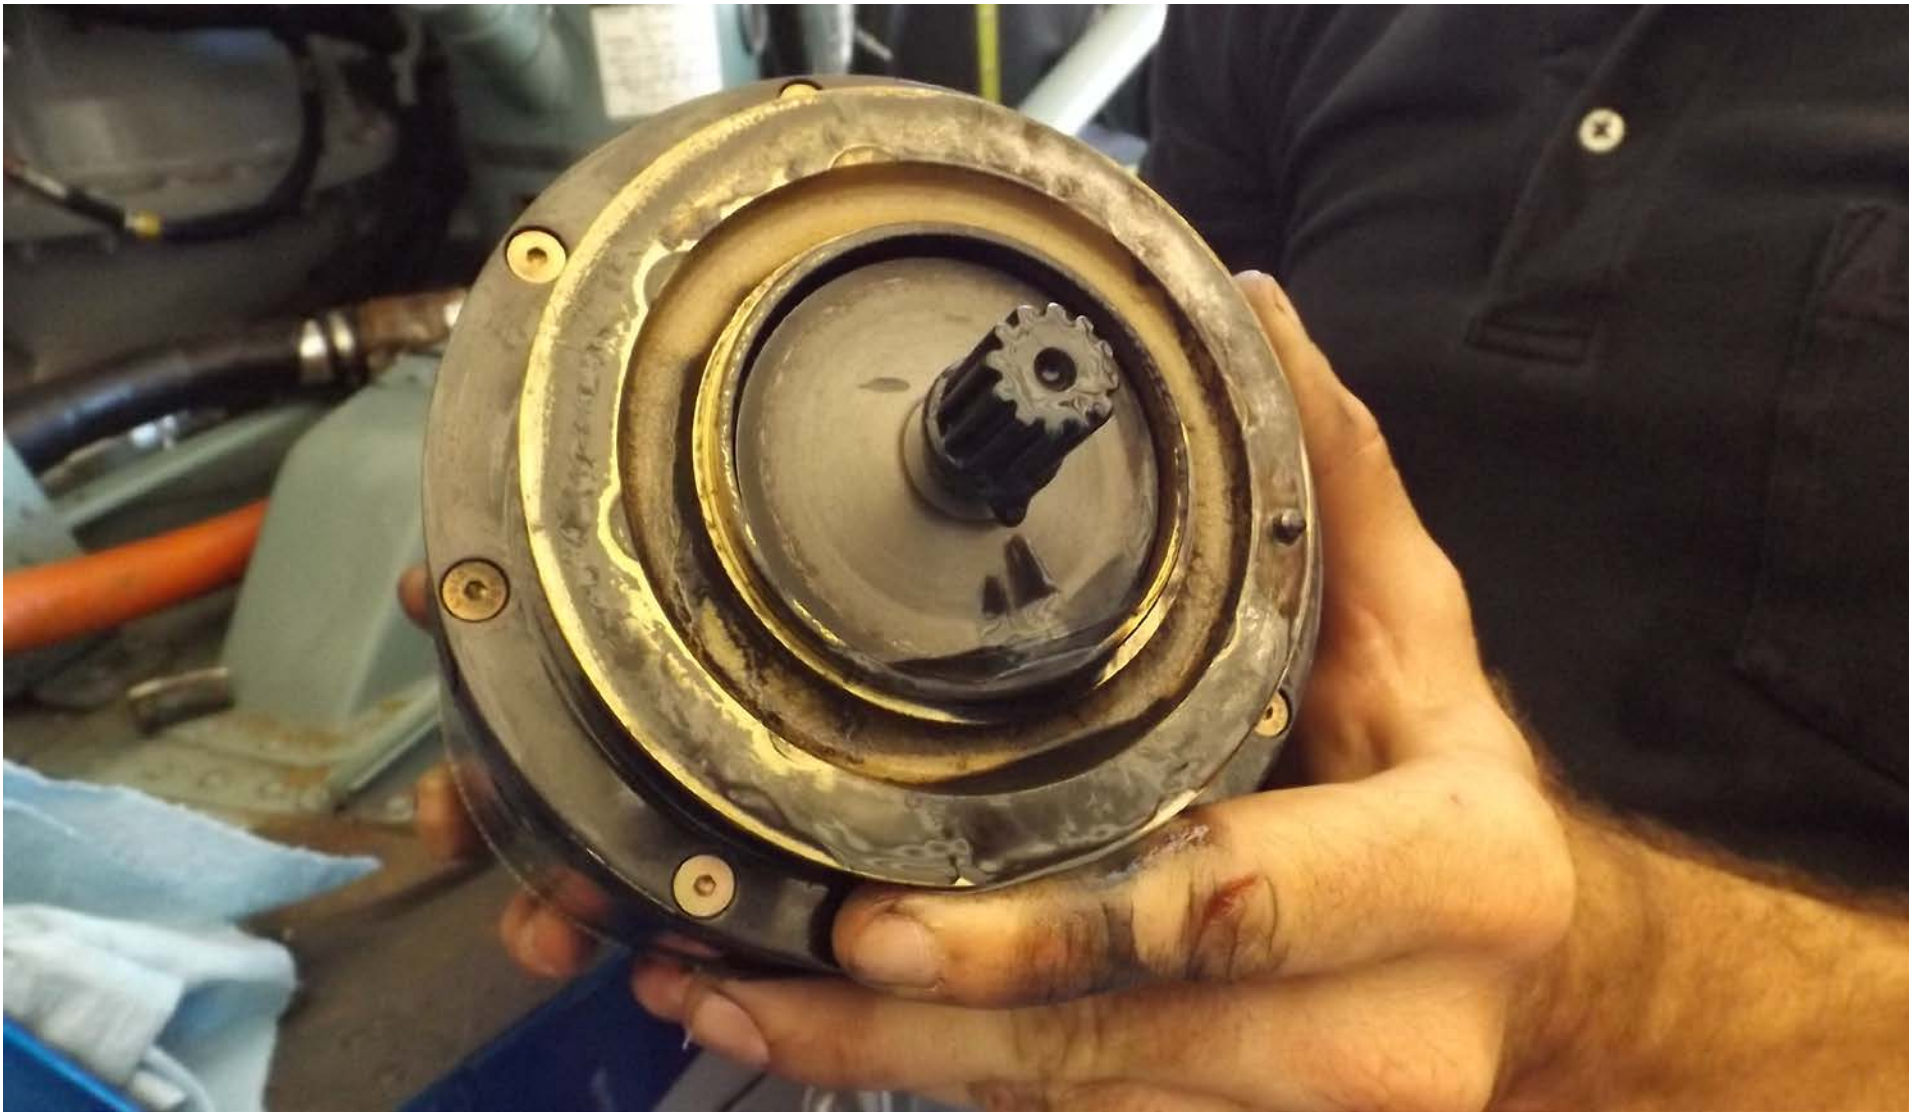
Photo 9 – Engine starter-generator as removed from engine.

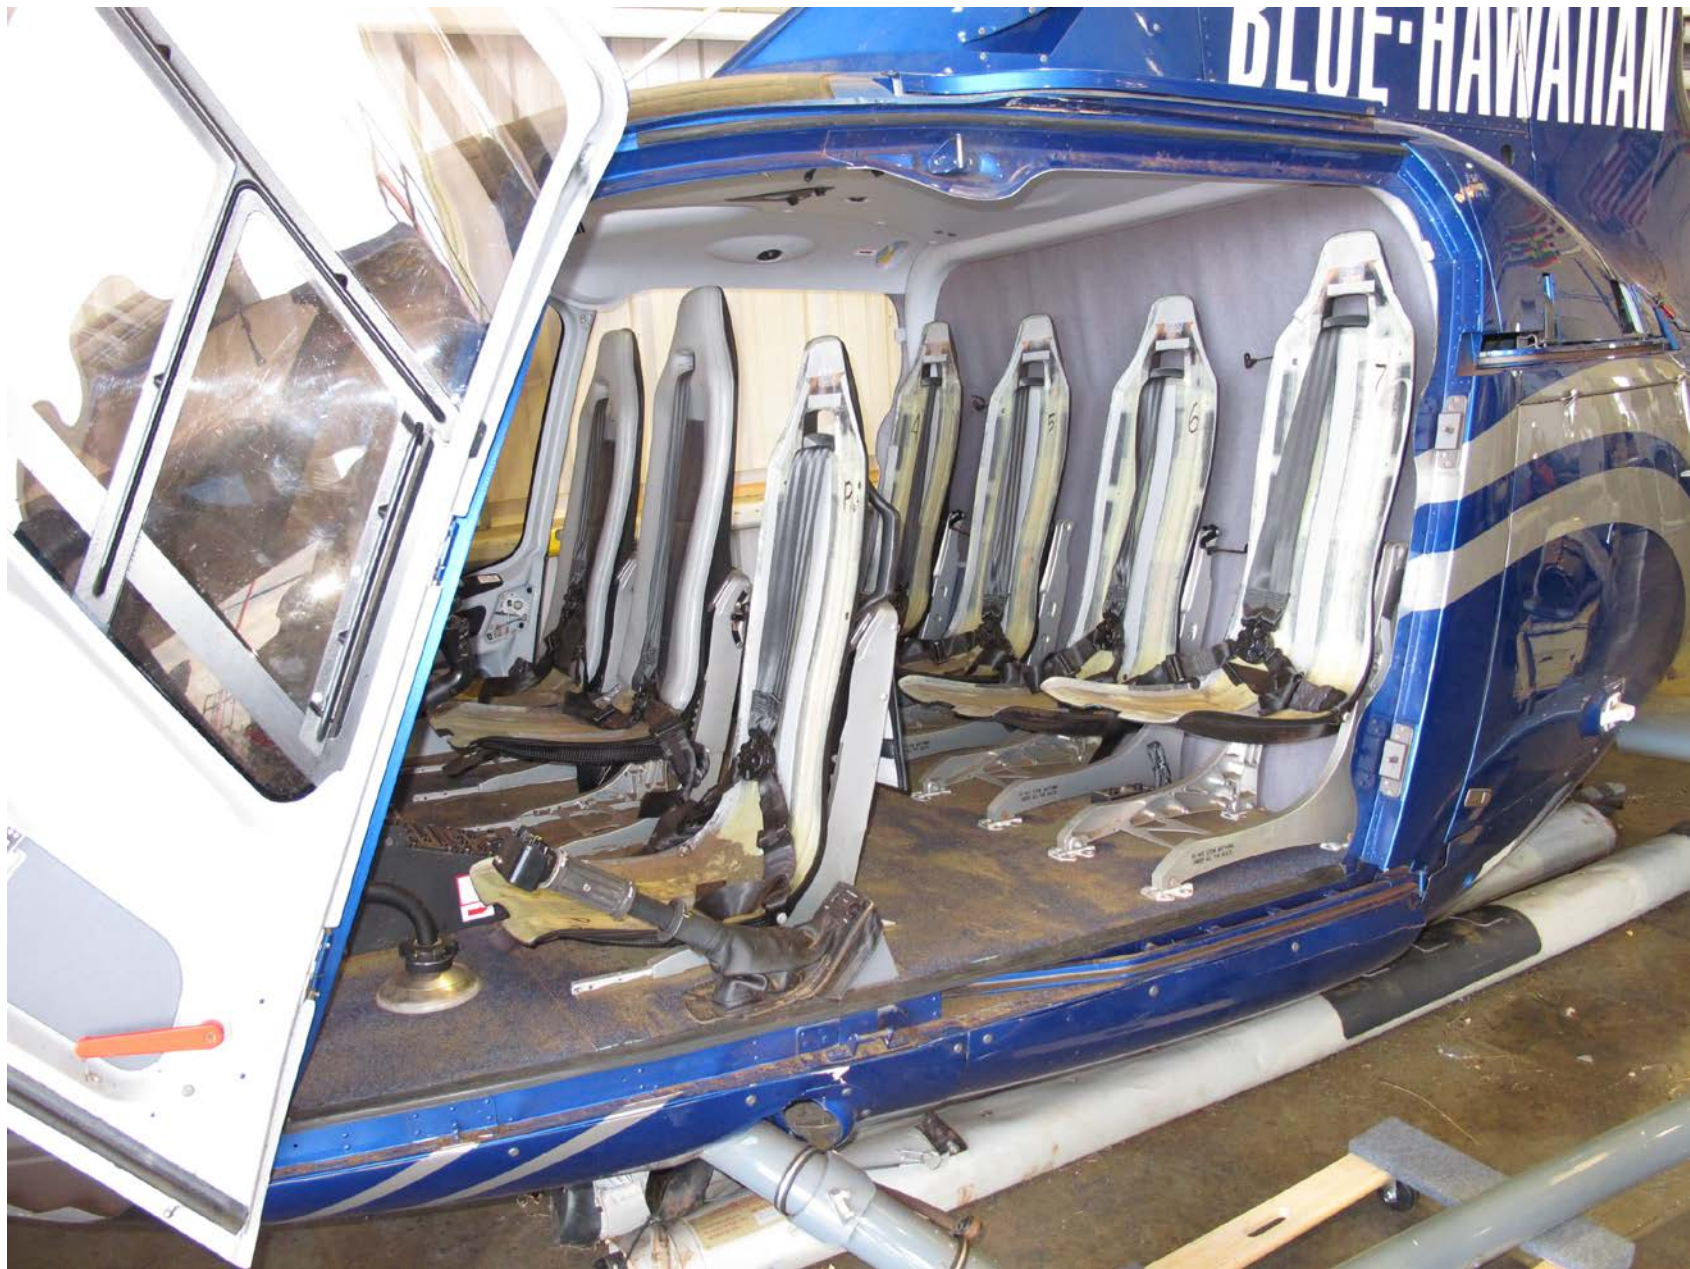
Photo 10 – View of the helicopter cabin showing all 7 seats after the accident. Seat cushion material removed.

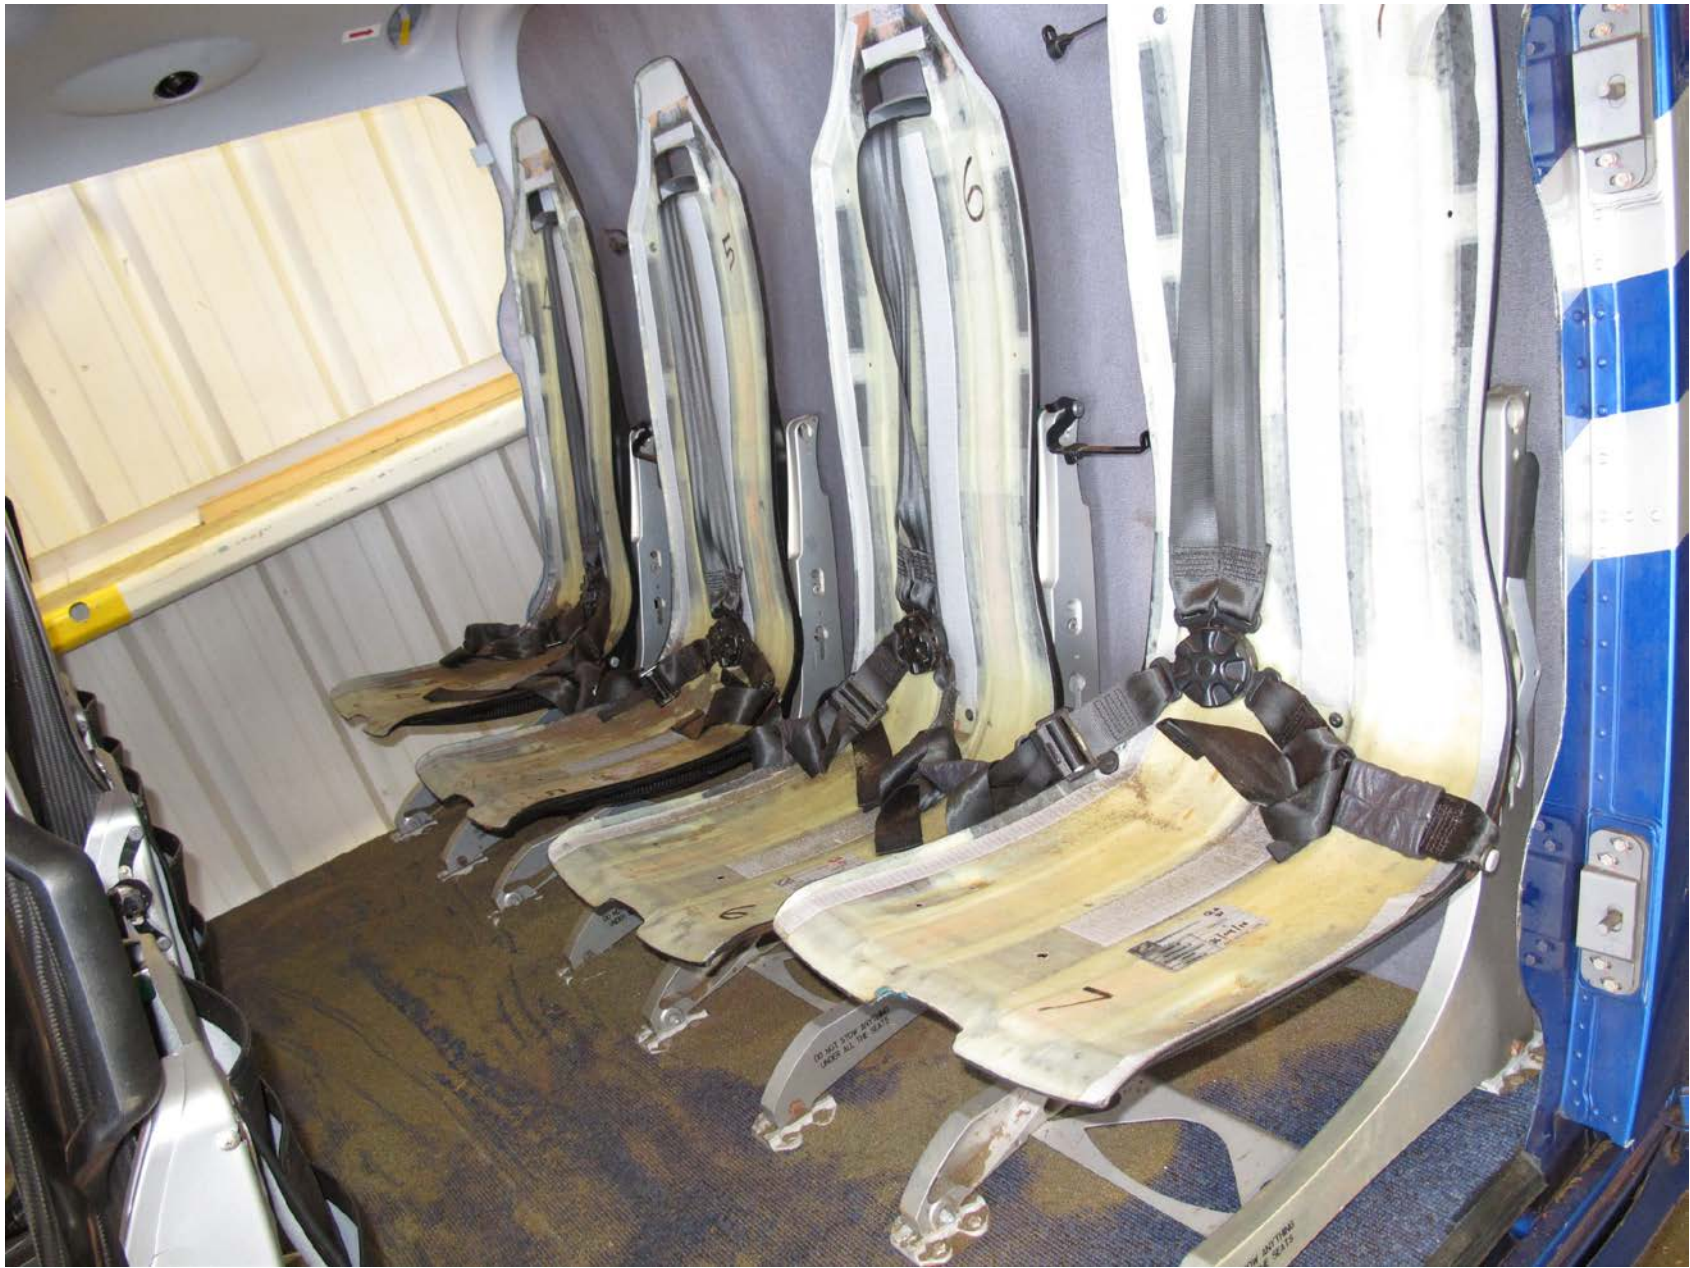
Photo 11 – View of the rear four seats of the helicopter. Seat cushions removed.

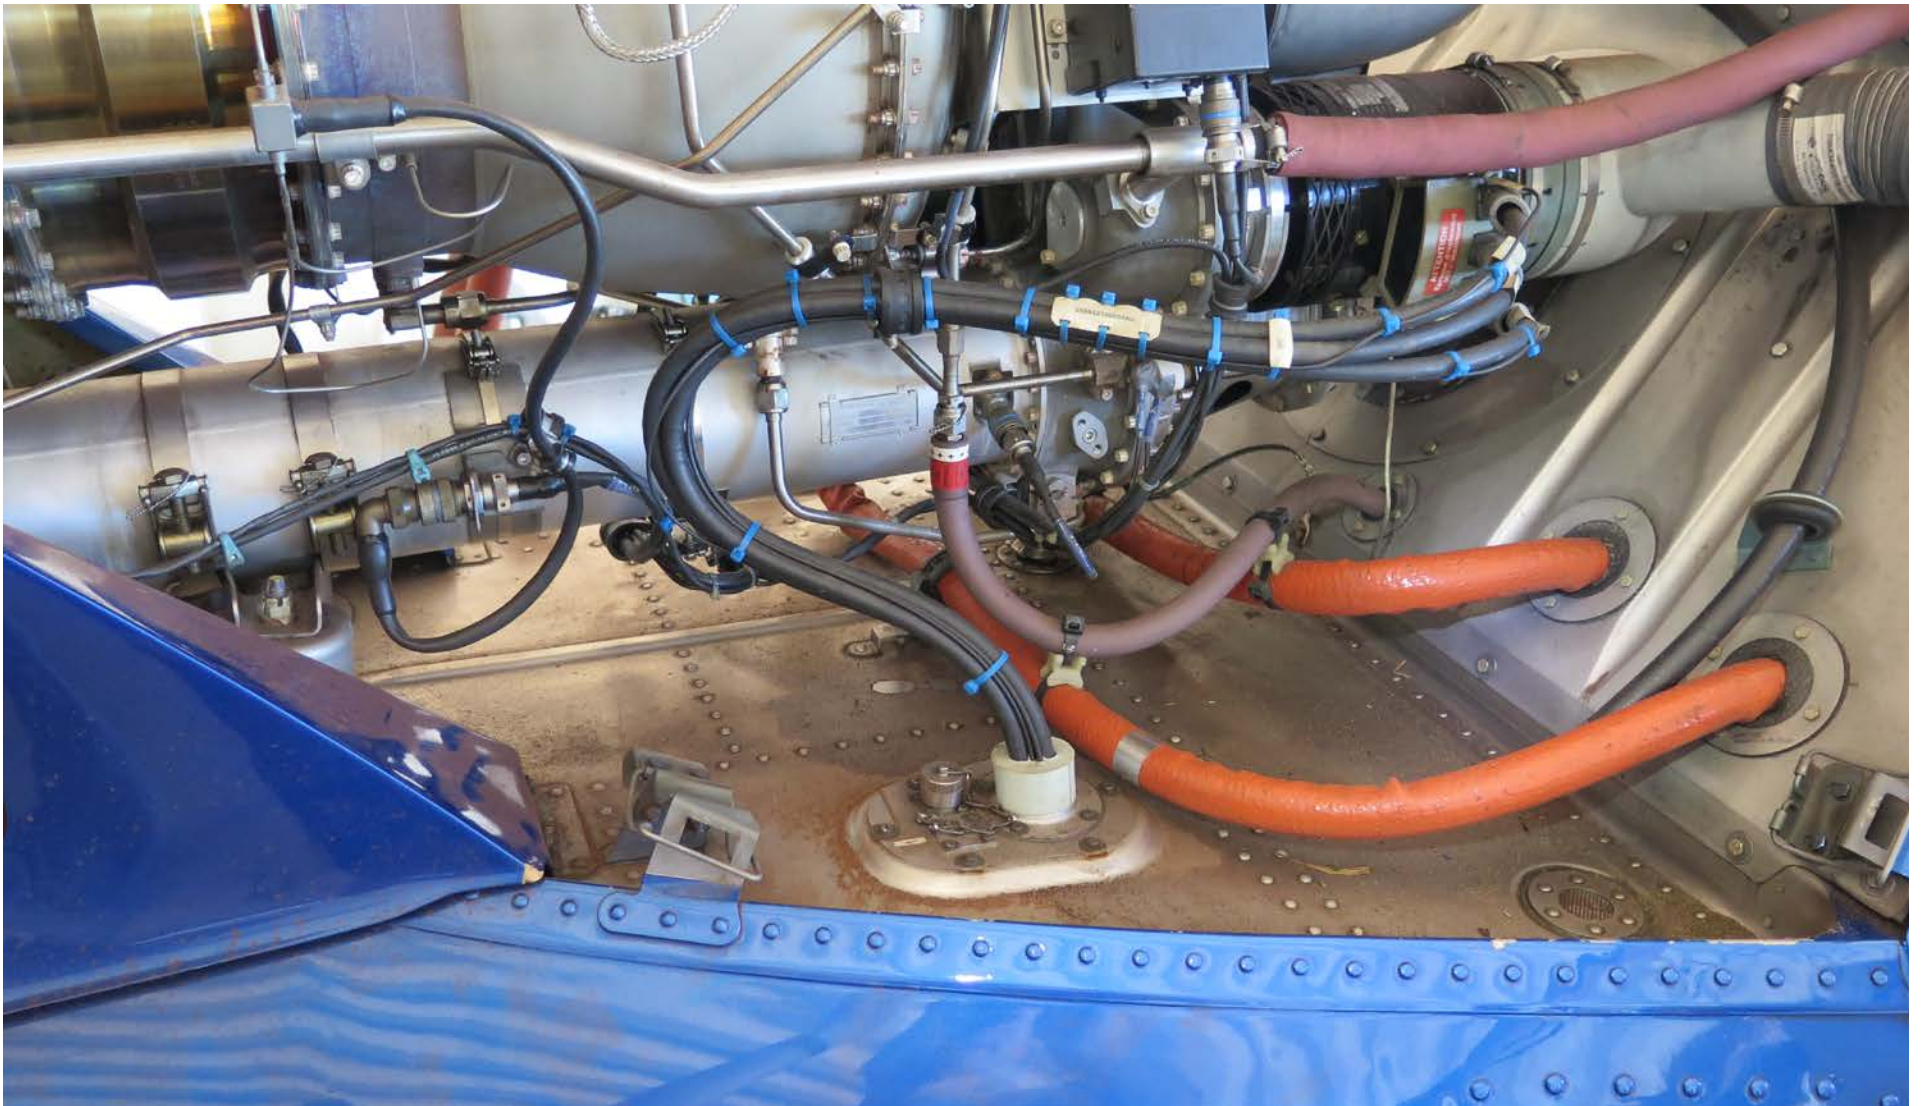
Photo 12 – Photo of the starter-generator attached to the engine and the condition of the engine deck with no dark-oily substance deposited on the engine deck below the starter-generator.
