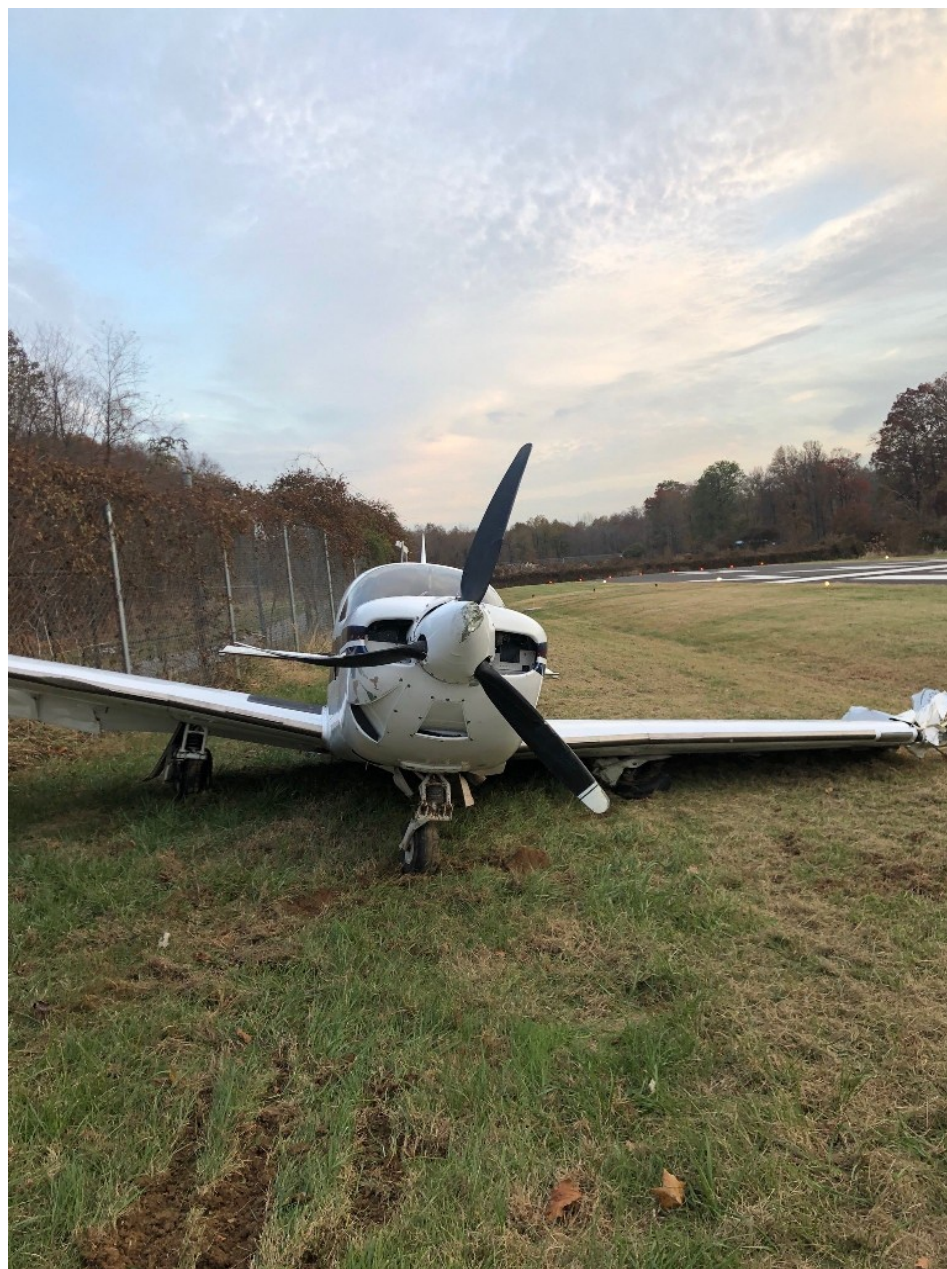
**Photo 1 – Main Wreckage**

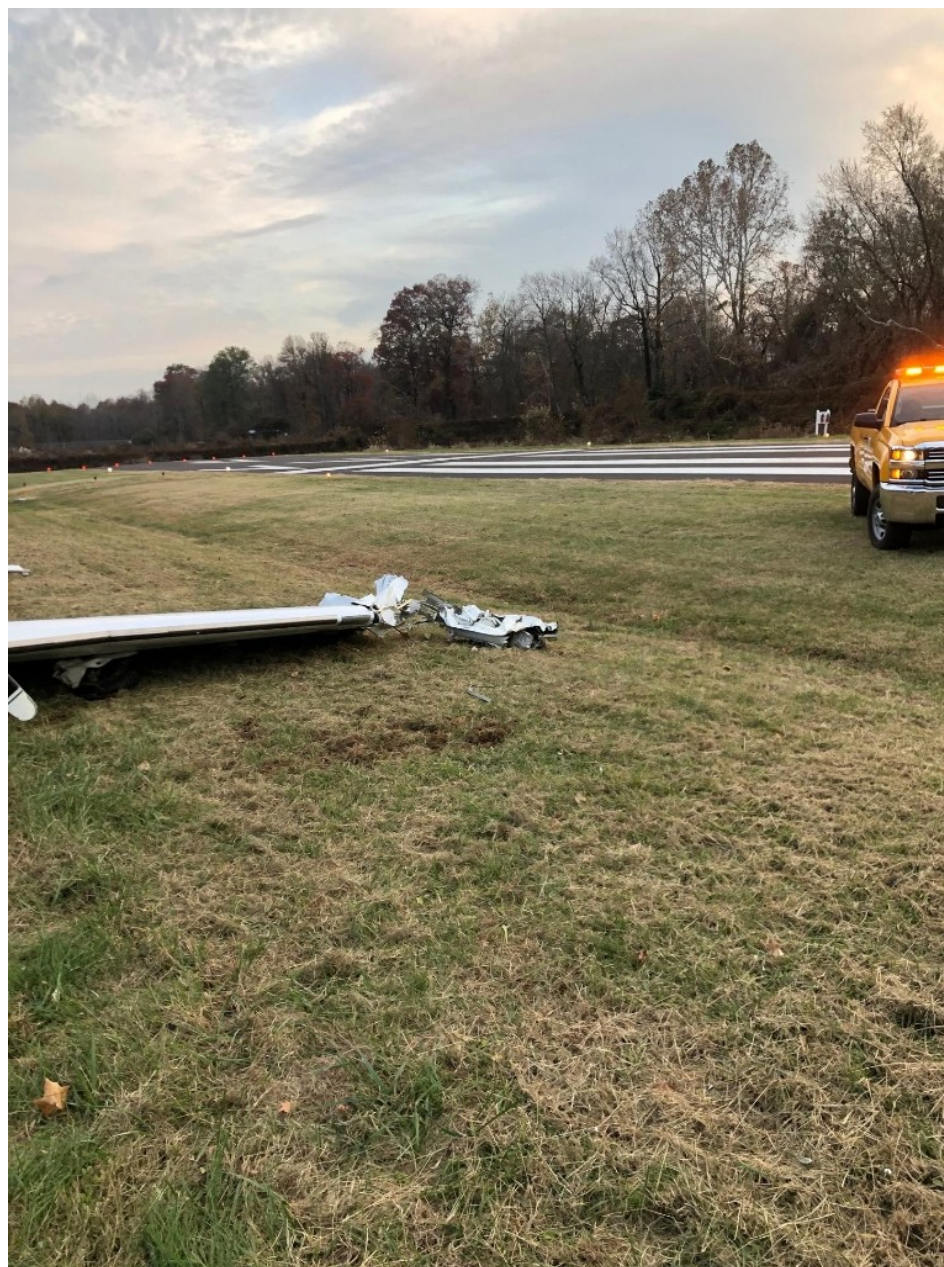
**Photo 2 – Left Wing Damage**

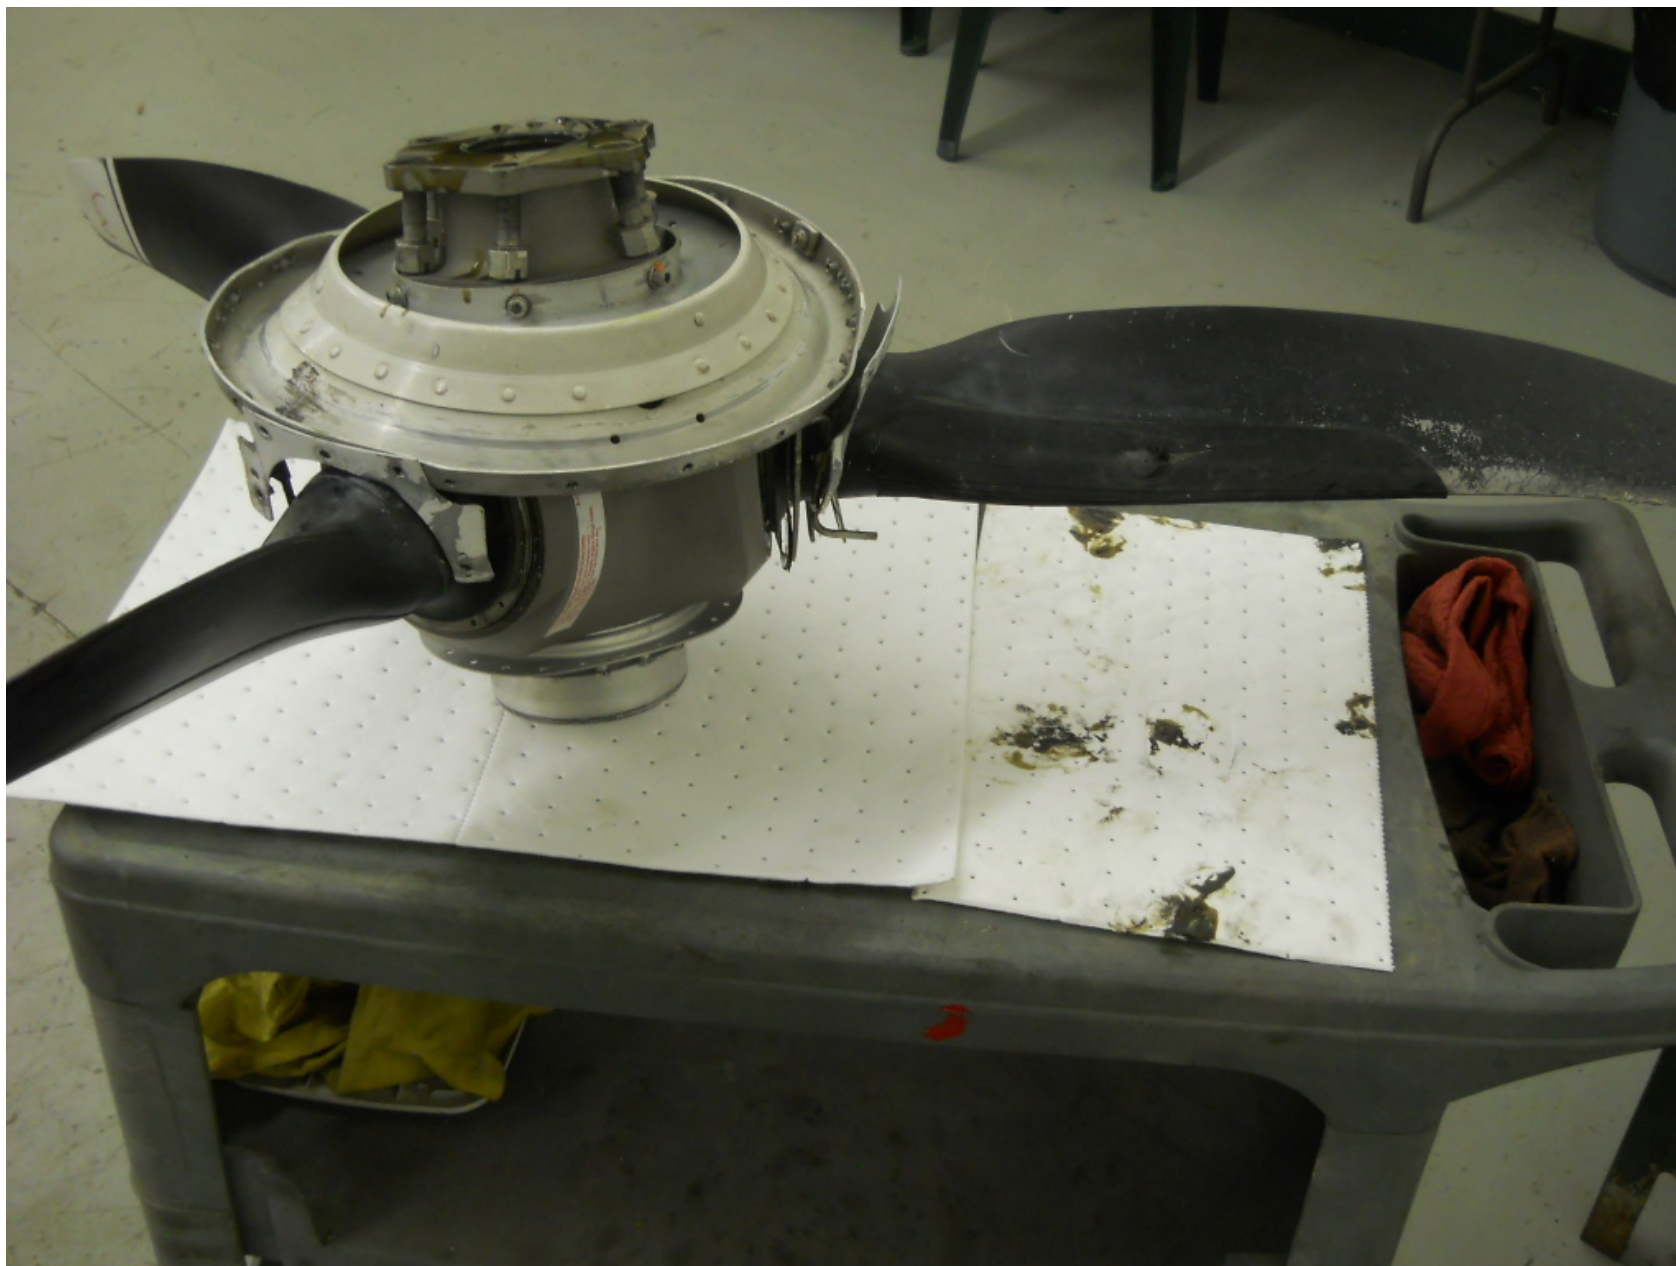
**Photo 4 – Propeller Removed**

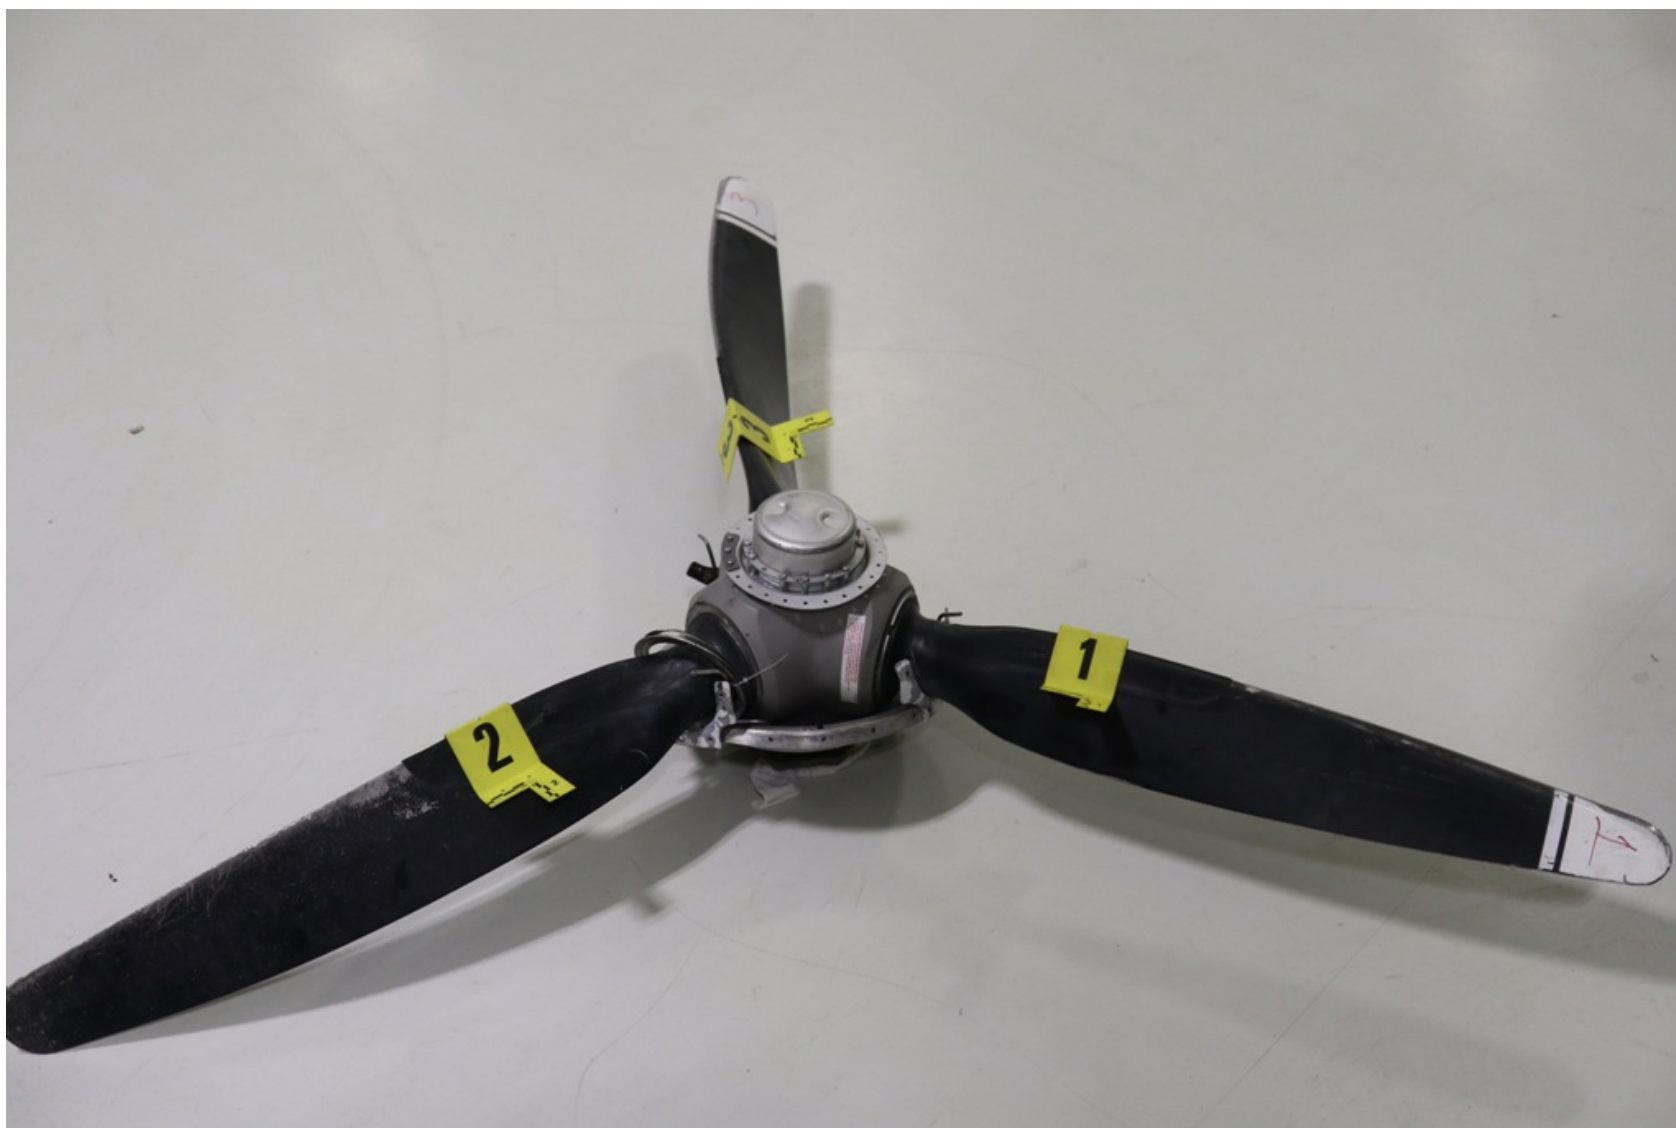
**Photo 5 – Propeller at Teardown Examination (Photo Courtesy of Textron)**
