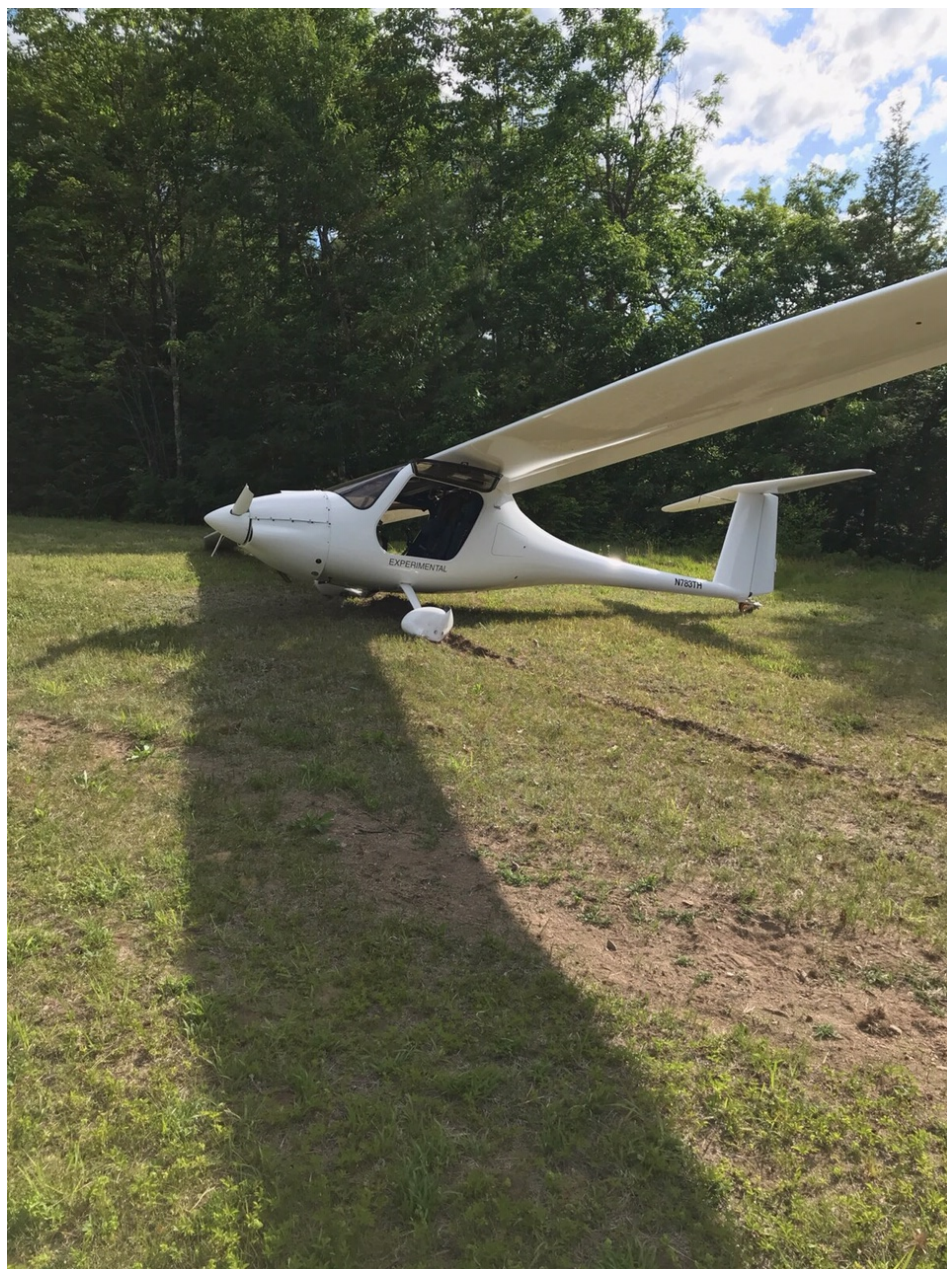
Photo 1 – Left Side View of Main Wreckage – Courtesy of FAA

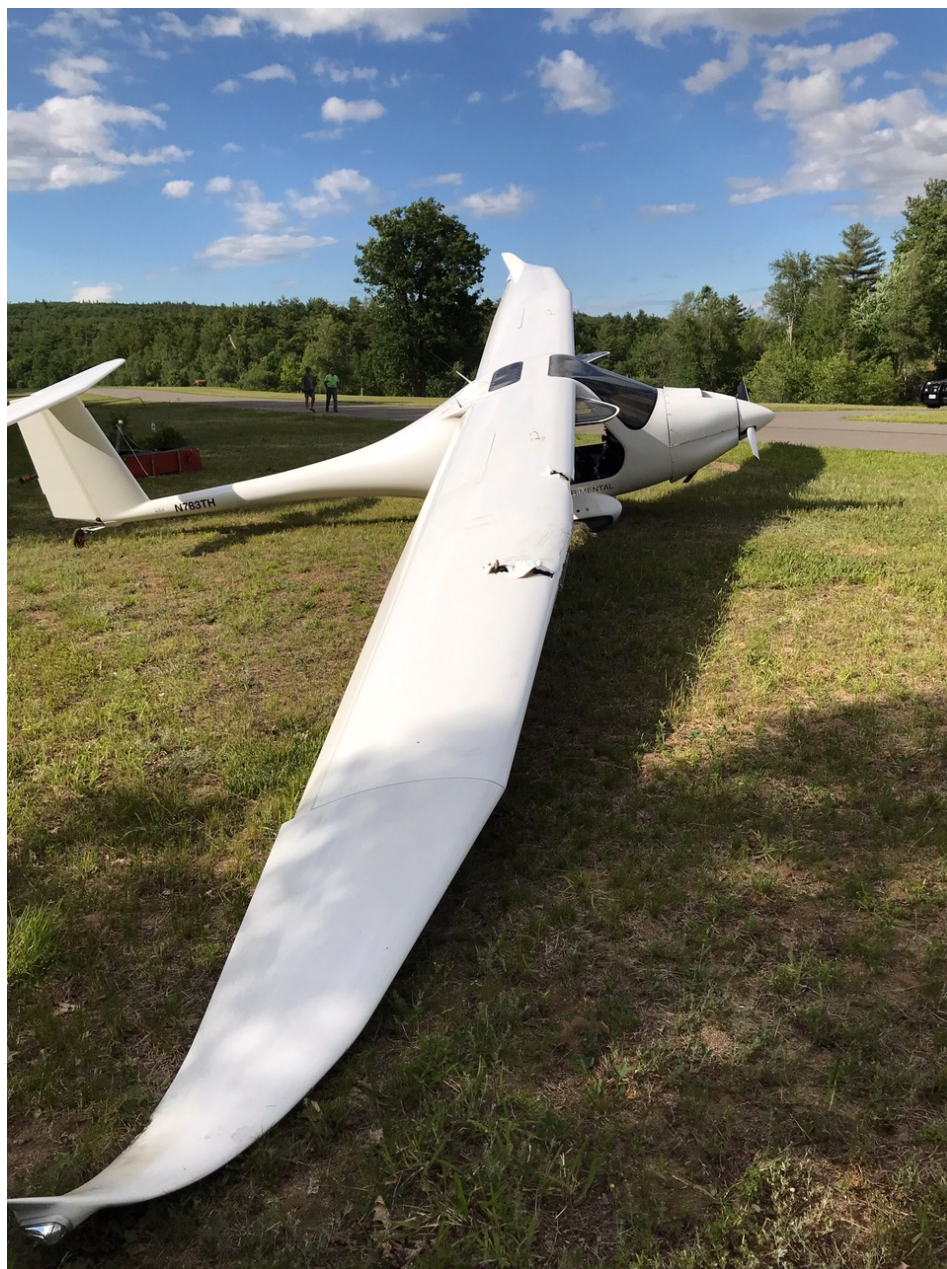
Photo 2 – Right Side View of Main Wreckage – Courtesy of FAA

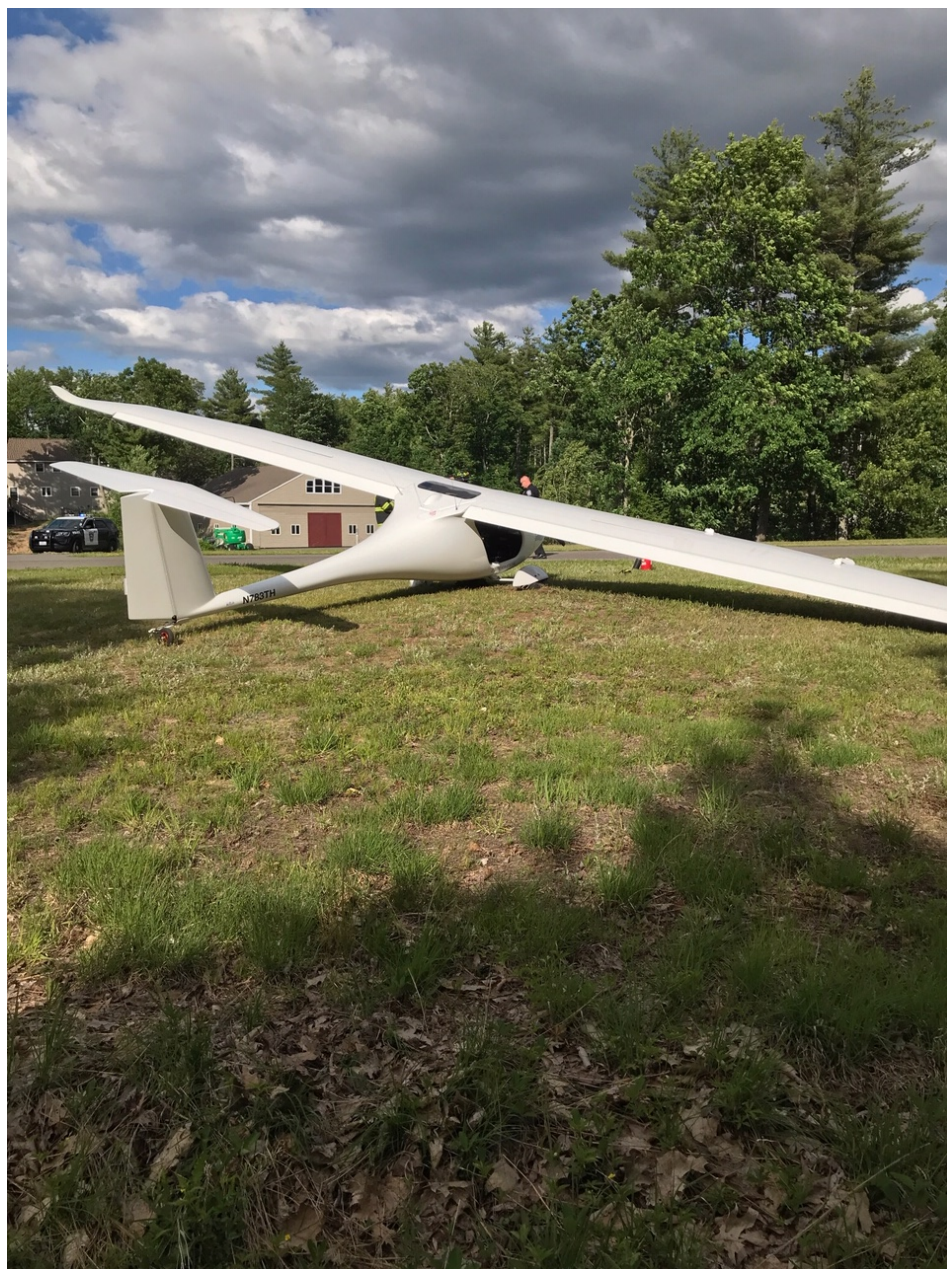
Photo 3 – Rear View of Main Wreckage – Courtesy of FAA

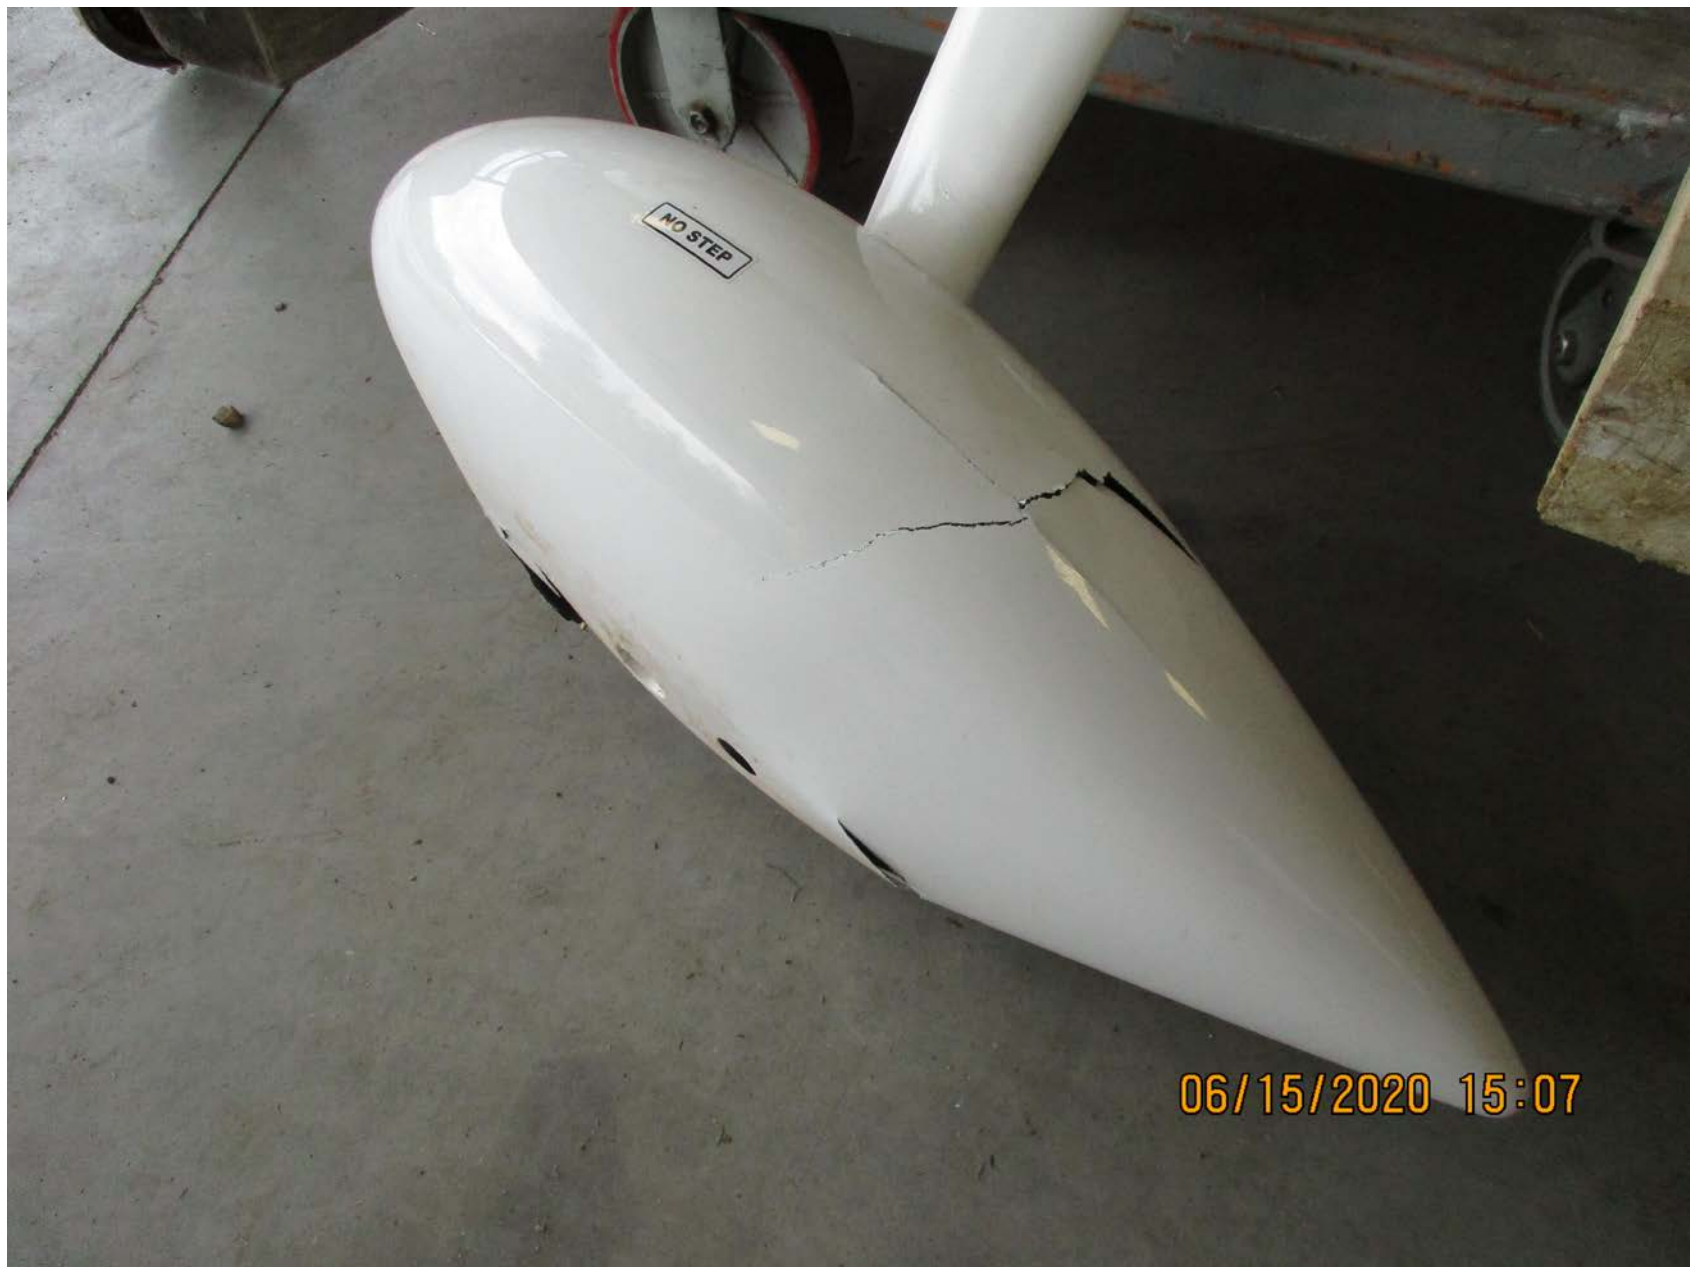
Photo 4 – Left Wheel Pant – Courtesy of FAA

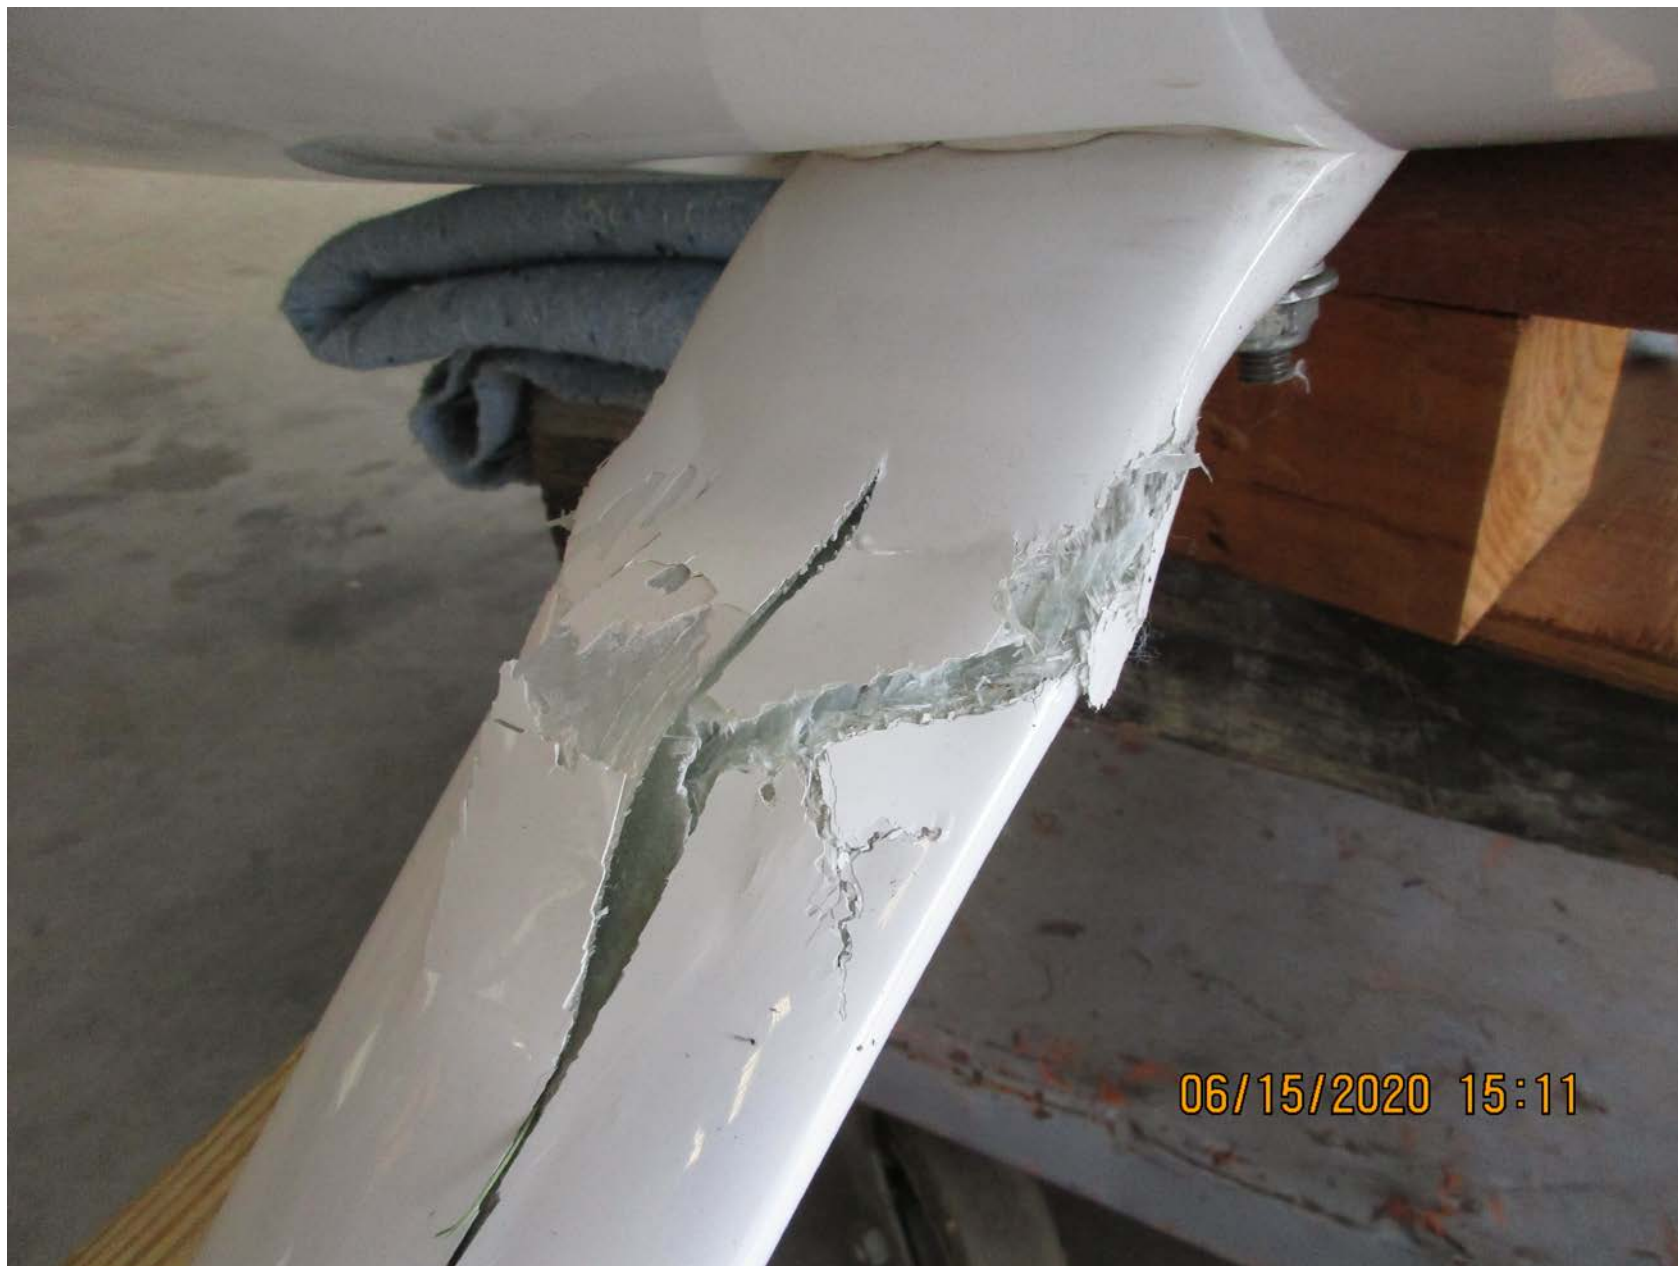
Photo 5 – Left Main Landing Gear Leg – Courtesy of FAA

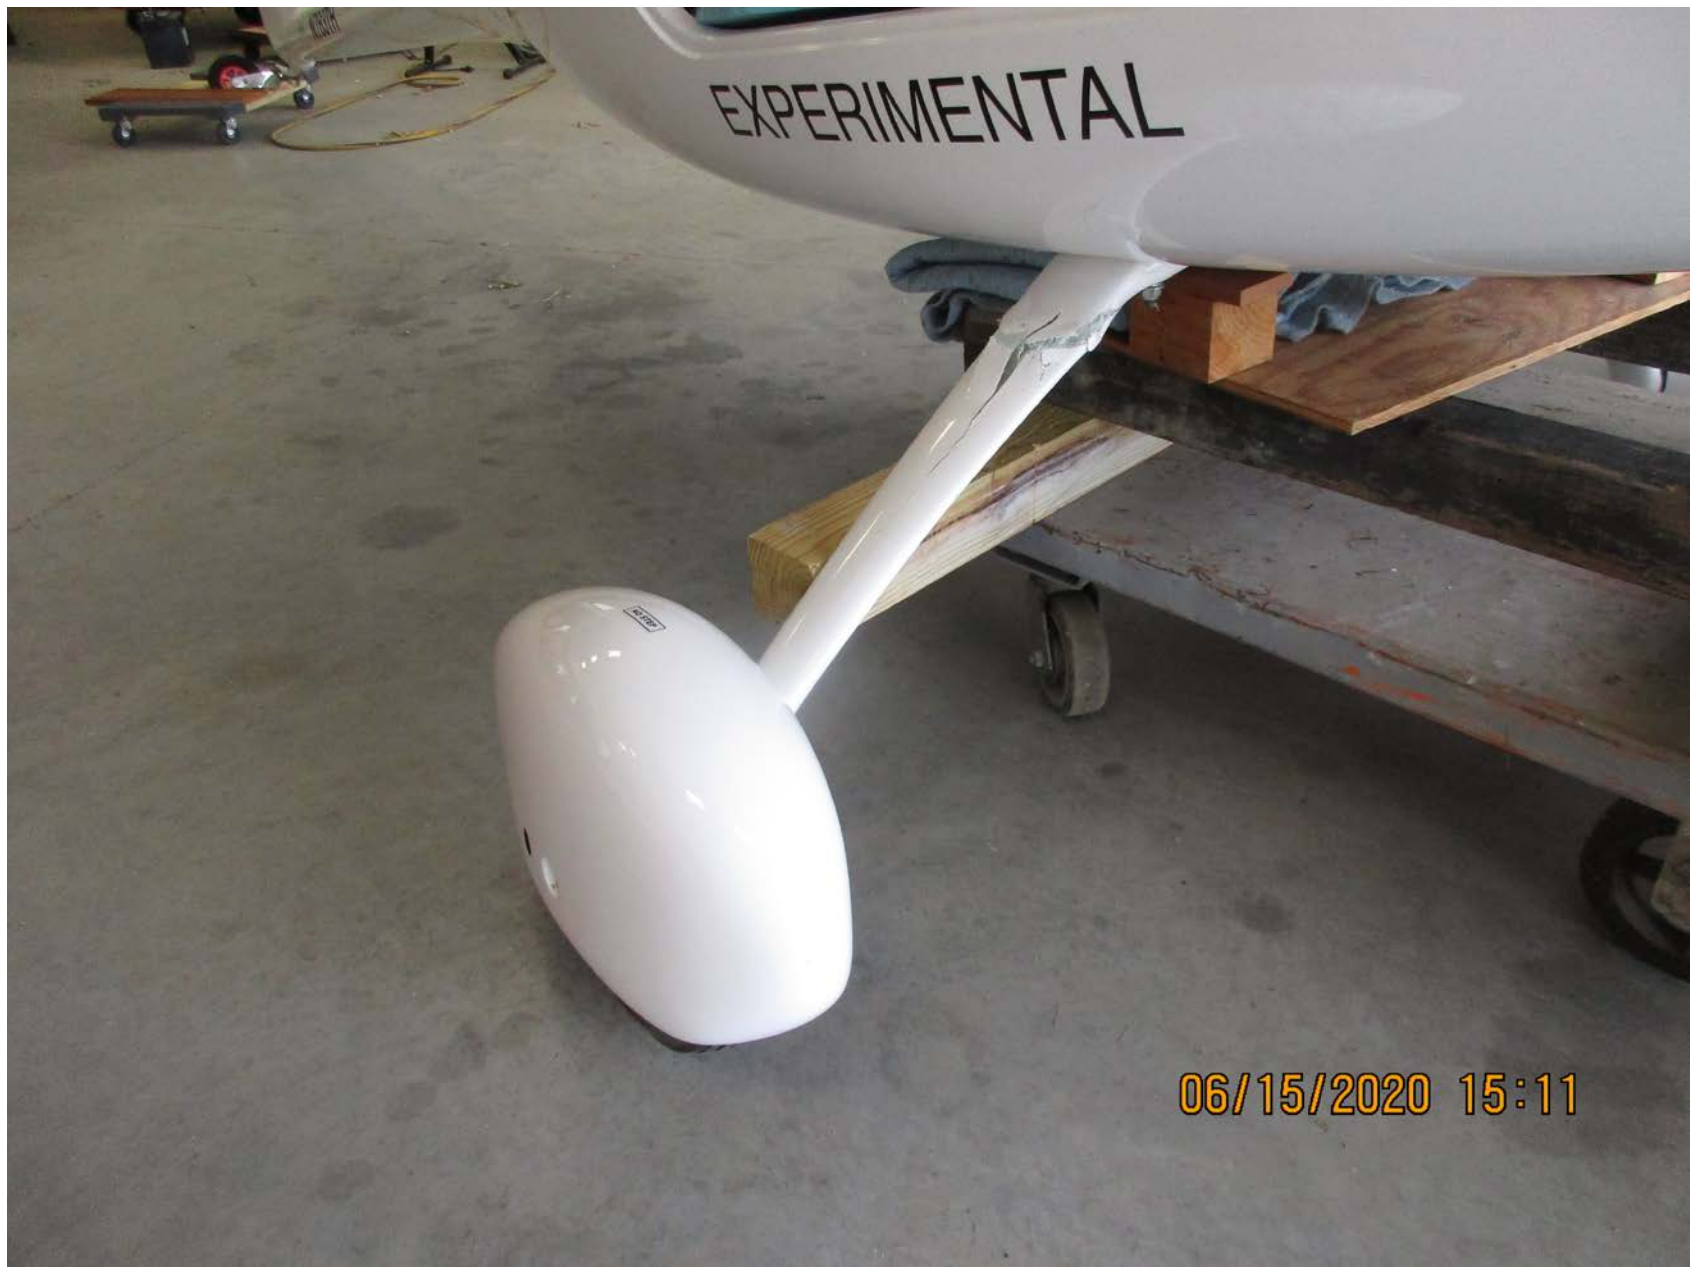
Photo 6 – Right Main Landing Gear – Courtesy of FAA

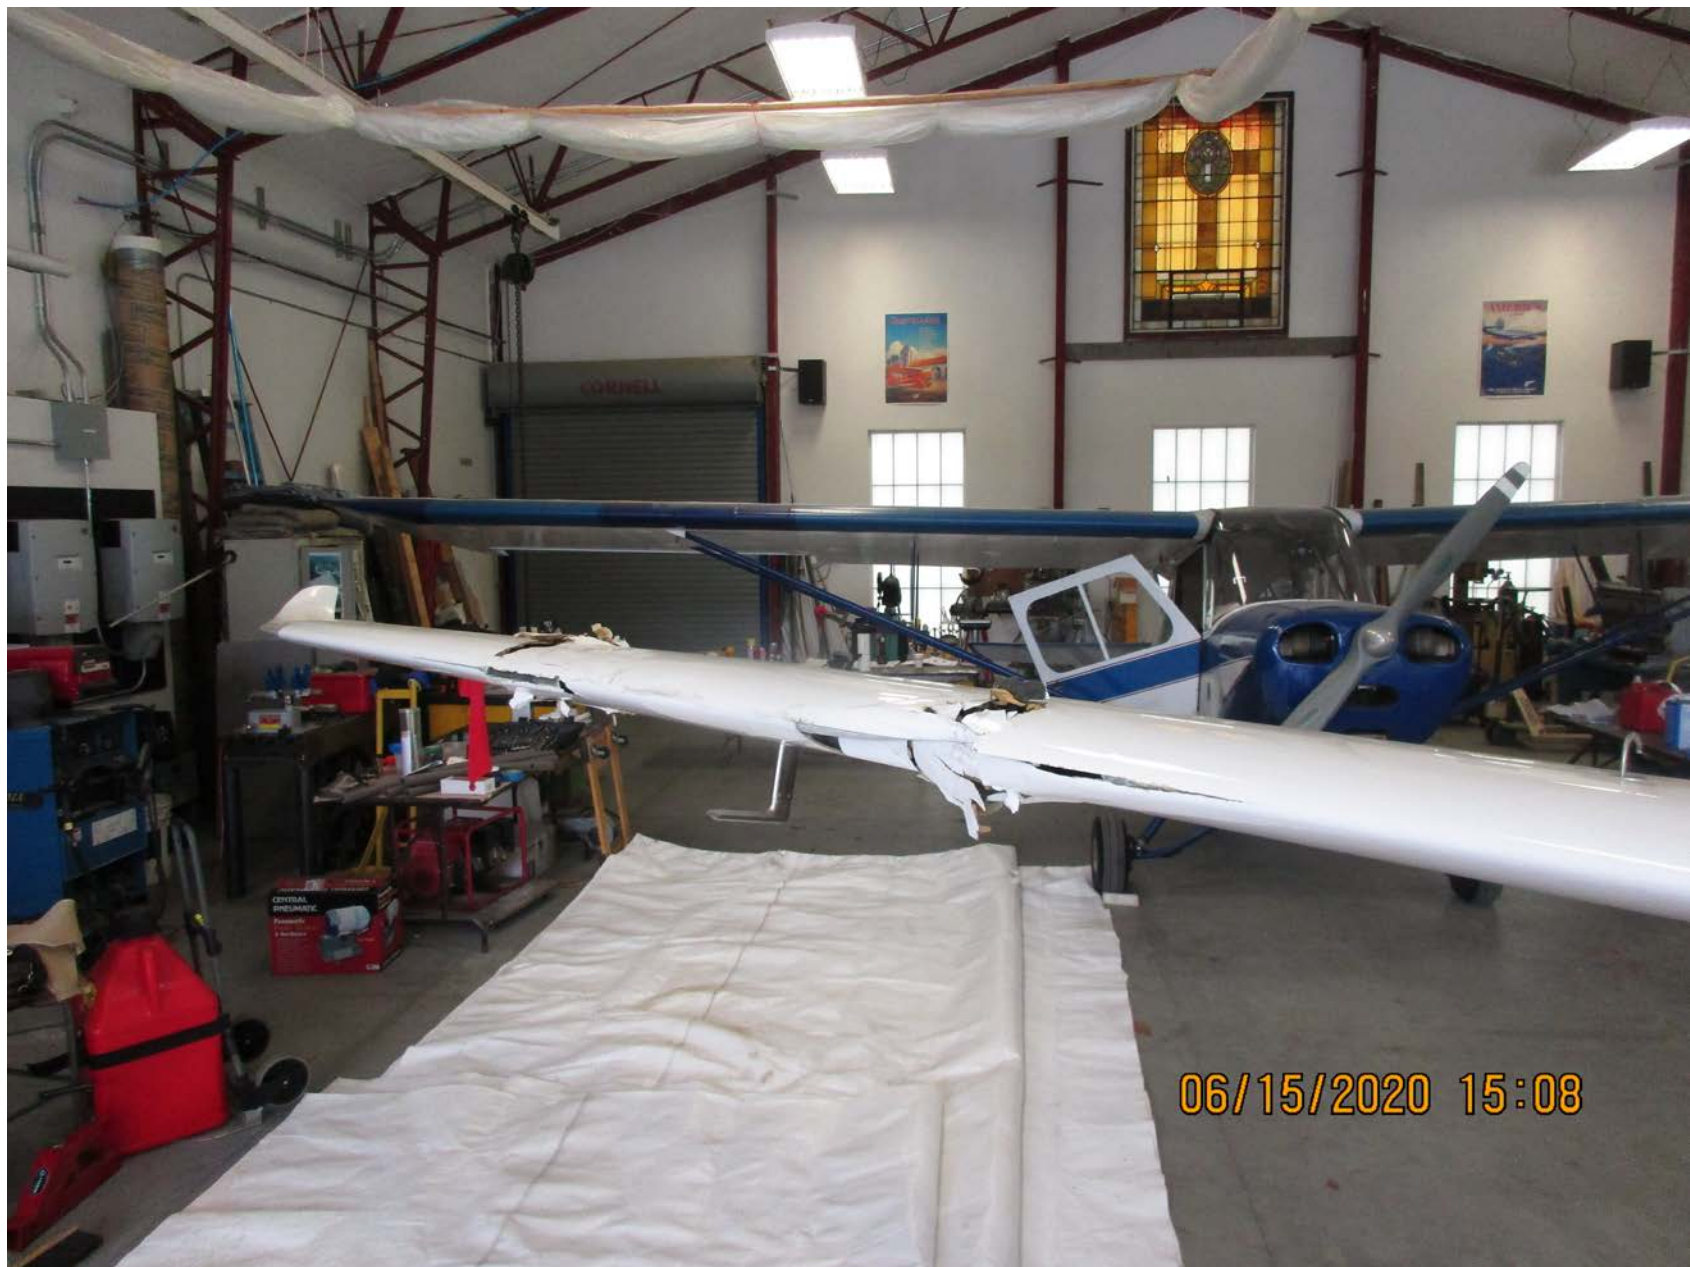
Photo 7 – Right Wing – Courtesy of FAA

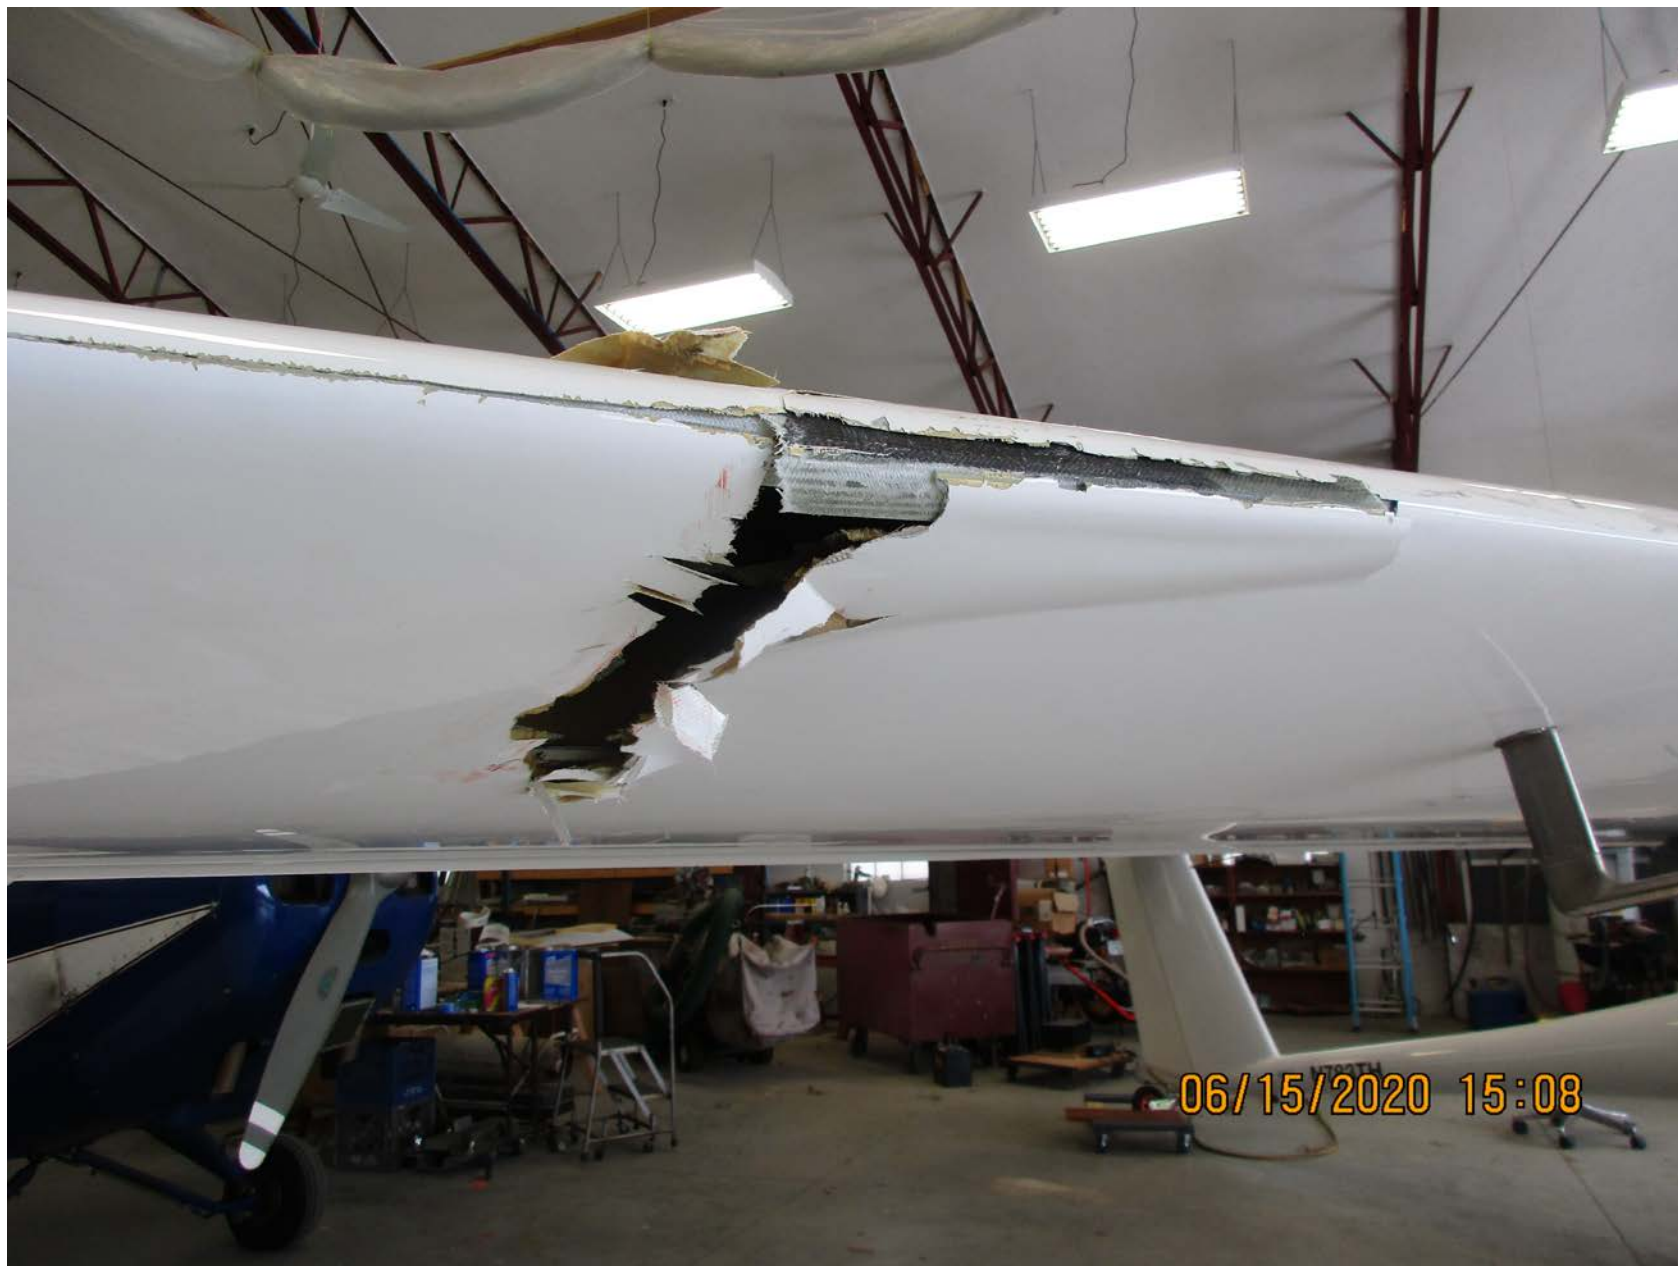
Photo 8 – Close Up of Wing Damage Outboard of Pitot Tube – Courtesy of FAA

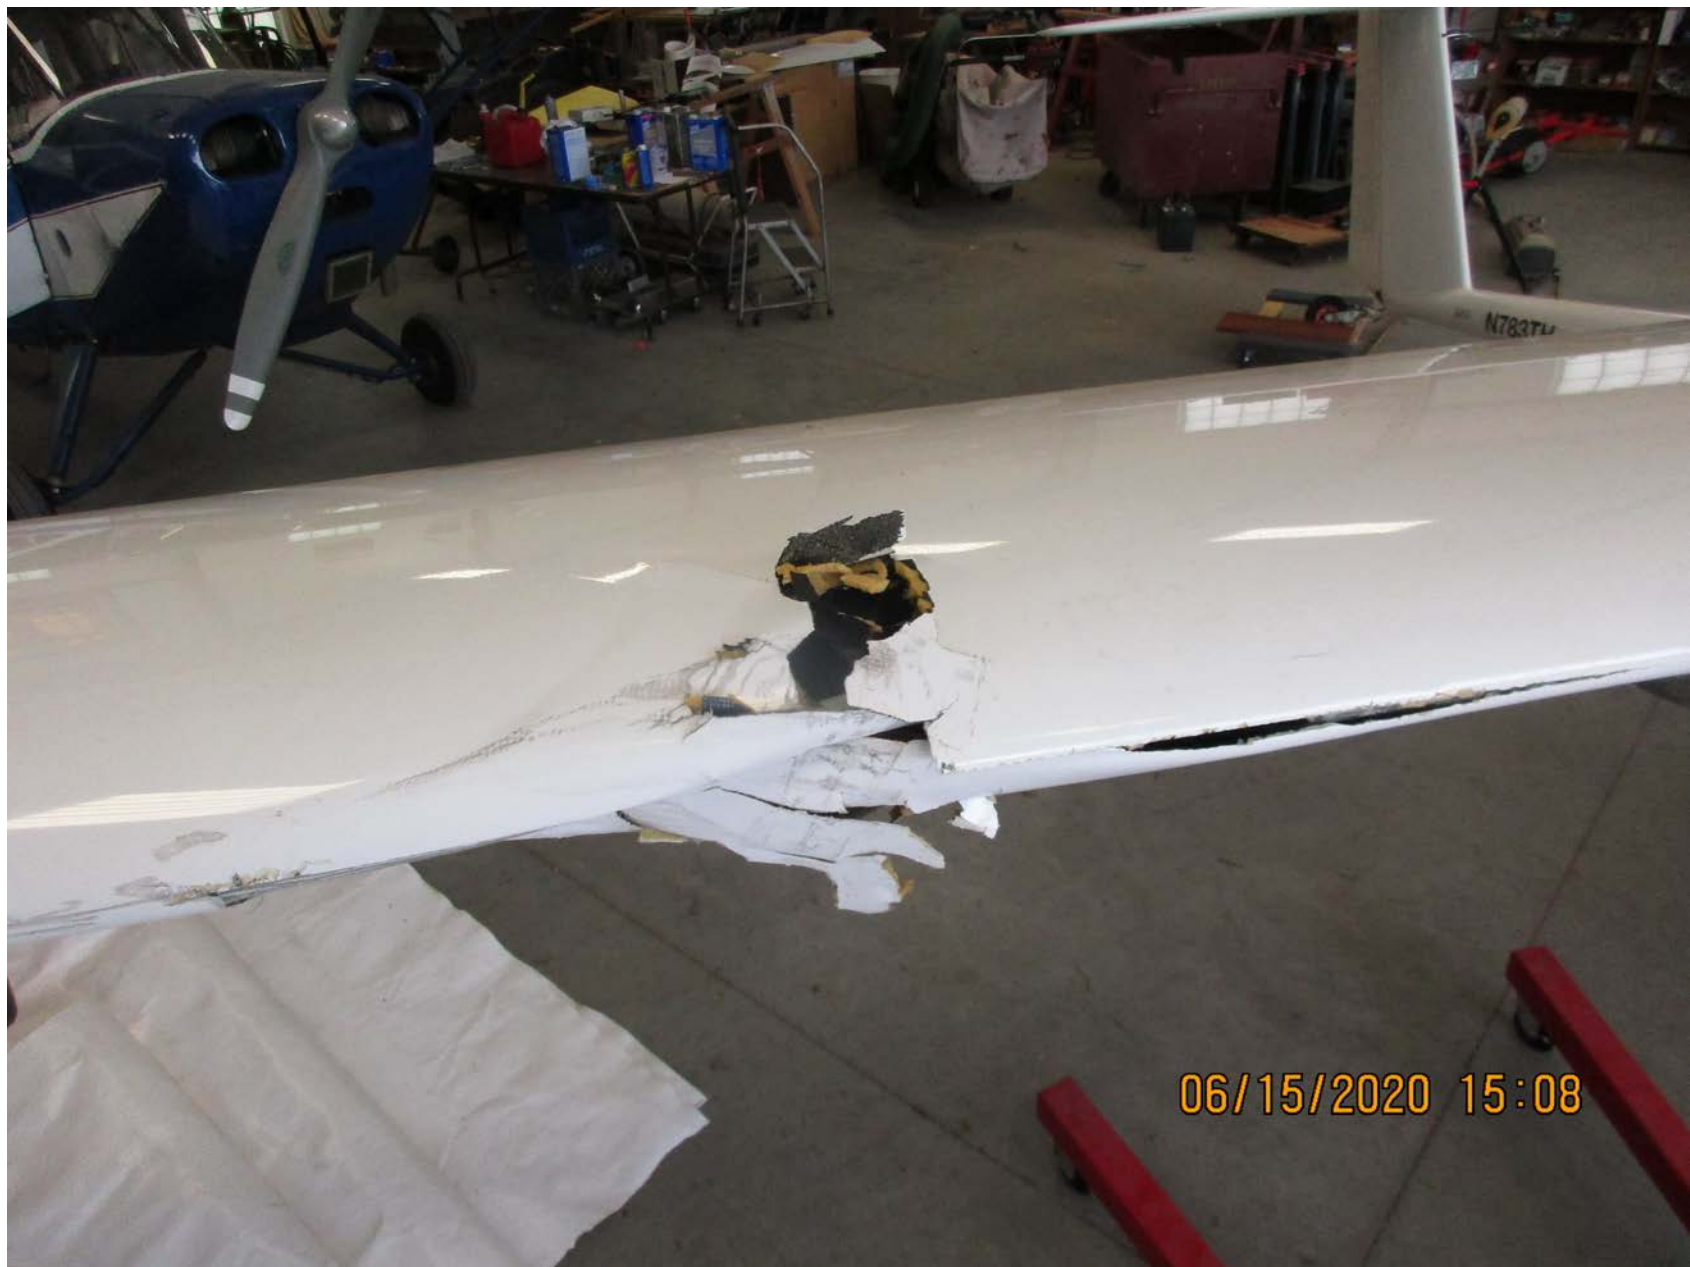
Photo 9 – Close Up of Right Wing Damage Inboard of Pitot Tube – Courtesy of FAA

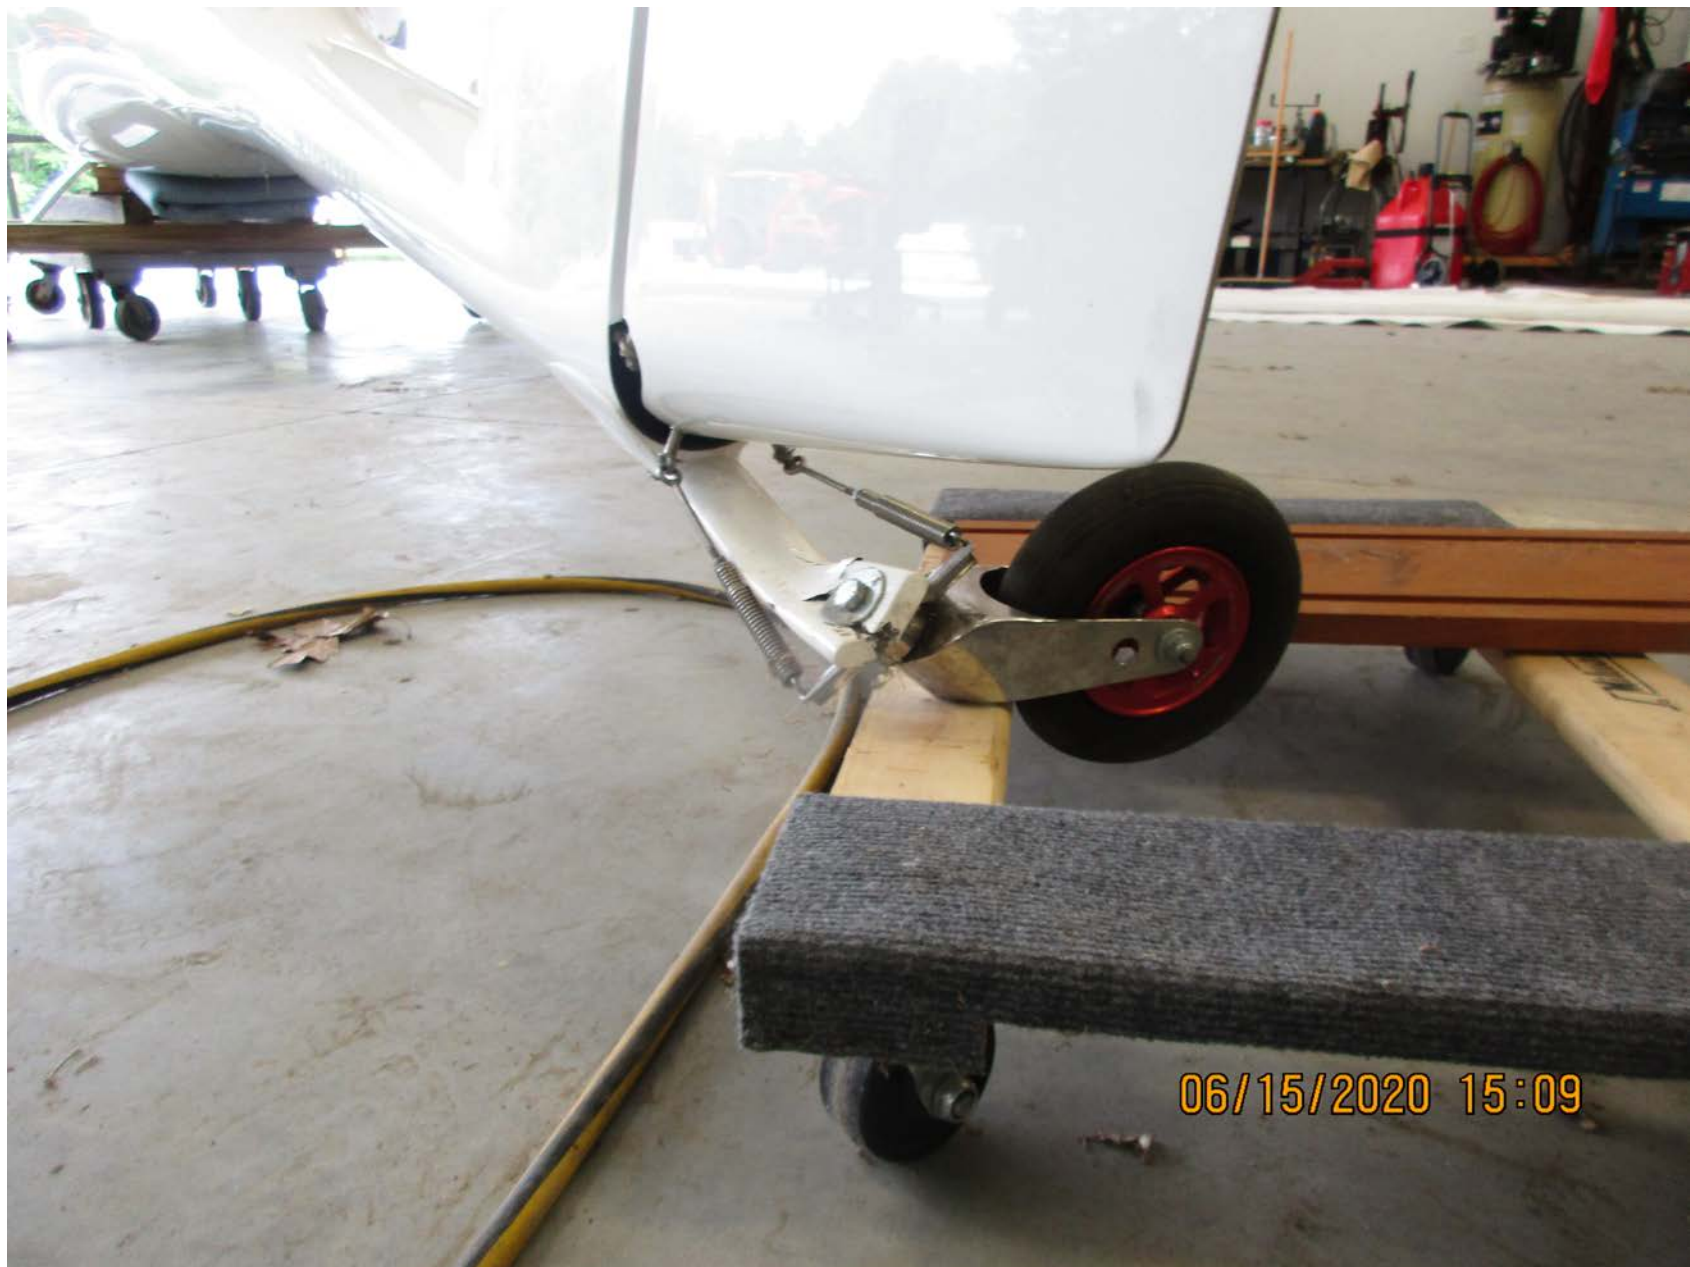
Photo 10 – Tail Wheel – Courtesy of FAA

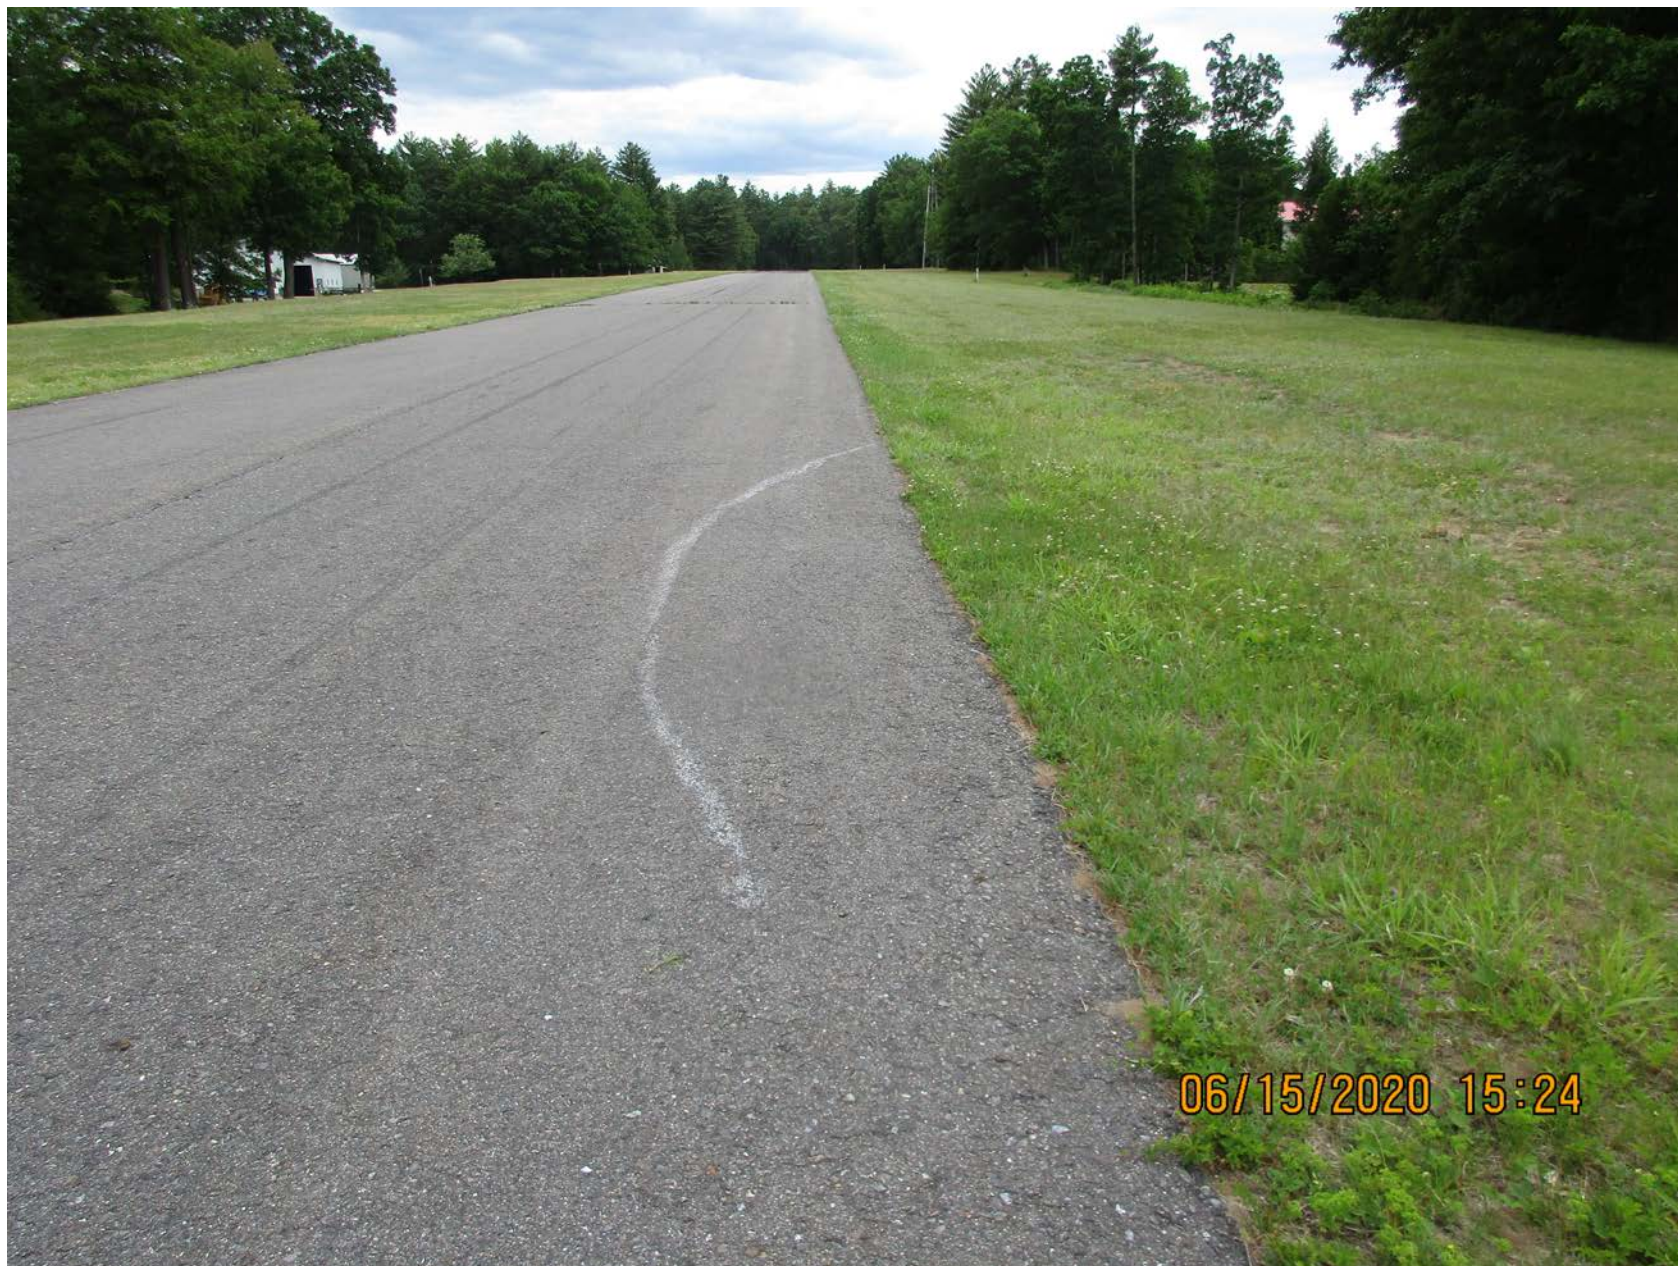
Photo 12 - First Paint Transfer – Courtesy of FAA

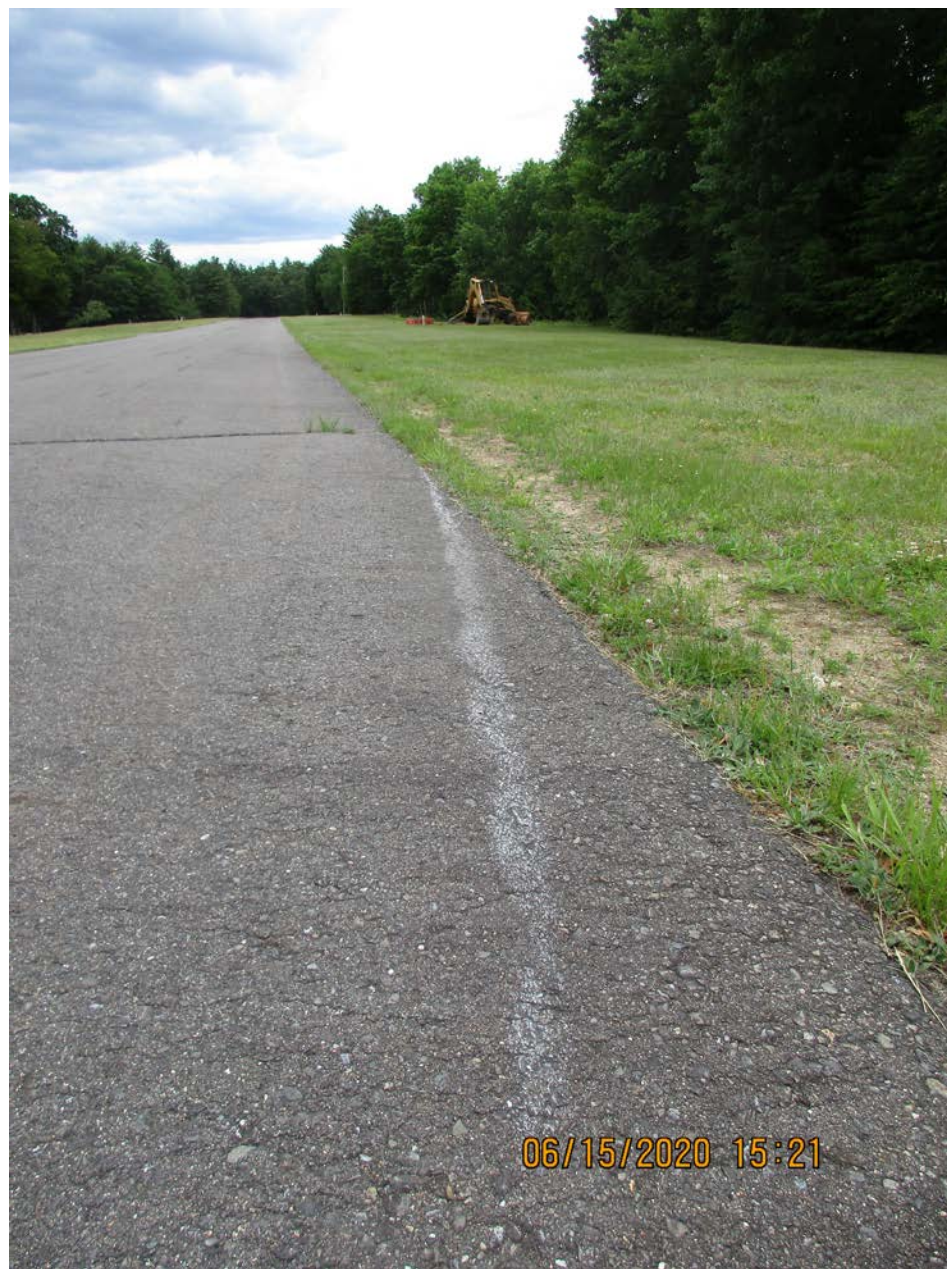
Photo 13 – Second Paint Transfer – Courtesy of FAA

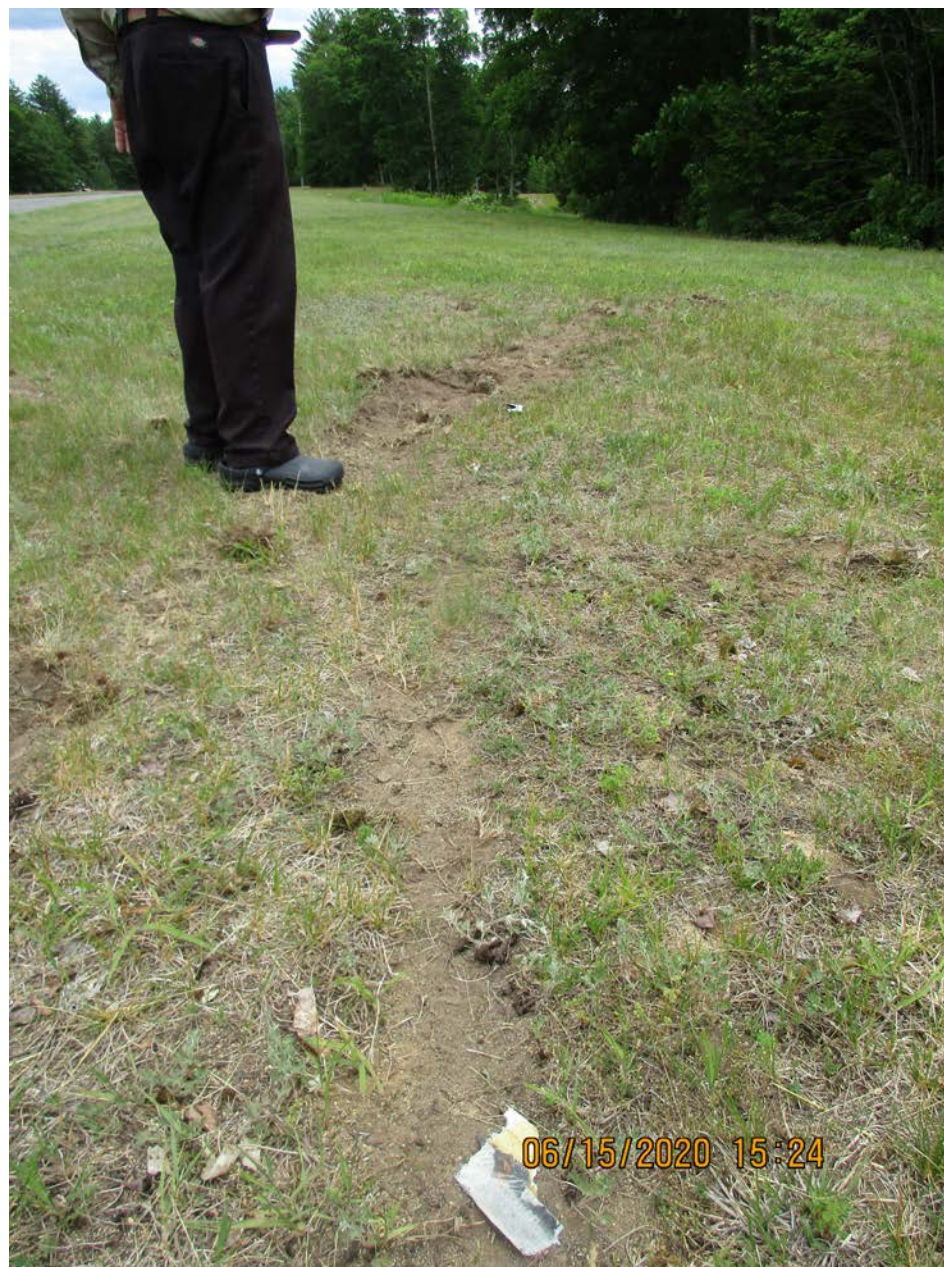
Photo 16 – Ground Scar – Courtesy of FAA
