ERA23FA024

INVESTIGATION PHOTOGRAPHS

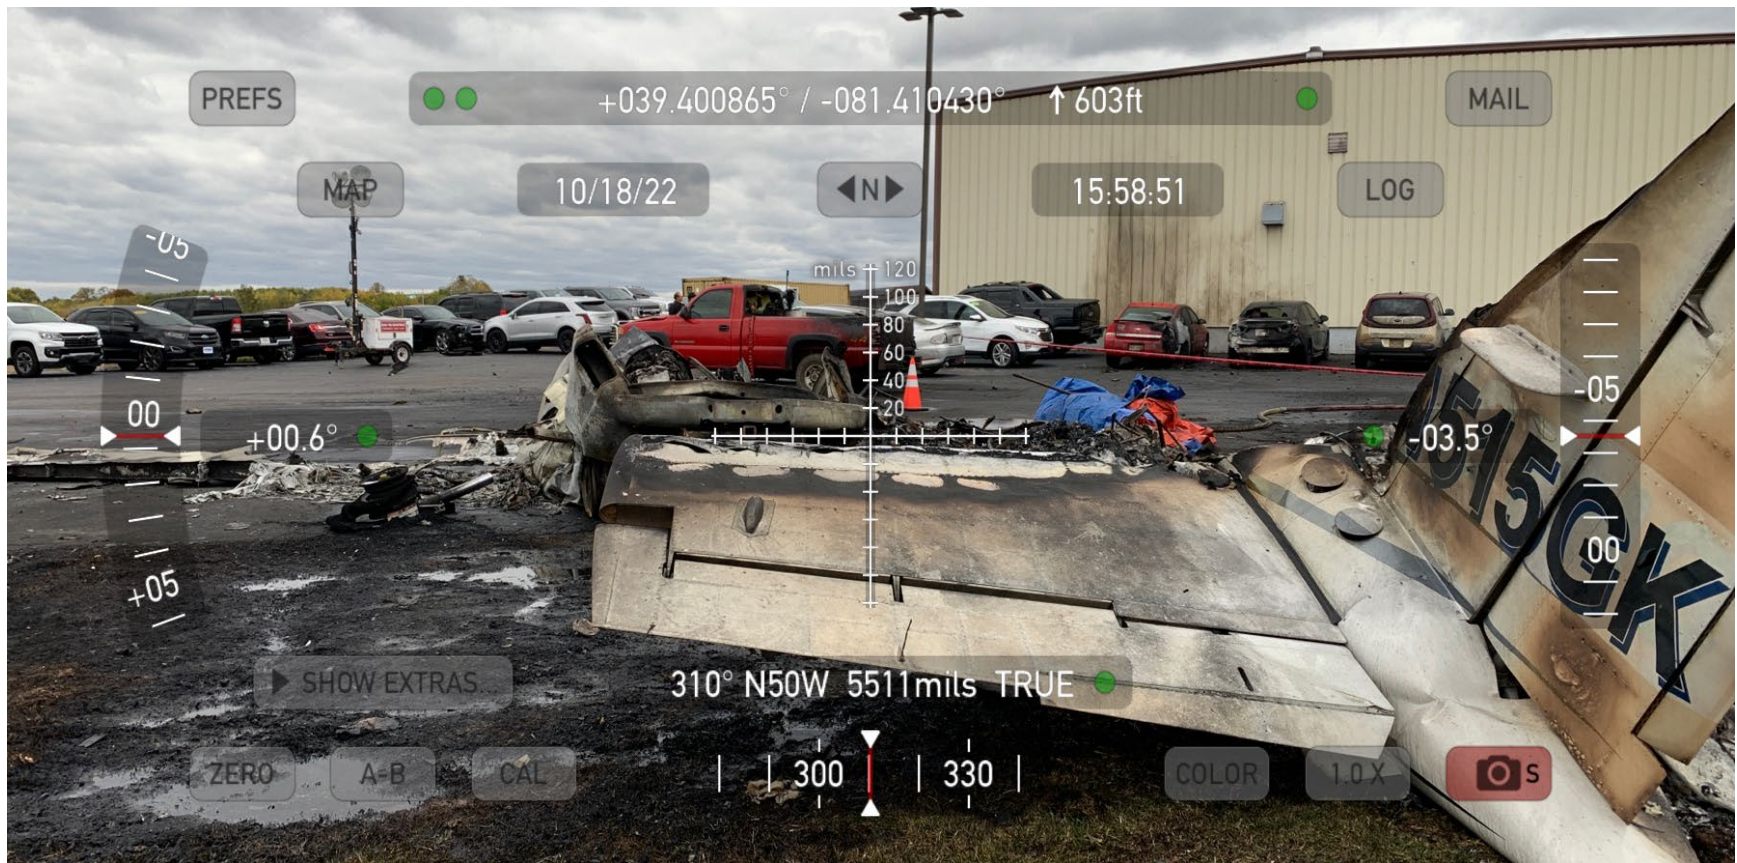
Photograph 1 - Wreckage view looking forward with heading and location tags.

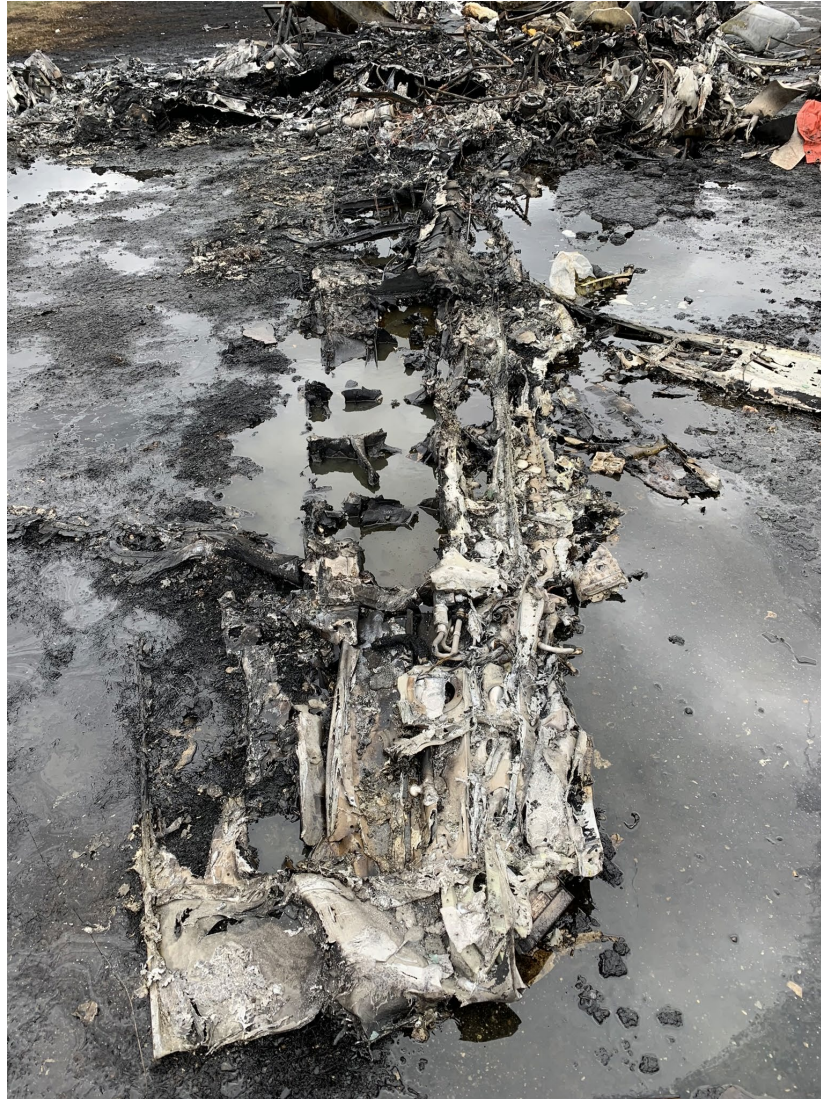
Photograph 2 - View of right wing damage.

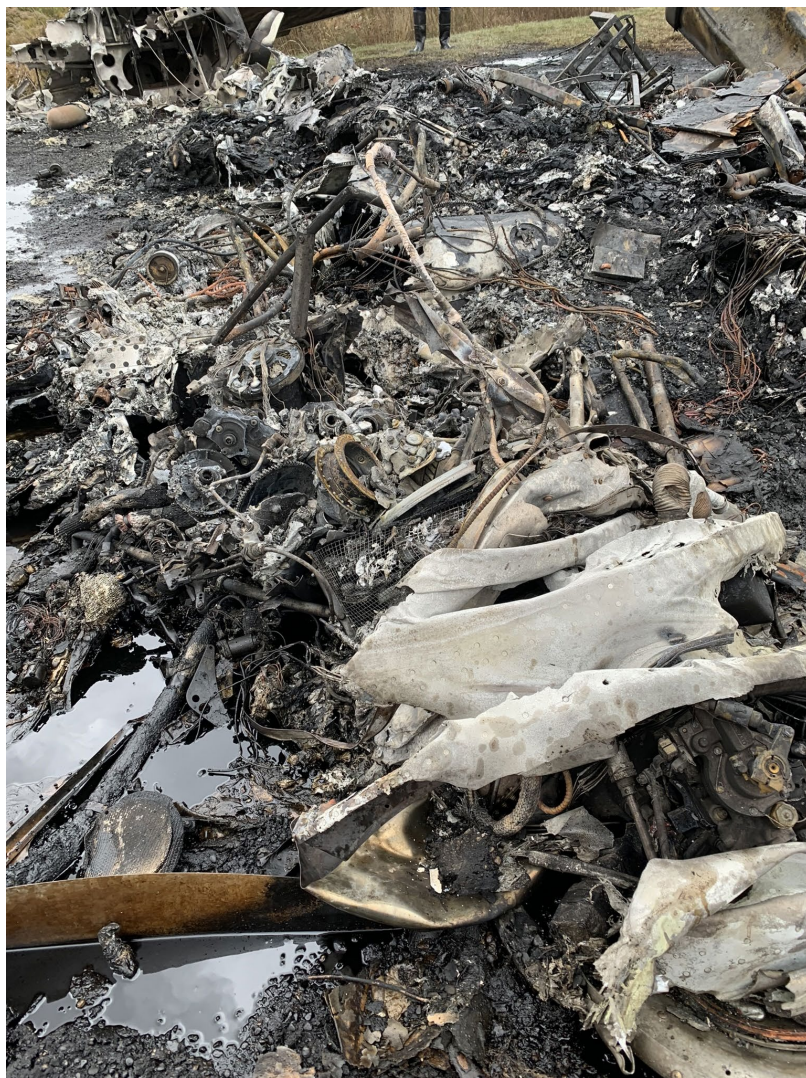
Photograph 3 - View of right propeller and engine looking aft.

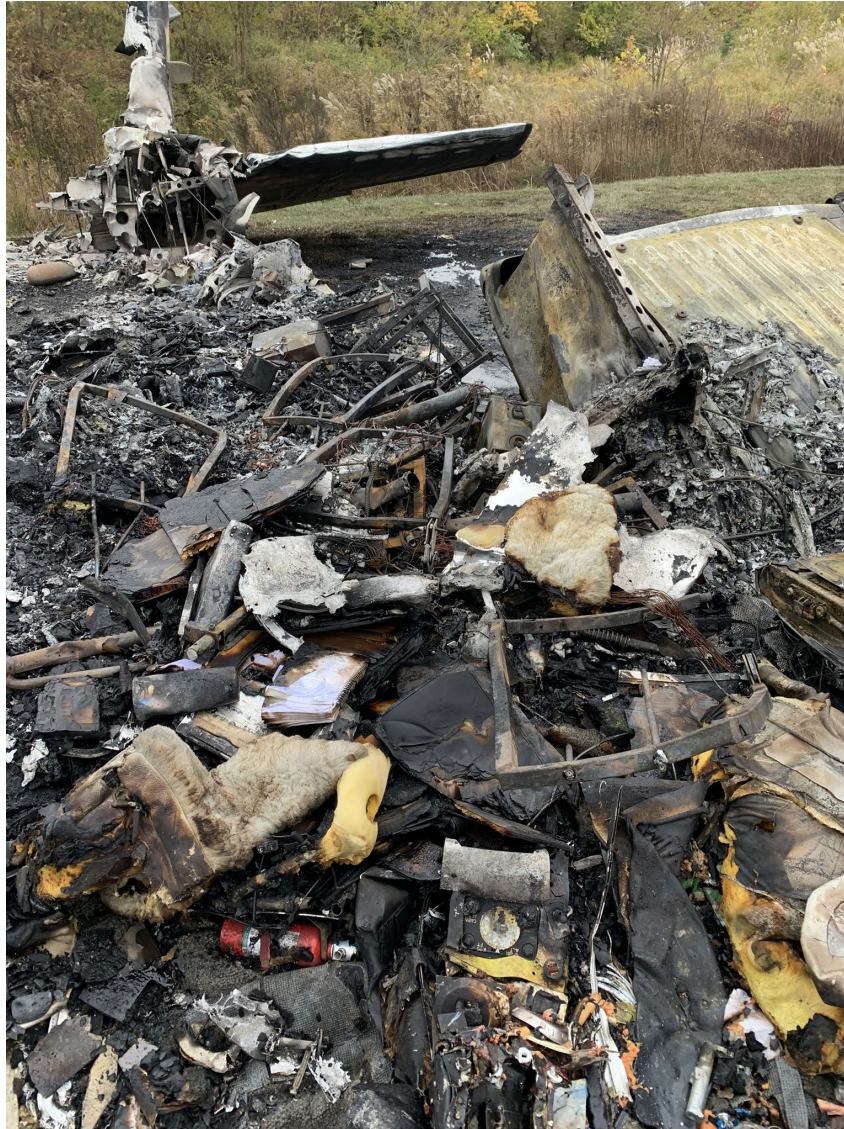
Photograph 4 - View of cockpit and cabin damage looking aft.

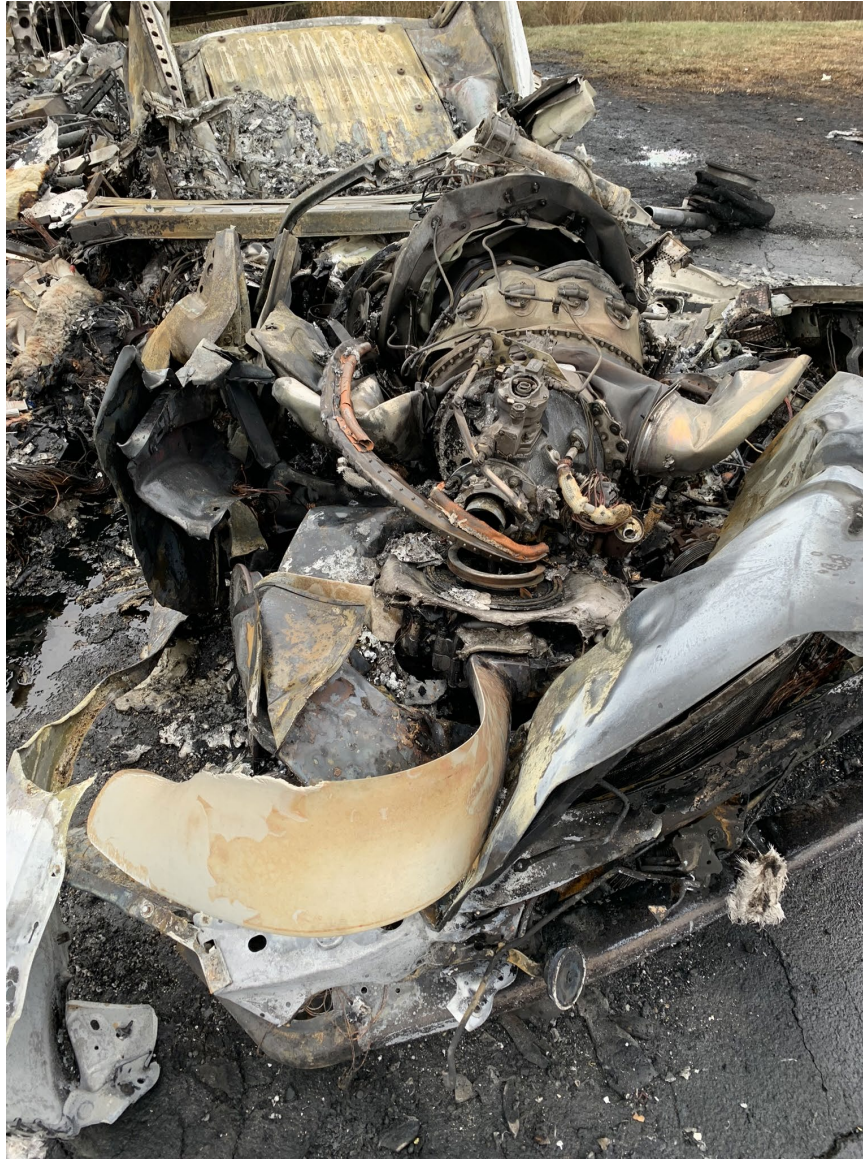
Photograph 5 - View of left propeller and engine looking aft. Note: Resting on top of damaged vehicle.

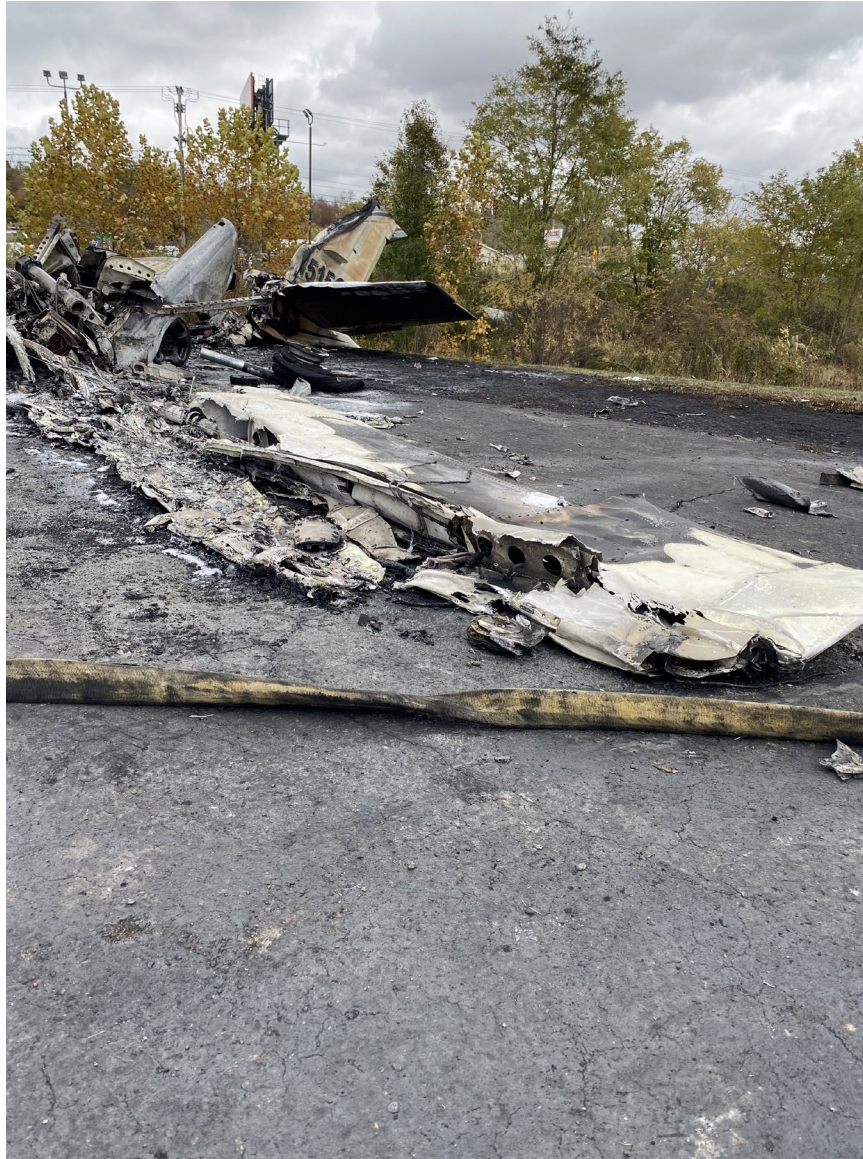
Photograph 6 - View of left wing damage.

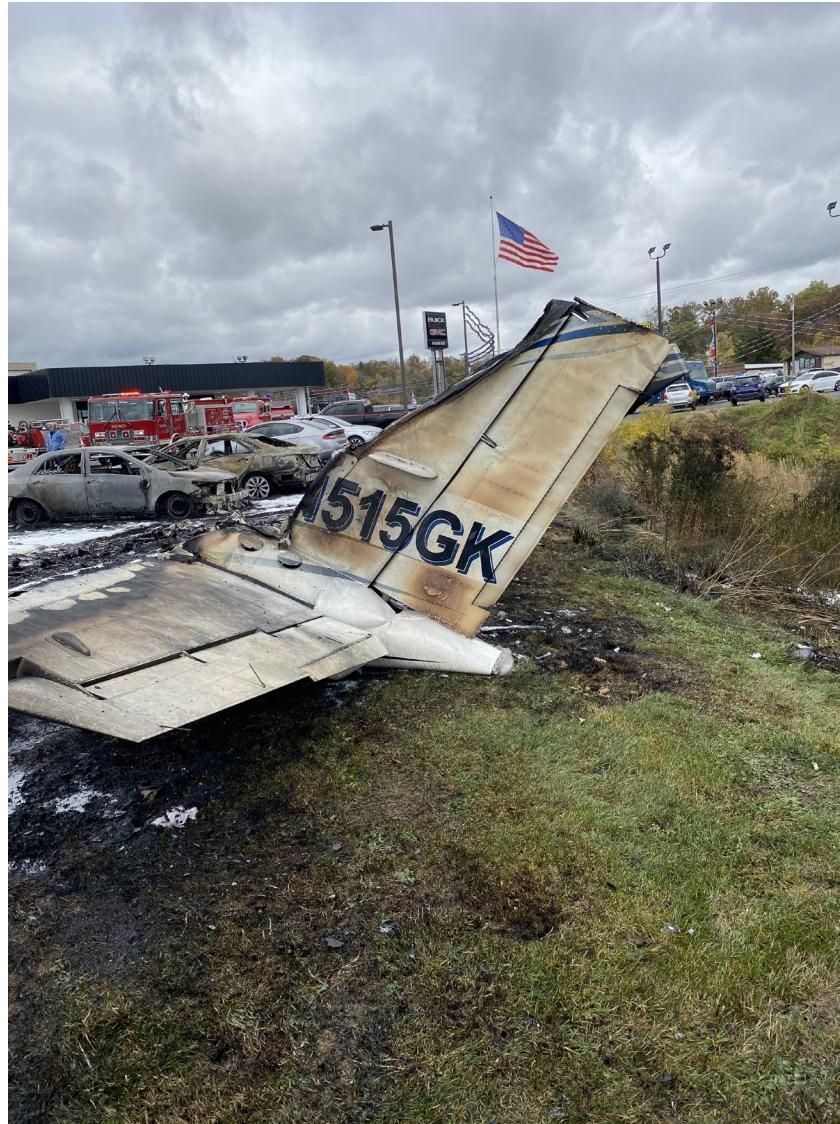
Photograph 7 - View of left side of empennage, elevator, and rudder.

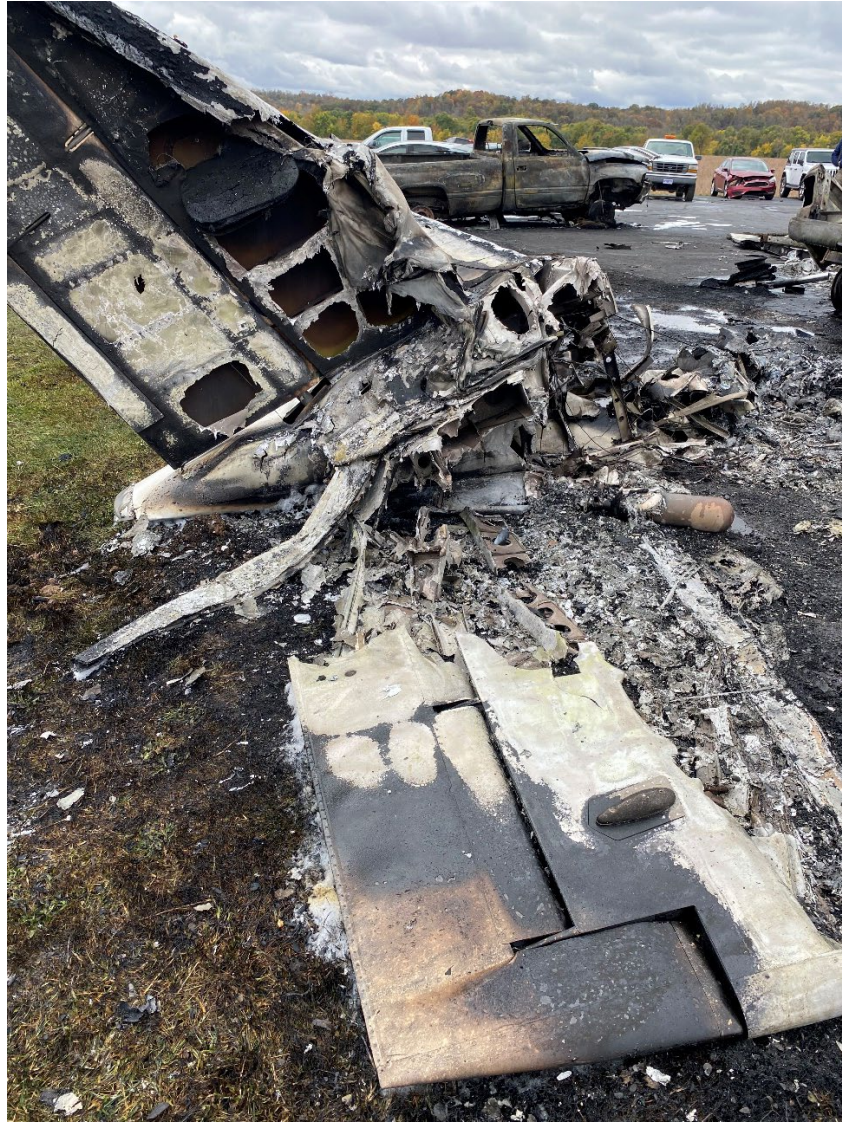
Photograph 8 - View of right side of empennage, elevator, and rudder.
