NTSB ERA21FA195

N53DE, Bell 429

Eden, NC

Photo Array

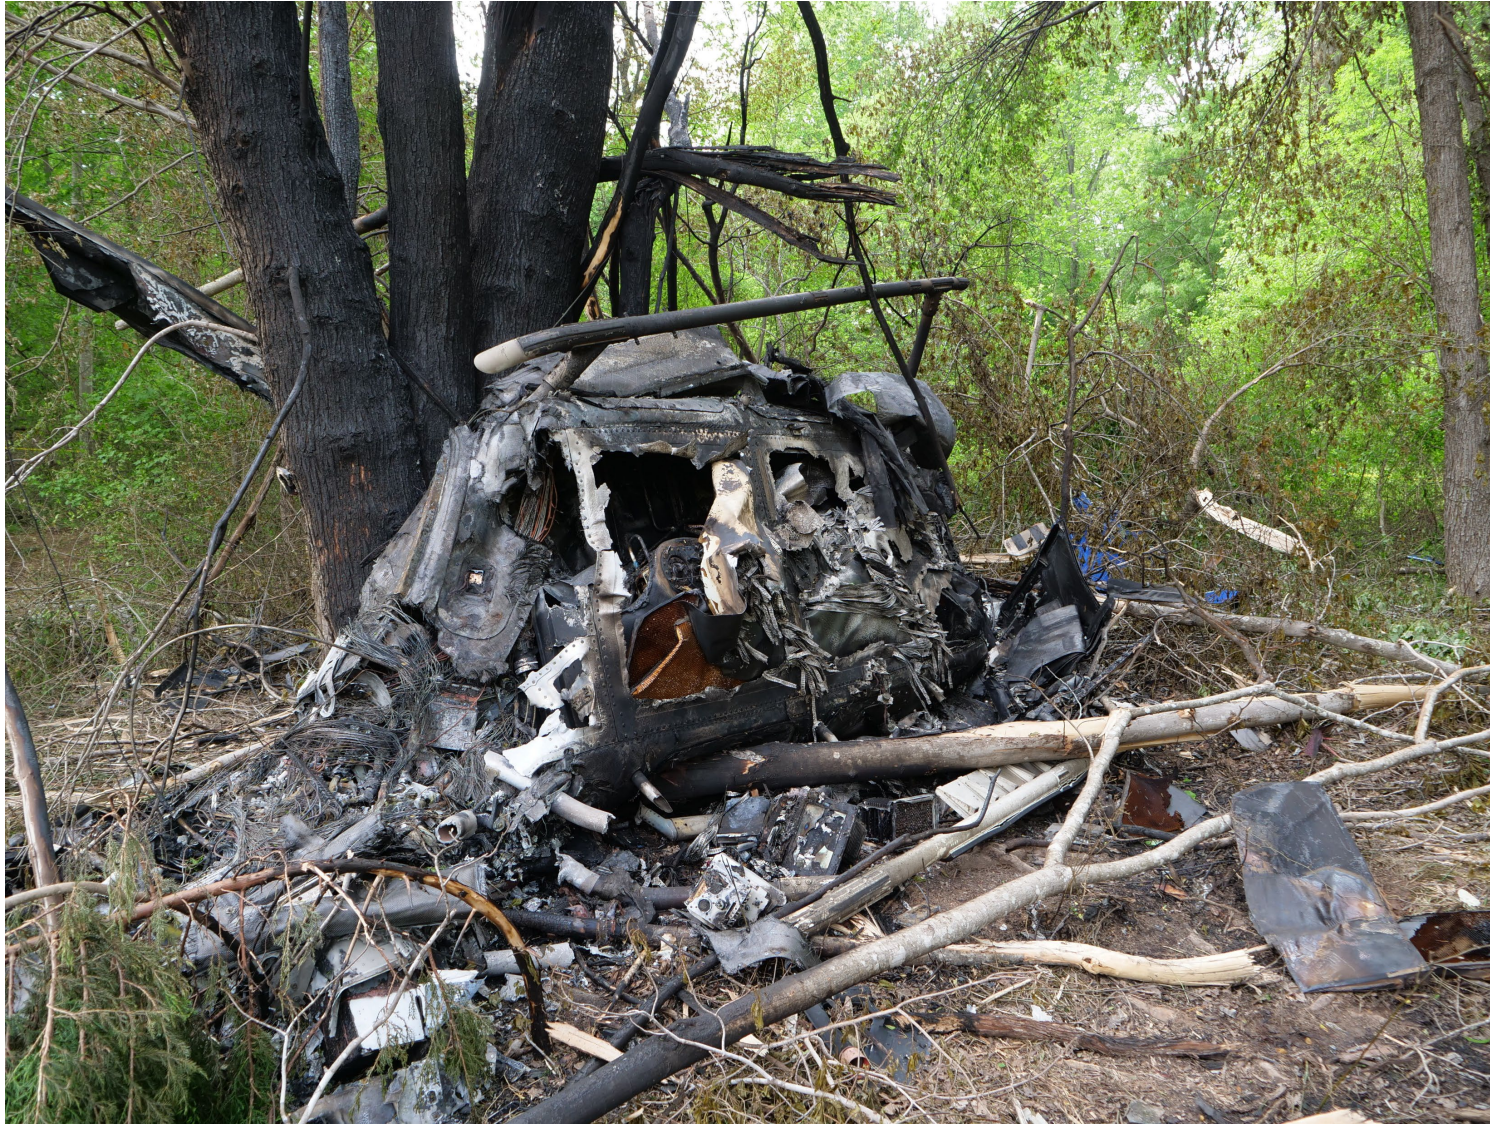
Photo 1: Main wreckage up against tree. Bottom of helicopter facing camera.

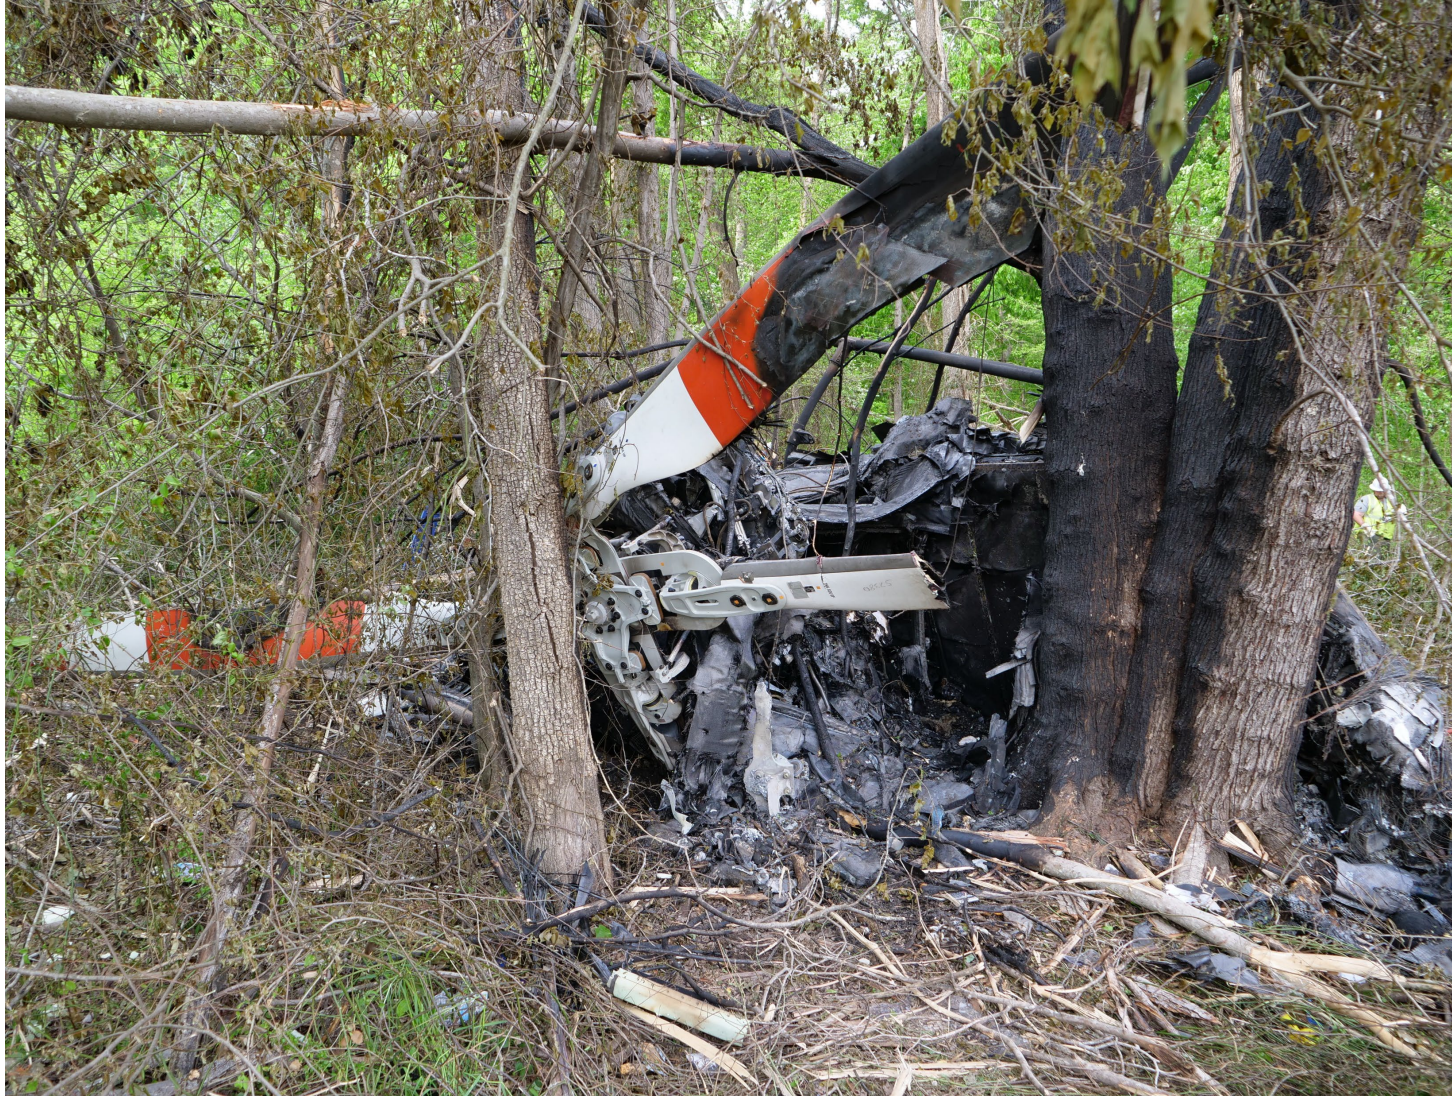
Photo 2: Main wreckage resting up against tree. Main rotor head and blades facing camera.

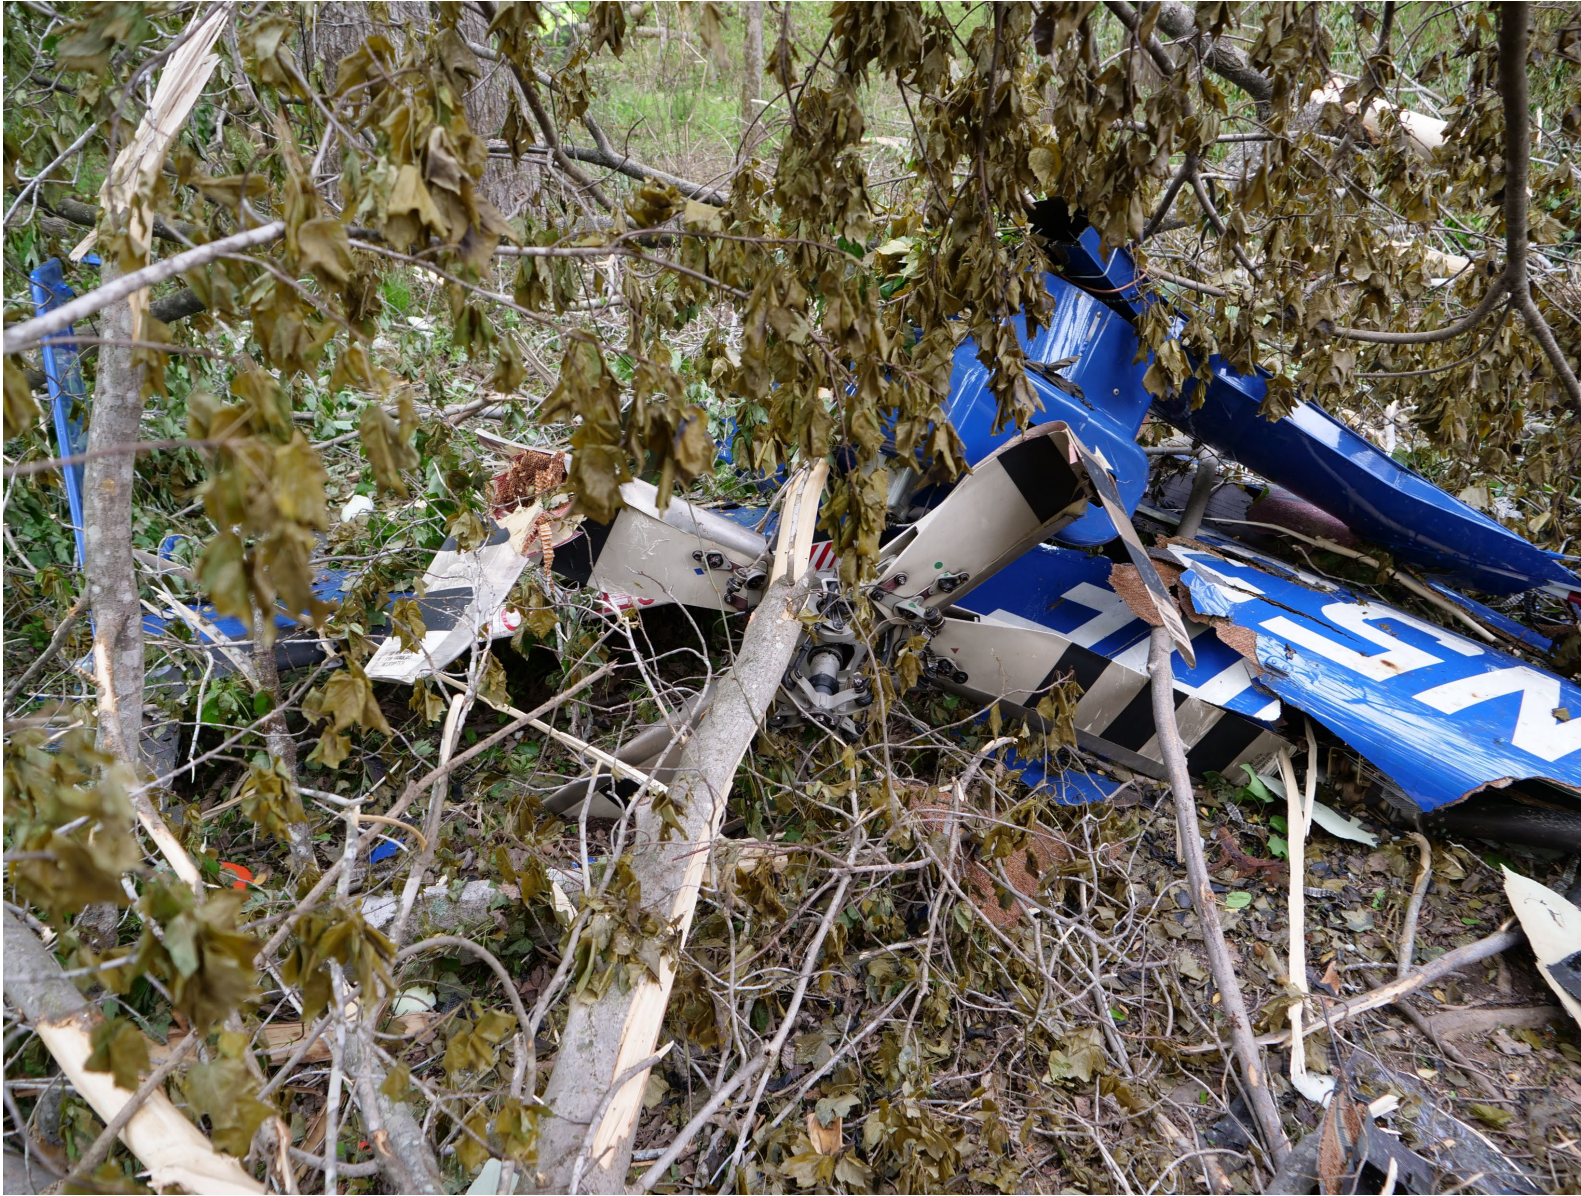
Photo 3: Tail rotor assembly wreckage at its final resting location.

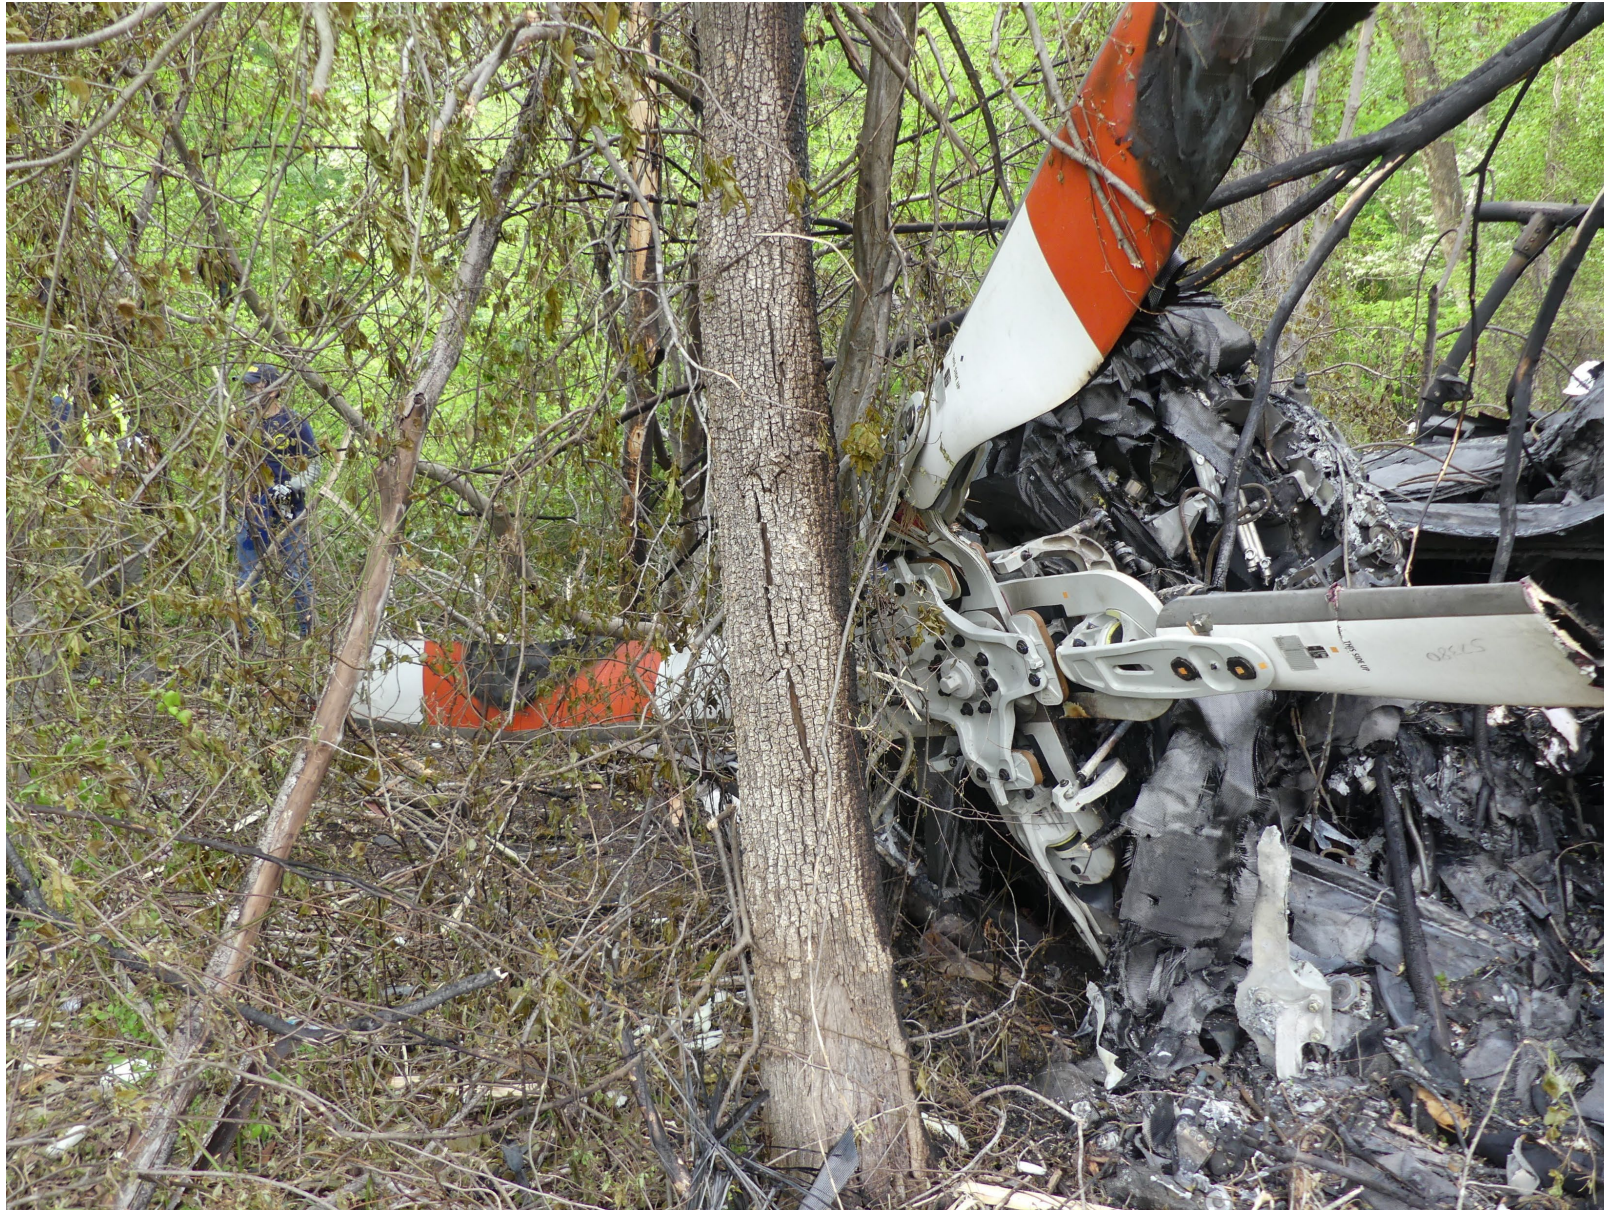
Photo 4: Closeup view of main rotor blade assembly resting up against tree.

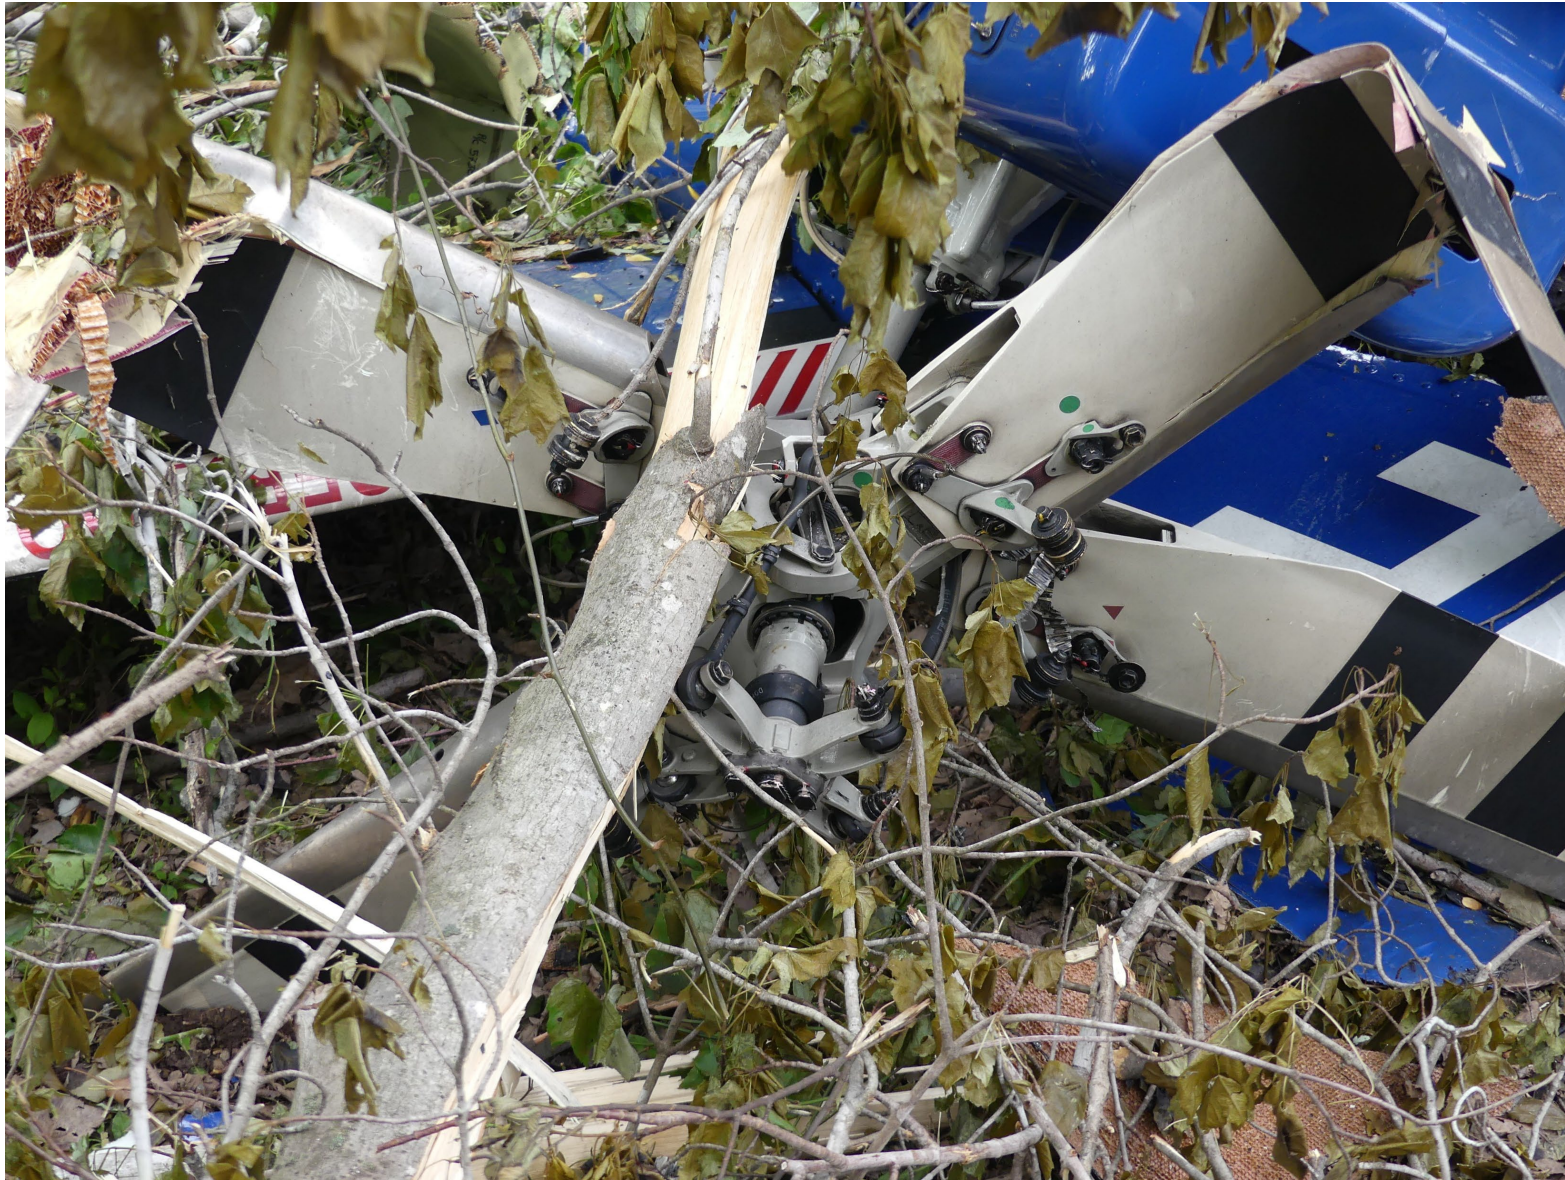
Photo 6: Closeup view of tail rotor blades.

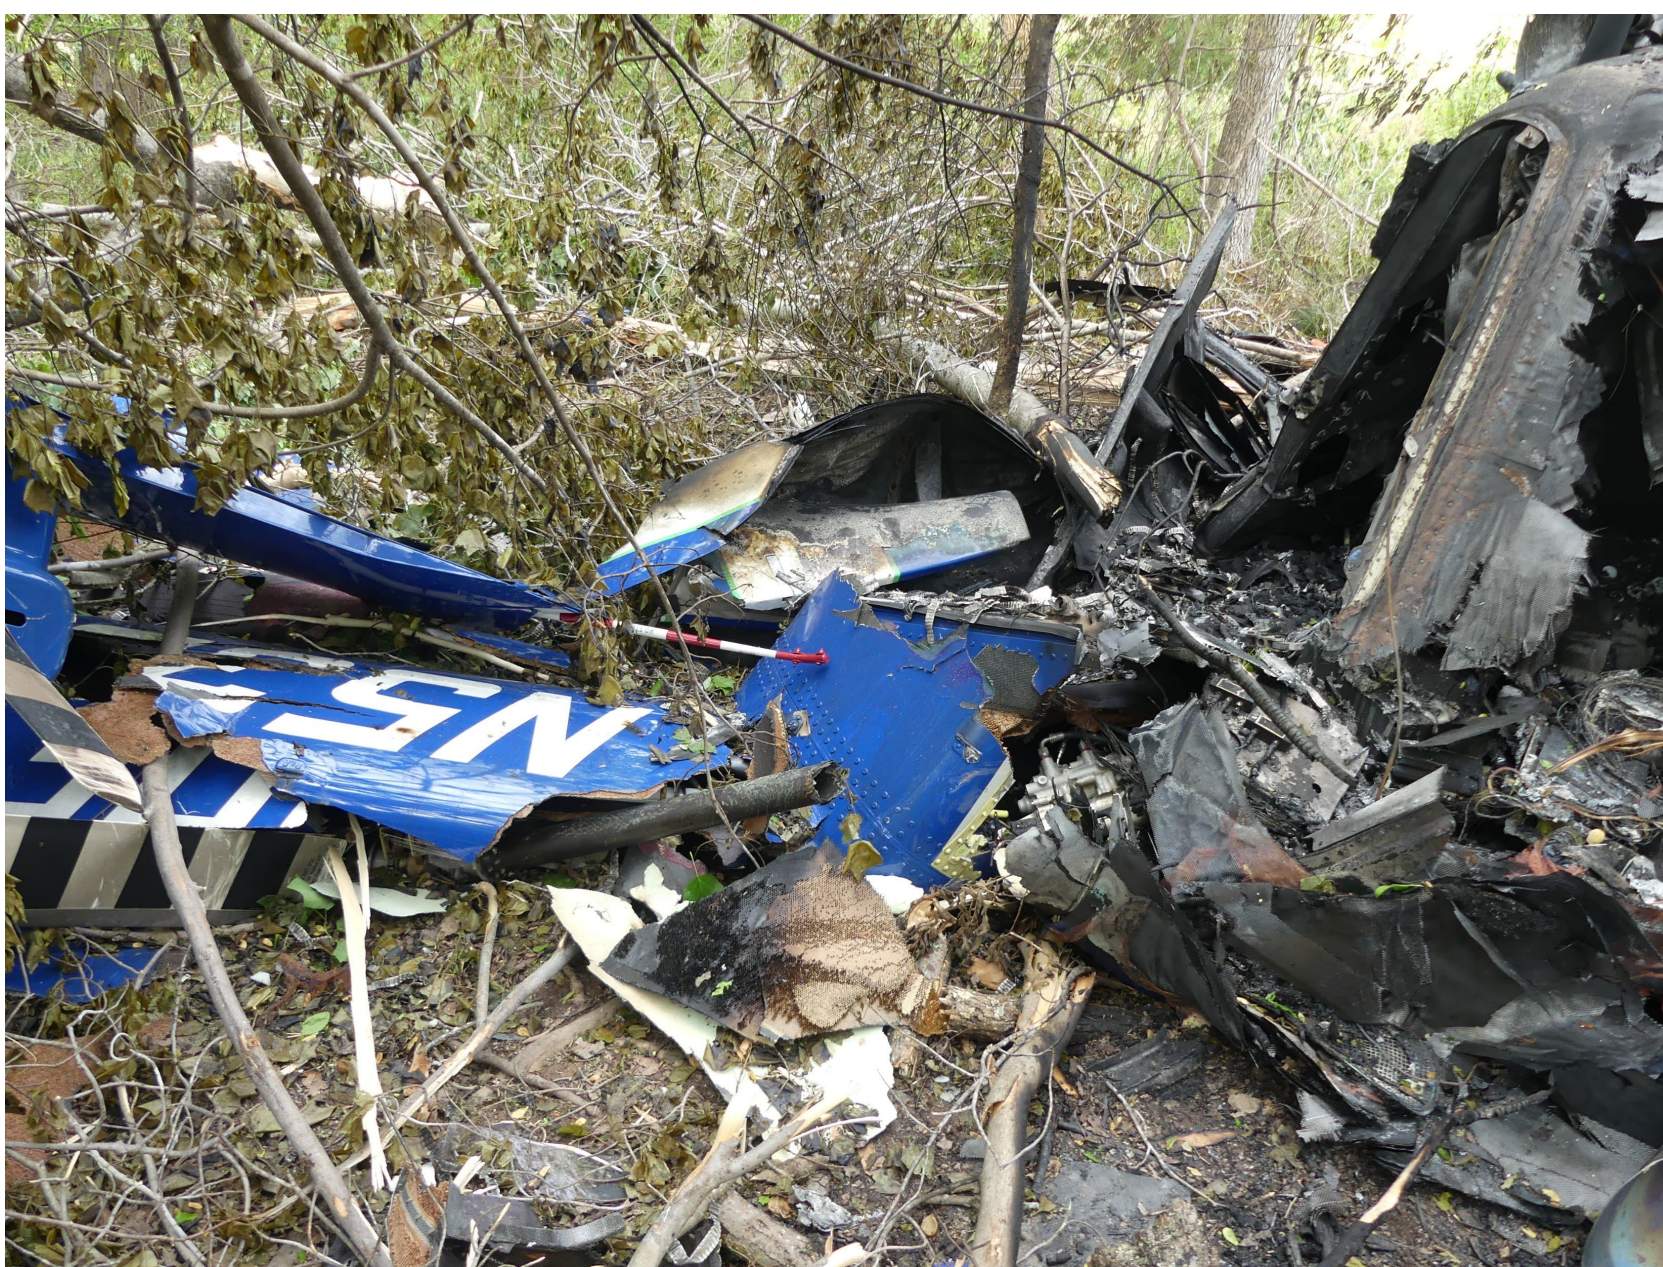
Photo 7: Tail boom on left and fuselage wreckage on right. Note tail rotor driveshaft sticking out of wreckage.

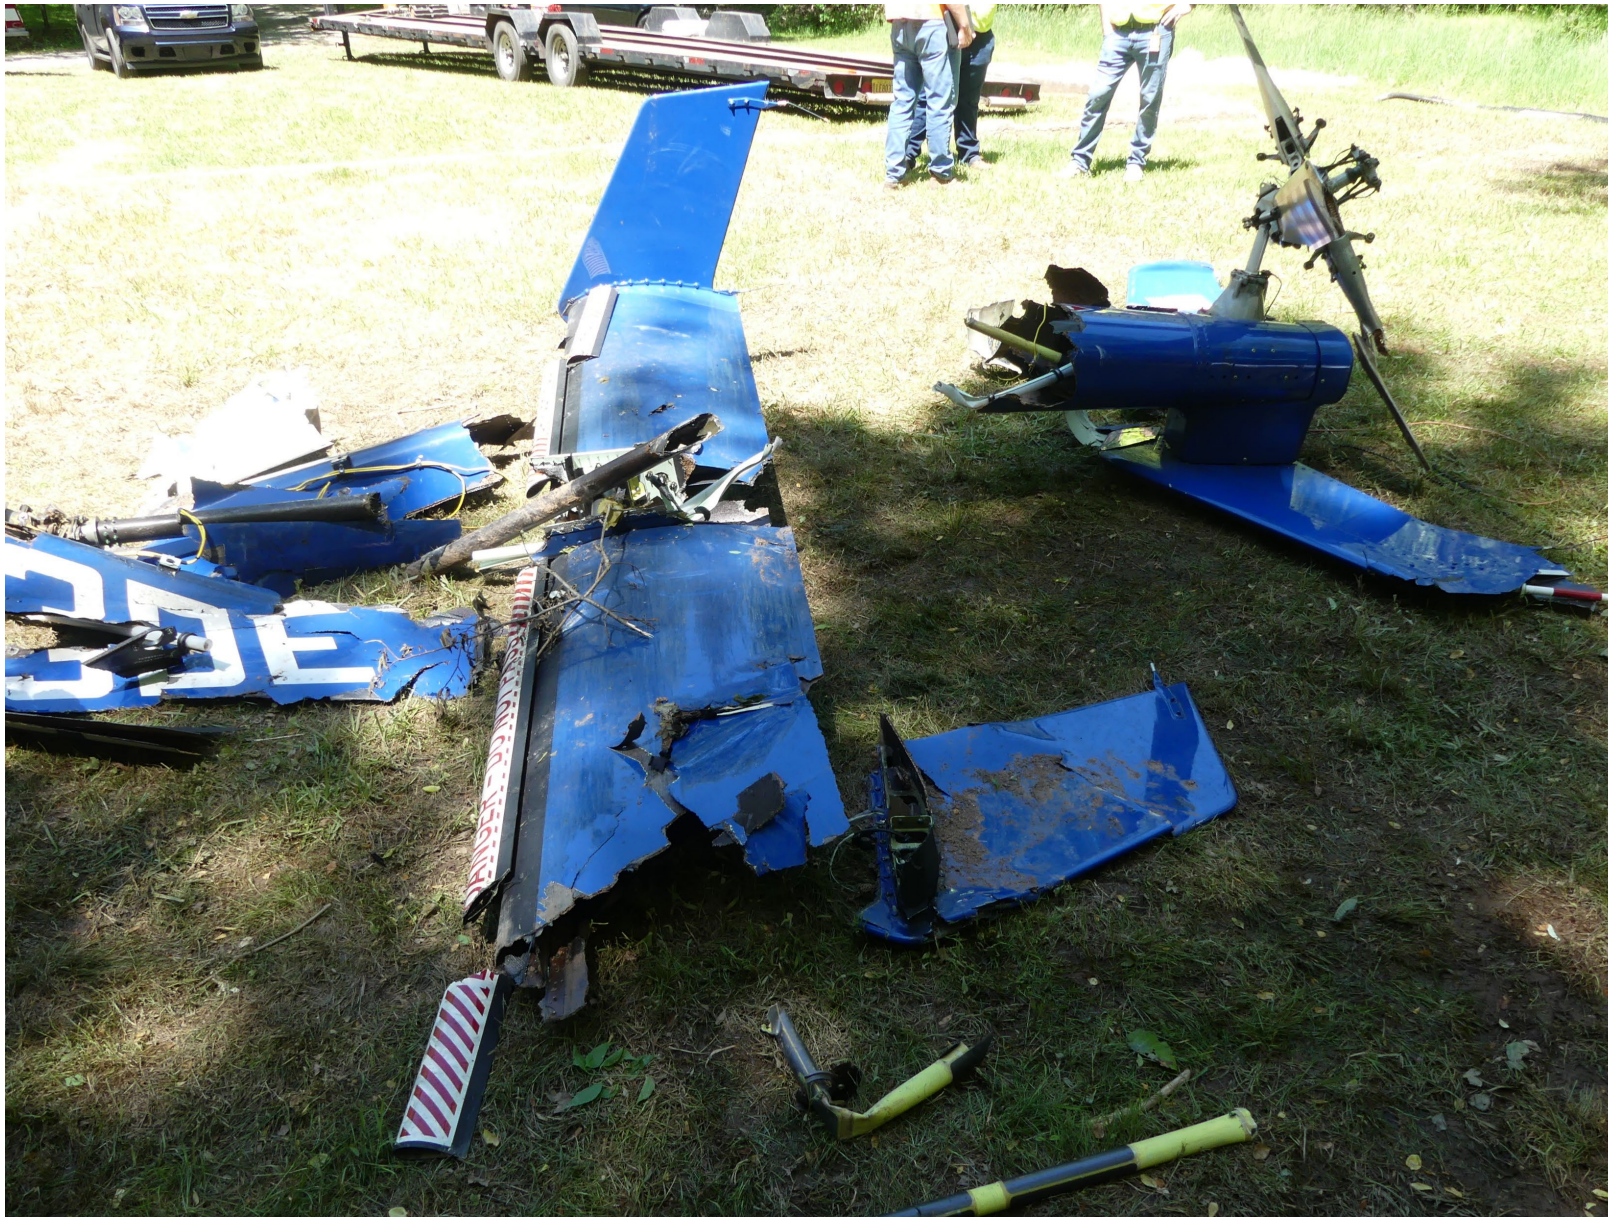
Photo 8: Tail boom and tail rotor assembly after recovery.

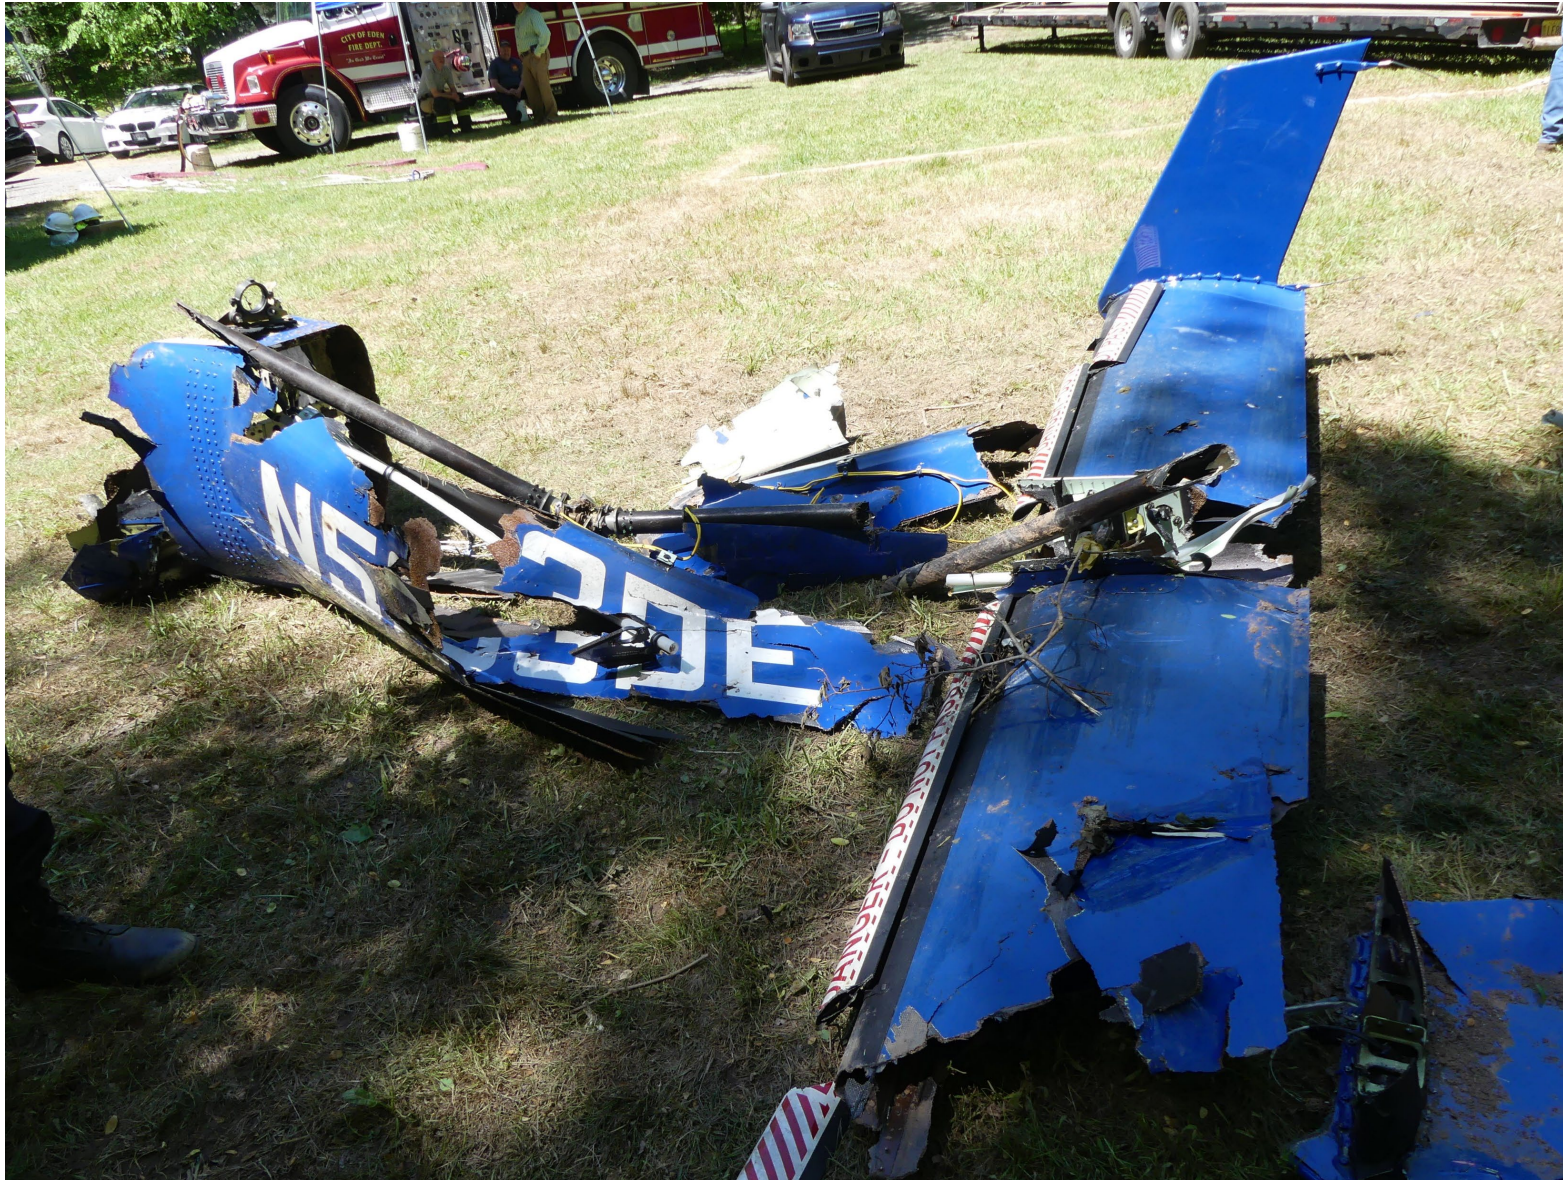
Photo 9: Tail boom and stabilizer after recovery.

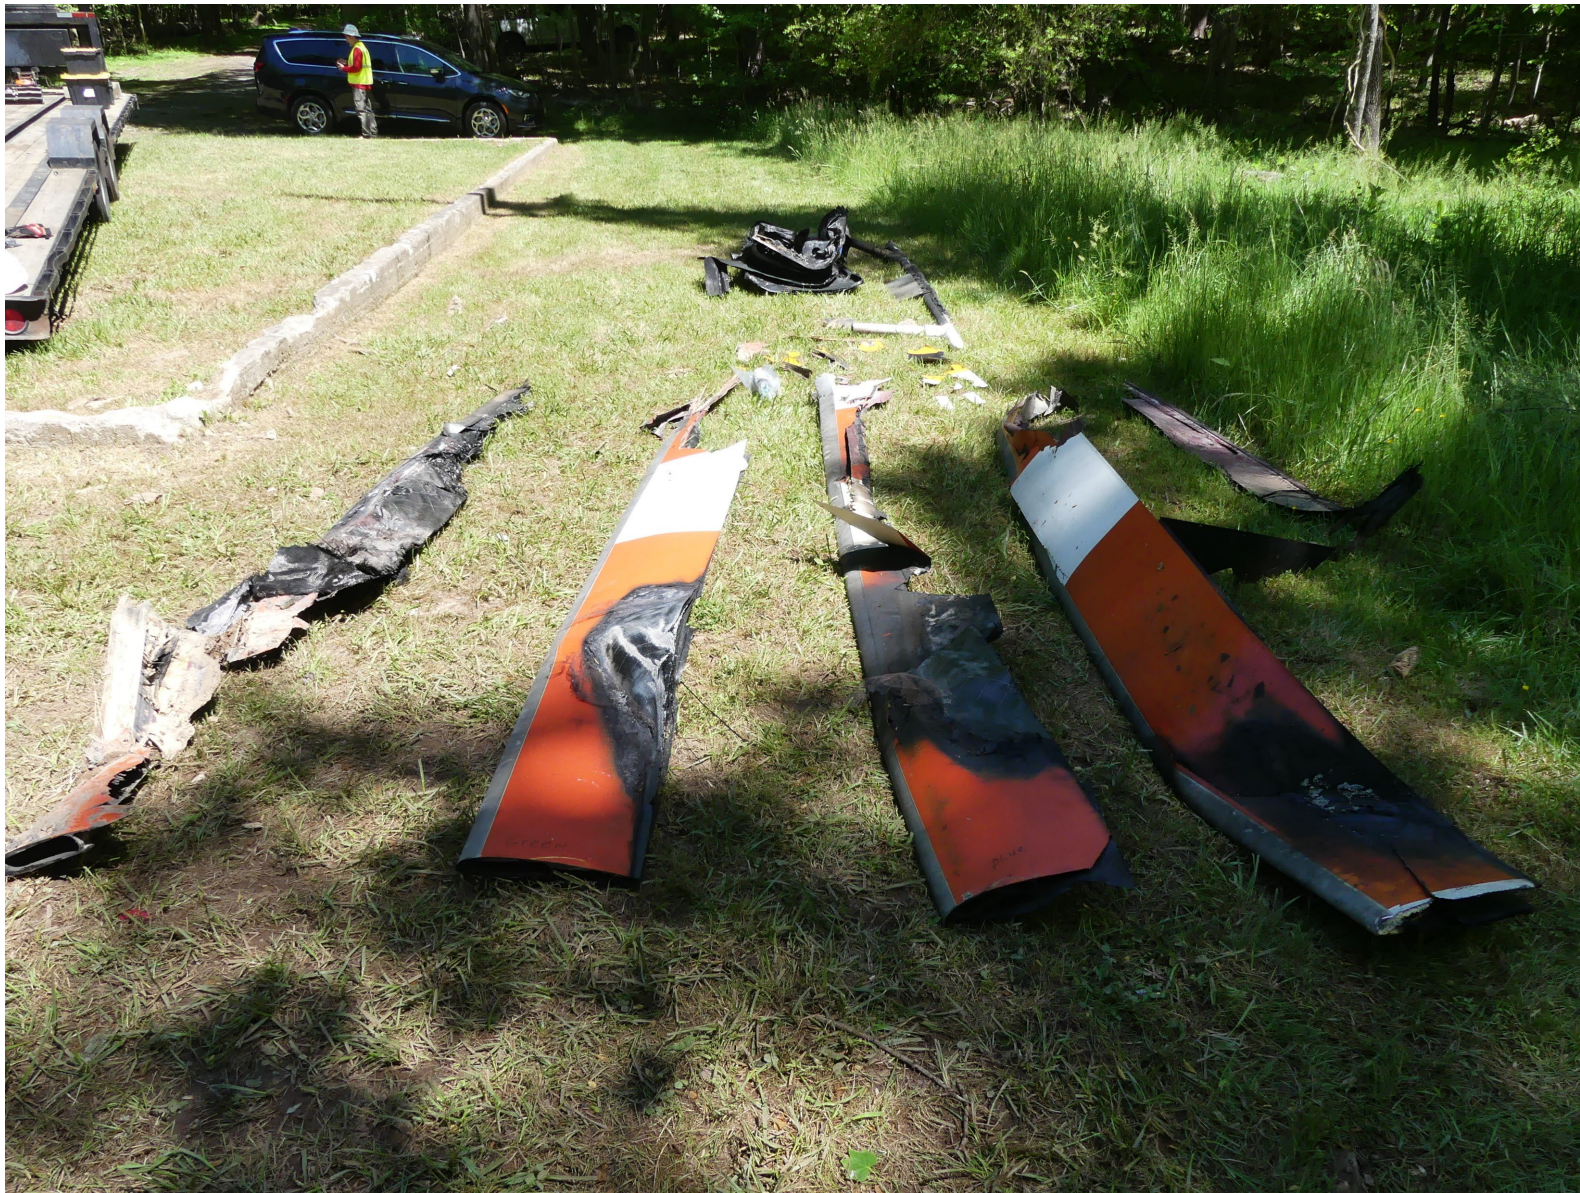
Photo 10: All four main rotor blades after recovery. (Courtesy of Bell)

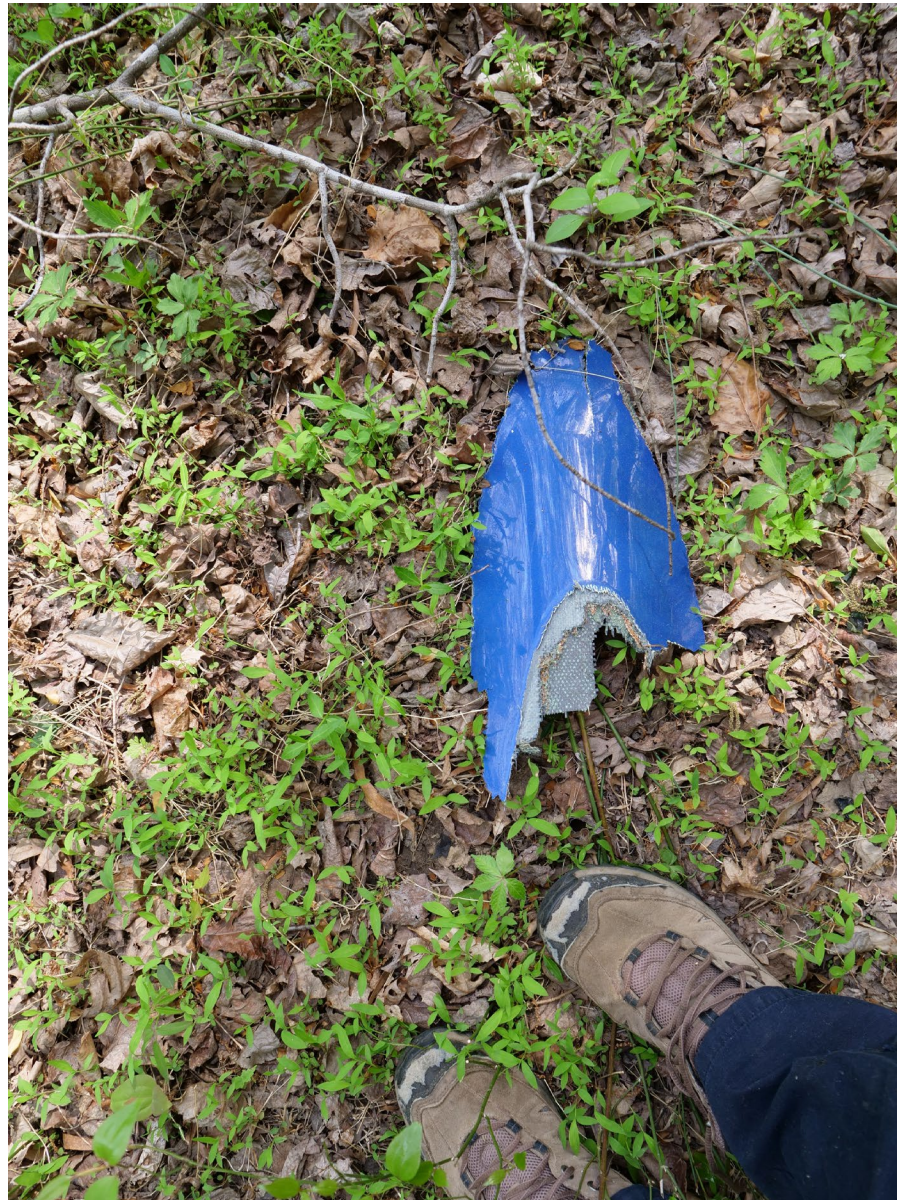
Photo 10: Damaged upper tail boom section discovered away from main wreckage. Note, this section is installed on the upper surface of the tail boom.

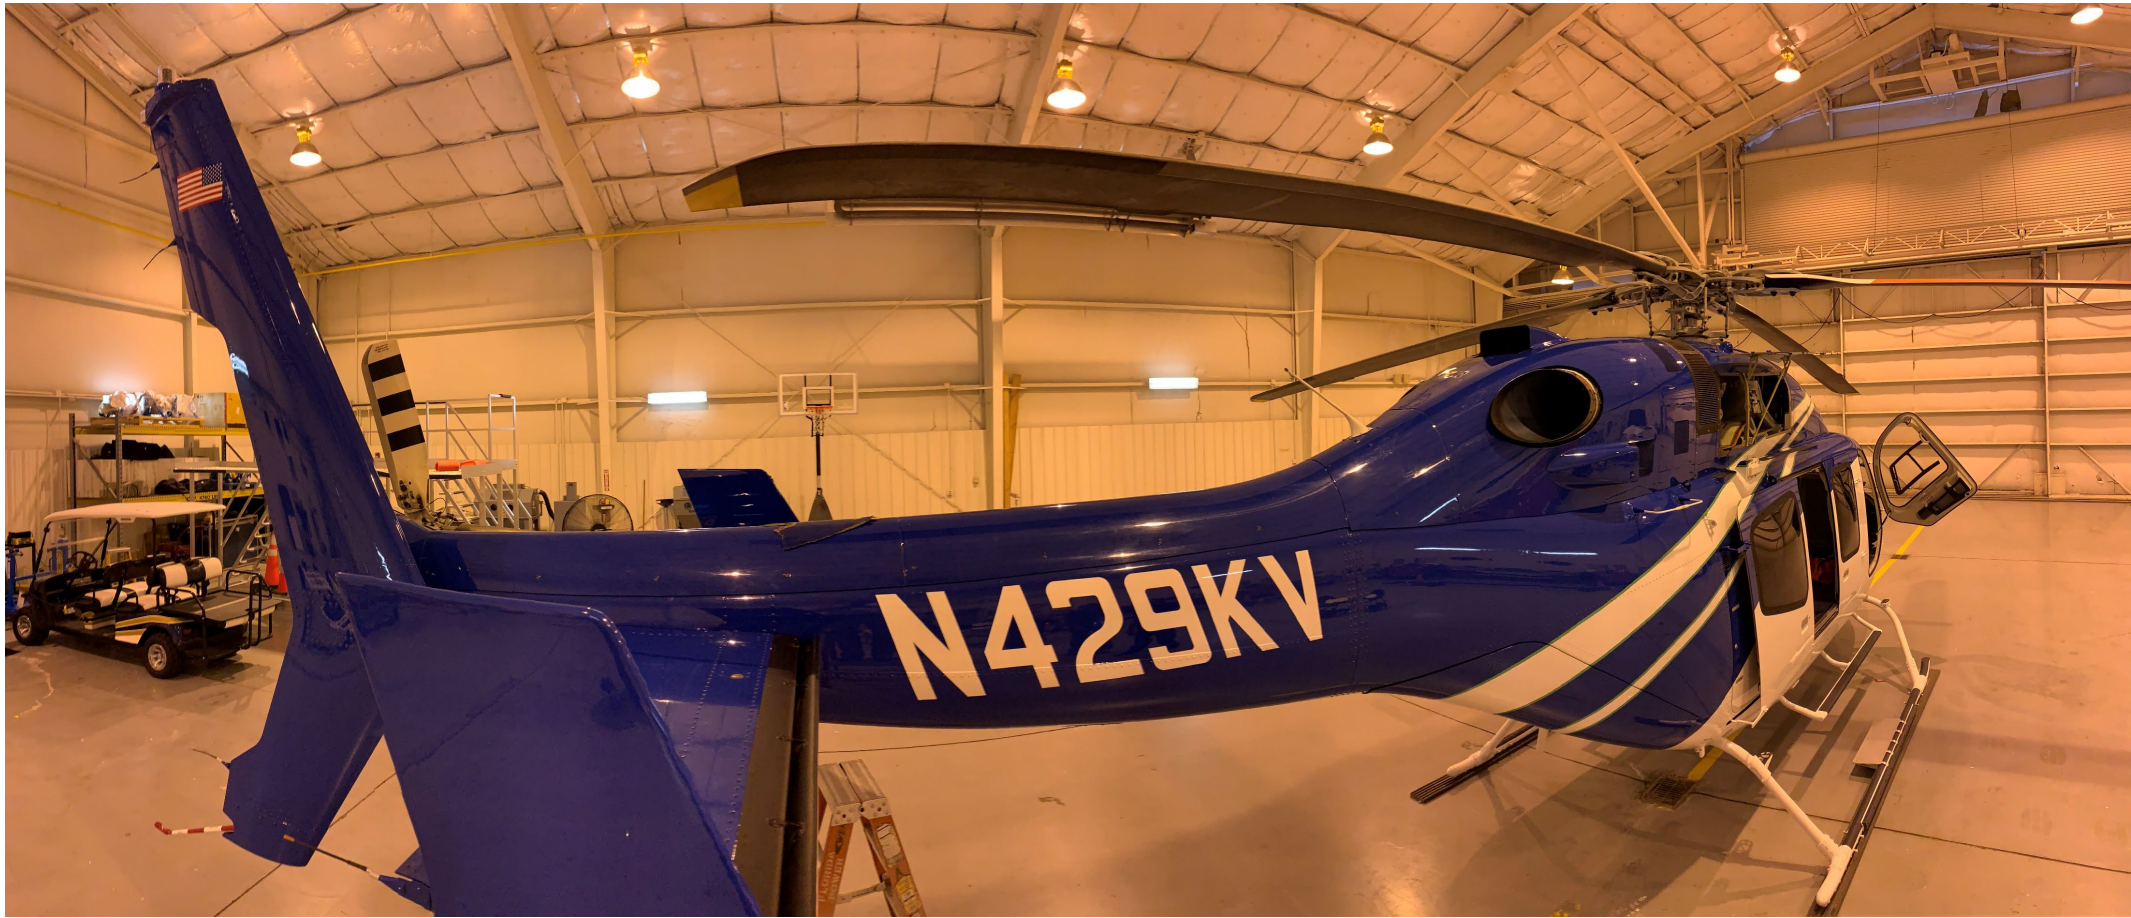
Photo 11: Damaged upper tail boom section/slice placed on approximate location of exemplar helicopter. Note: Wreckage piece located just above the “N” in line with the leading edge of the stabilizer.
