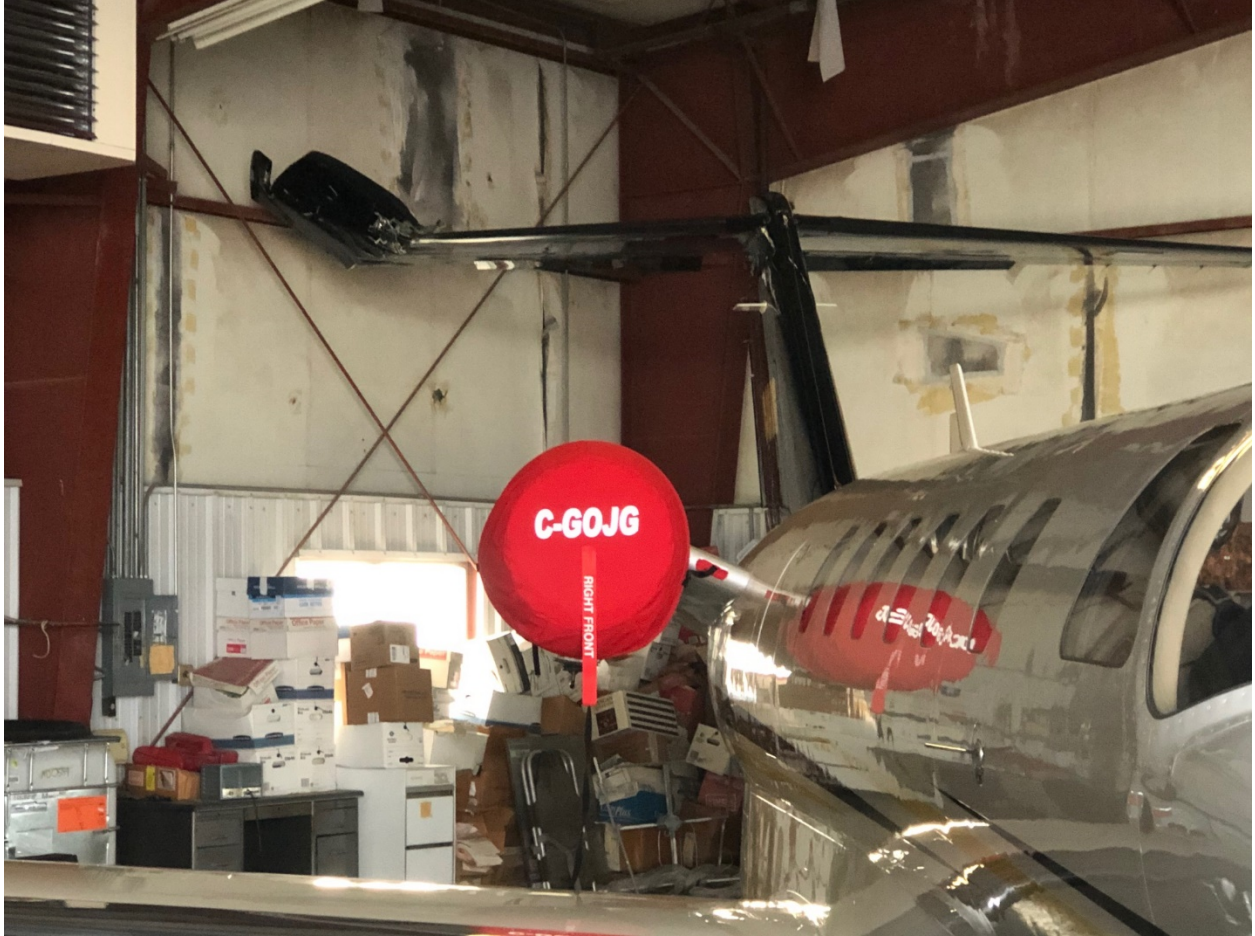
Photo 1: Photo of Right Horizontal Stabilizer and Right Elevator Damage

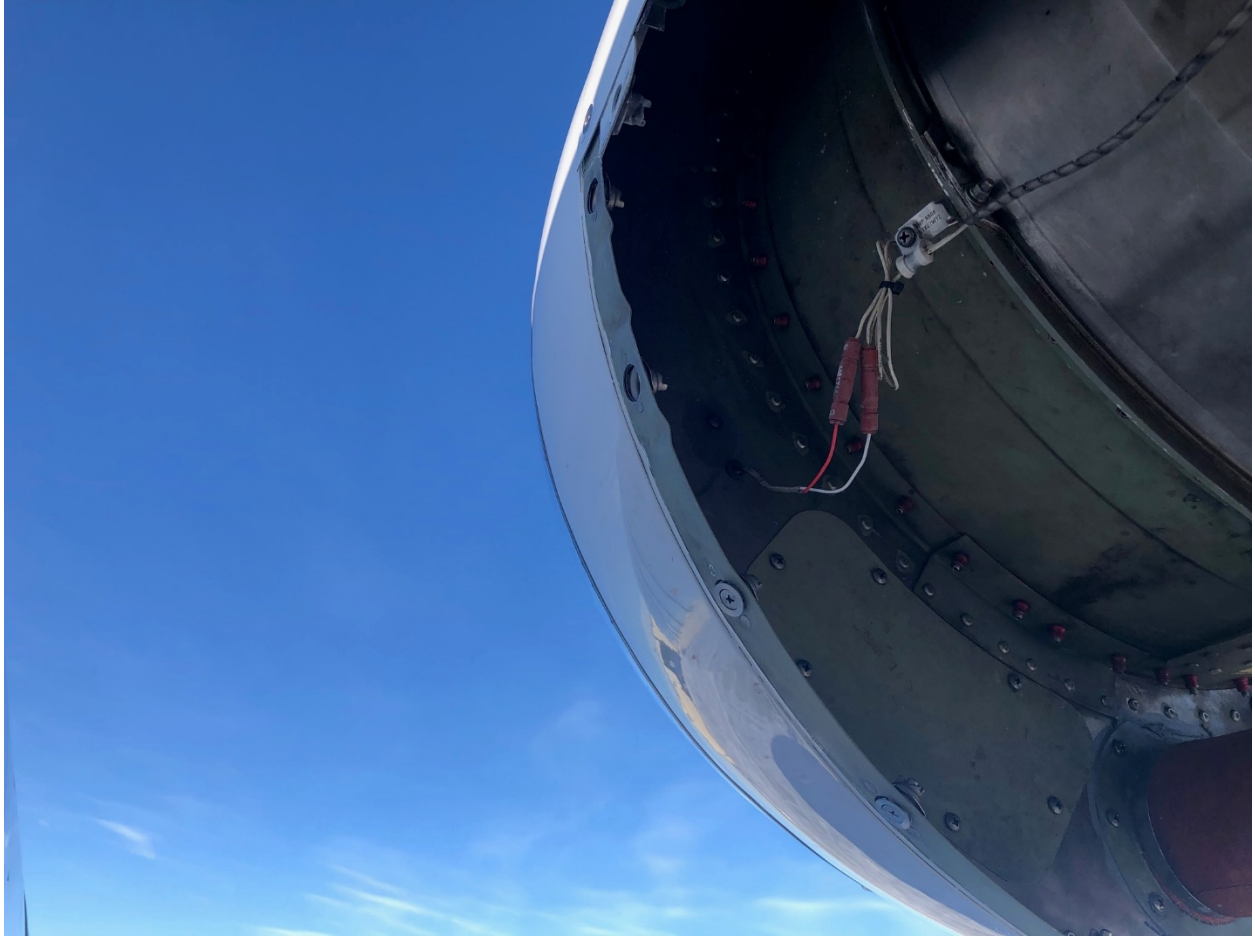
Photo 2: View of Right Engine Inboard Lower Cowl with Three Missing Fasteners

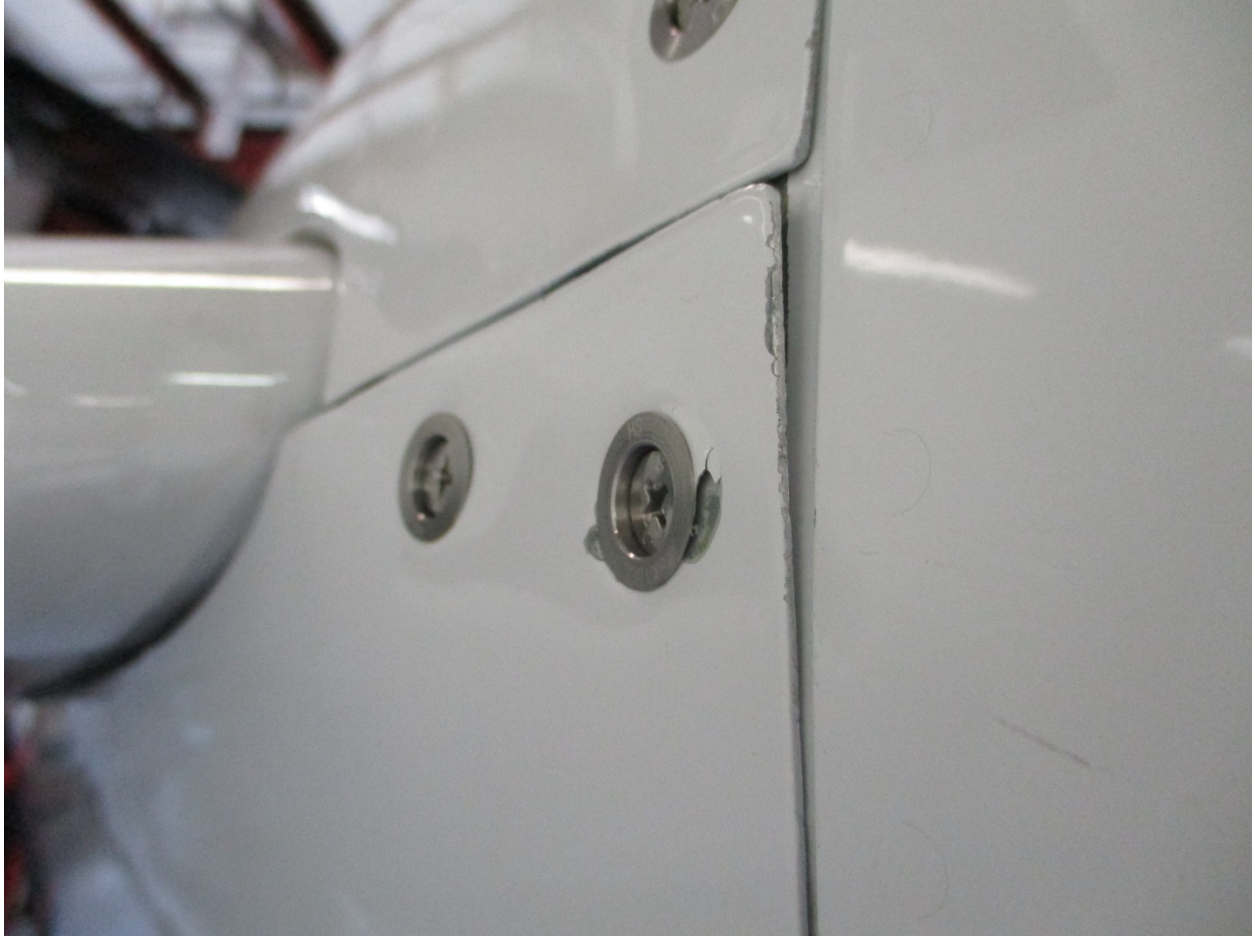
Photo 3: View of the Left Engine Inboard Lower Cowl
