Photo 1 –N4112K with right wing on the runway at the accident scene. (Source: Hageland Aviation Services)

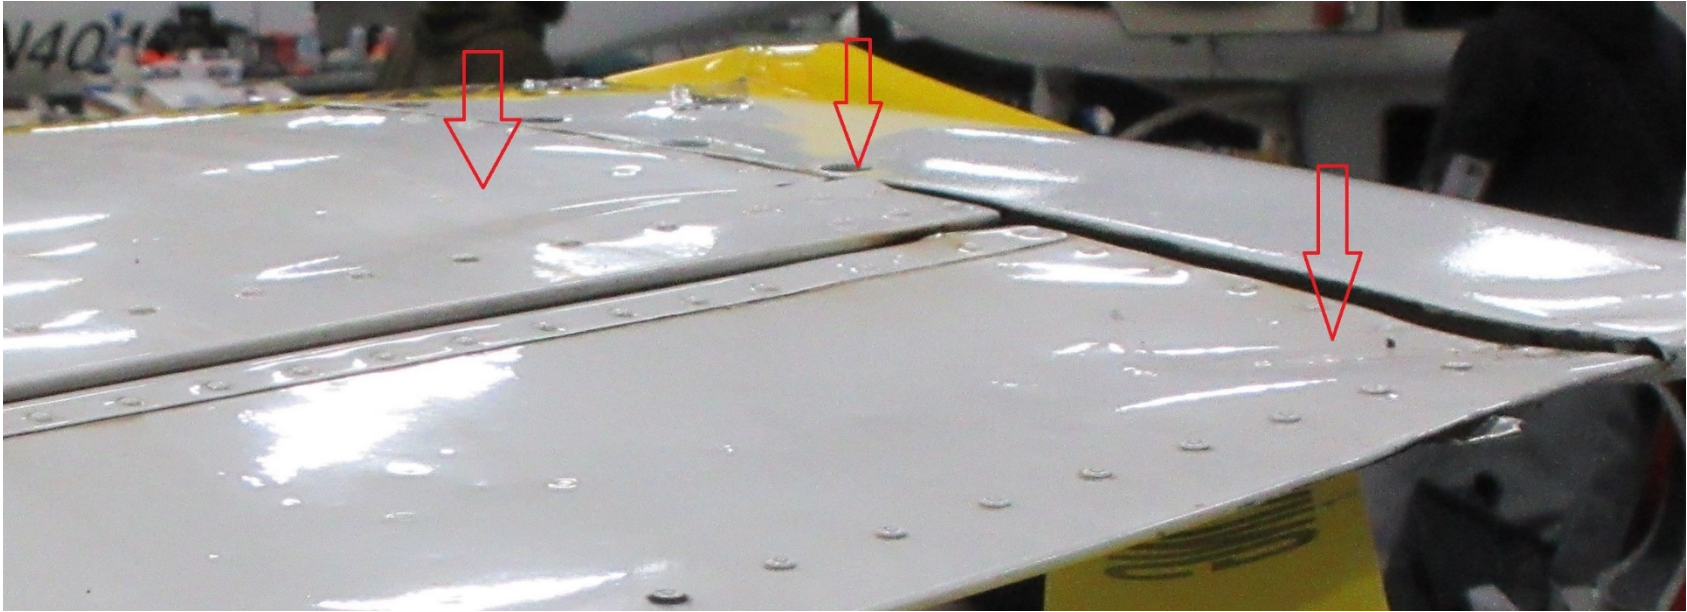
Photo 2 - Right wing substantial damage. (Source: FAA)

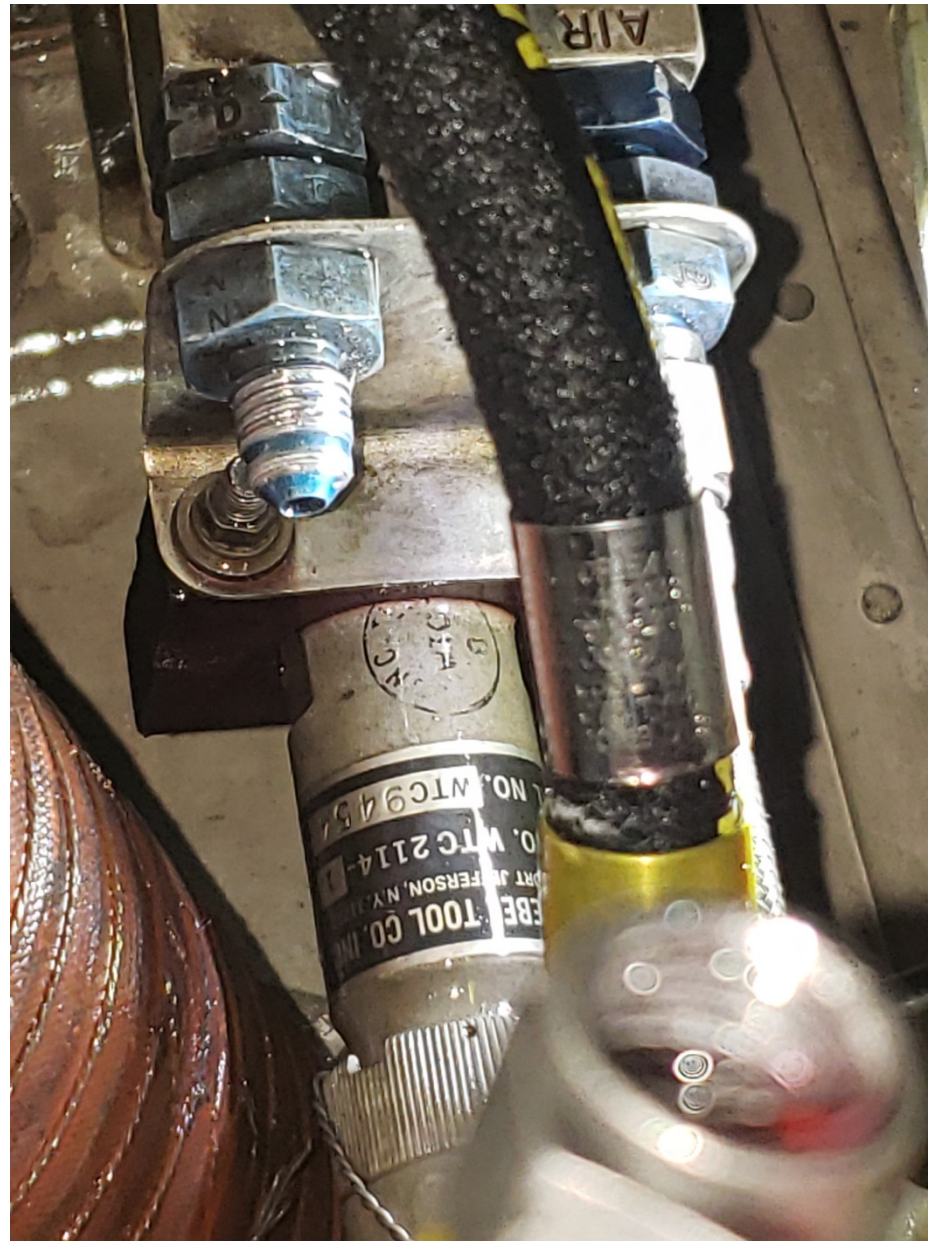
Photo 3 - Hydraulic fitting for the left main landing gear door actuator. (Source: FAA)

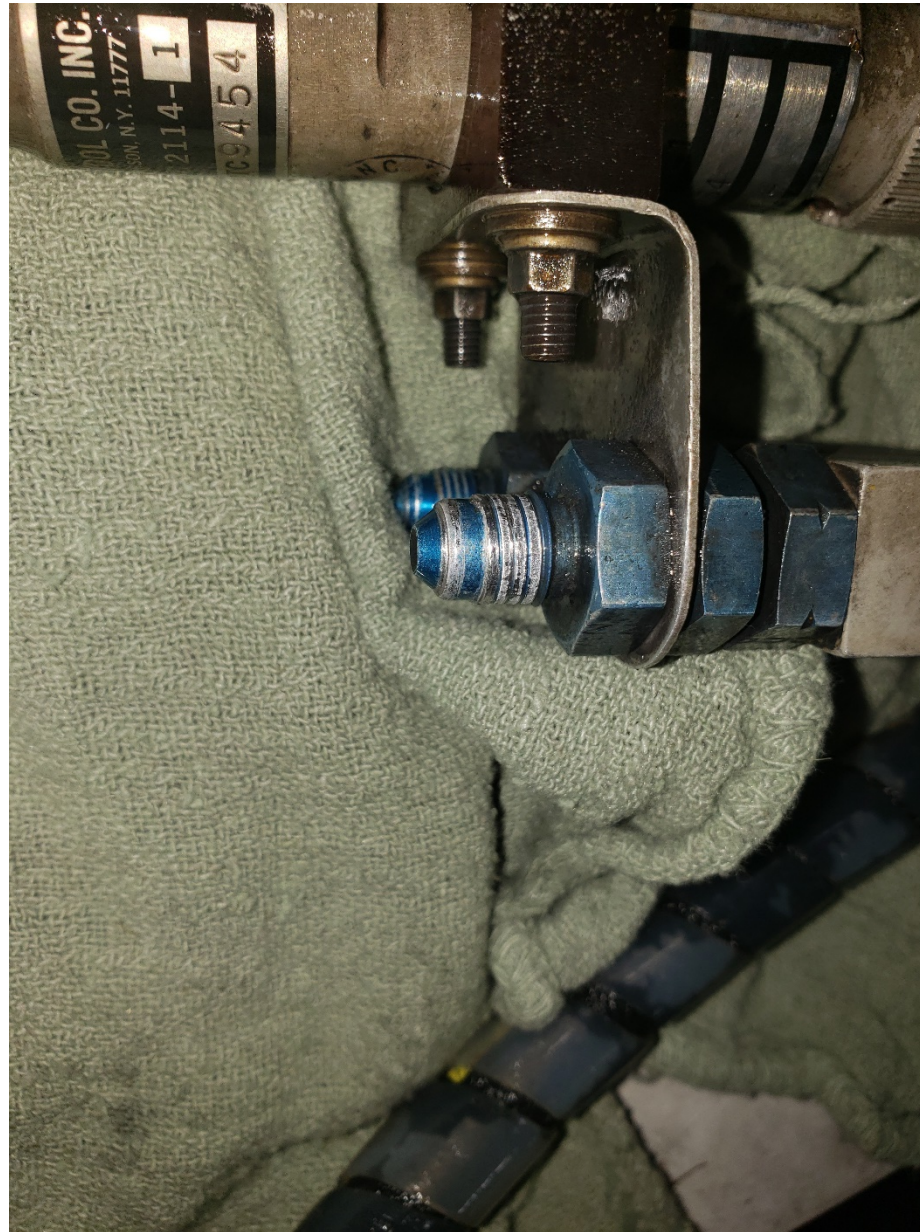
Photo 4. - Hydraulic actuator fitting exhibiting stripped grooves. (Source: FAA)

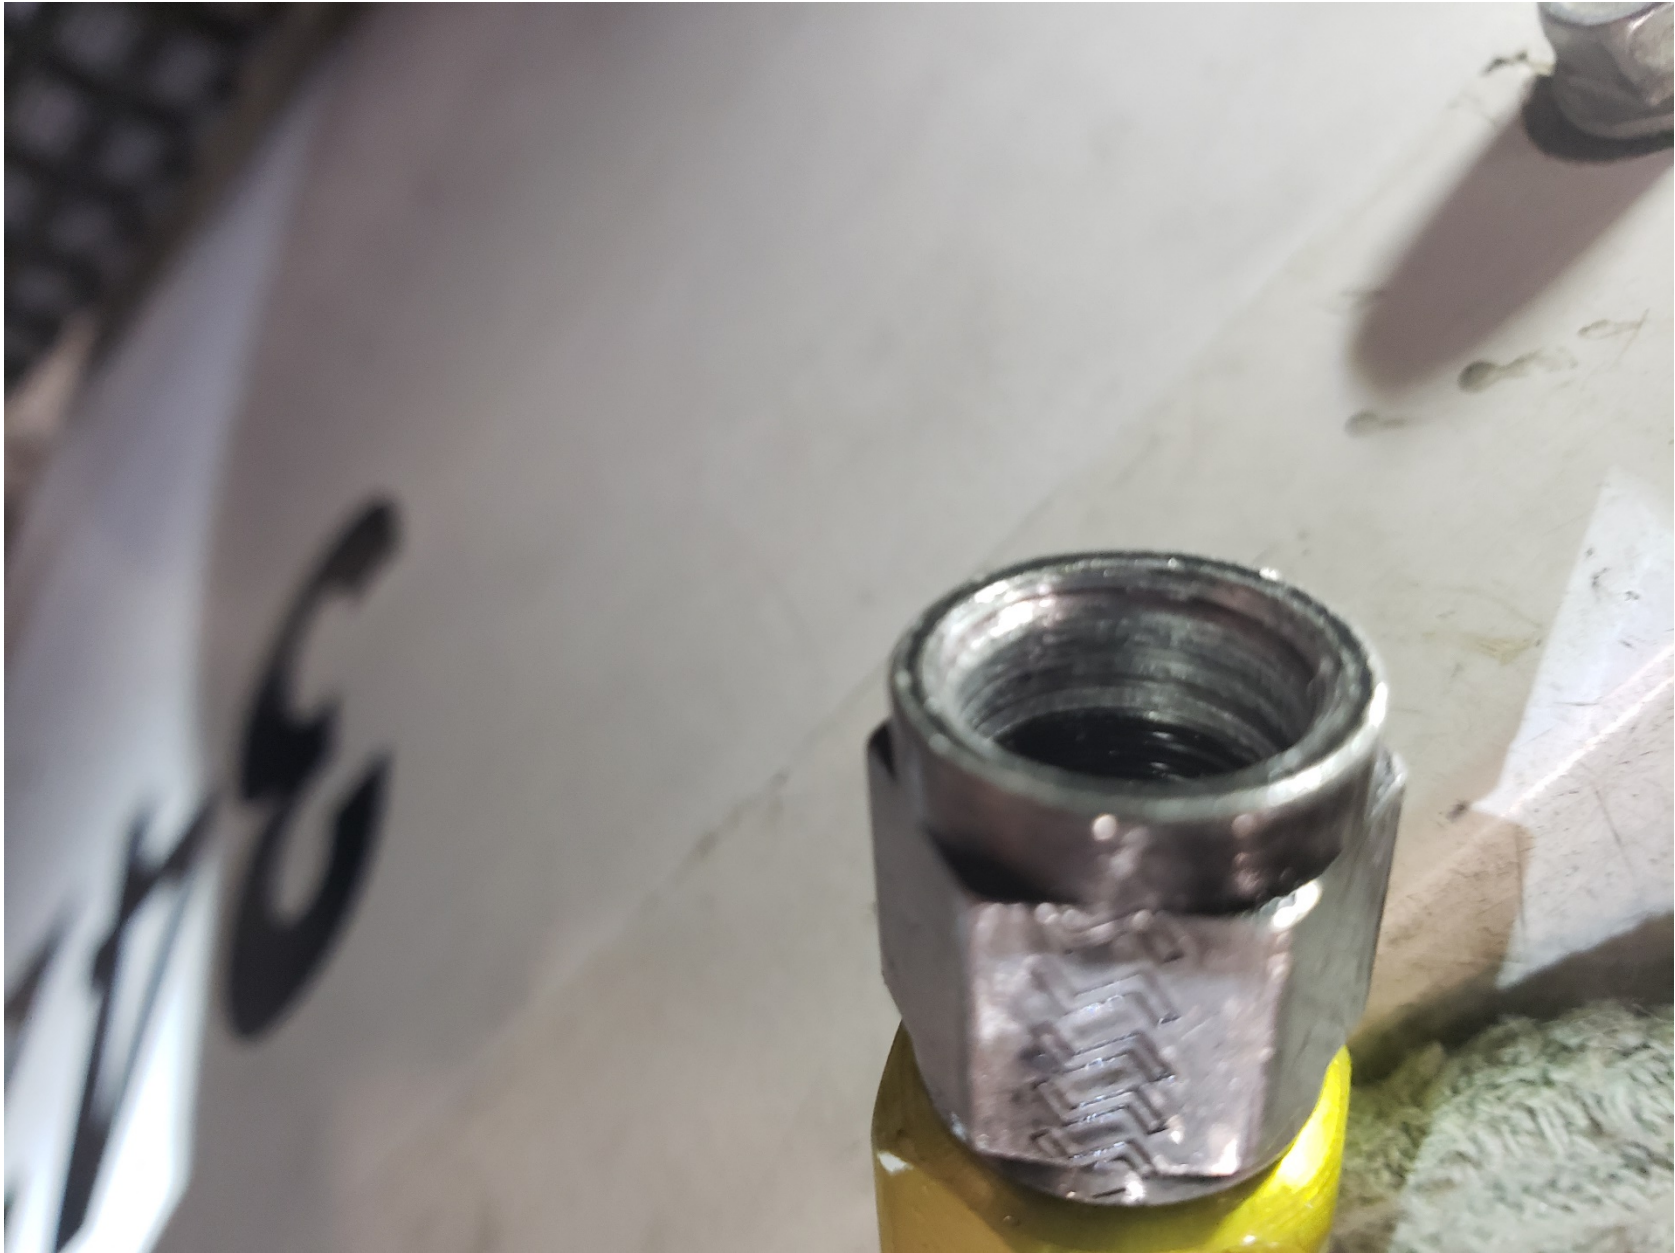
Photo 5 - Female end of hydraulic actuator fitting exhibiting stripped grooves. (Source: FAA)
