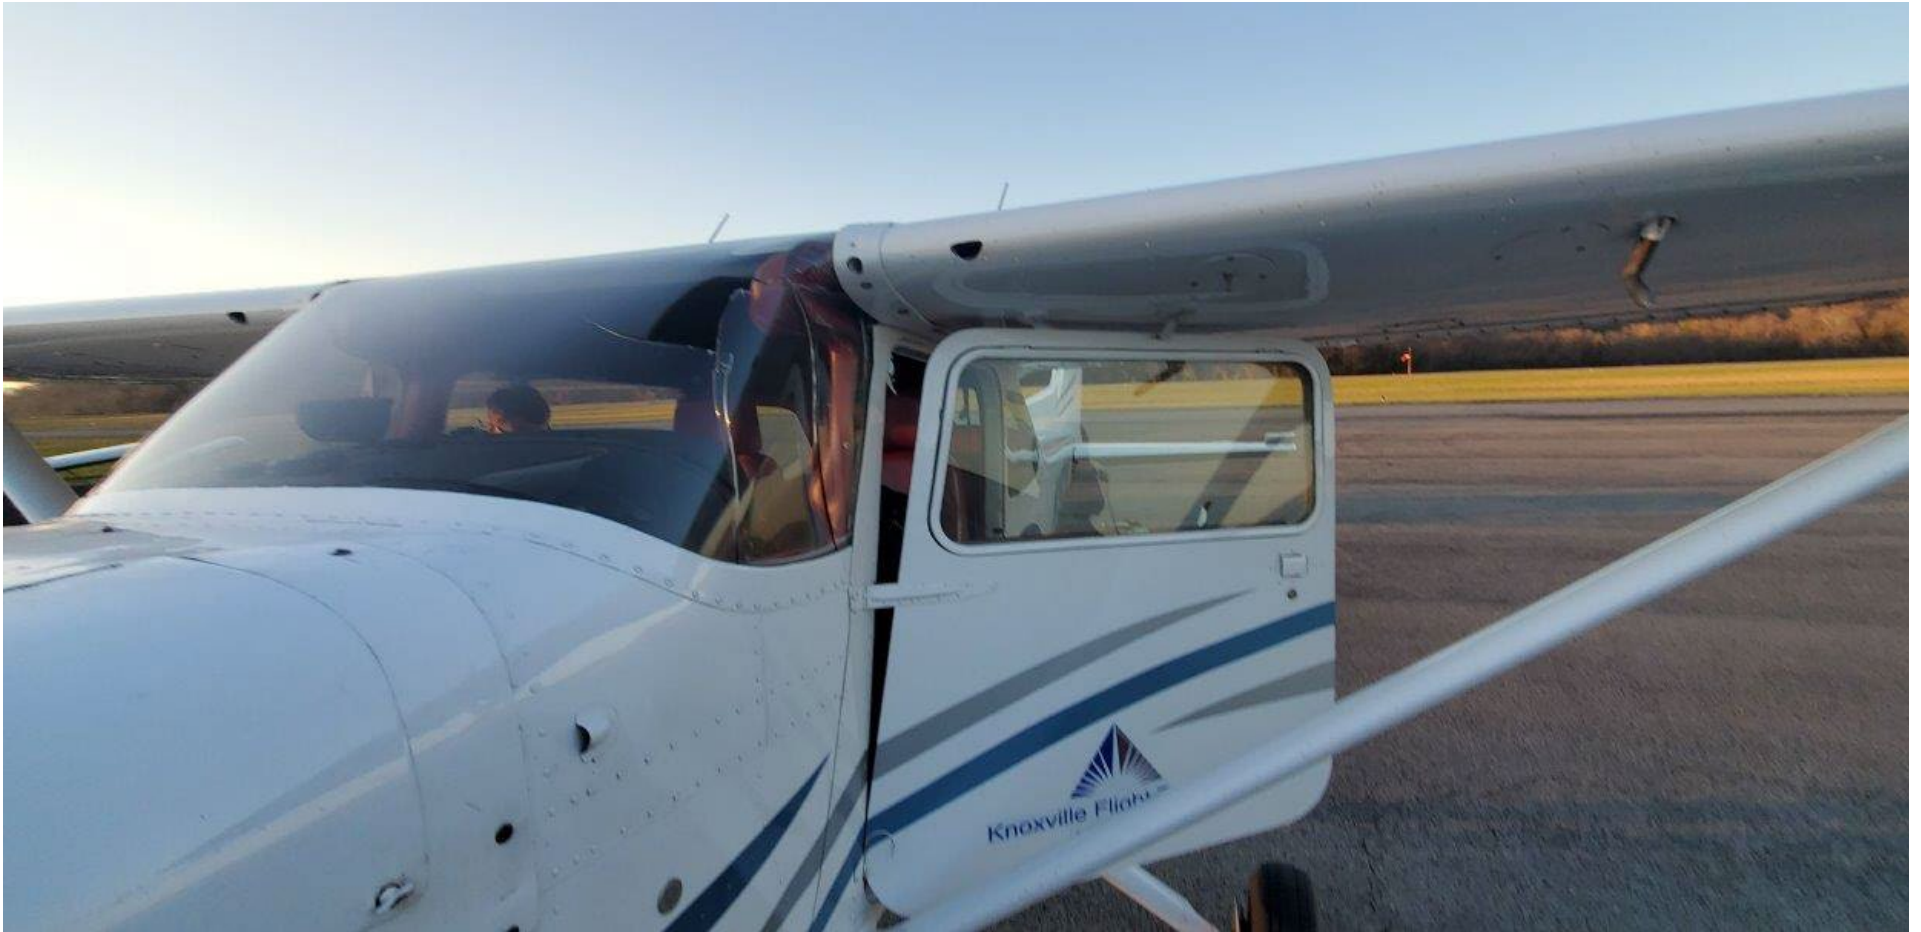
Photo 1 – View of N19710 windscreen damage

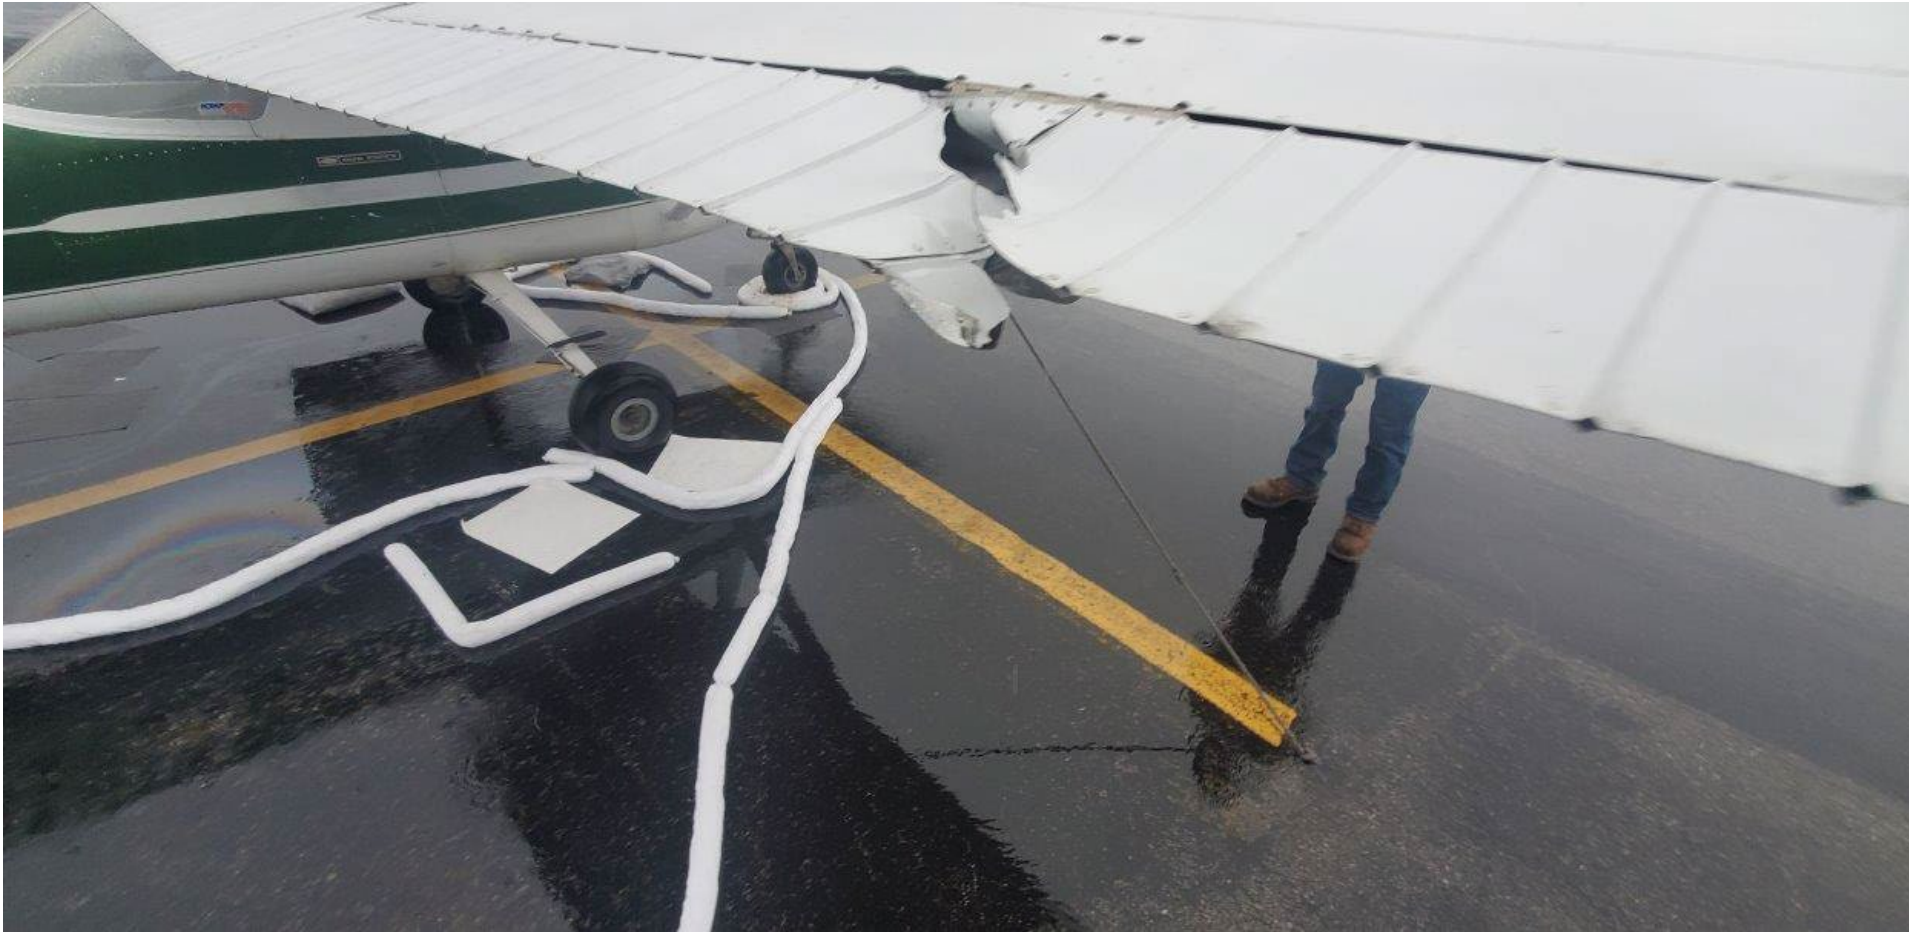
Photo 2 – View of right aileron damage of N1308U

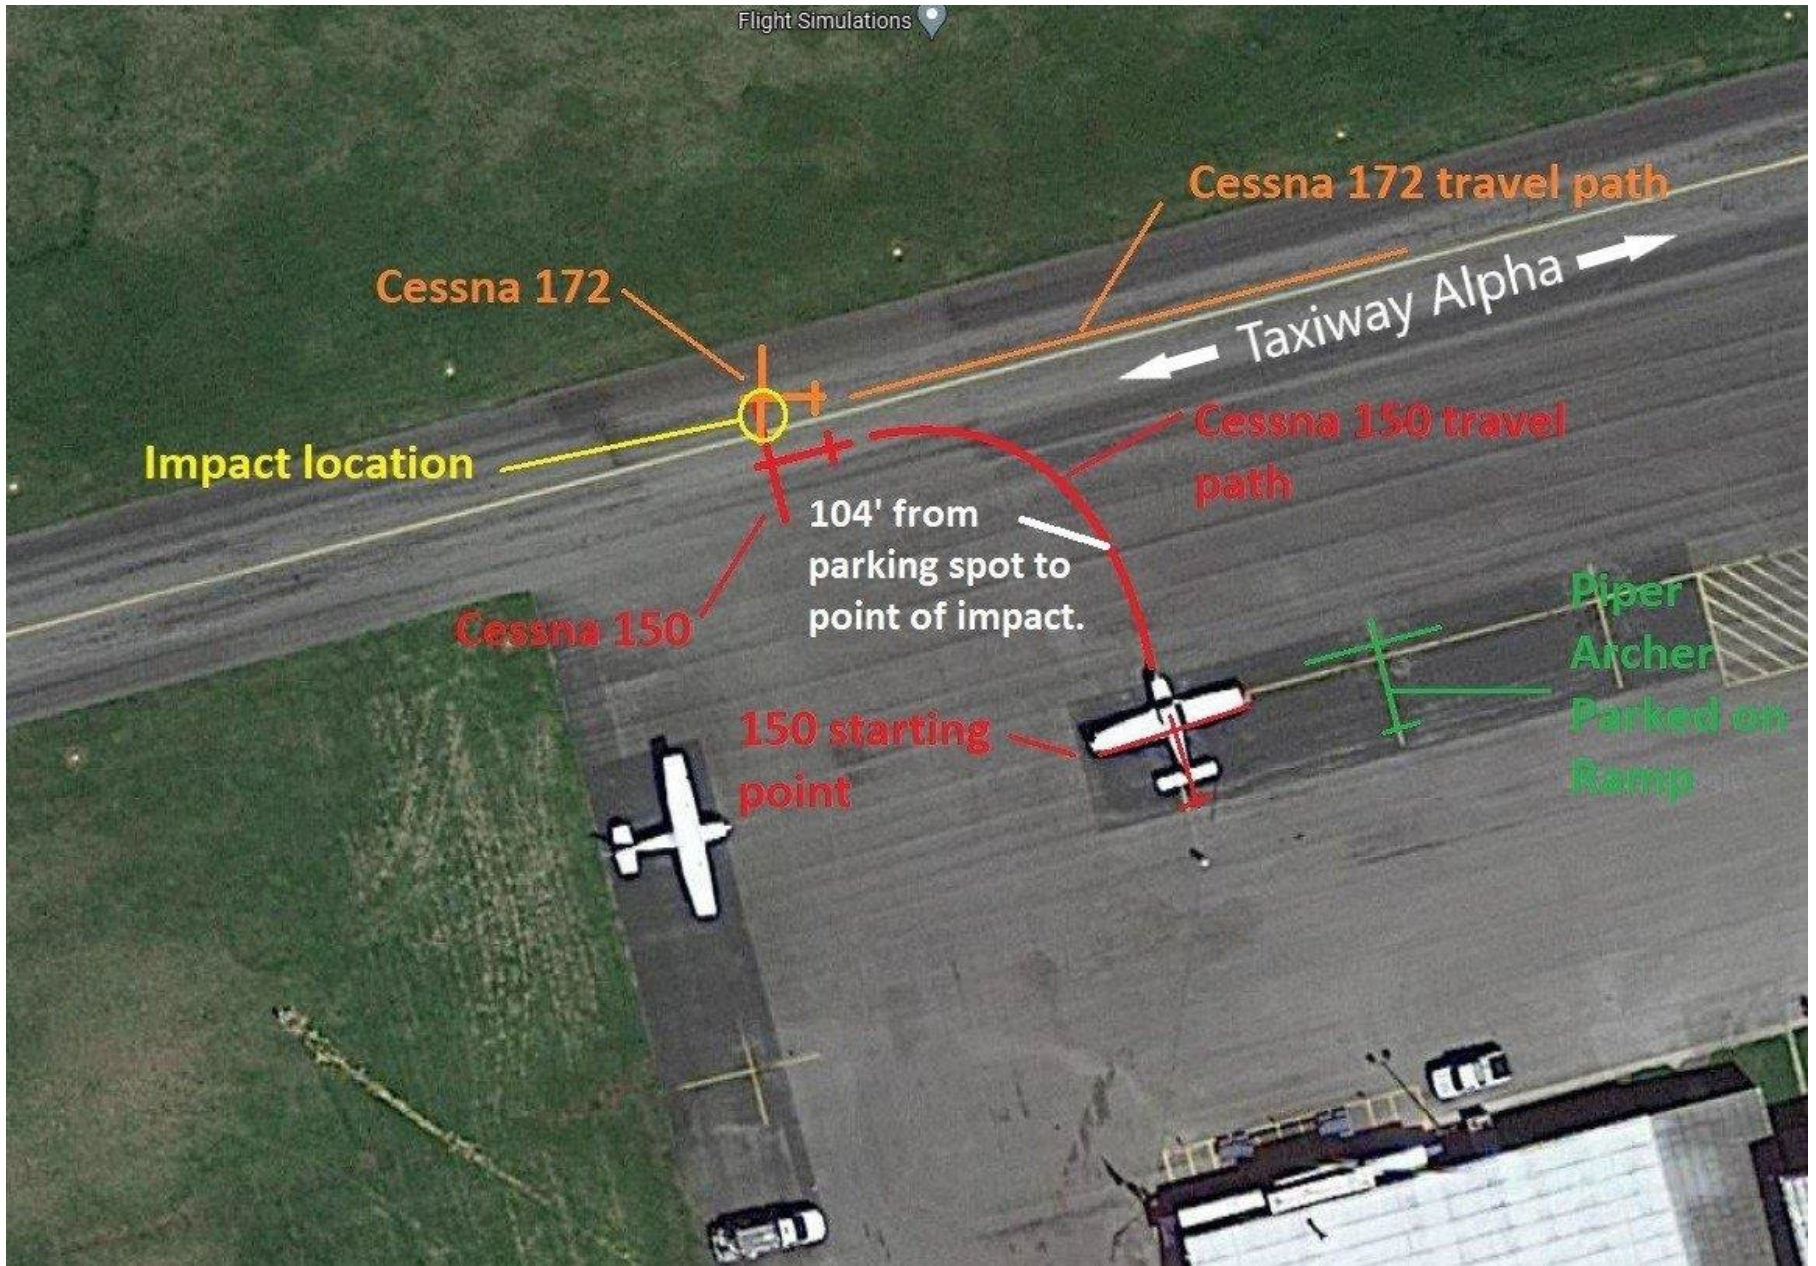
Photo 3 – Diagram of ramp and taxiway showing an illustration of event
