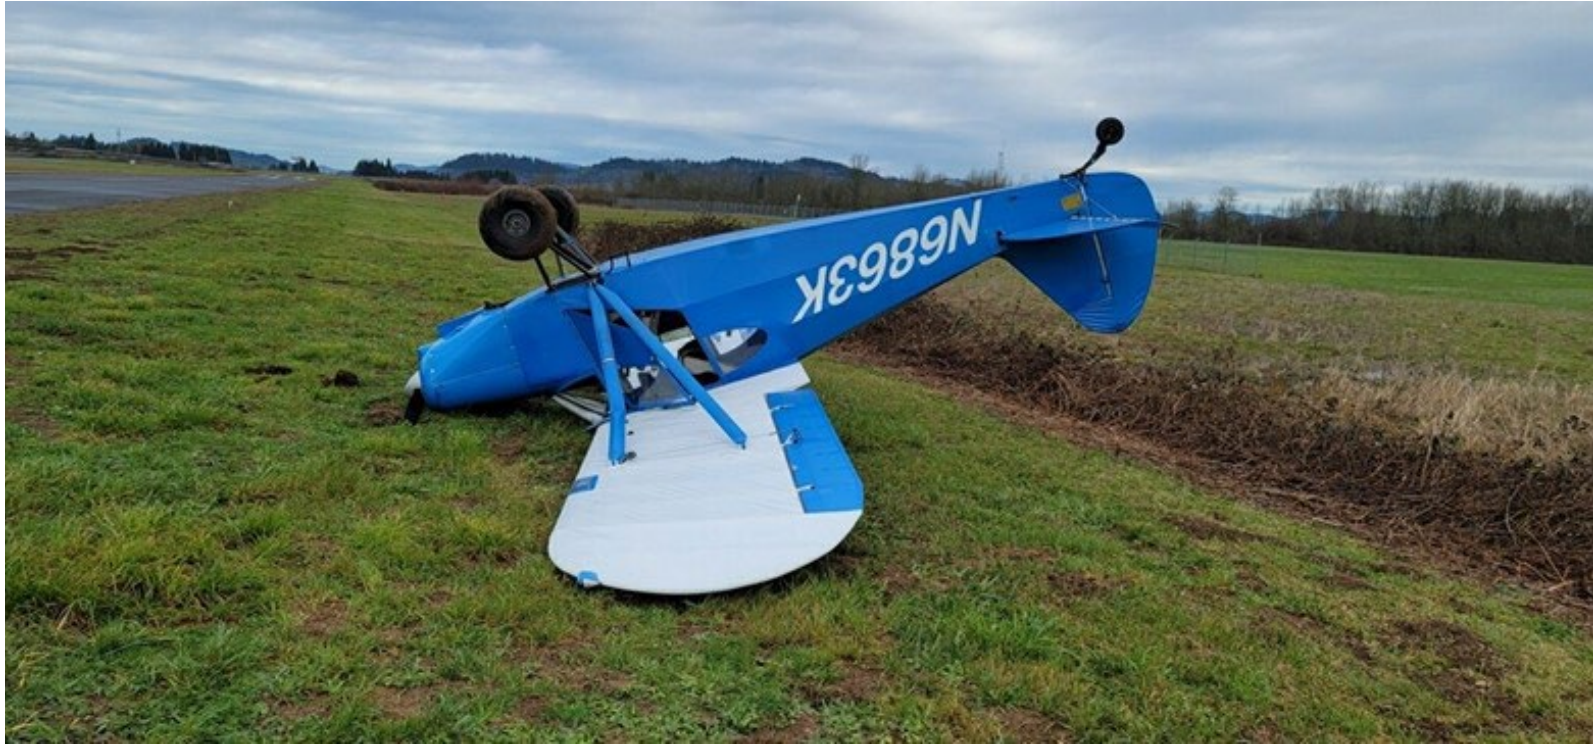
Photo 1 – View of damage to the right wing lift strut and rudder (Courtesy of Operator)
