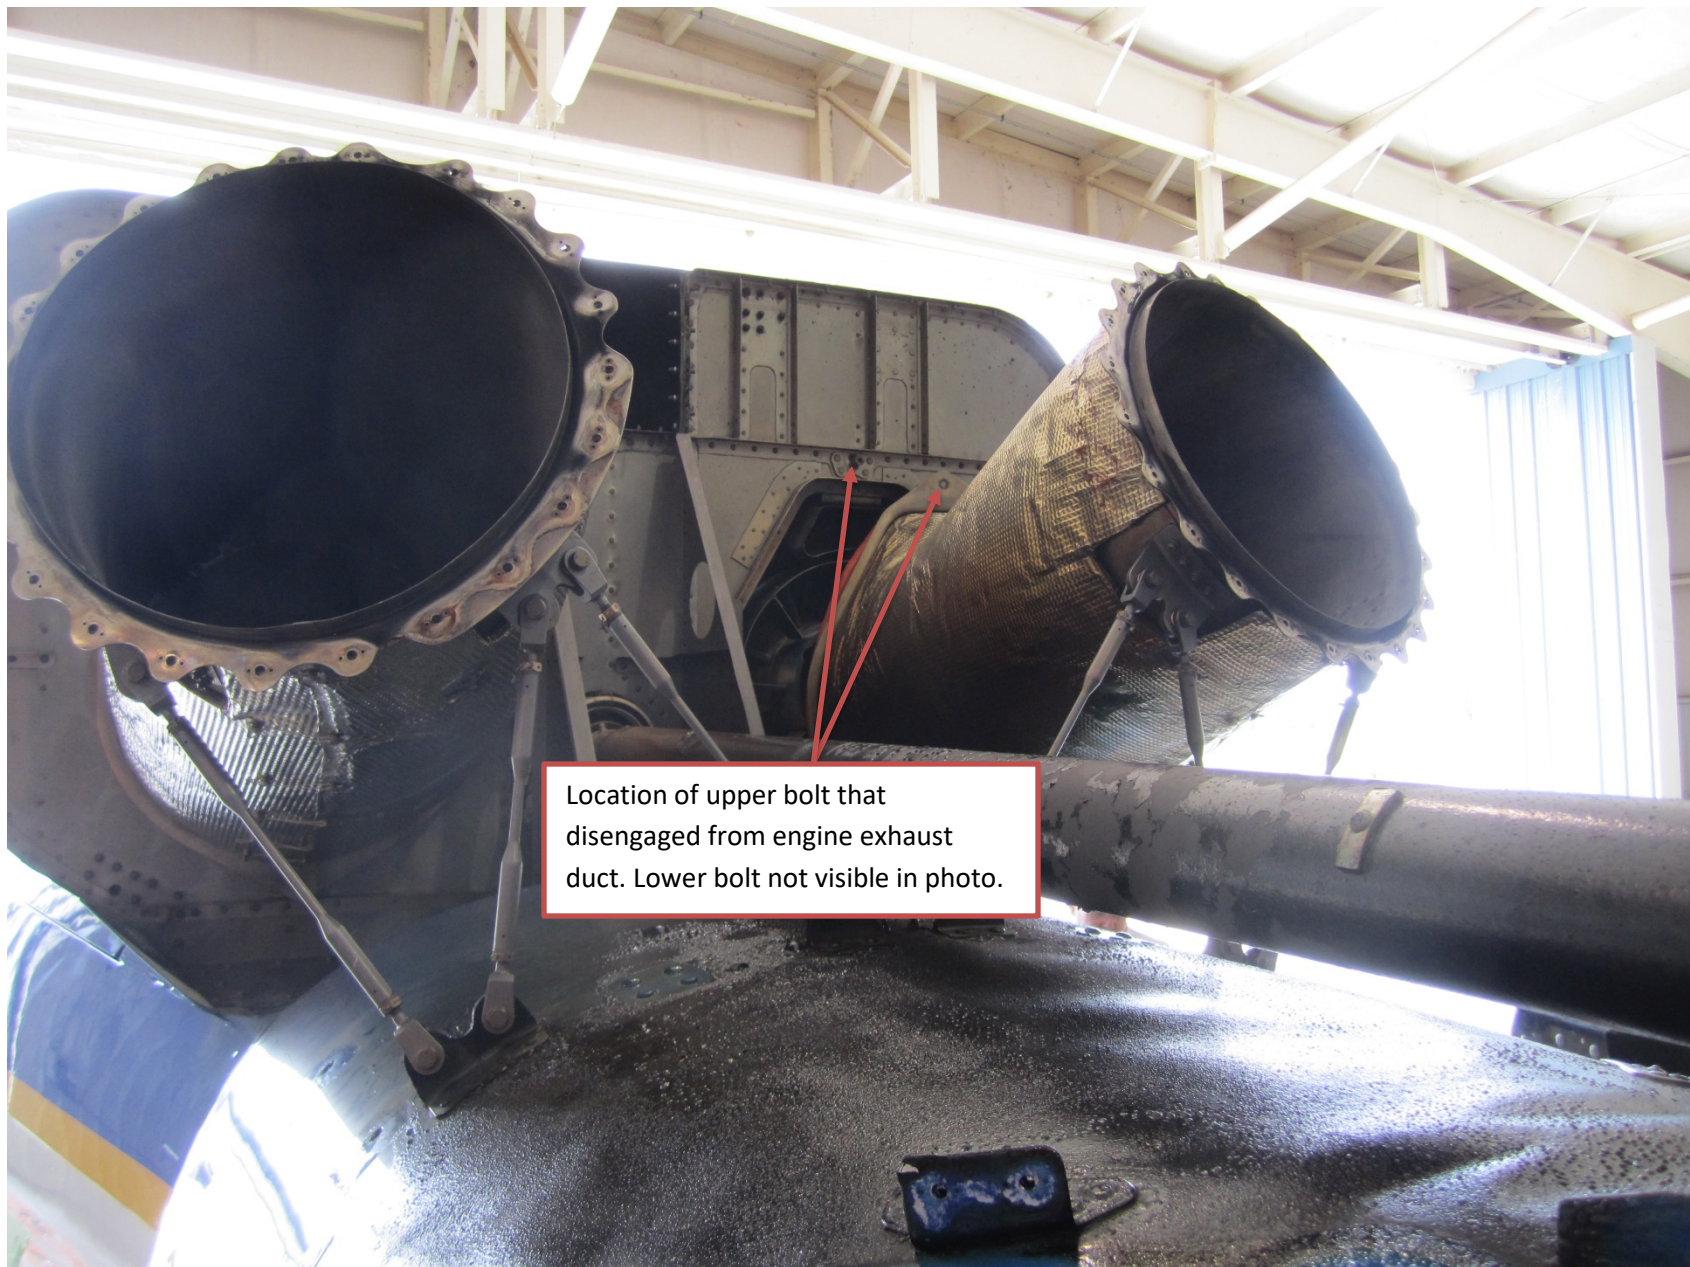
**Photo 1 – Detached Engine #2 (Right Side) Exhaust Duct (Photo Courtesy of FAA)**

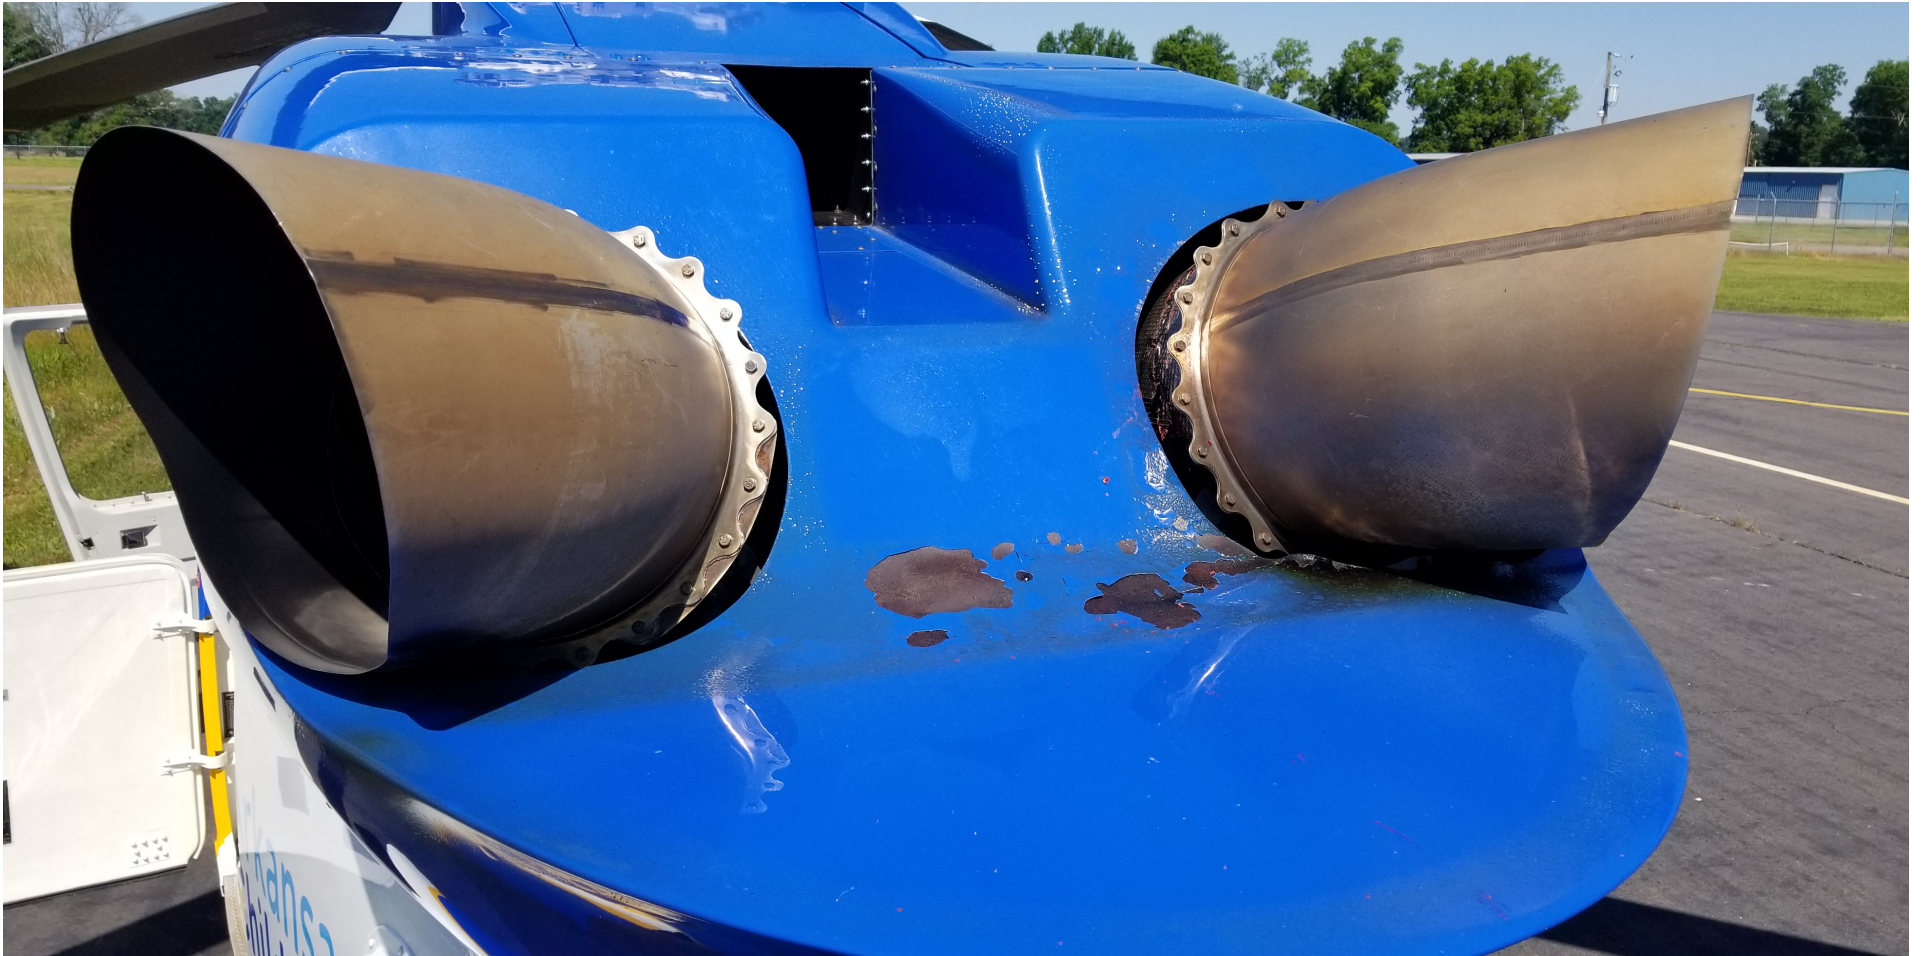
**Photo 2 – Heat Damage to the Upper Skin of the Engine Compartment. (Photo Courtesy of FAA)**
