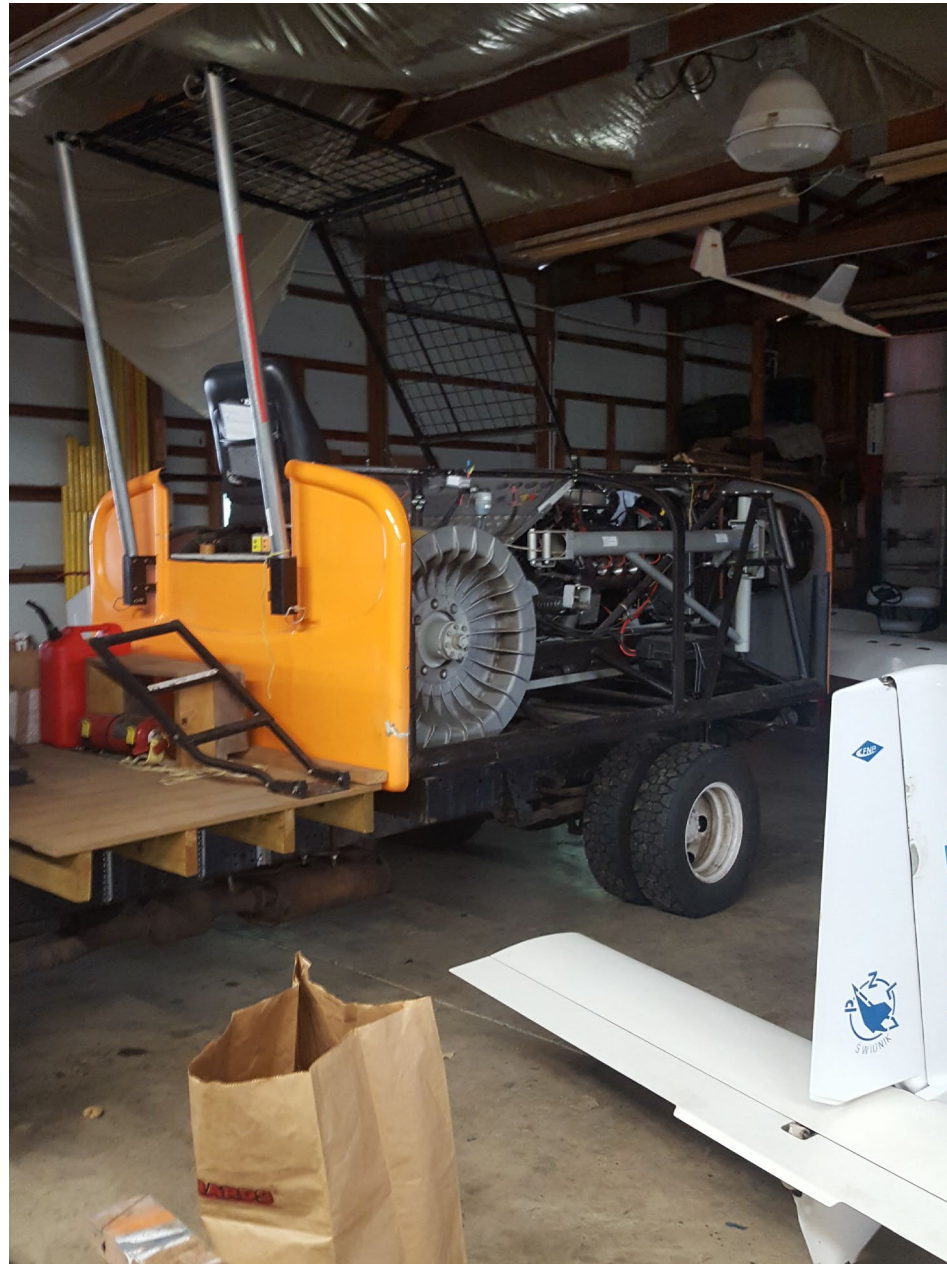
Photo 1 – View of the ground winch system (courtesy of the flight instructor).

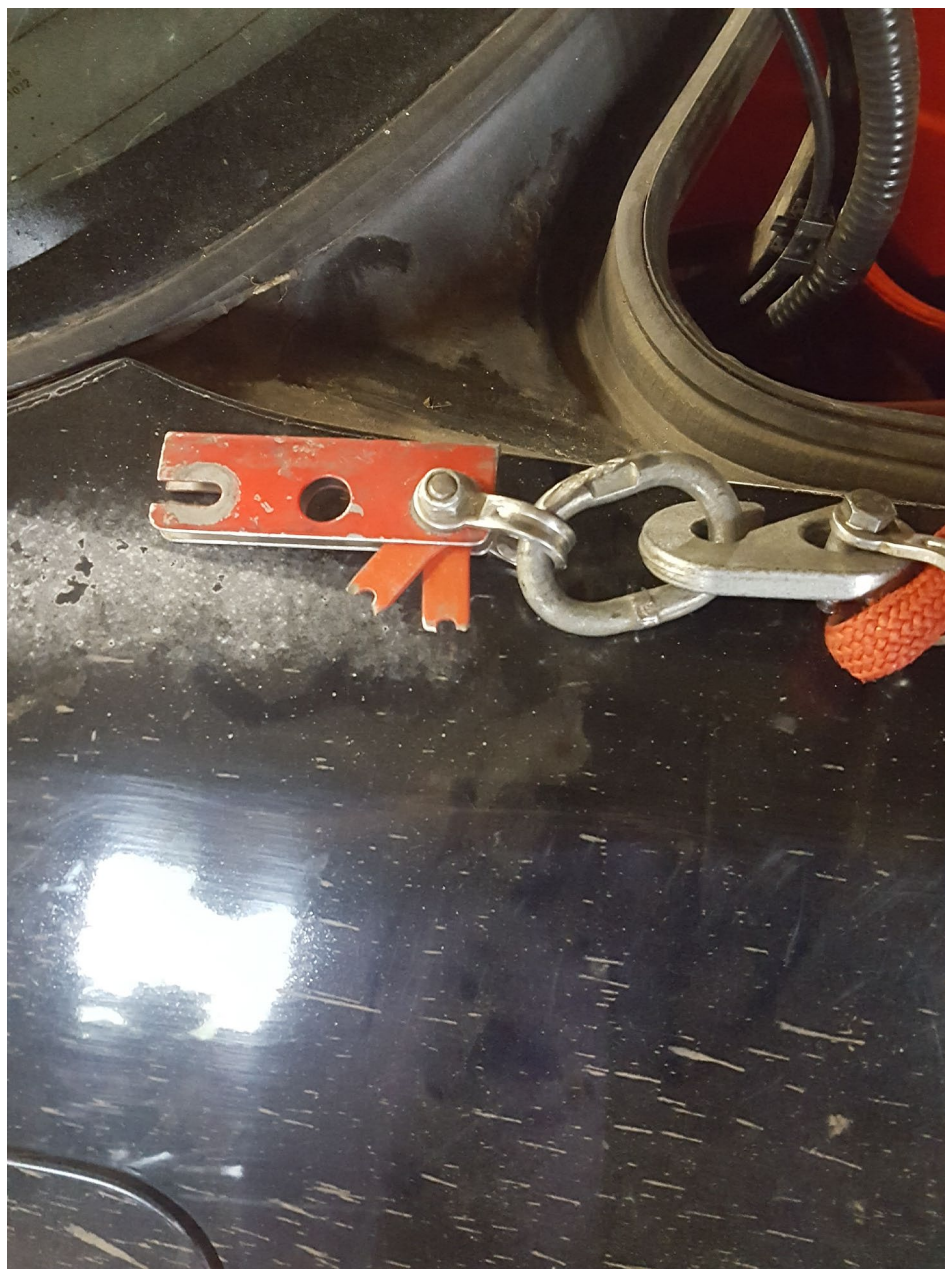
Photo 2 – View of the broken weak link/safety link (courtesy of the flight instructor).

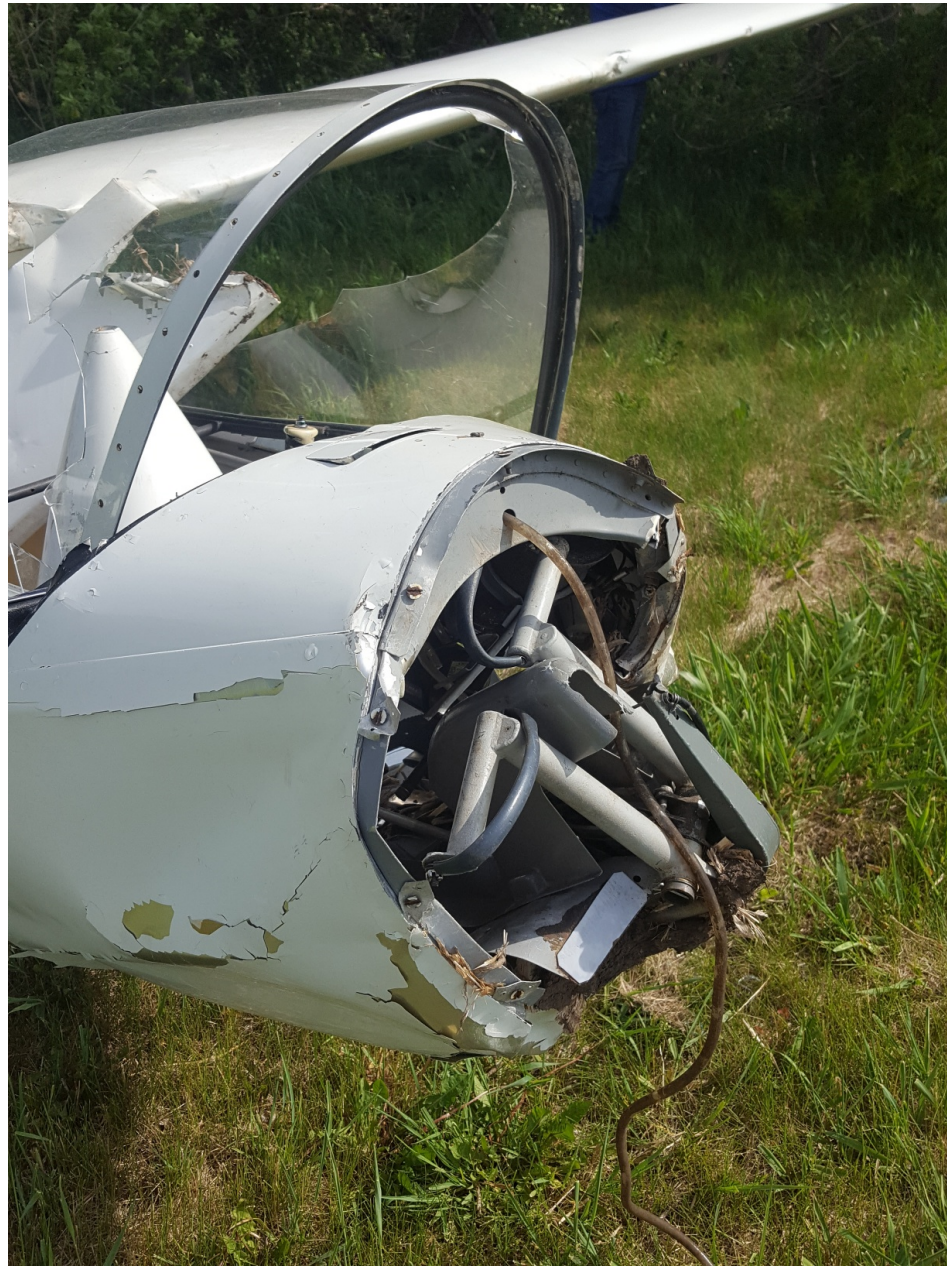
Photo 3 – View of the substantial damage sustained to the fuselage (courtesy of the flight instructor).

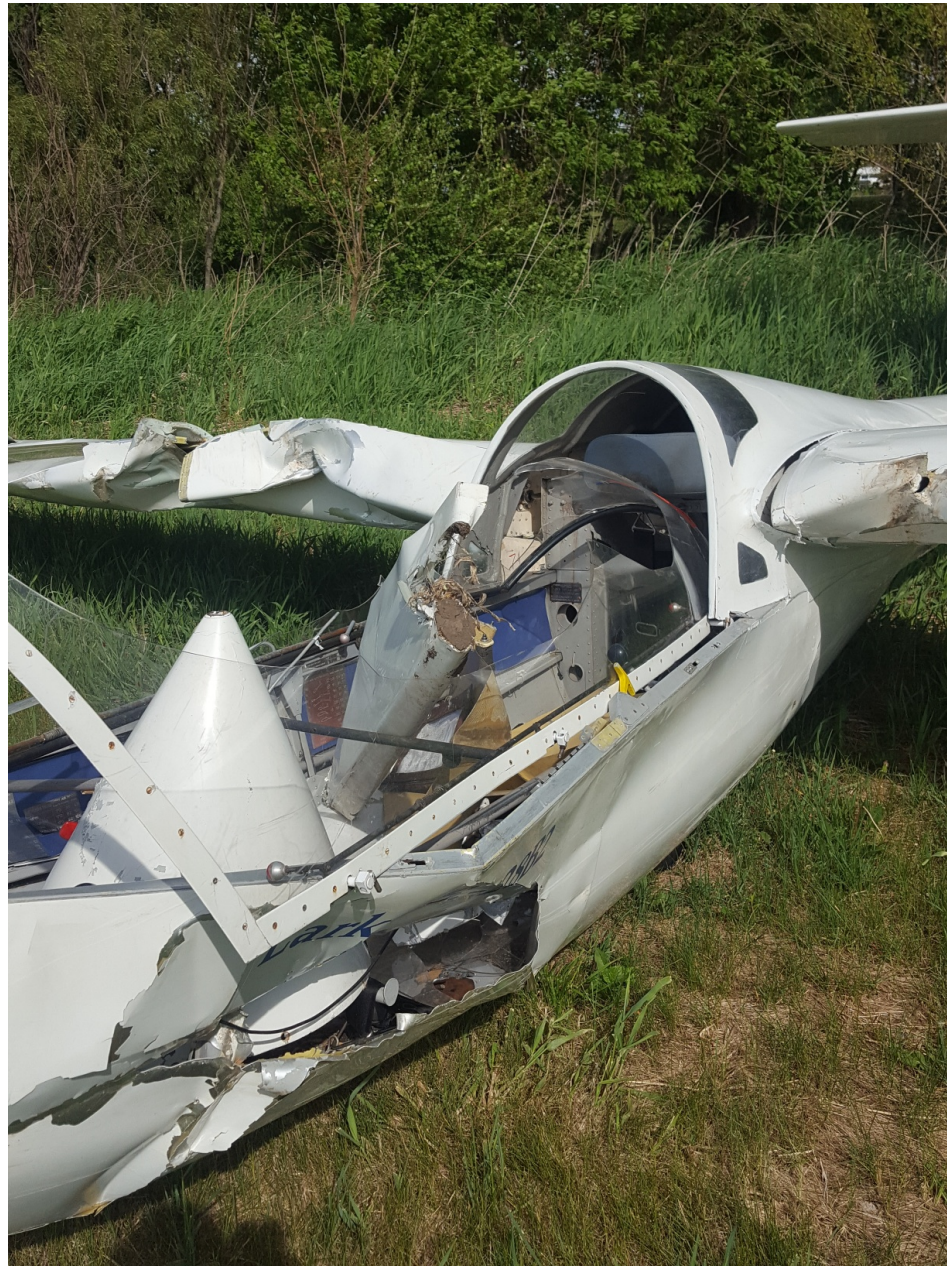
Photo 4 – View of the substantial damage sustained to the fuselage and both wings (courtesy of the flight instructor).

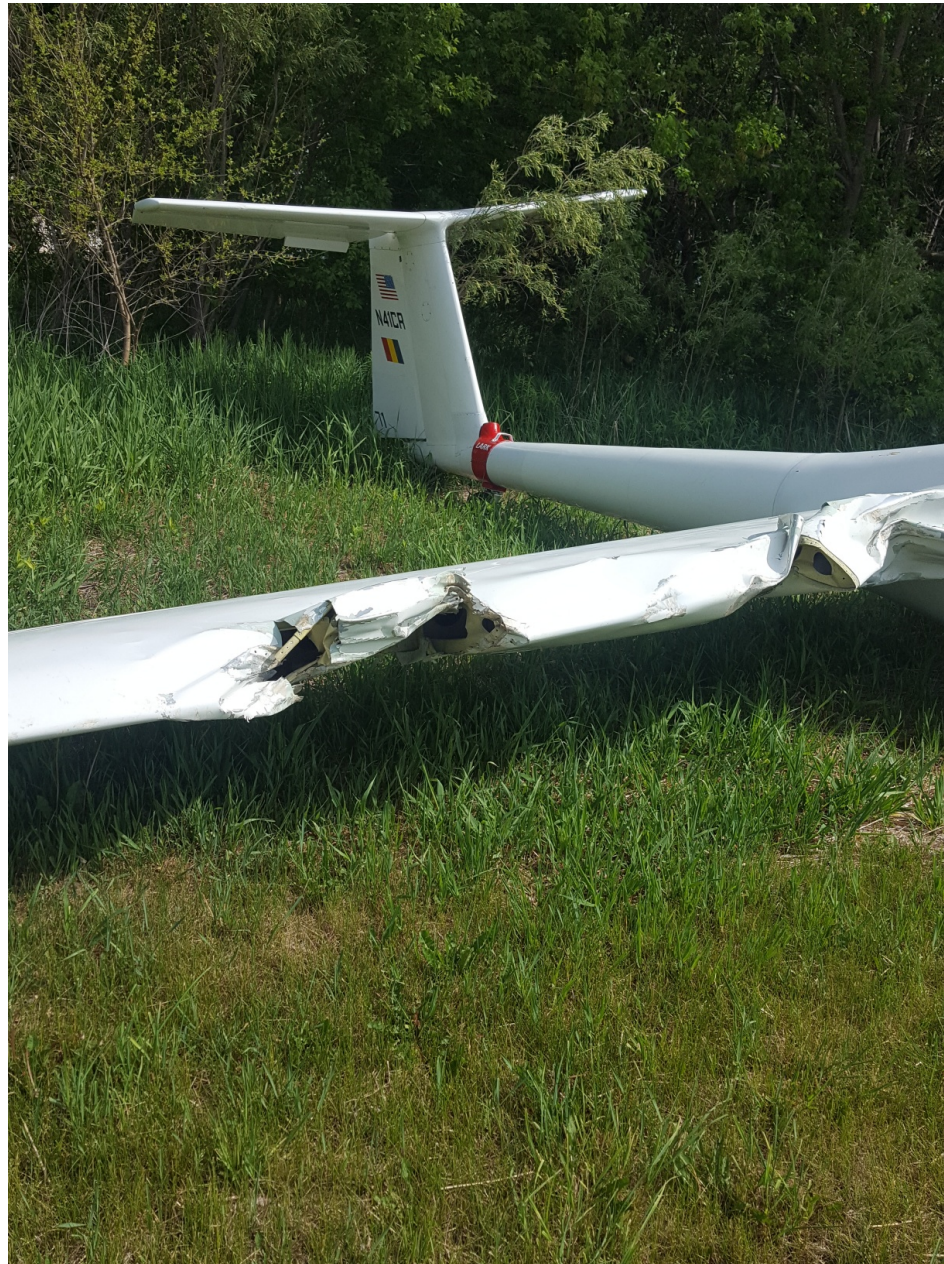
Photo 5 – View of the substantial damage sustained to the right wing (courtesy of the flight instructor).
