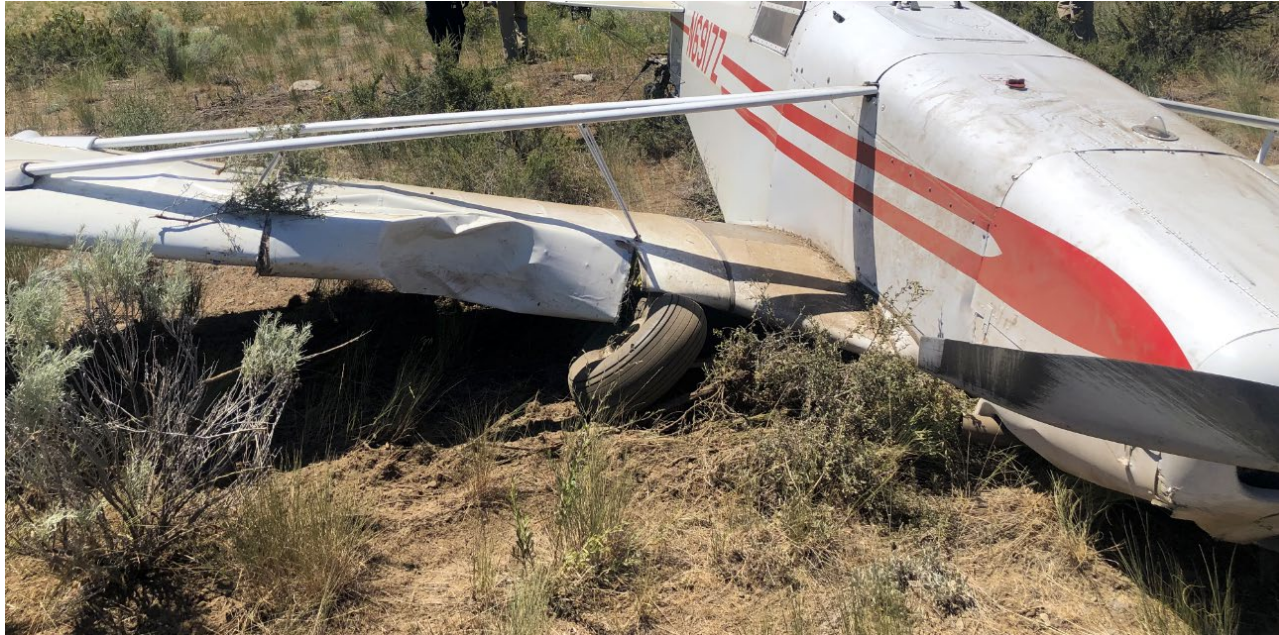
Photo 1 – View of damage to the right wing leading edge (Courtesy of FAA)

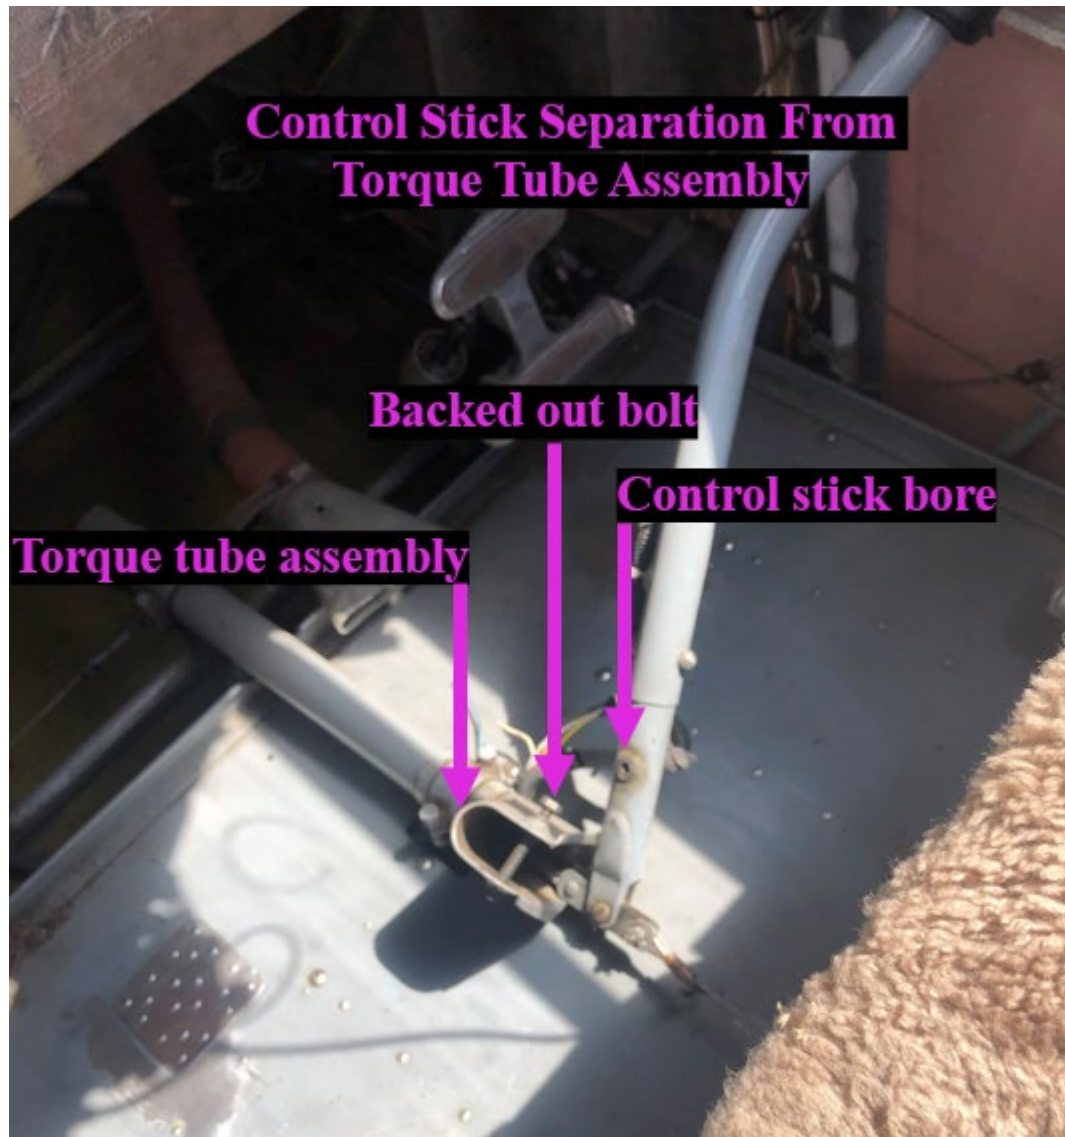
**Photo 2 – View of the unseated bolt located in the torque tube assembly bore, and the separated control stick
(Courtesy of FAA)**
