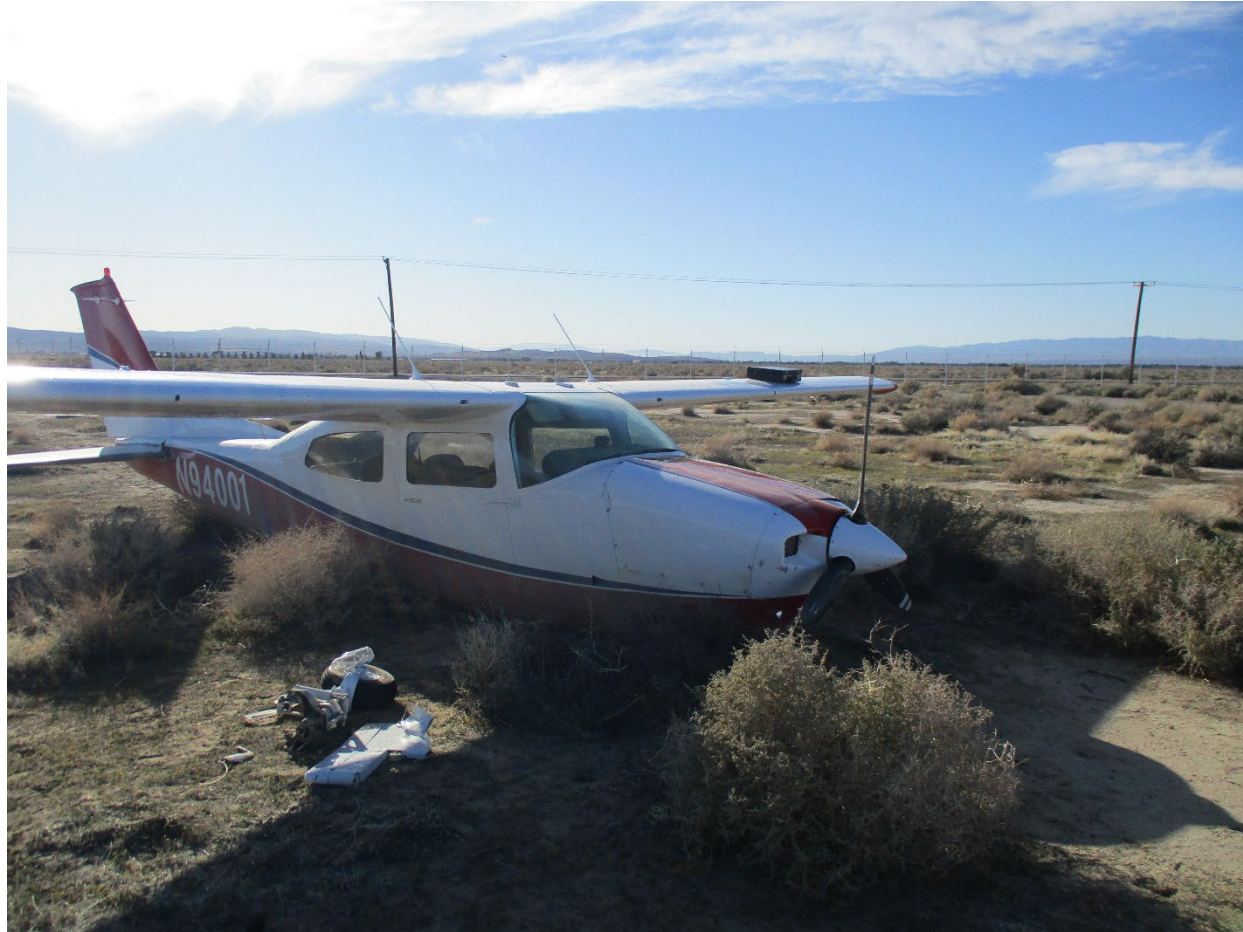
**Photo 1 – View of damage to the inboard, right side horizontal stabilizer and empennage (Courtesy of Pilot)**

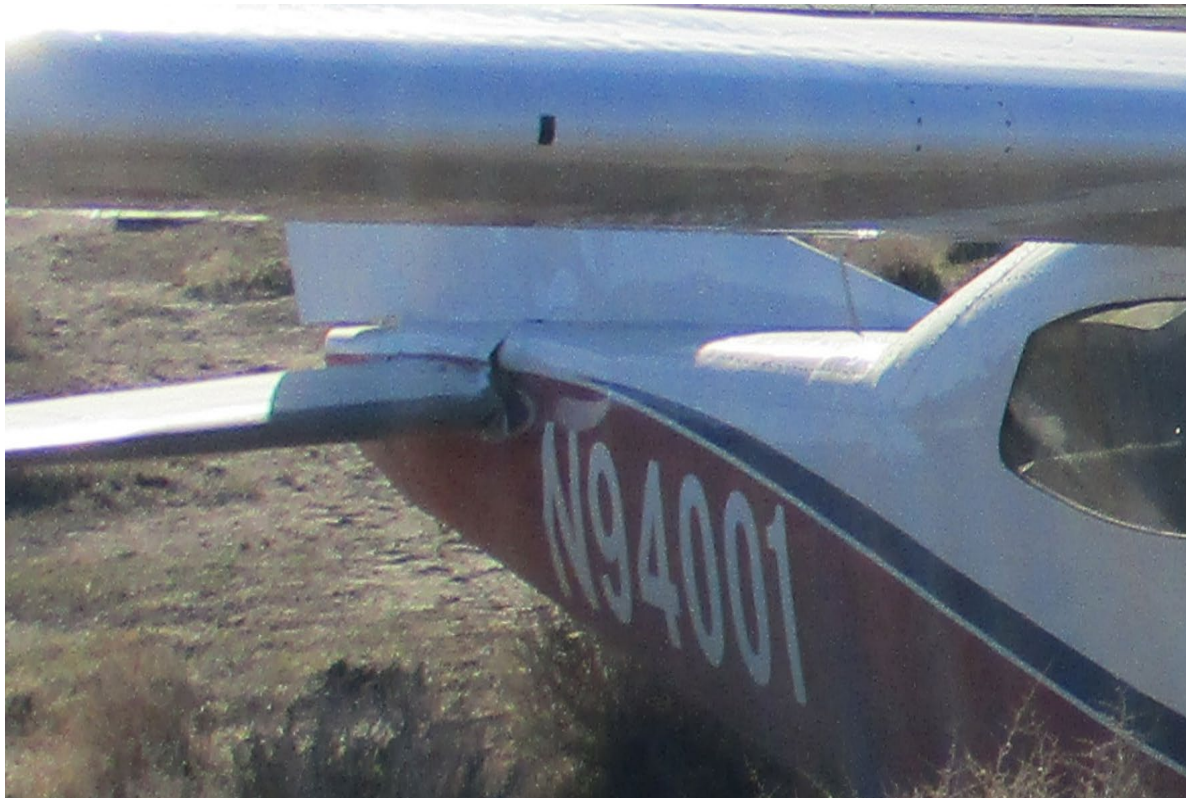
**Photo 2 – View of damage to the inboard, right side horizontal stabilizer, and empennage (Courtesy of Pilot)**

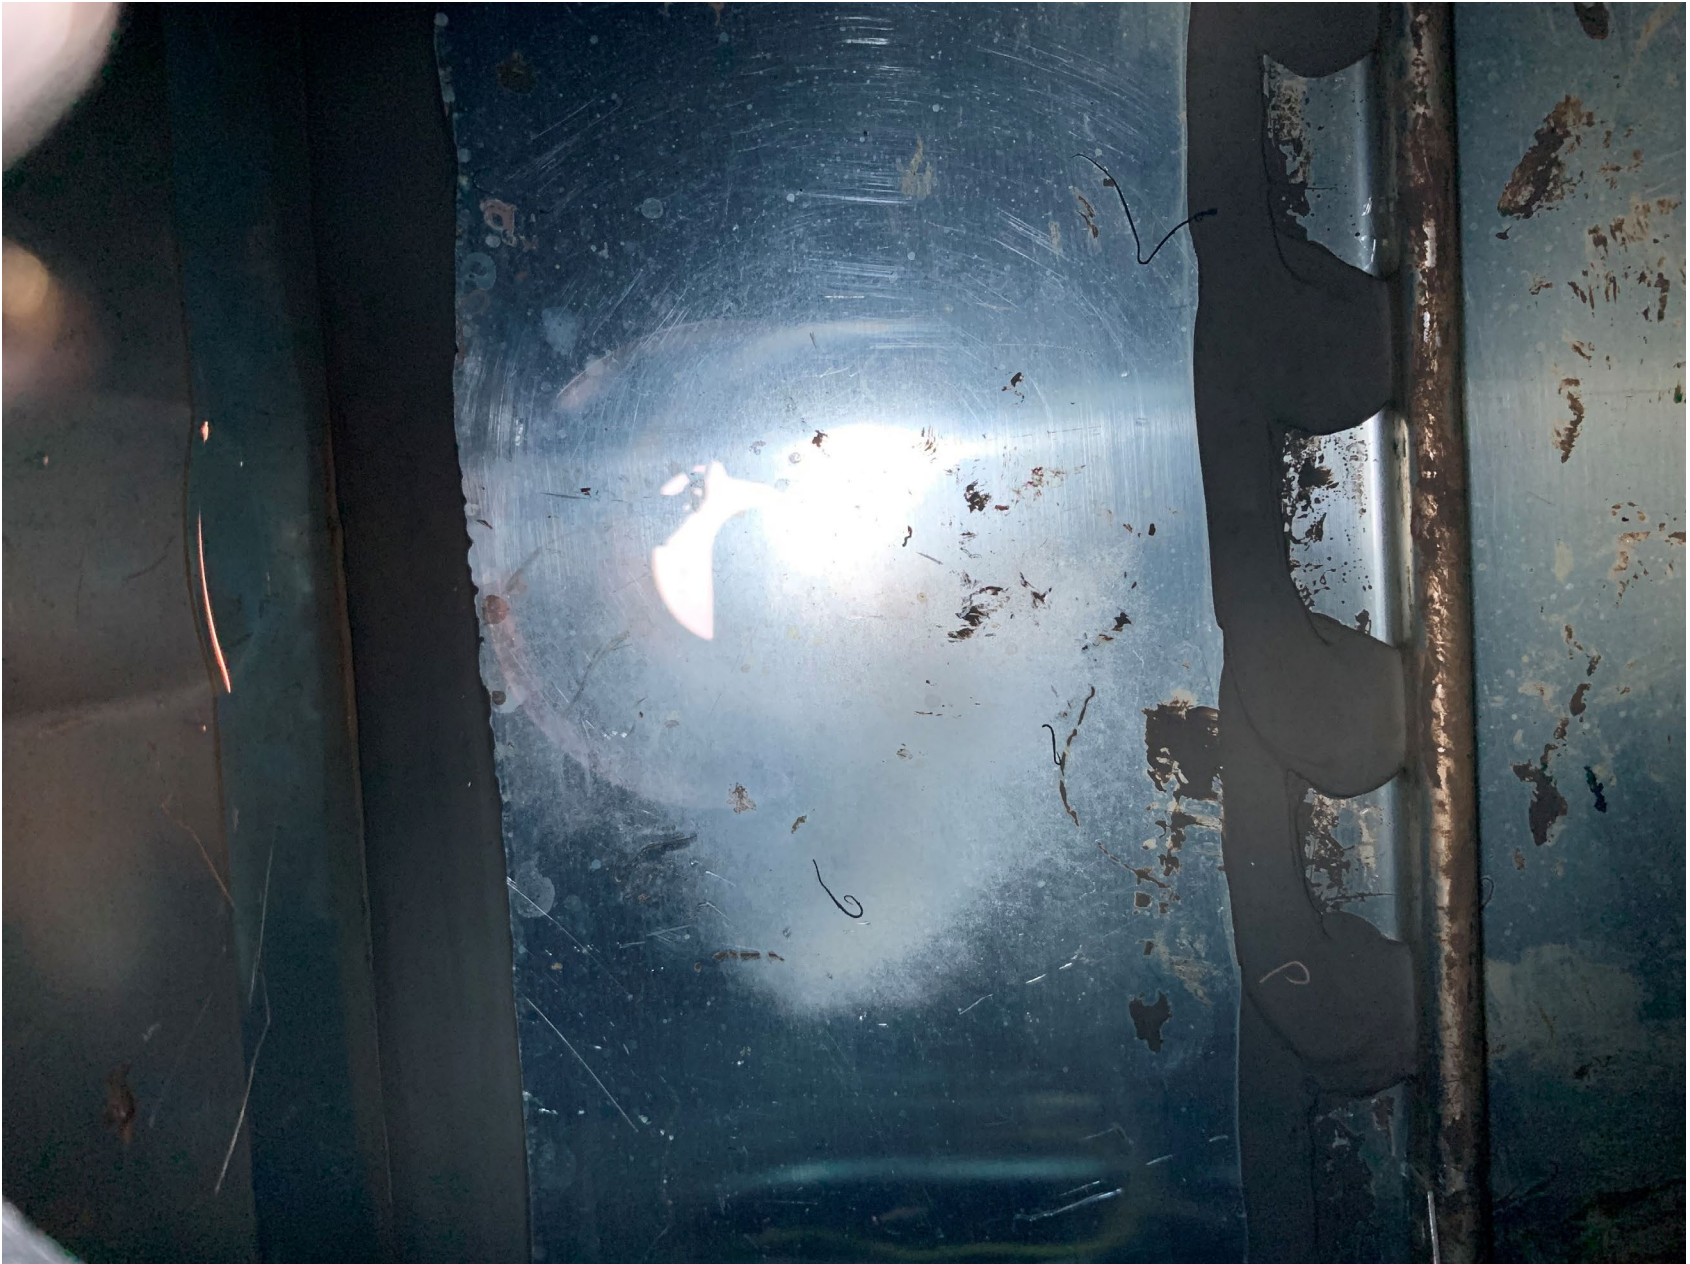
**Photo 3 – View of post-accident left fuel tank quantity (Courtesy of Pilot)**

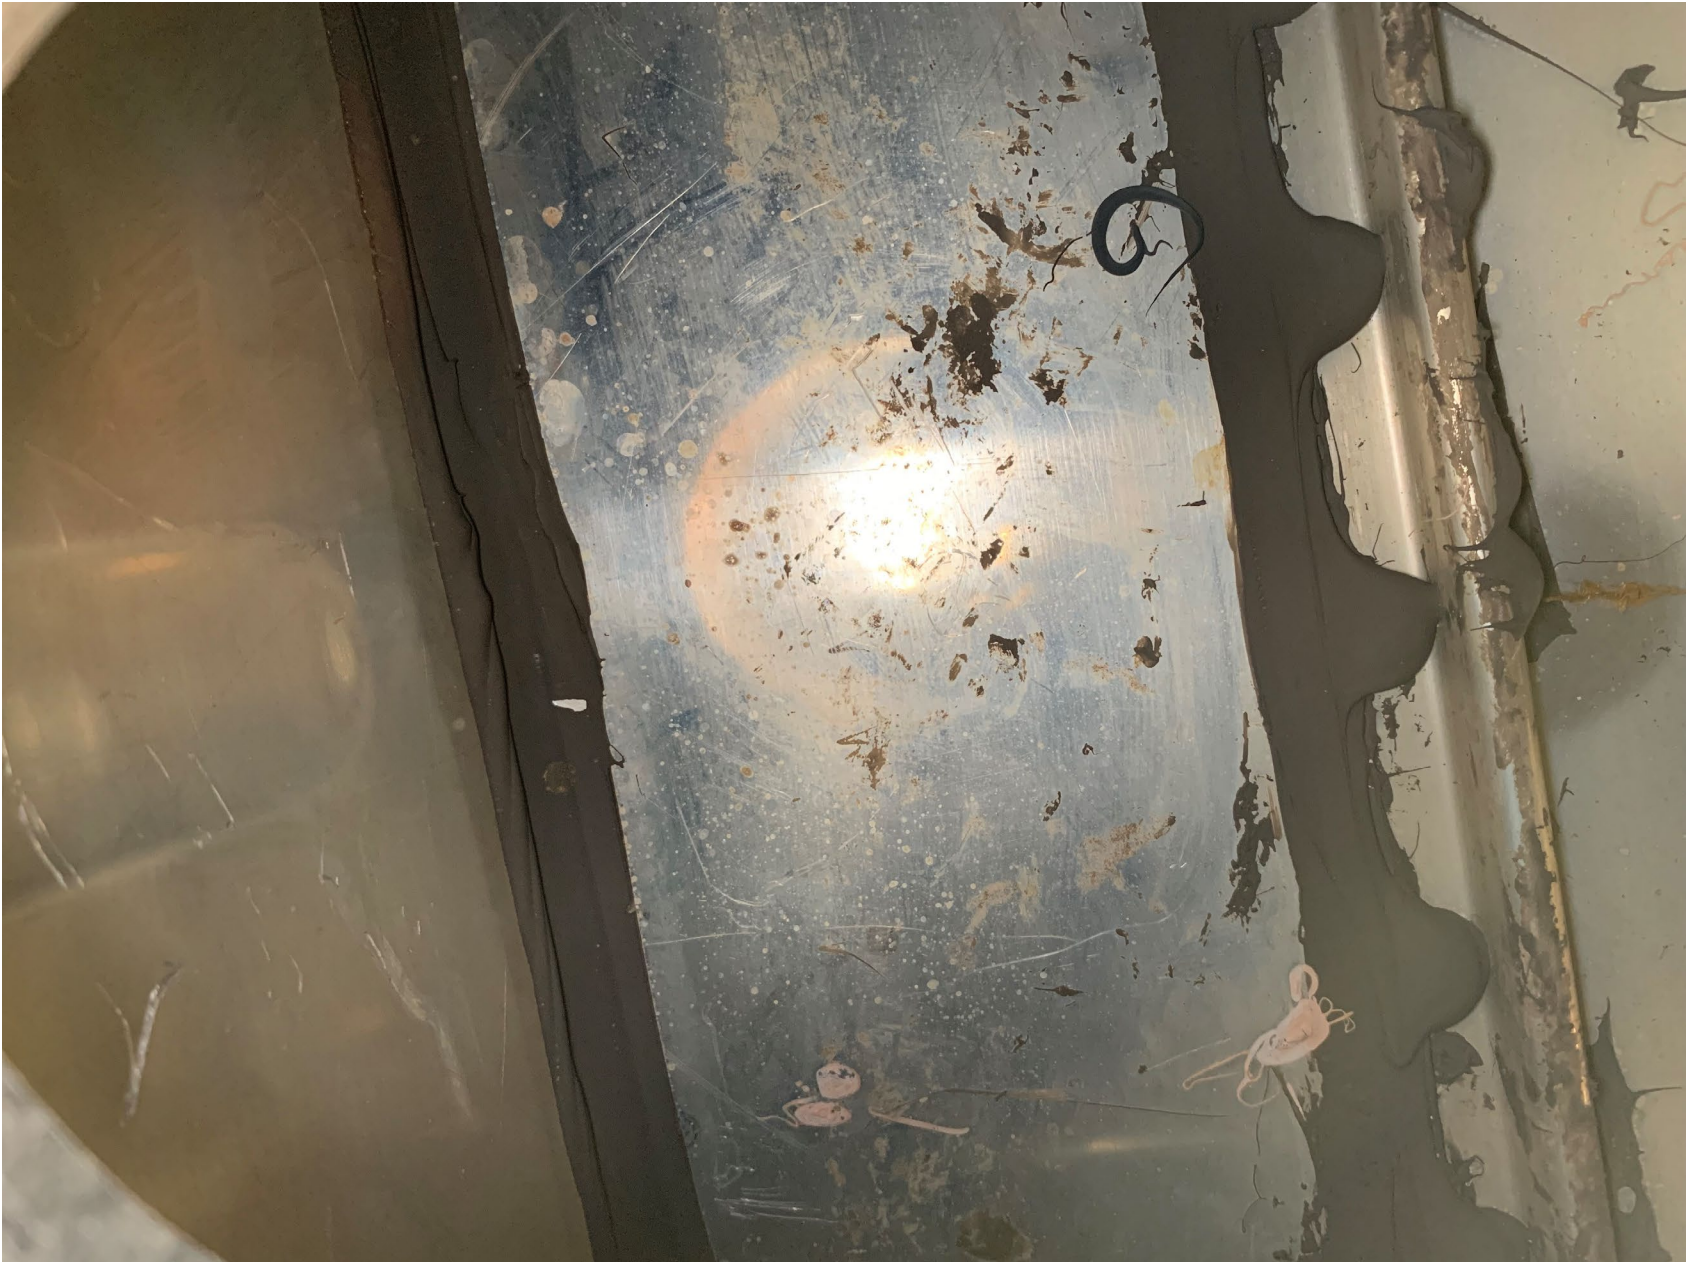
**Photo 4 – View of post-accident right fuel tank quantity (Courtesy of Pilot)**
