**Crashworthiness/Survival Factors
Investigation Attachment- Photographs**

**Joplin, Montana
RRD21MR017**

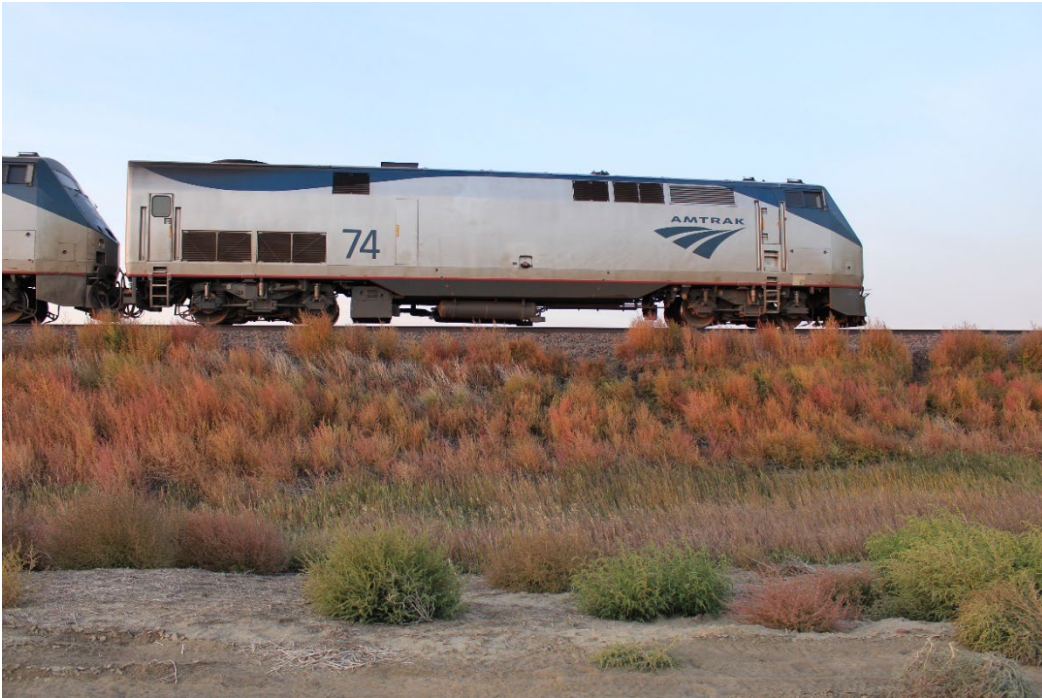
Figure 1 Photograph of the head-end locomotive ATK 74 which did not derail during the accident. (Source: NTSB)

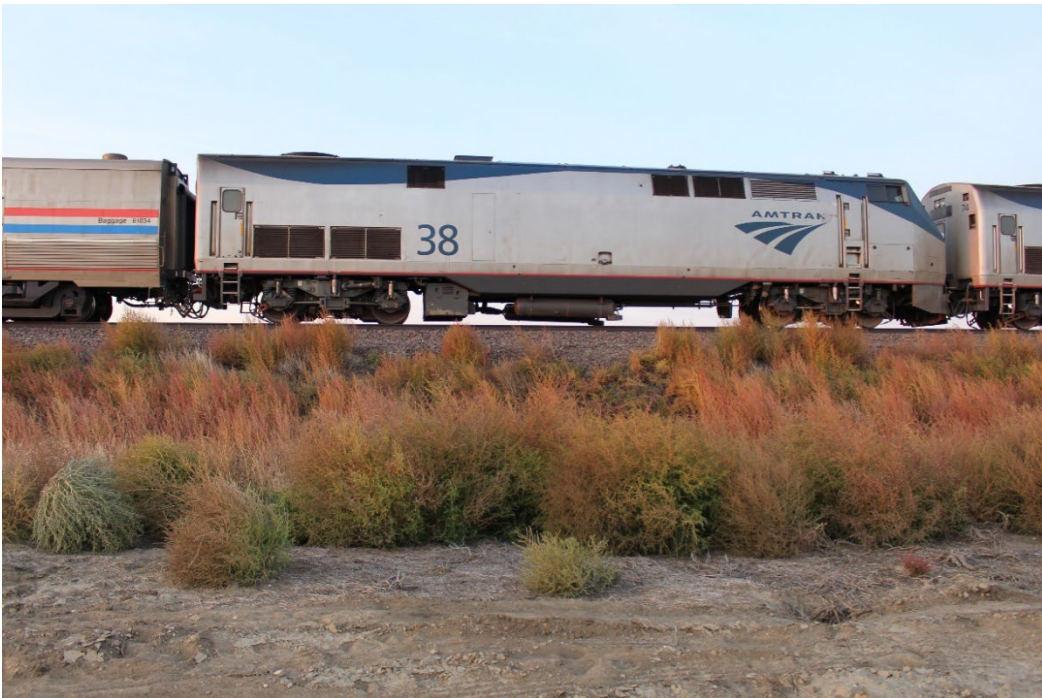
Figure 2 Photograph of trailing locomotive ATK 38 still coupled to head-end locomotive and baggage car. (Source NTSB)

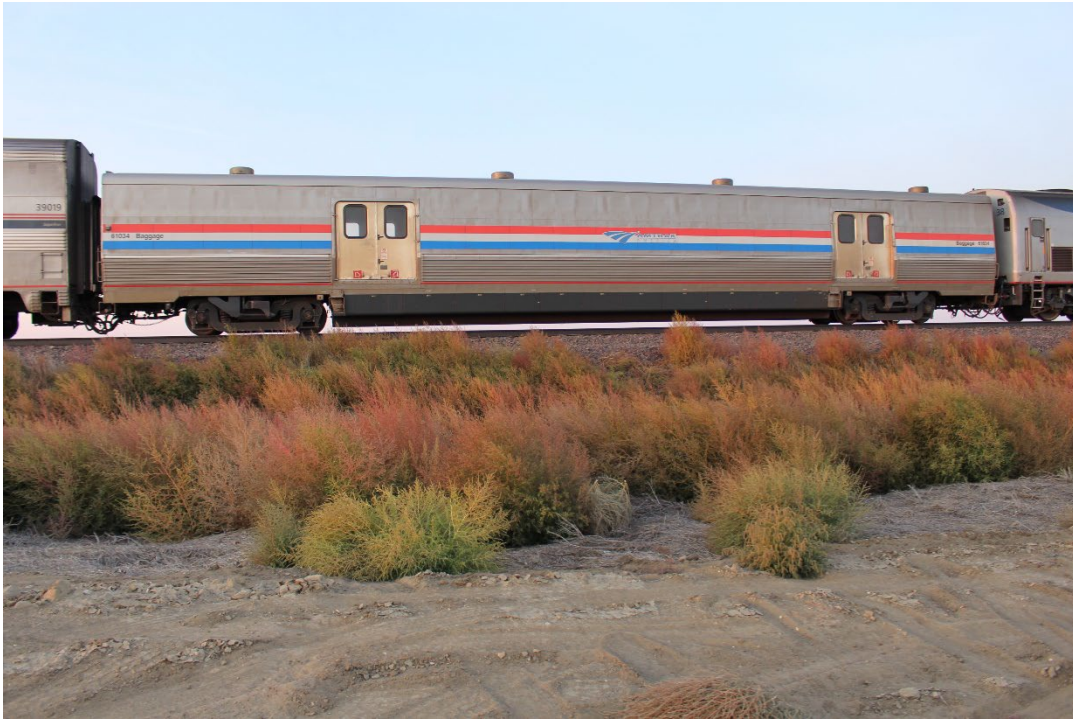
Figure 3 Photograph of the Baggage Car ATK 61034, positioned behind the rear locomotive, ATK 38. (Source: NTSB)

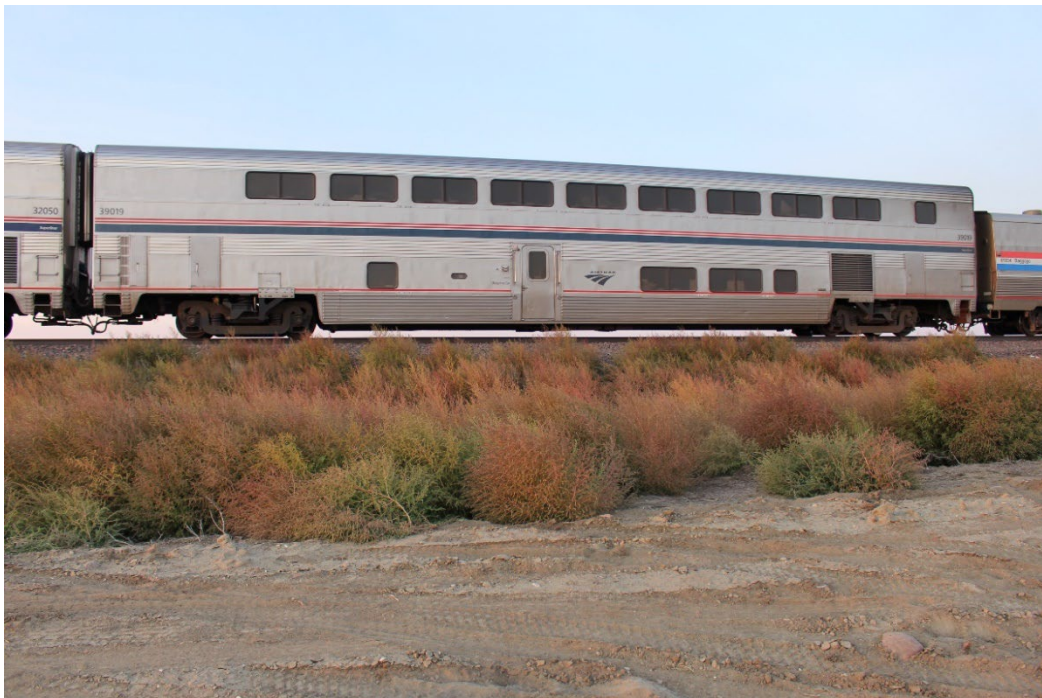
Figure 4 Photograph of the first passenger car in the train consist identified as Transition Crew Dorm/Sleeper ATK 39019. (Source: NTSB)

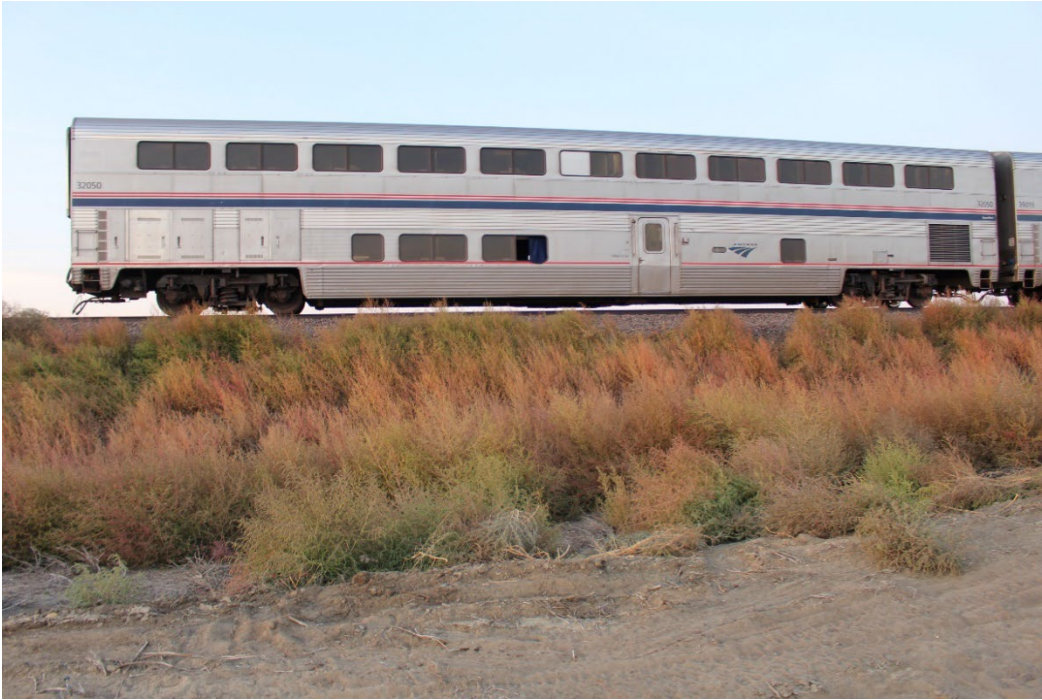
Figure 5 Photograph of Sleeper Car ATK 32050. The train car sustained very little damage in the derailment. (Source: NTSB)

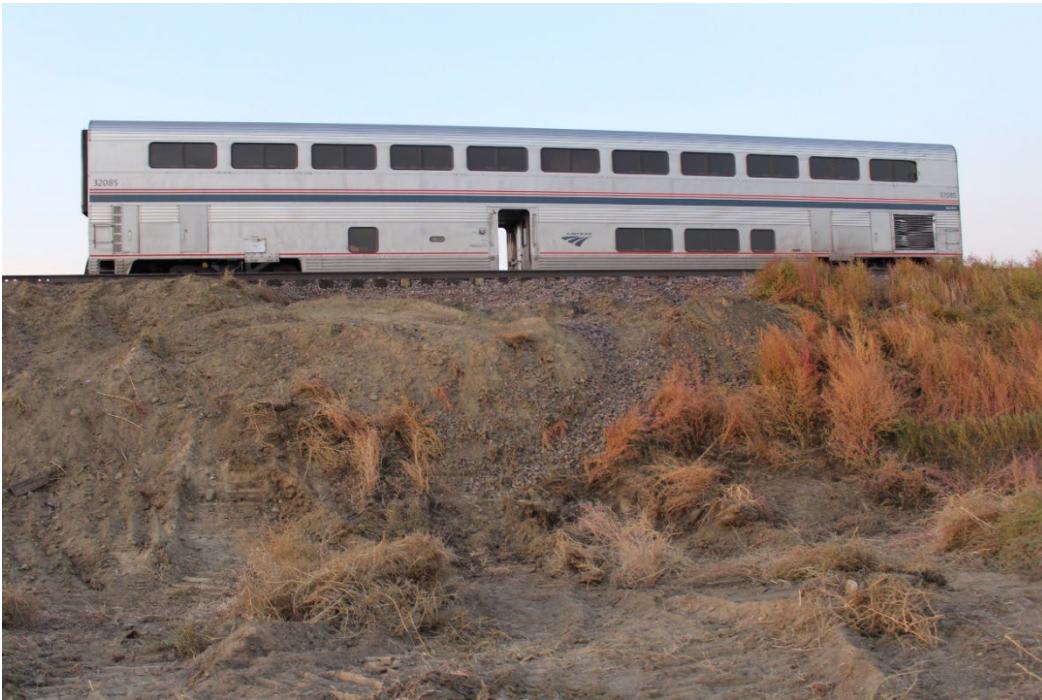
Figure 6 Photograph of third sleeper car in the train consist, ATK 32085, after the car was repositioned back on the track. (Source: NTSB)

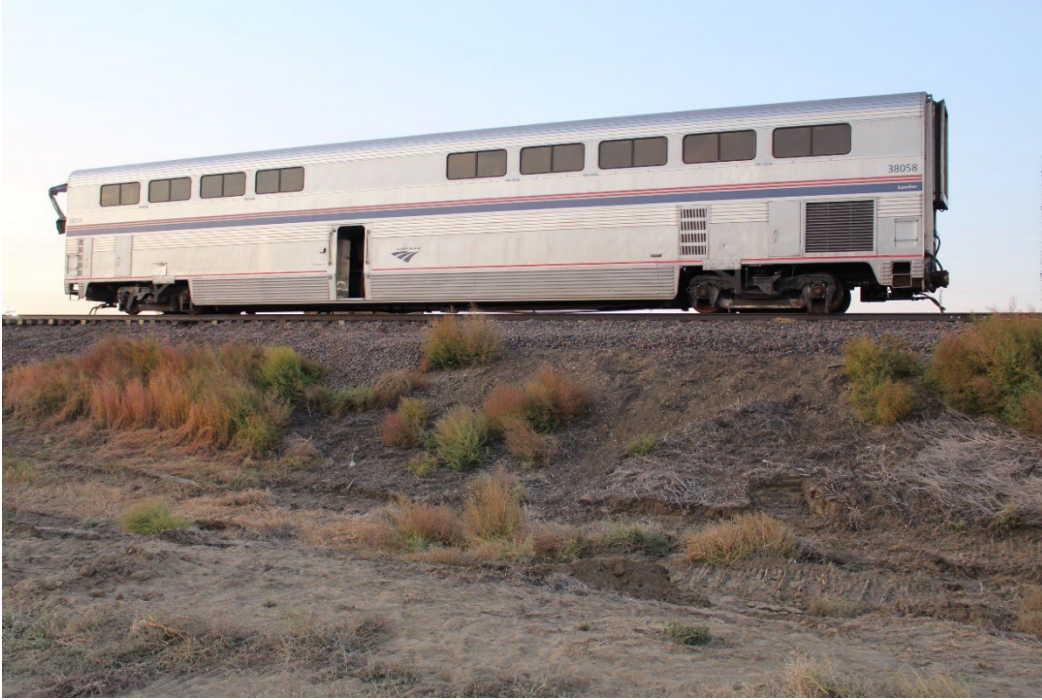
Figure 7 Photograph of the Diner Car, ATK 38058 repositioned on the track. (Source: NTSB)

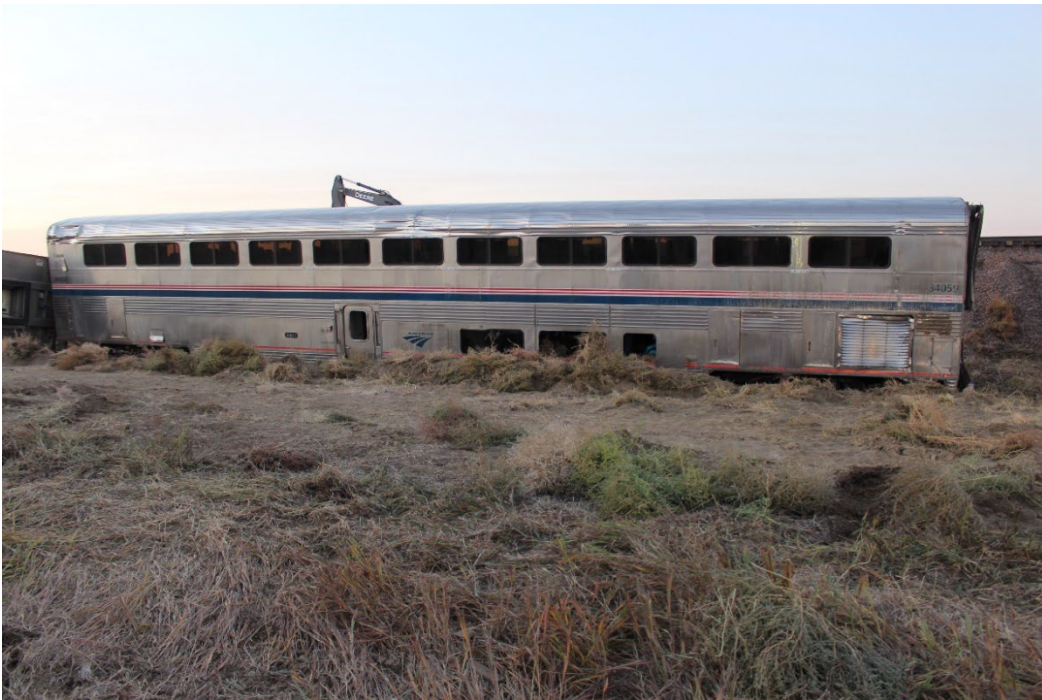
Figure 8 Photograph of the first Coach Car, ATK 34059, after being removed from the track and stabilized on the scene. (Source: NTSB)

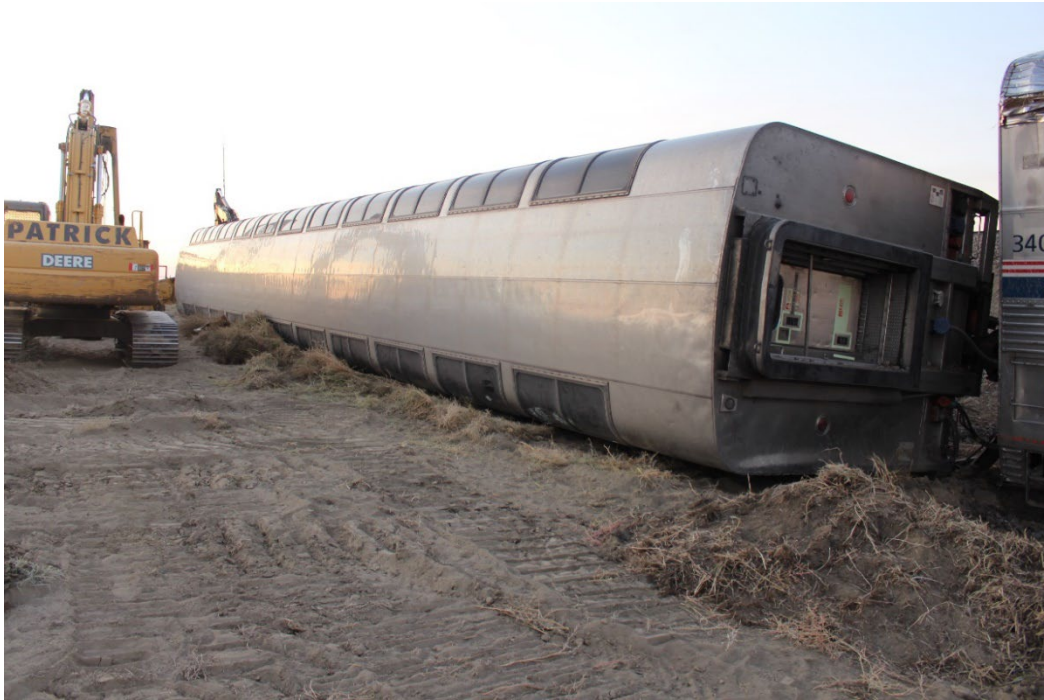
Figure 9 Photograph of the Lounge Car, ATK 33049, lying on its right side on the scene. (Source: NTSB)

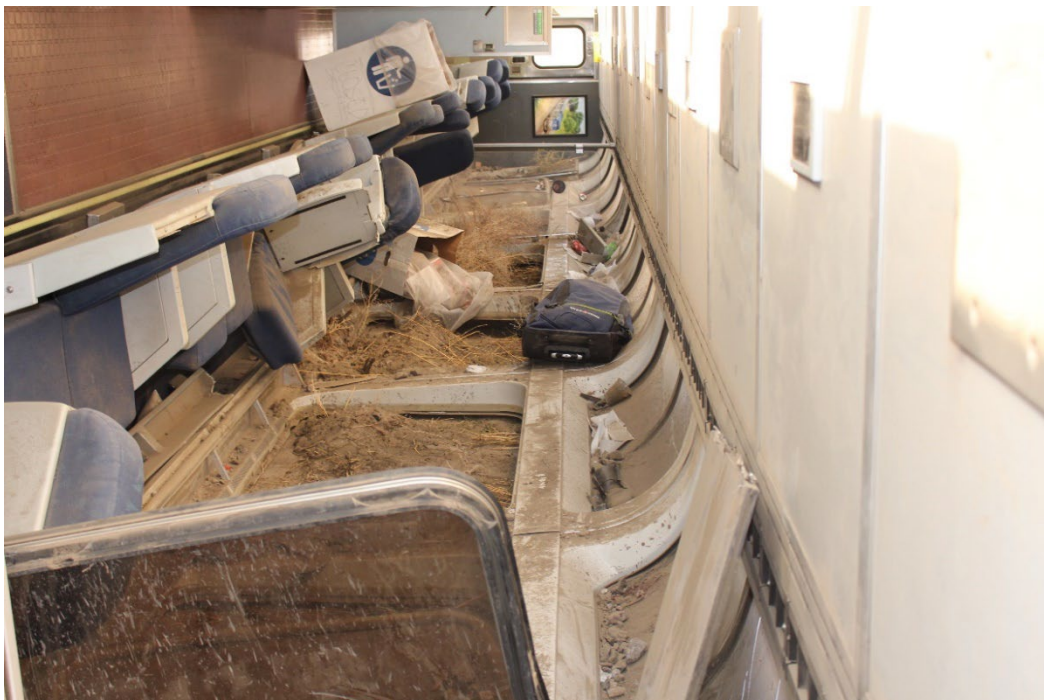
Figure 10 Photograph of the interior of the Lounge Car, ATK 33049, looking forward from the trailing end. The ground outside of the car is visible through the spaces created by the missing windows. (Source: NTSB)

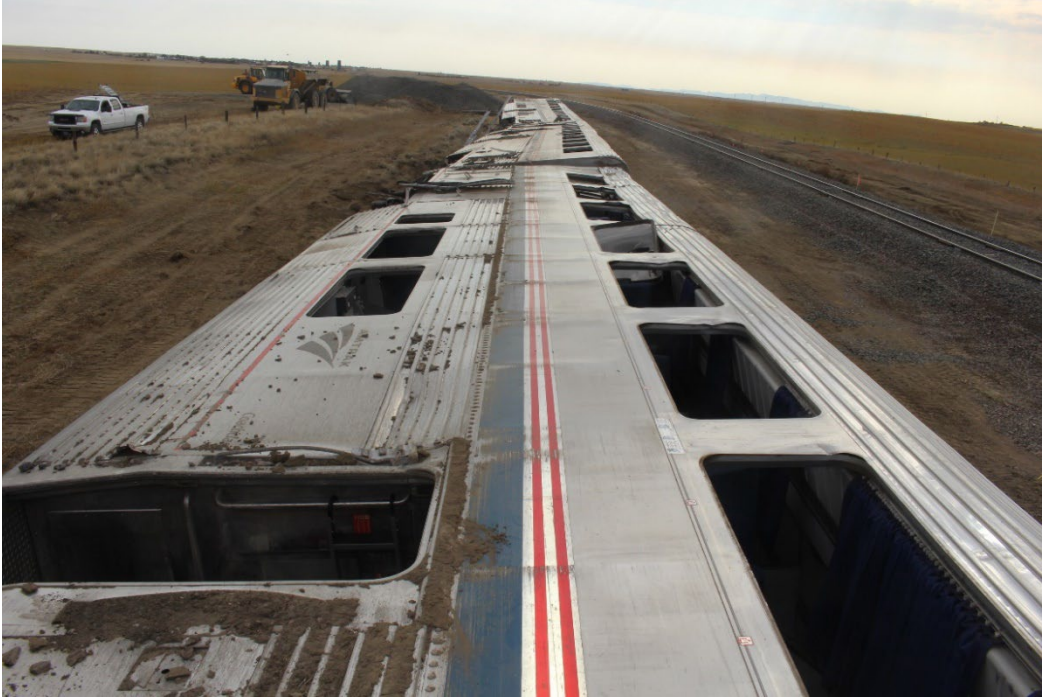
Figure 11 Photograph taken from the top (right) side of the three uncoupled train cars that overturned east of the main train body. The train cars were flipped onto their left side during the search for victims. (Source: NTSB)

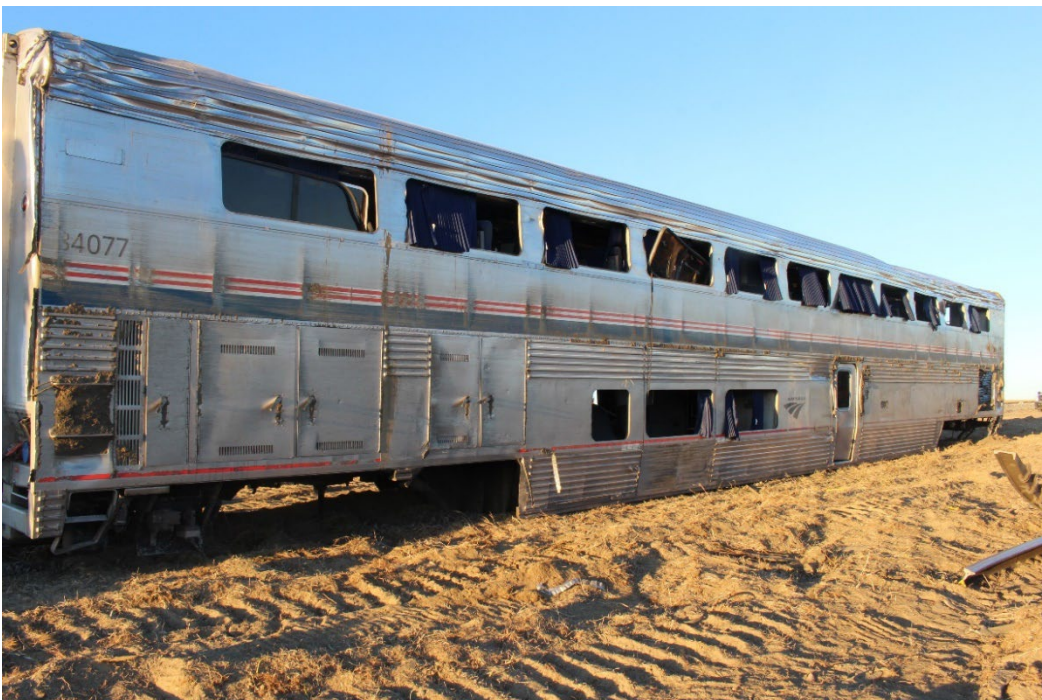
Figure 12 Photograph of westernmost uncoupled train car, ATK 34077, after the car had been righted. The Photograph shows the damage to the right side of the car caused by the contact with the ground. (Source: NTSB)

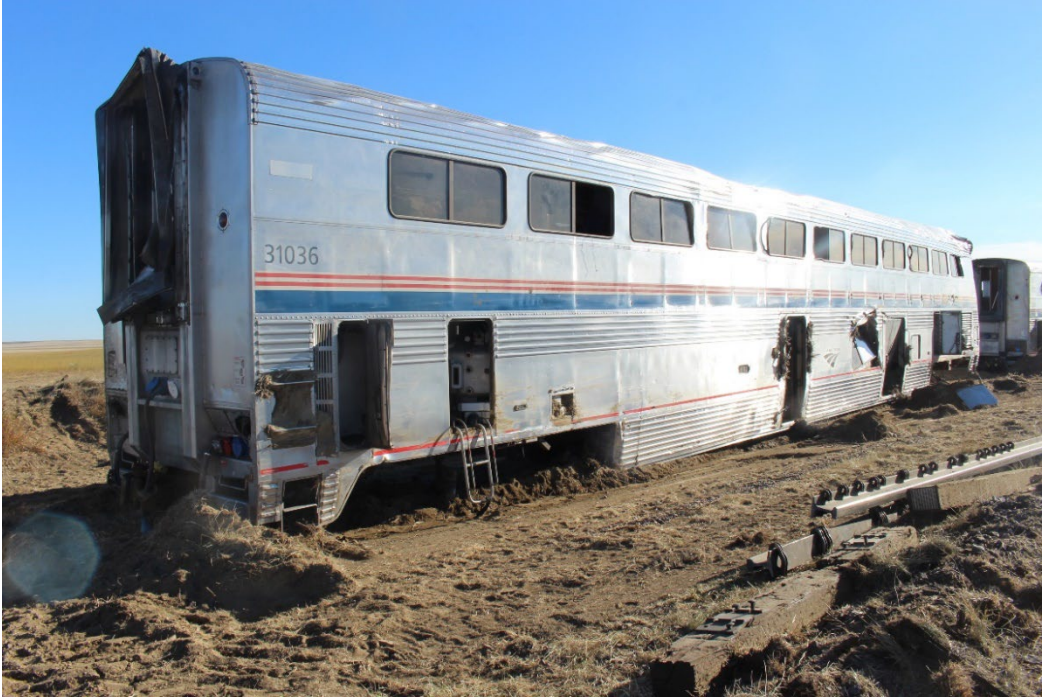
Figure 13 Photograph of the middle of the three uncoupled train cars. Coach Car ATK 31036 remained coupled to ATK 34077 in the lead and the Sleeper ATK 32007 that was trailing. Damage shown includes rescue damage caused by emergency responders and construction crews on scene. (Source: NTSB)

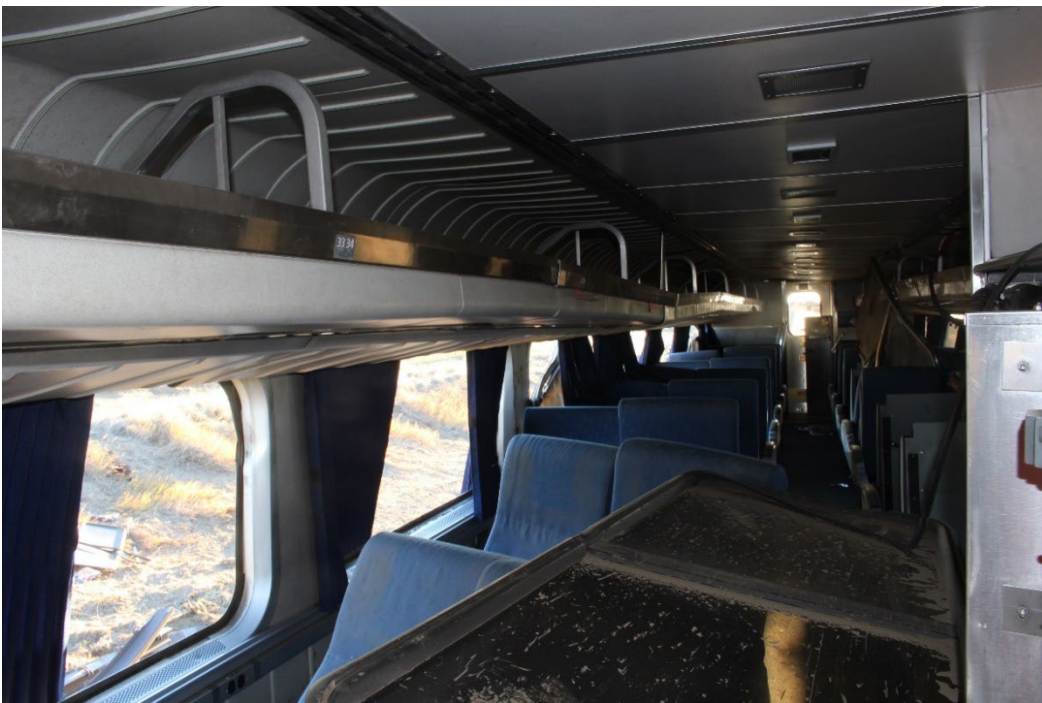
Figure 14 Photograph of the interior of Coach Car ATK 31036 showing the damage sustained in the derailment to include deformation to spaces above train seats caused by impact with passenger heads and missing and removed windows. (Source: NTSB)

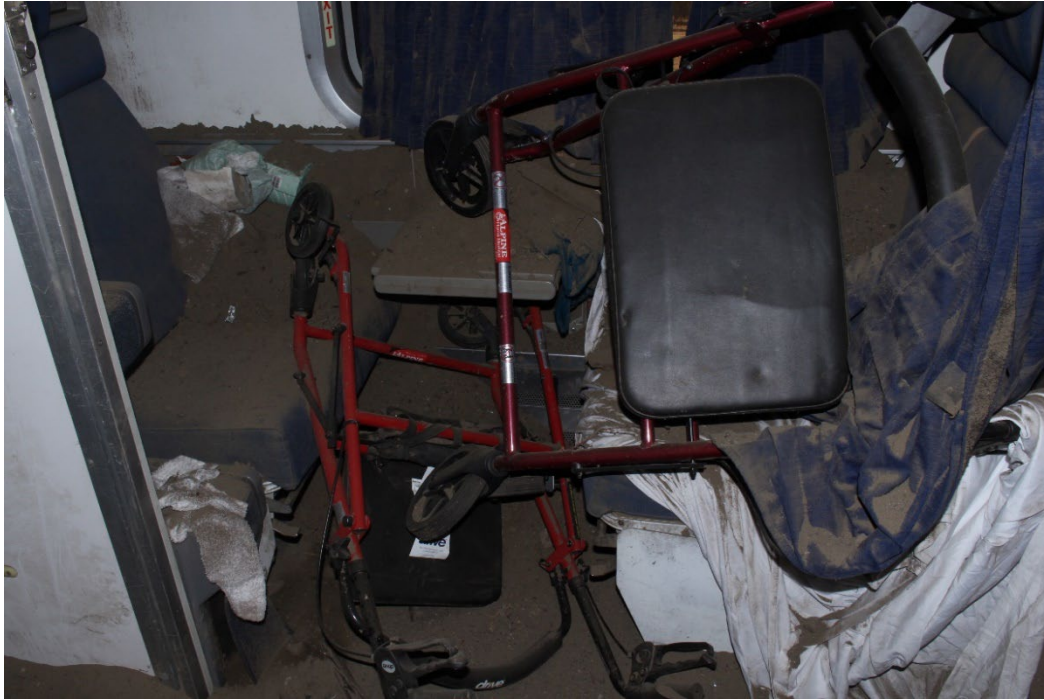
Figure 15 Photograph of the interior lower bedroom in Sleeper Car ATK 32007. The room is filled with dirt that infiltrated the car after the car window fell out of its frame. (Source: NTSB)

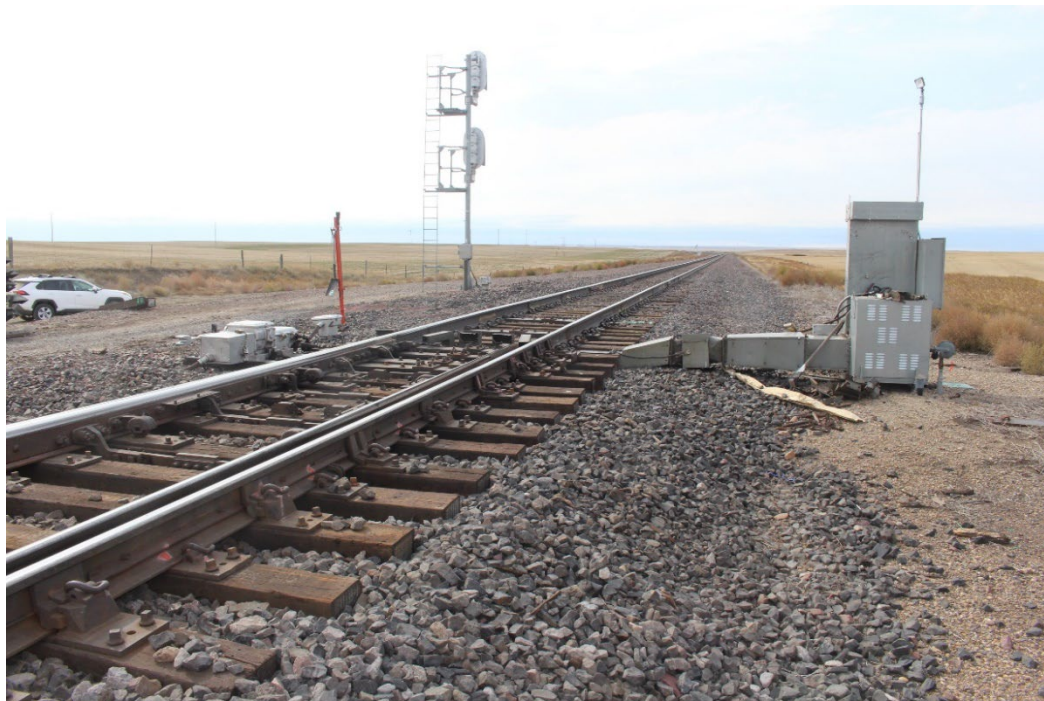
Figure 16 A photograph of the track switch heater in place at the Buelow West track. The switch heater sits 11 feet back from the track. The duct work and connecting hoses feeds propane from a tank (not pictured) to heat the track surface. (Source: NTSB)
