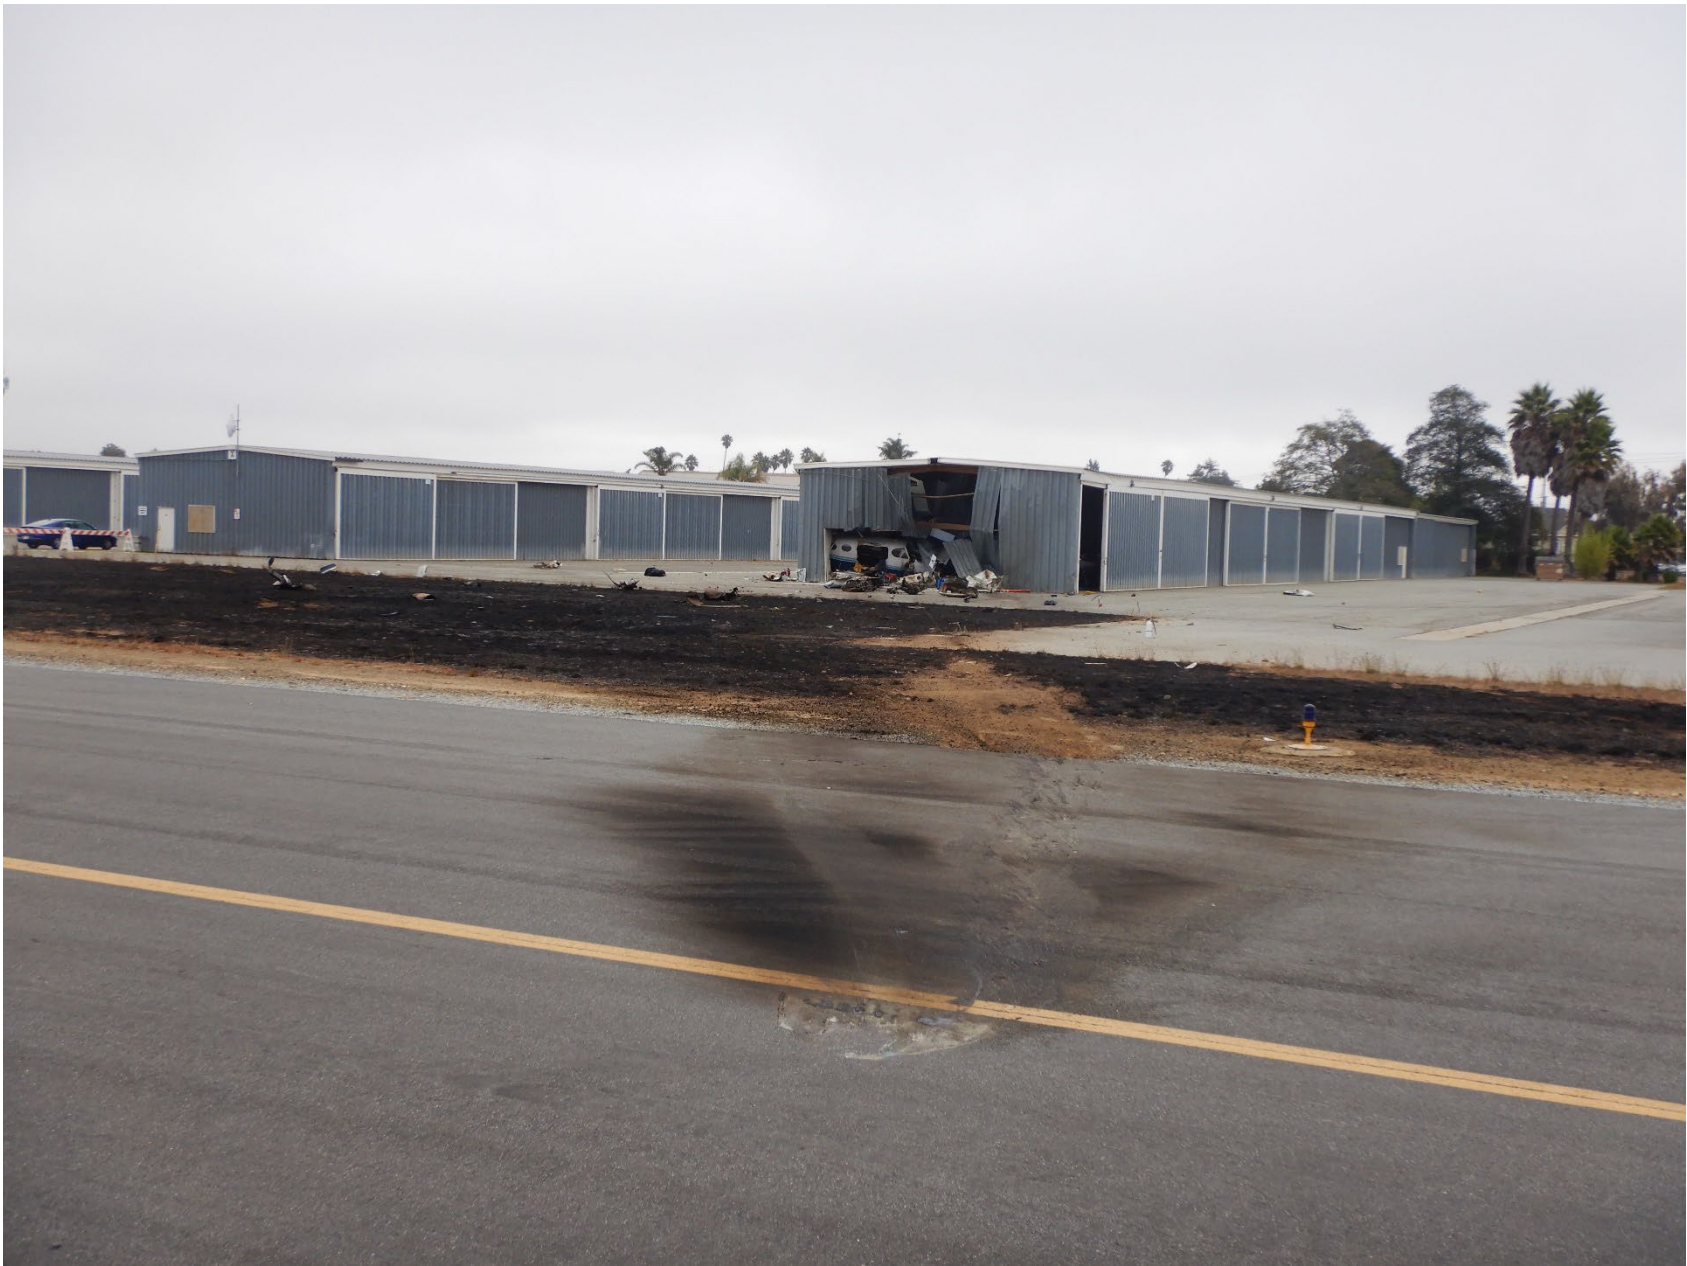
Photo 1 – N740WJ first point of probable impact. The airplane is in the background.

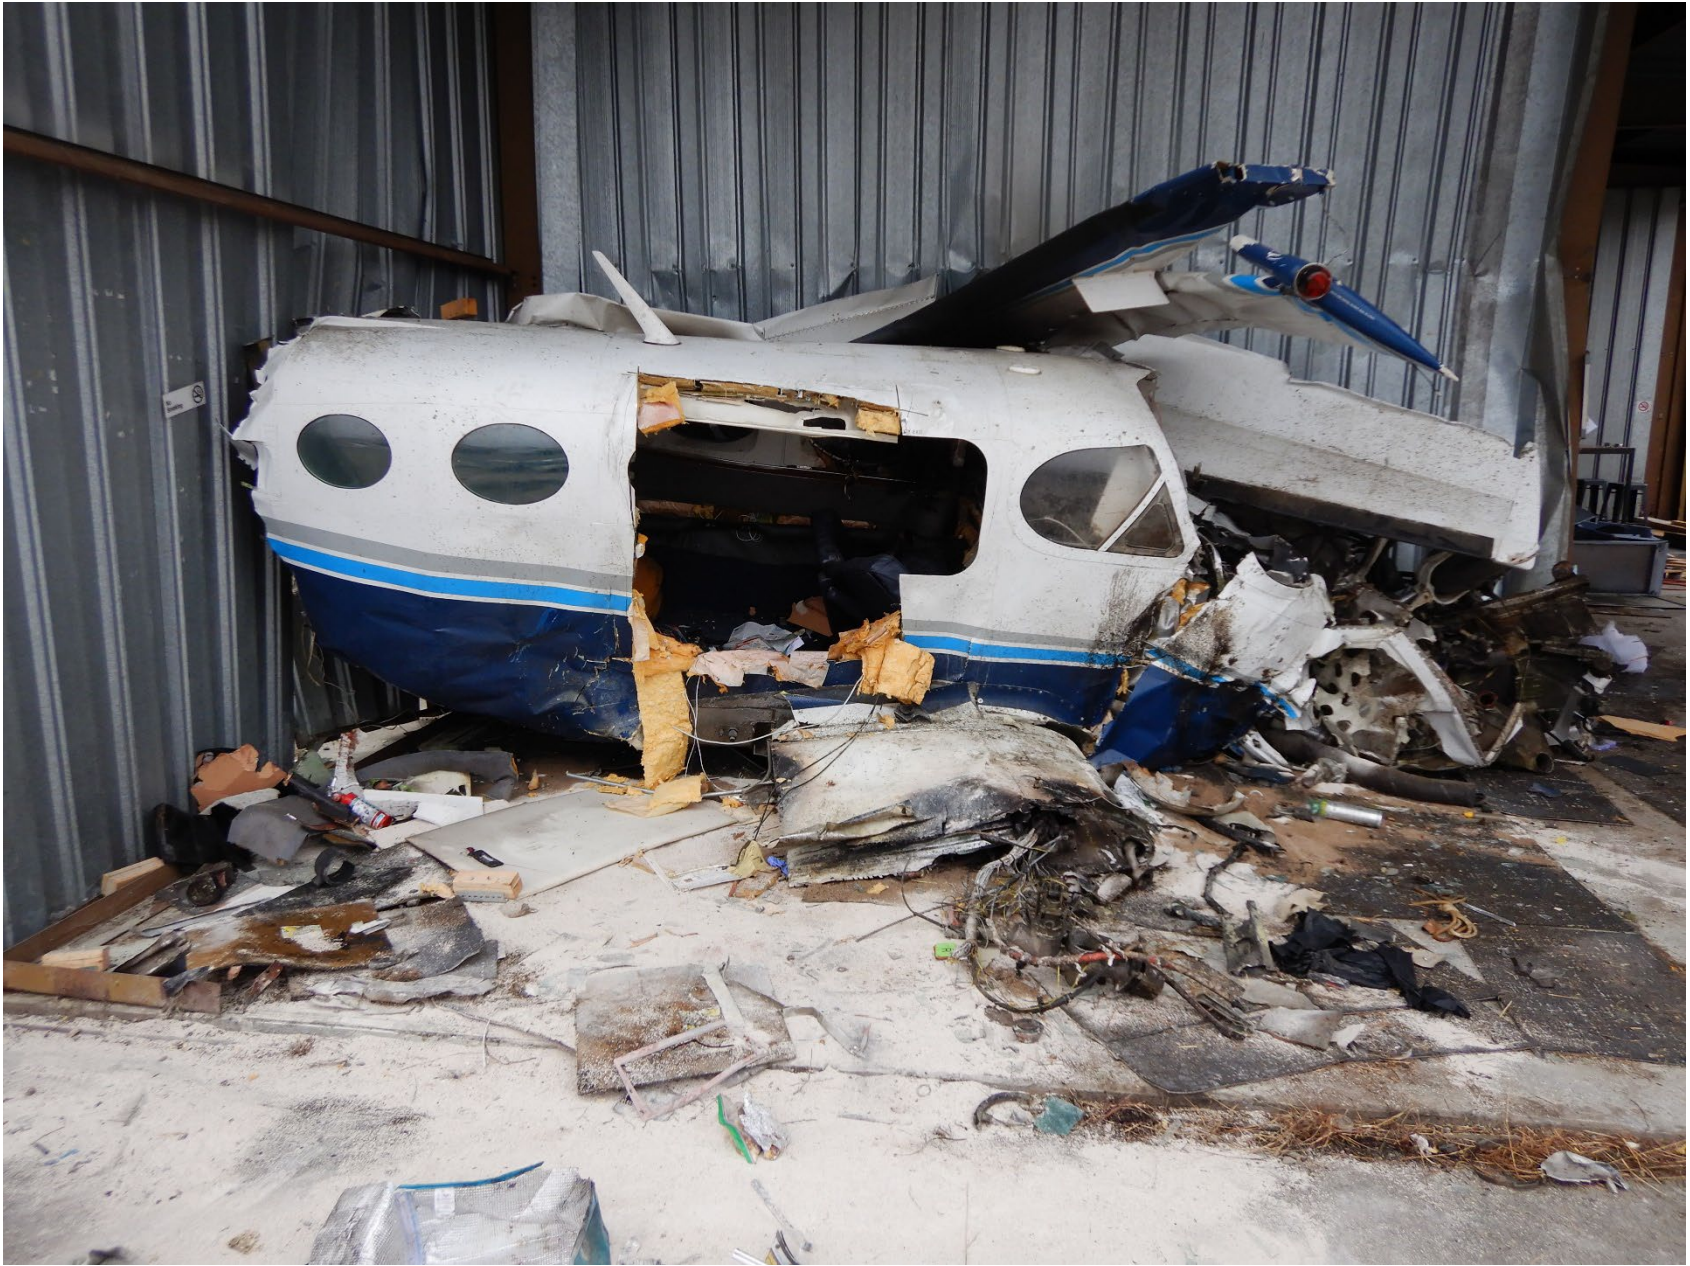
Photo 2 -N740WJ, showing the cutaway area used during recovery.

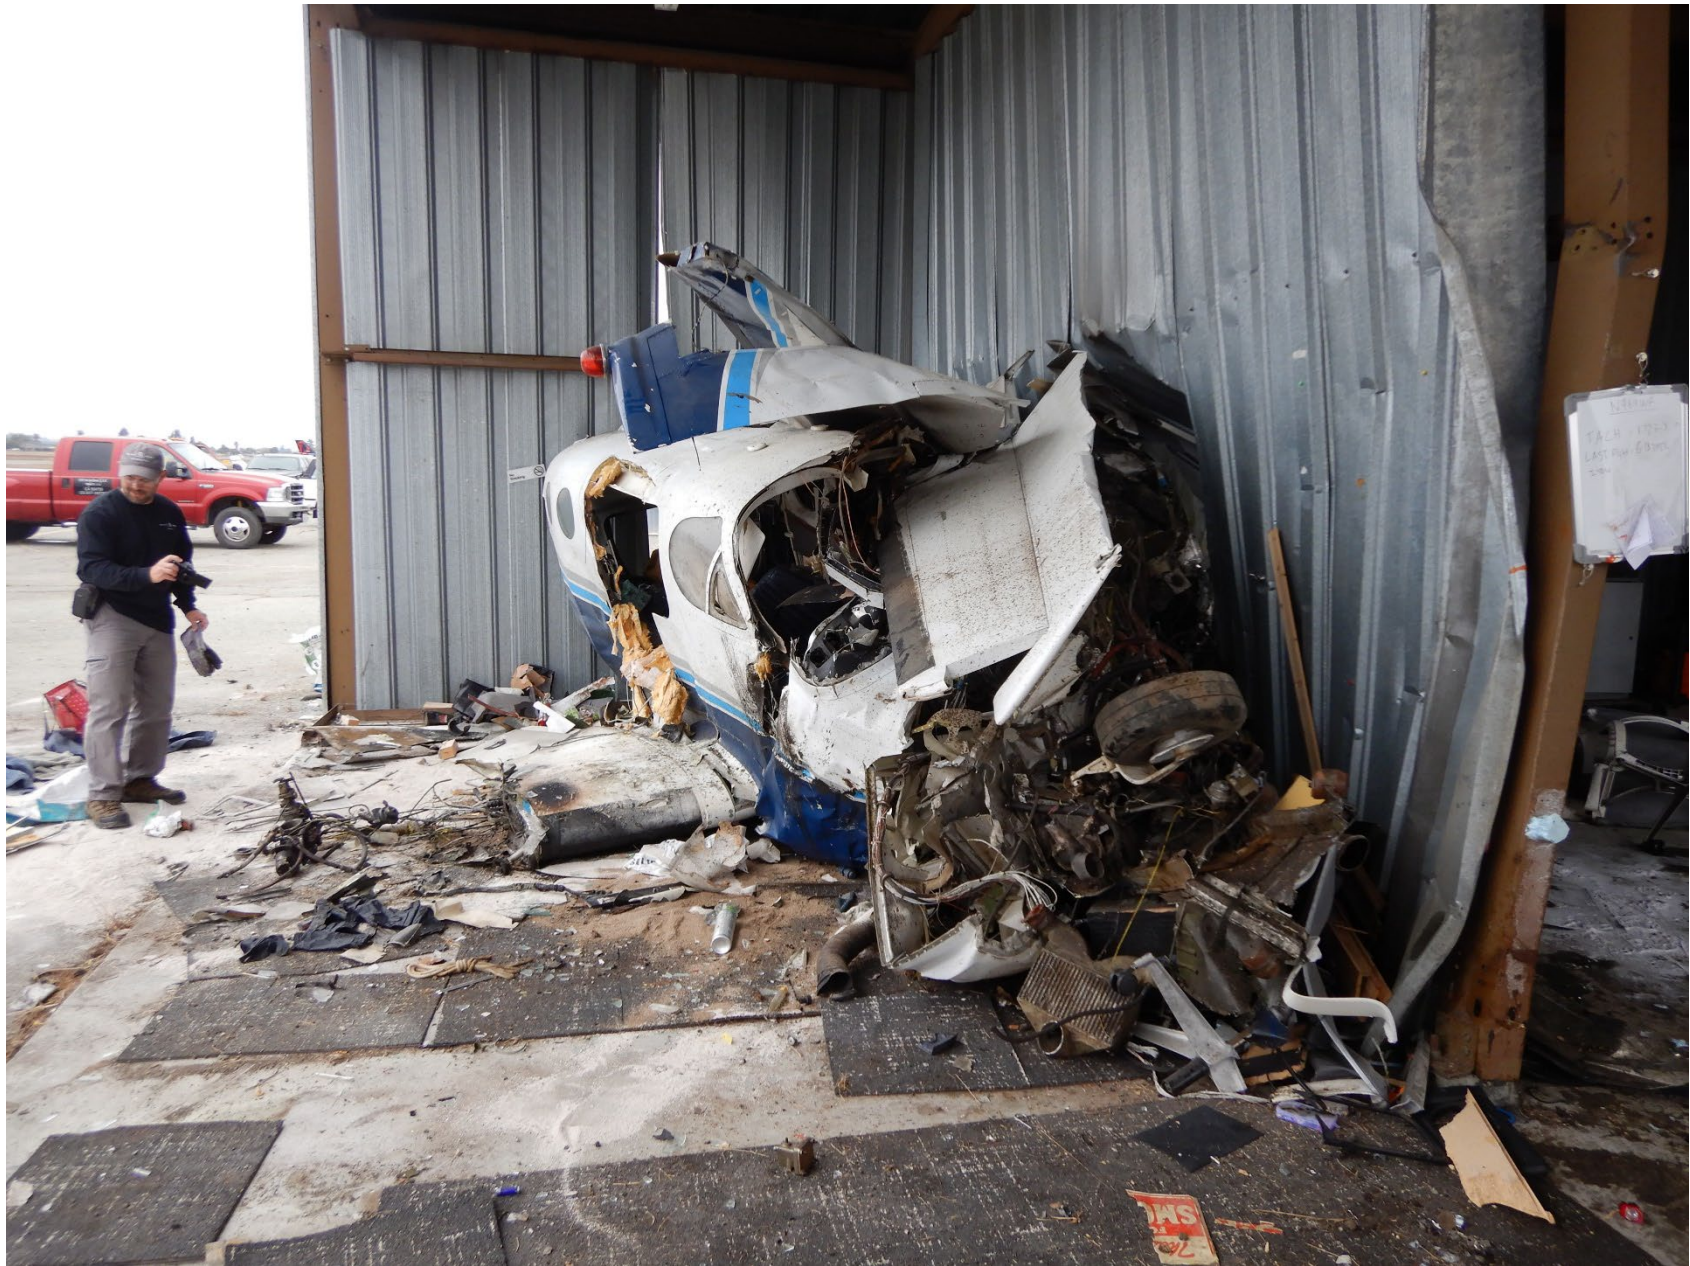
Photo 3 – N740WJ, front view.

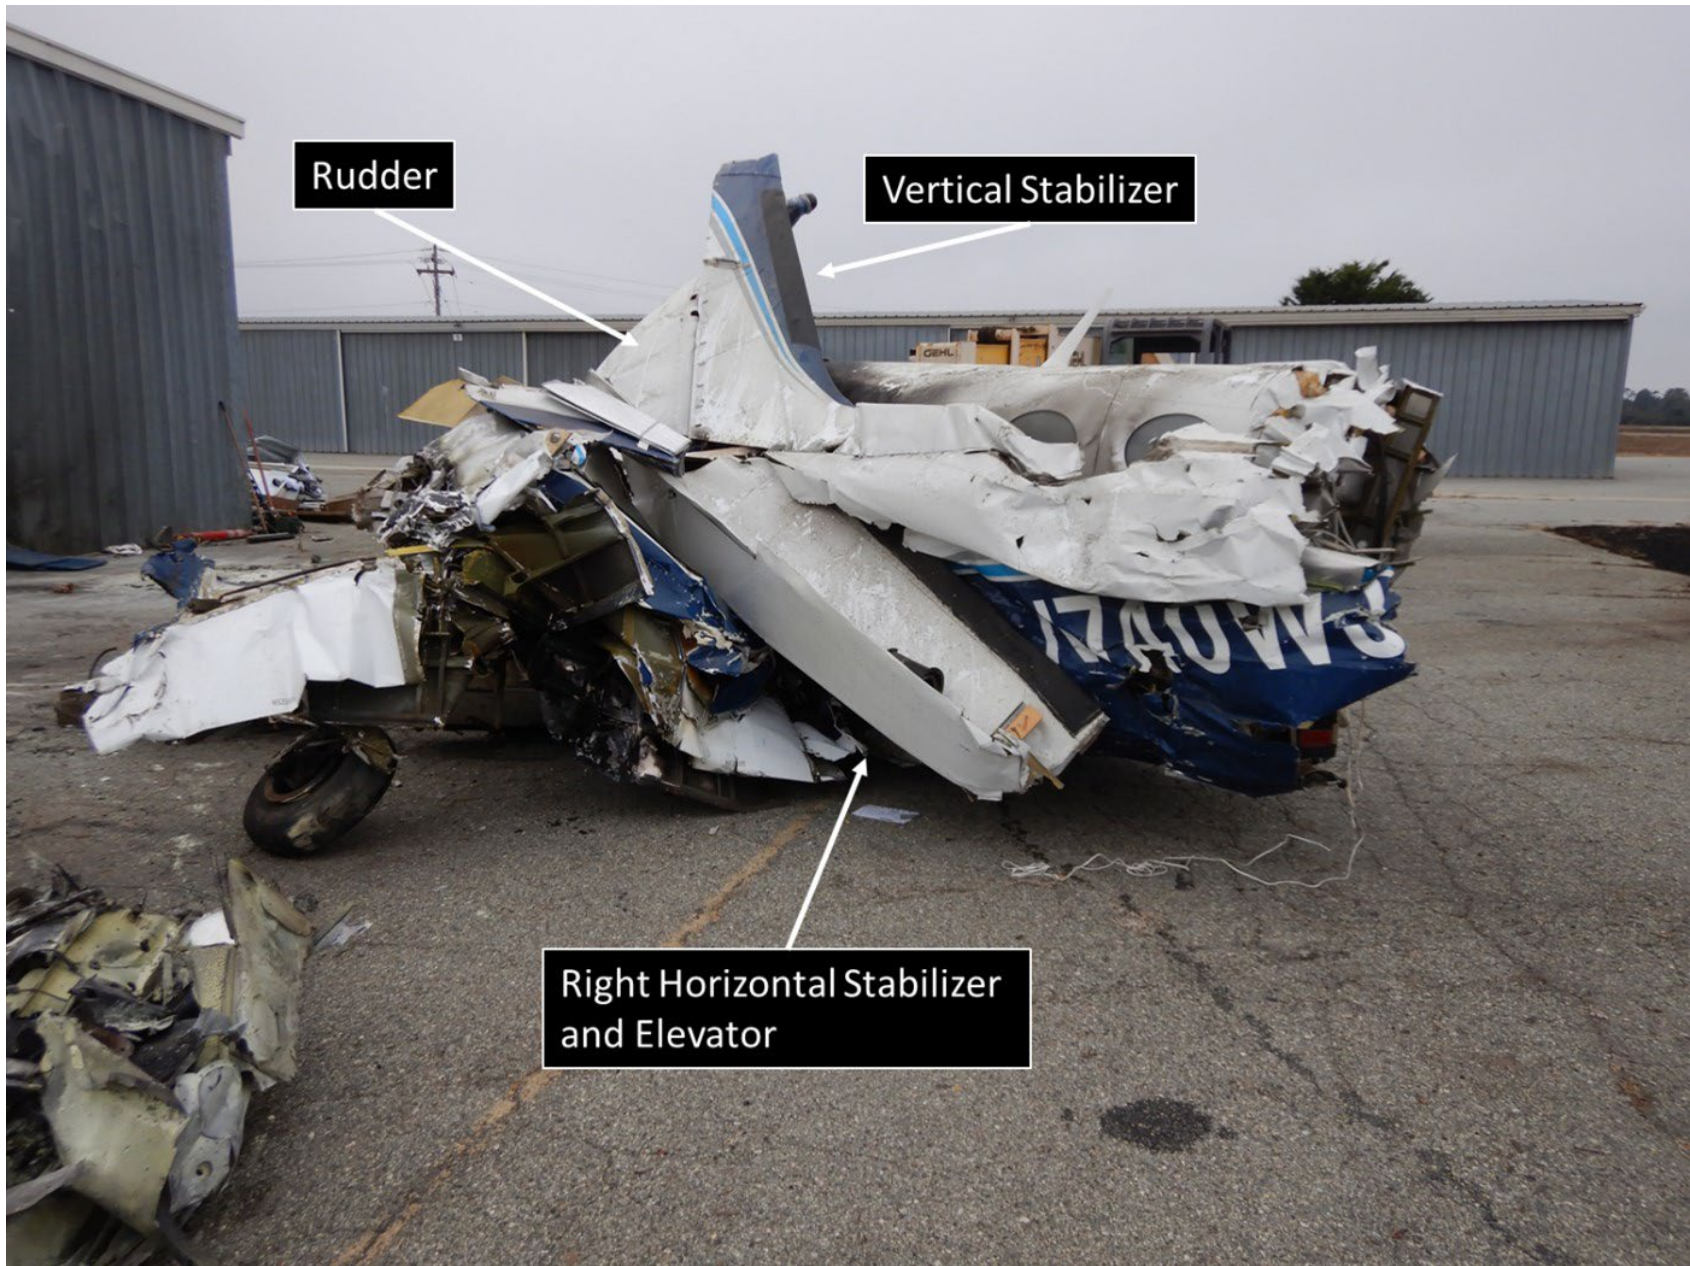
Photo 4 – N740WJ, left-side. The right side of the empennage is in view and wrapped around the left side of the fuselage.

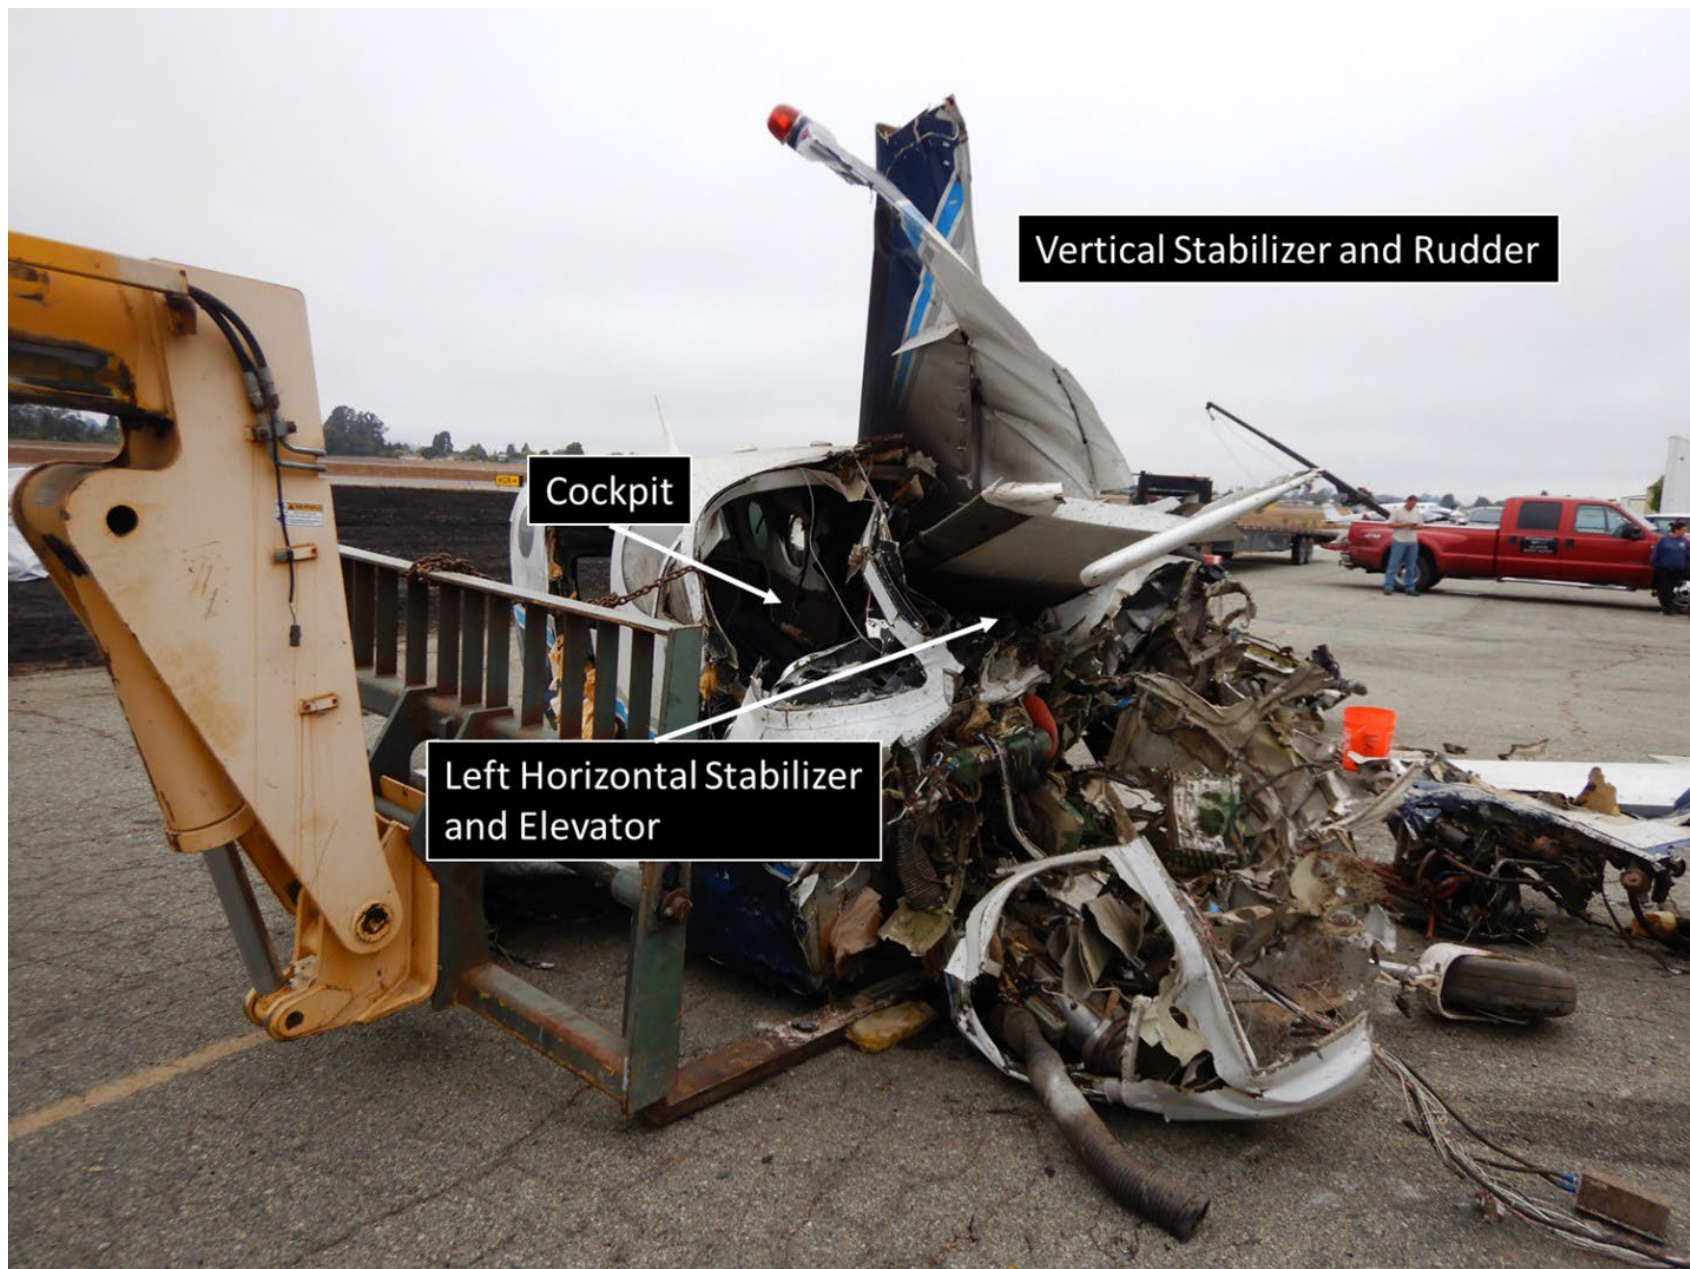
Photo 5 – N740WJ, front view.

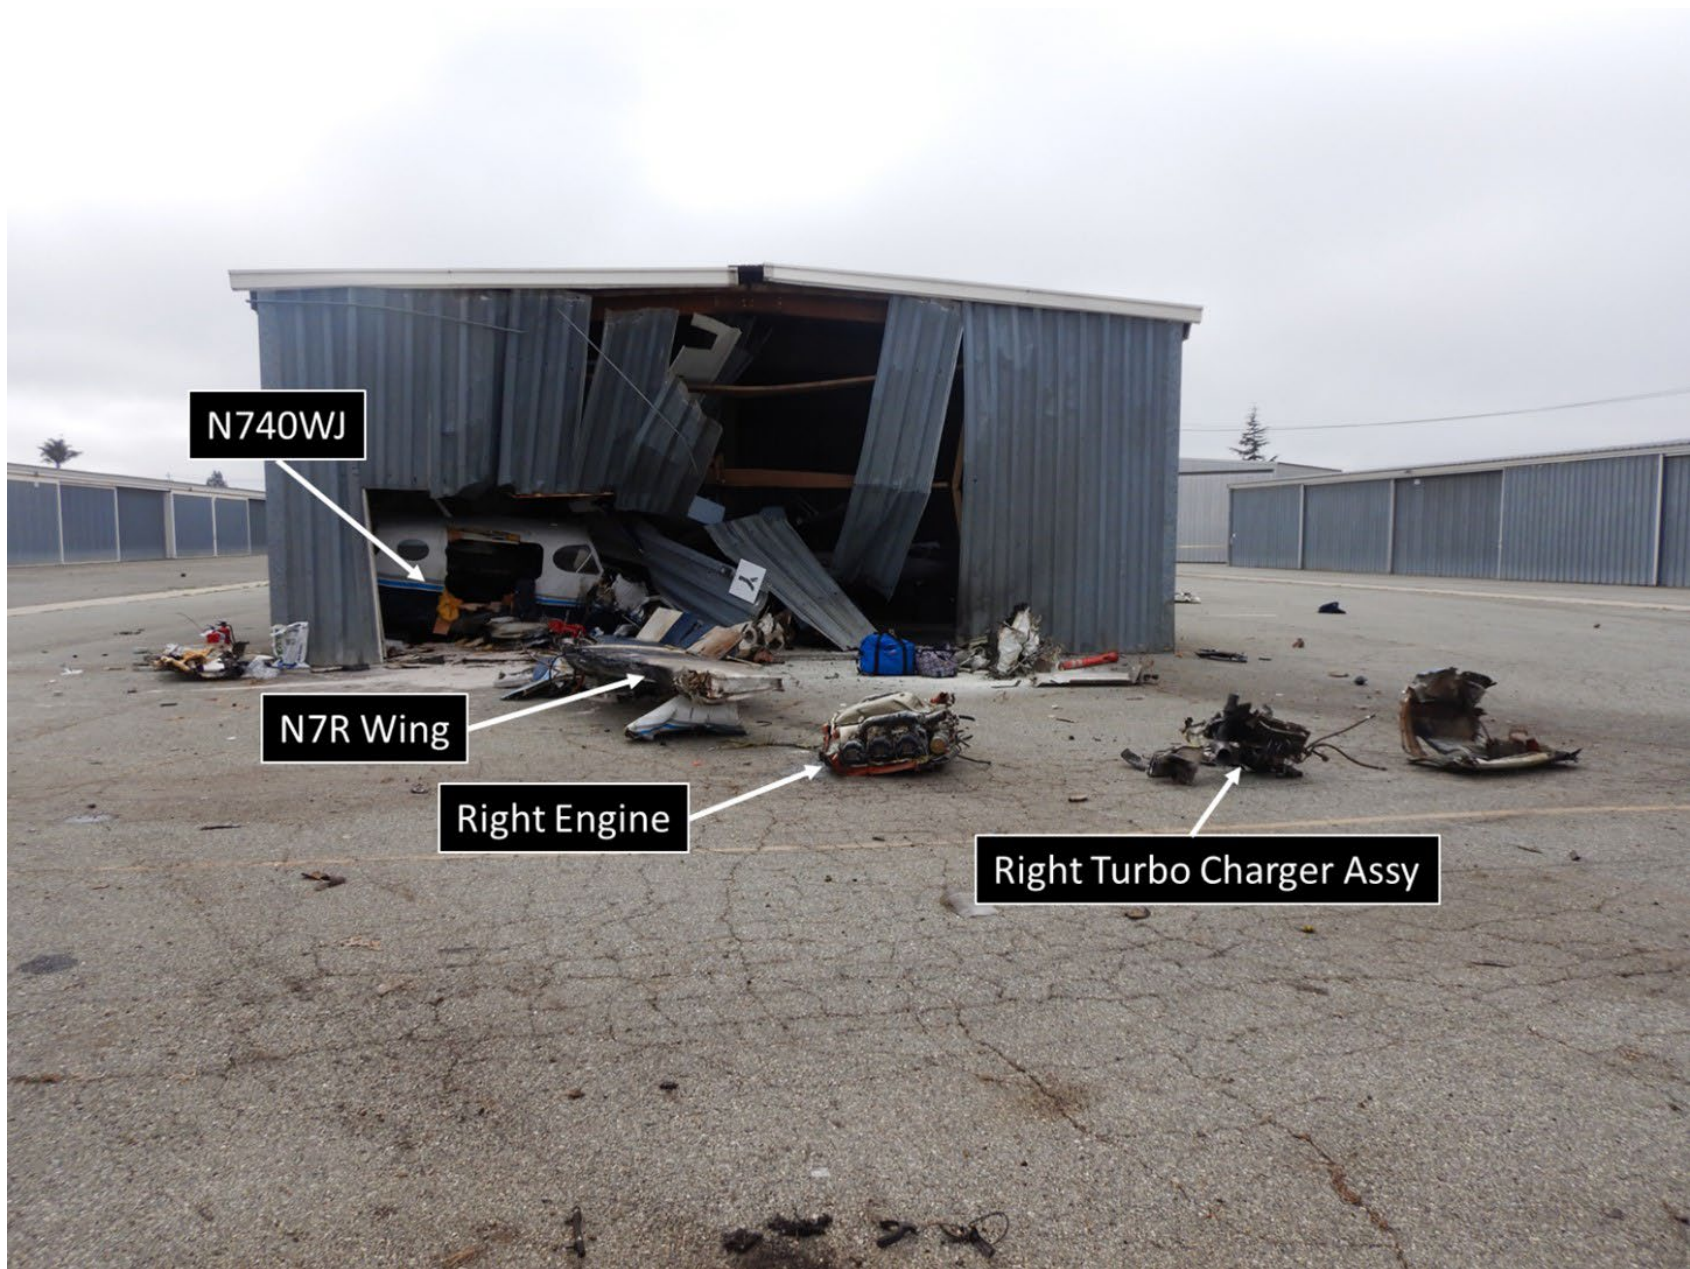
Photo 6 – N740WJ, debris field.

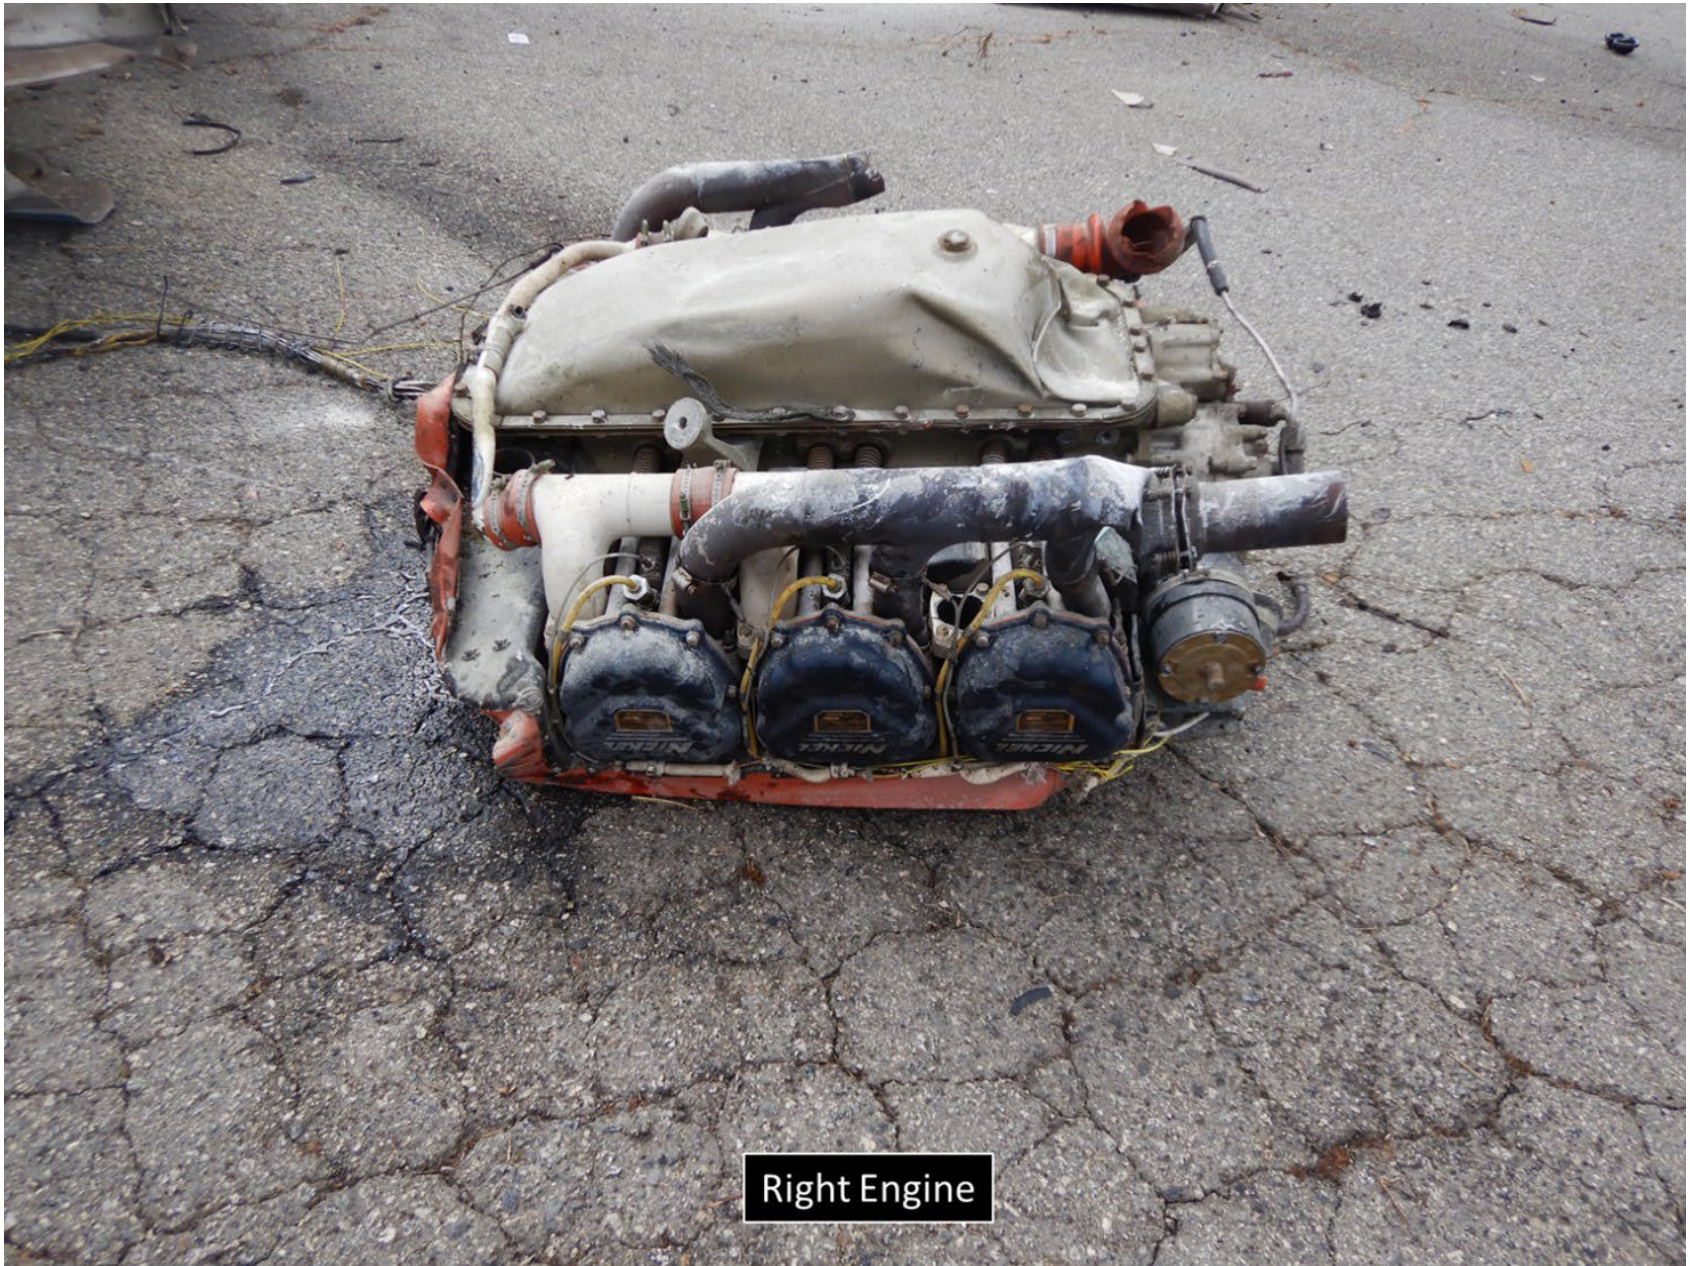
Photo 7 – Right engine.

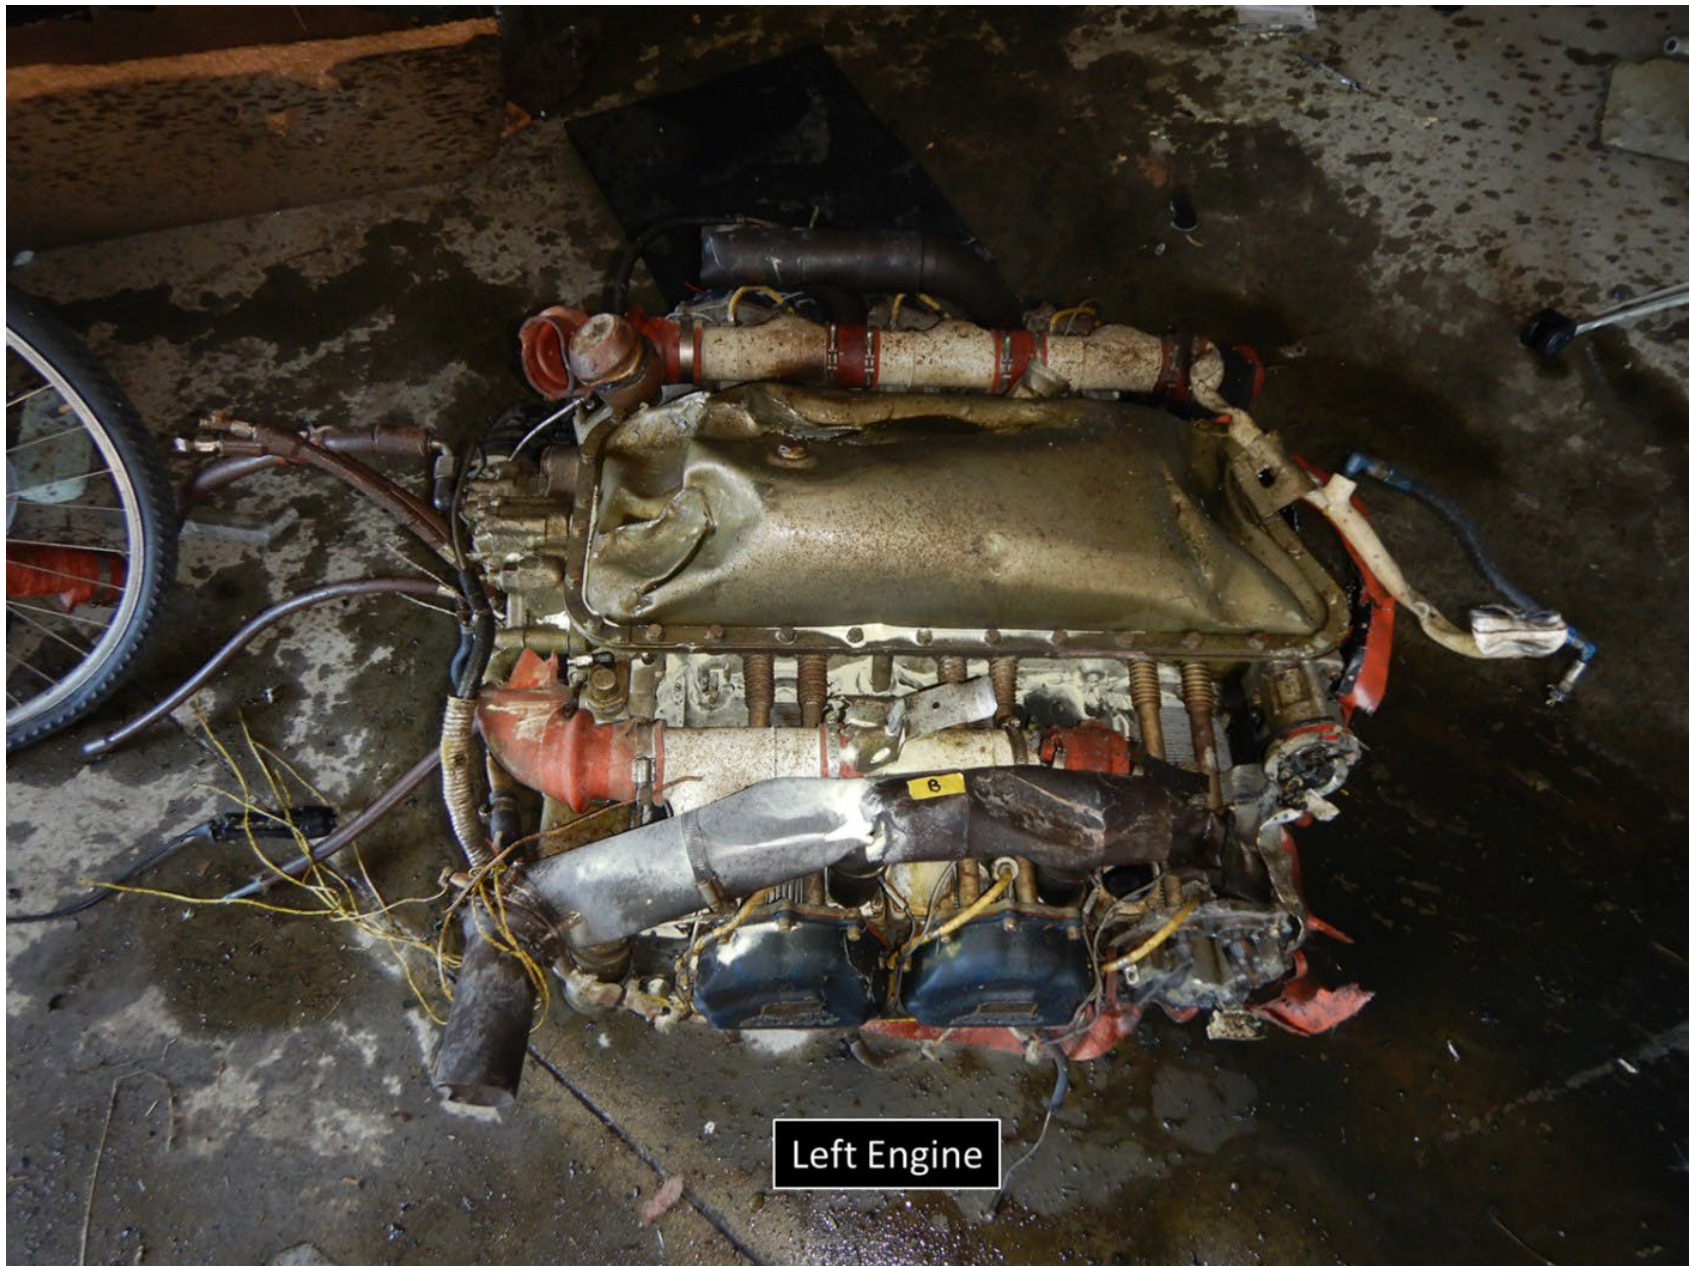
Photo 8 – Left engine.

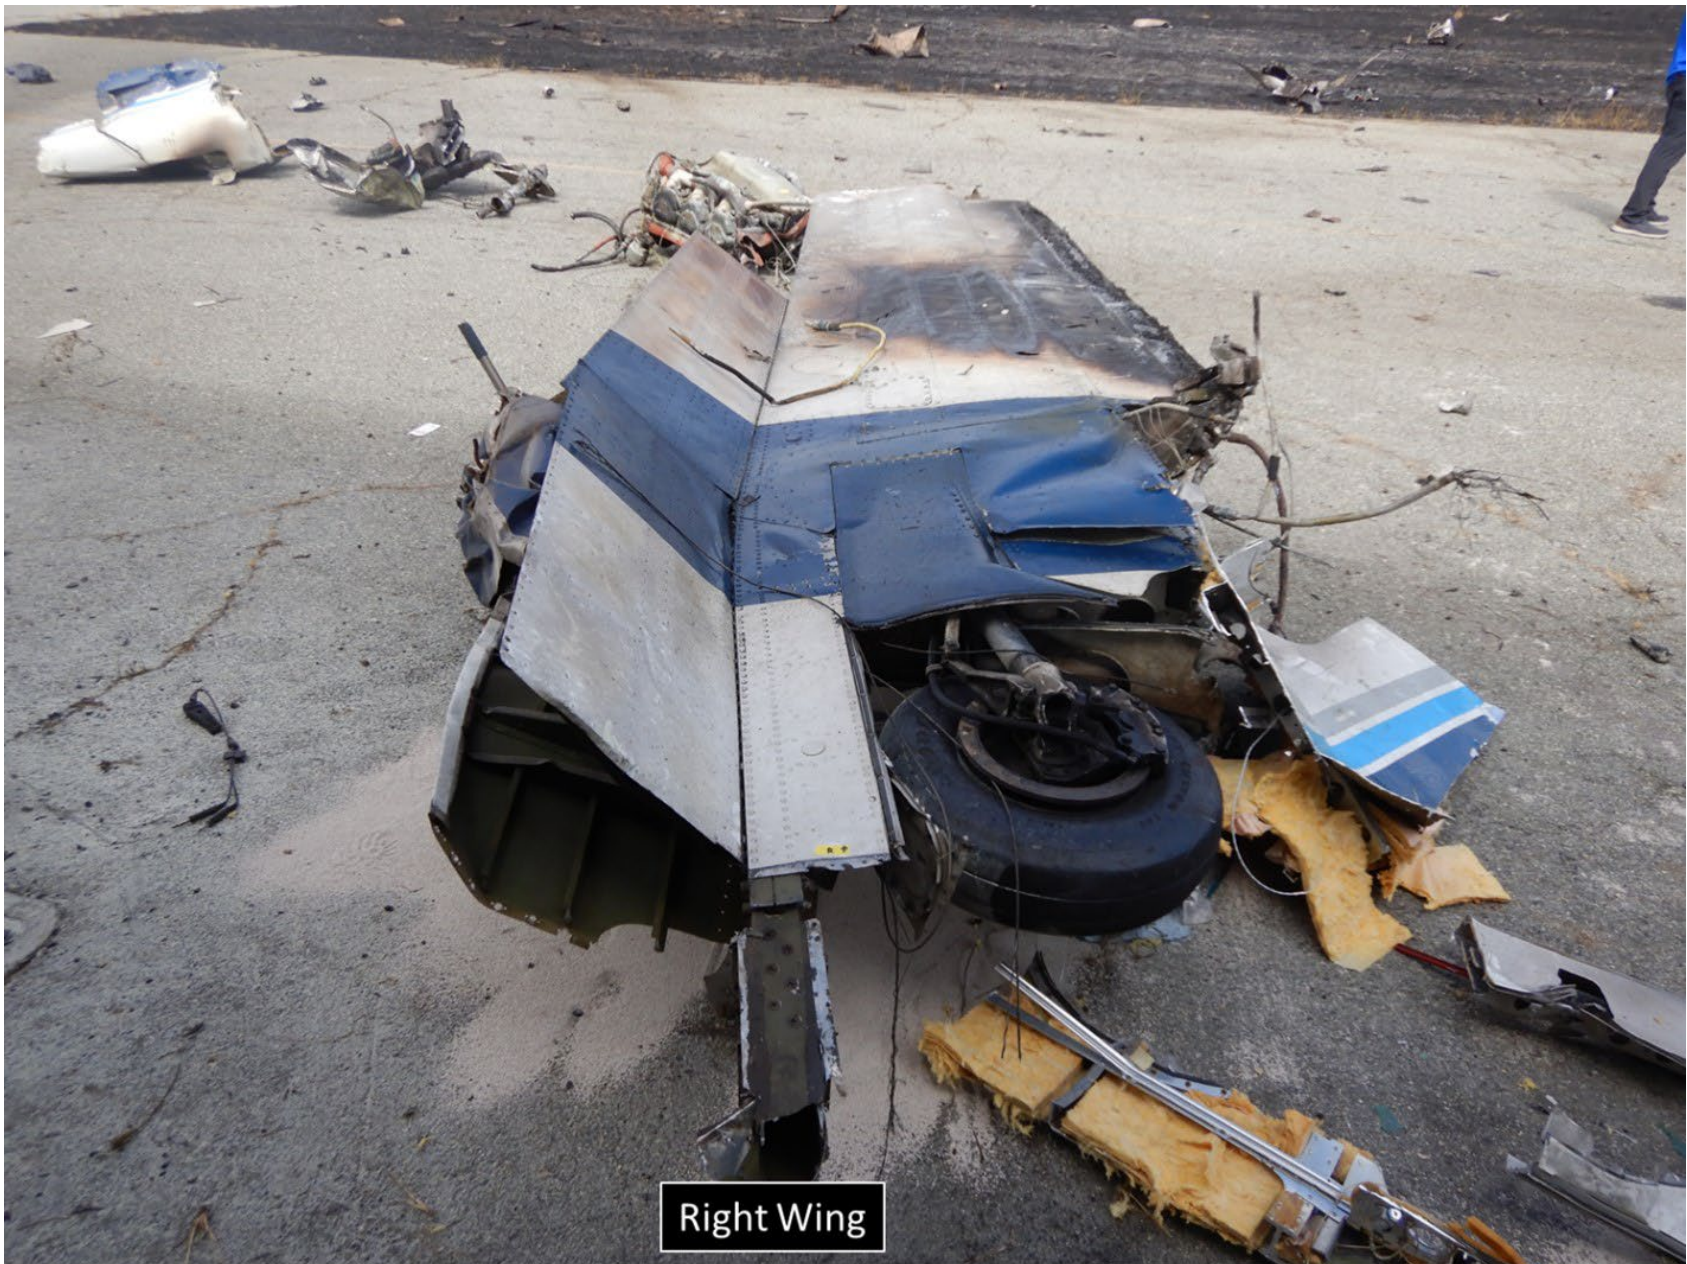
Photo 9 – Right wing.

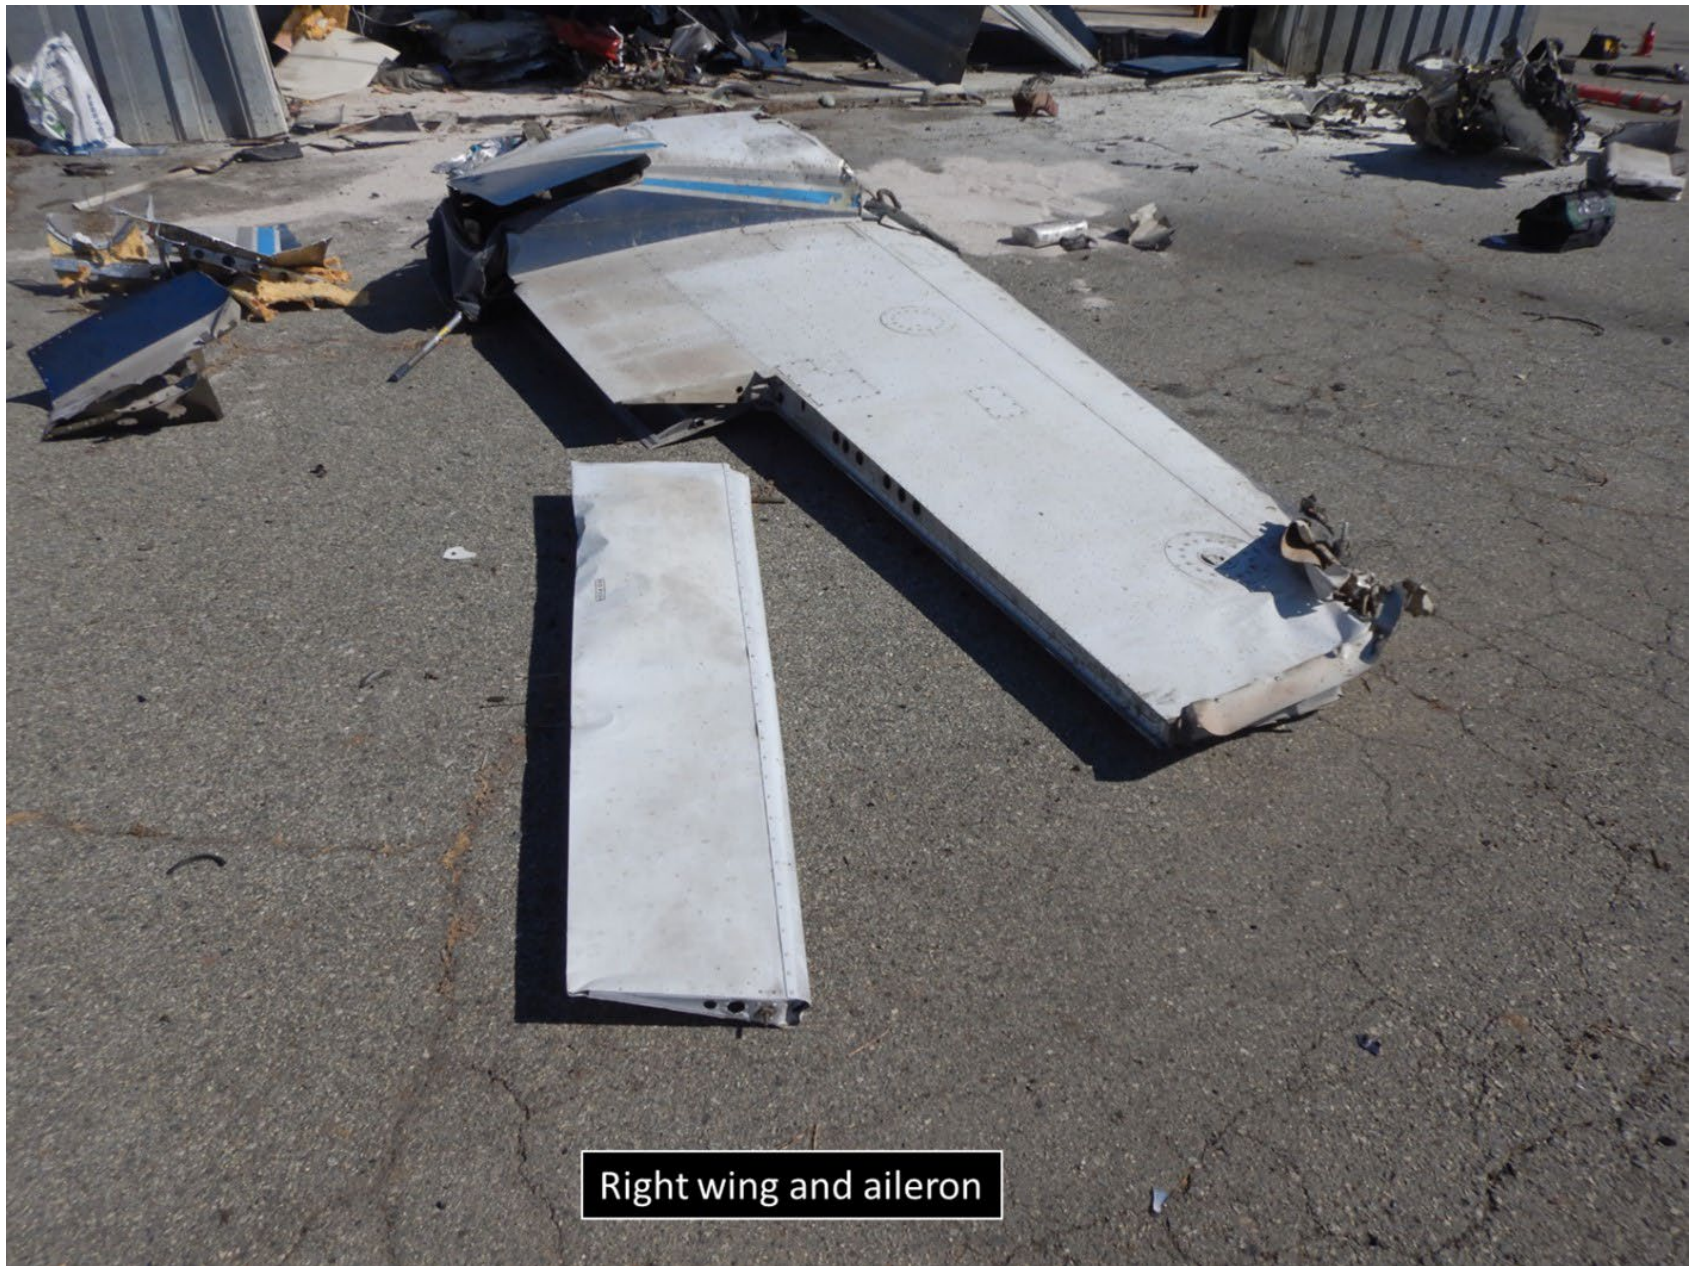
Right wing and aileron

Photo 10 – Right wing and aileron, top side.
