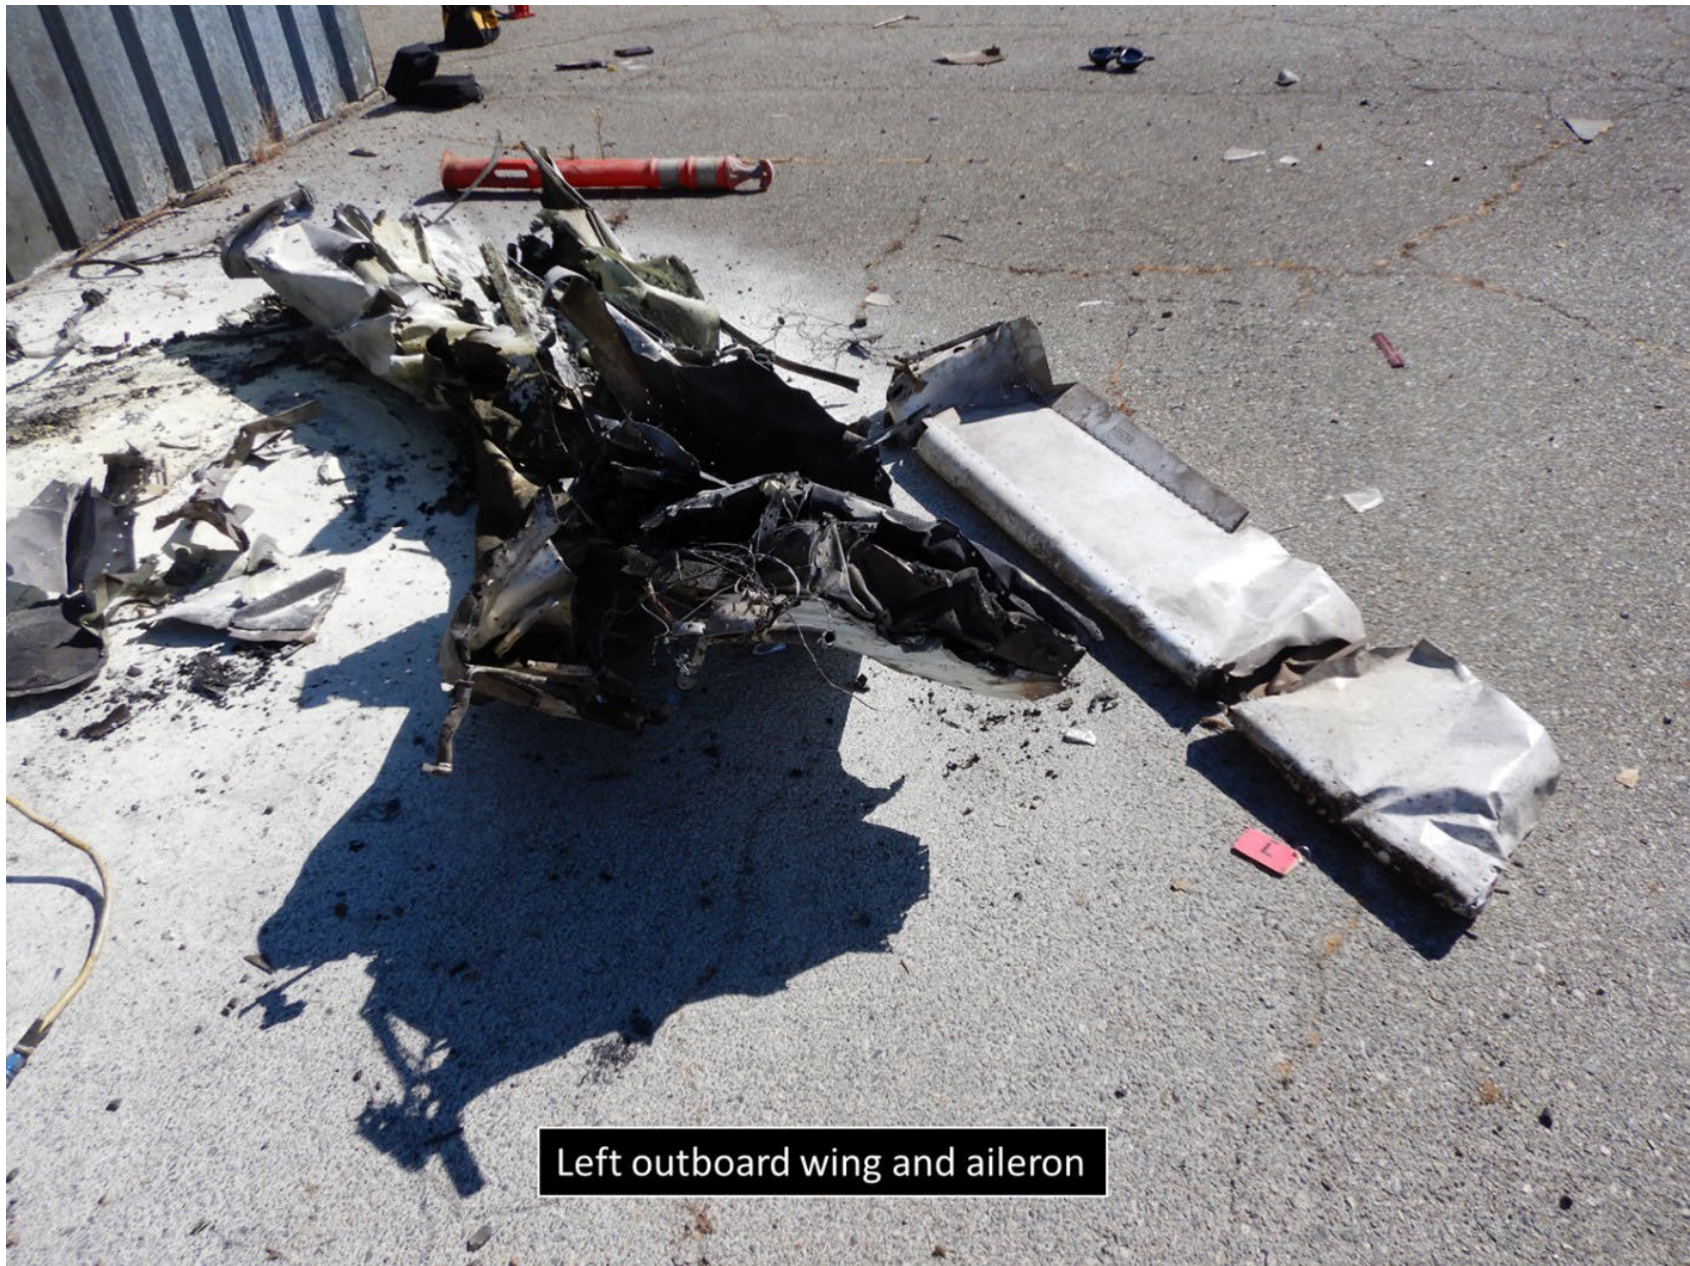
Left outboard wing and aileron

Photo 11 – Left wing and aileron.

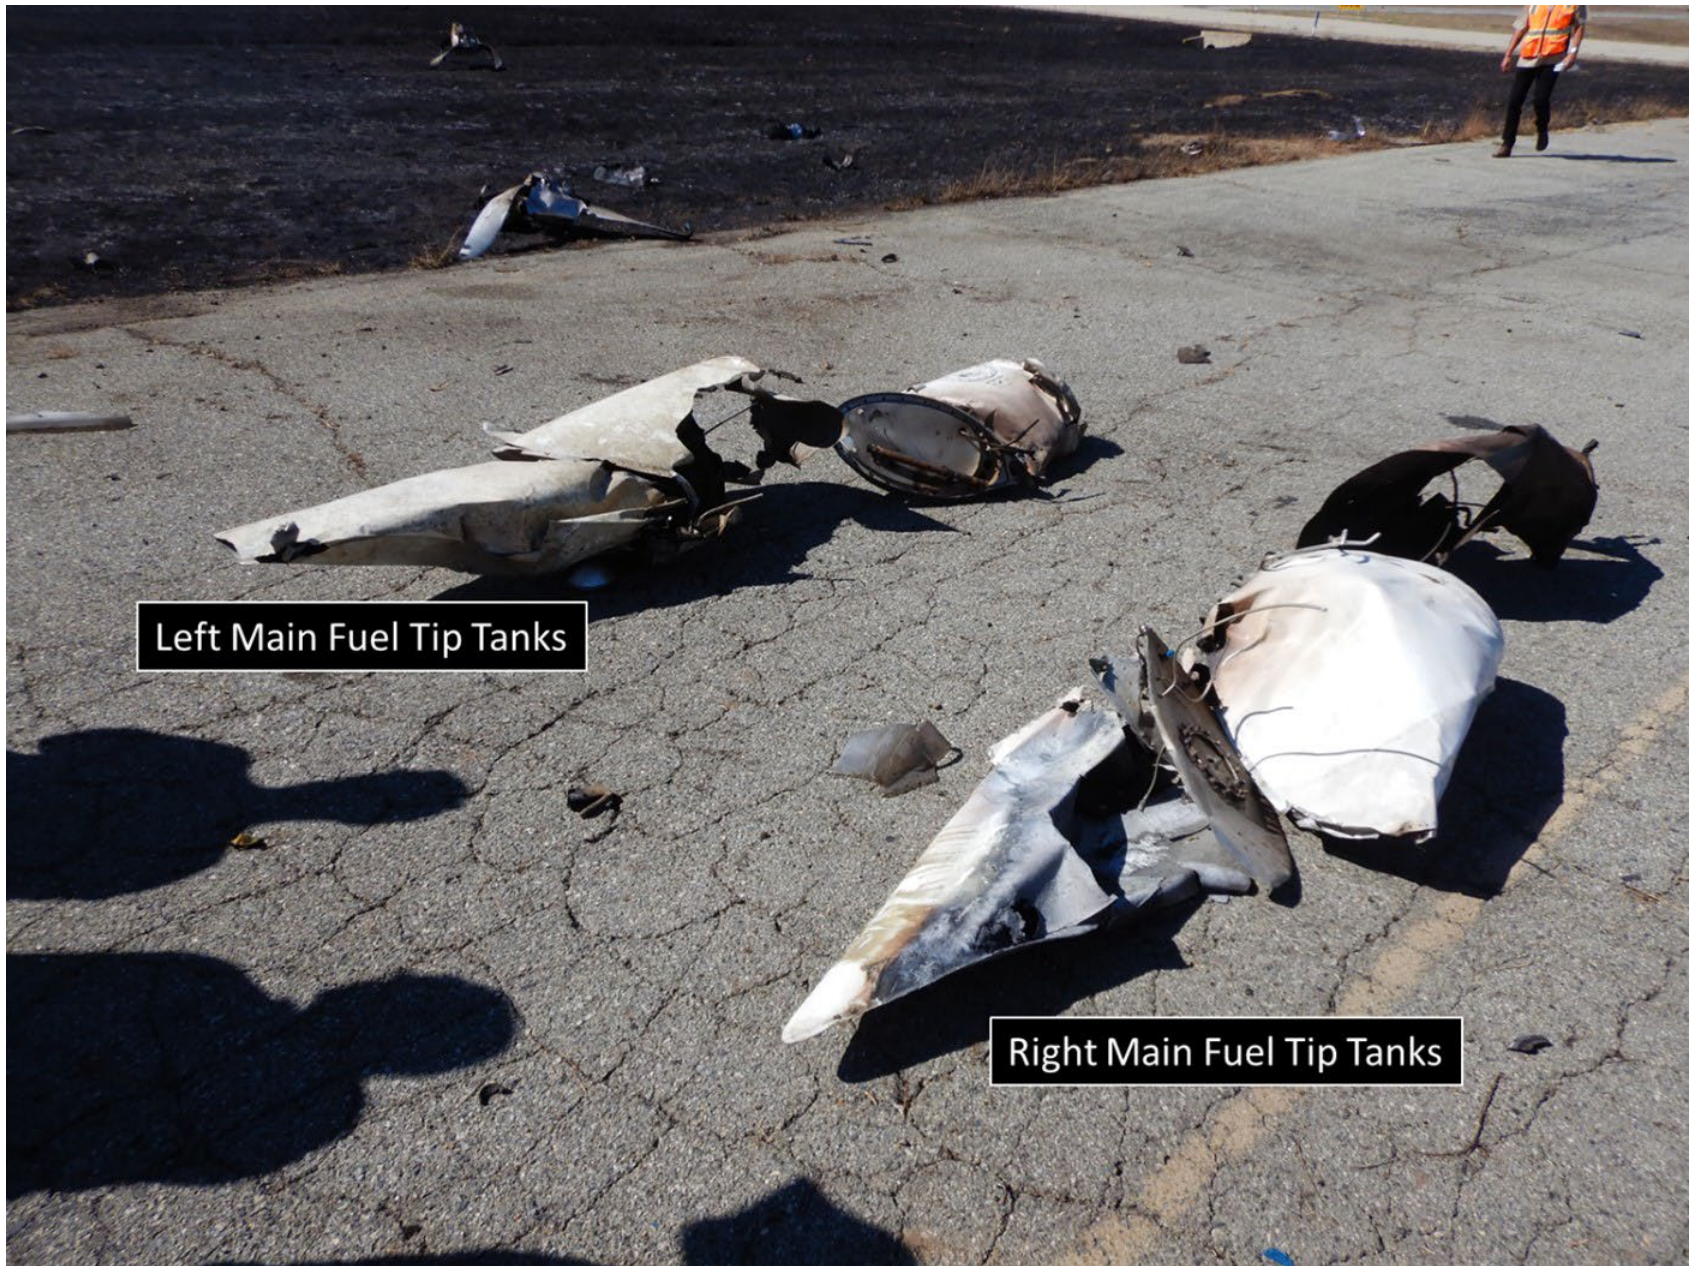
Left Main Fuel Tip Tanks

Right Main Fuel Tip Tanks

Photo 12 – Fuel tanks

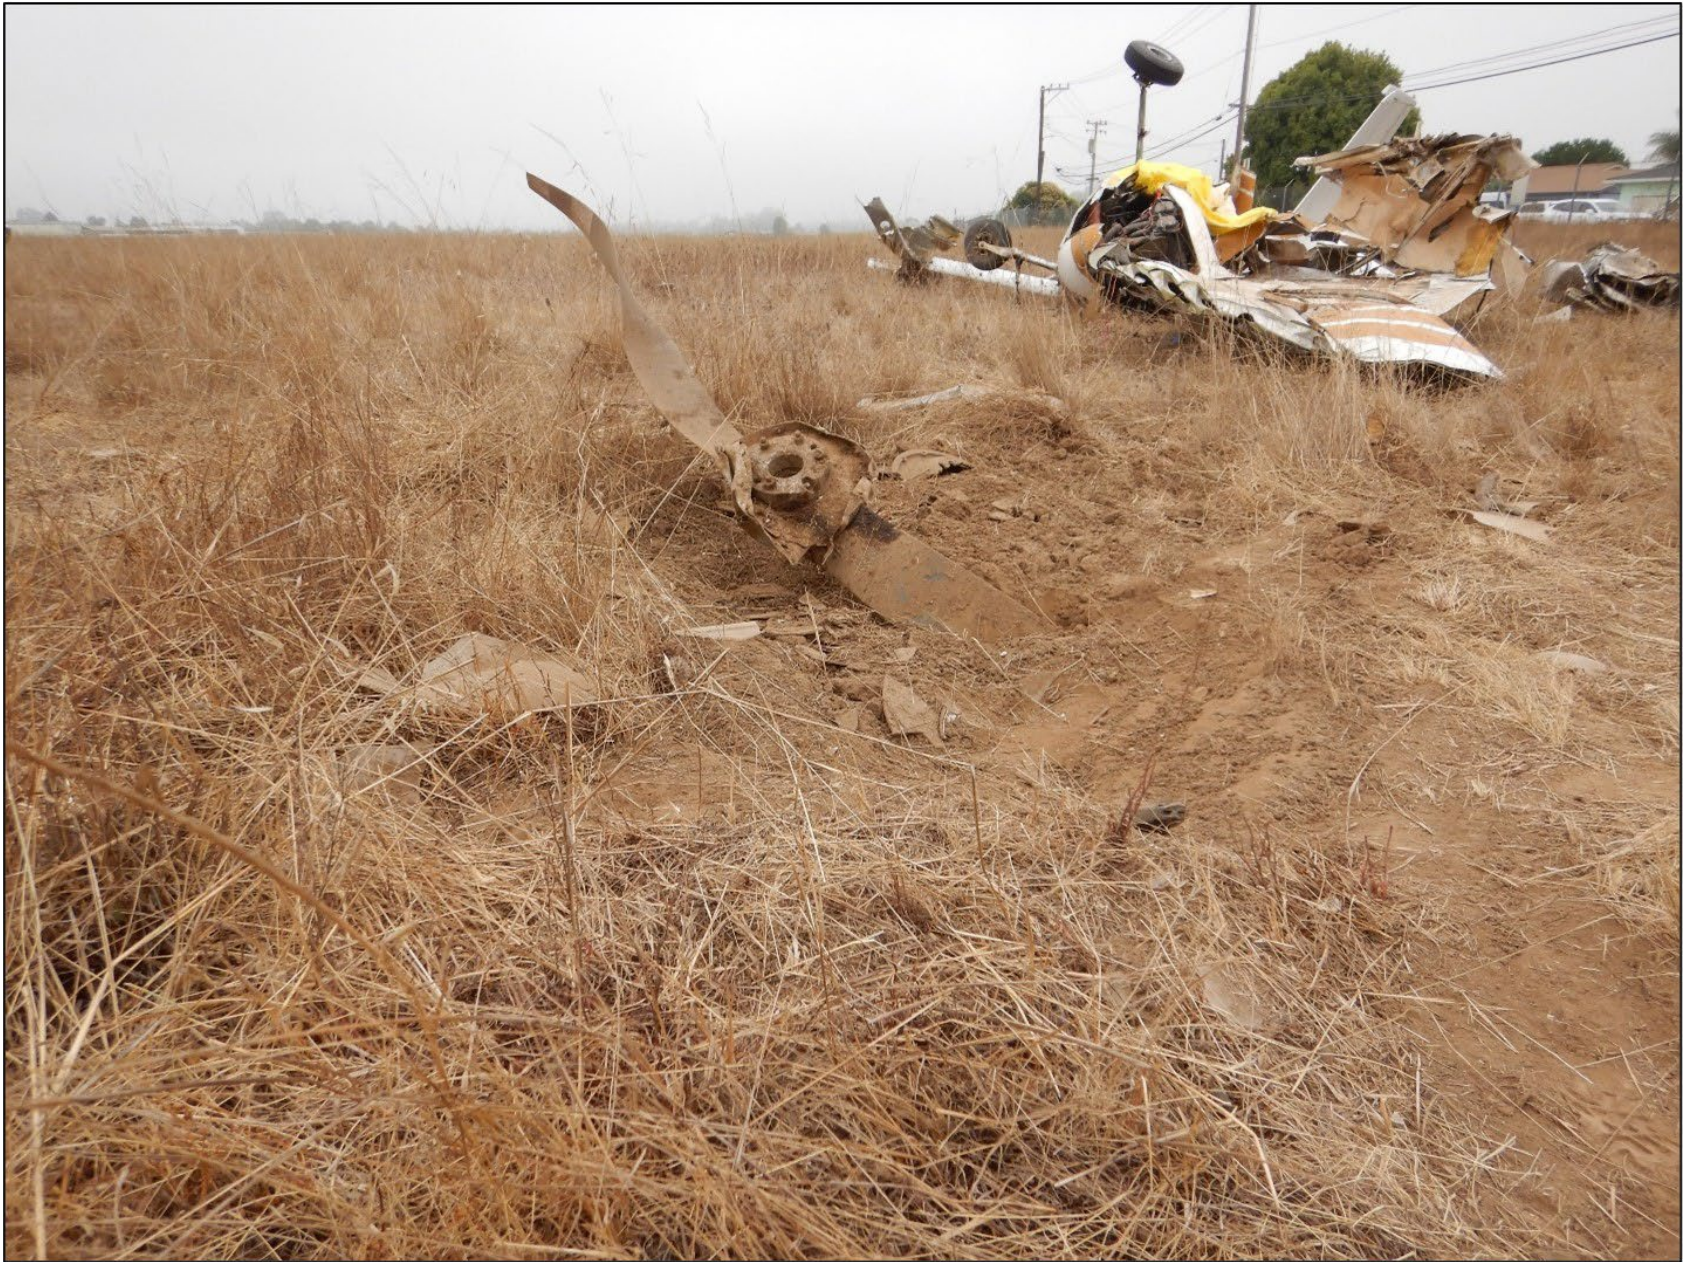
Photo 13 – N49931 at its accident location.

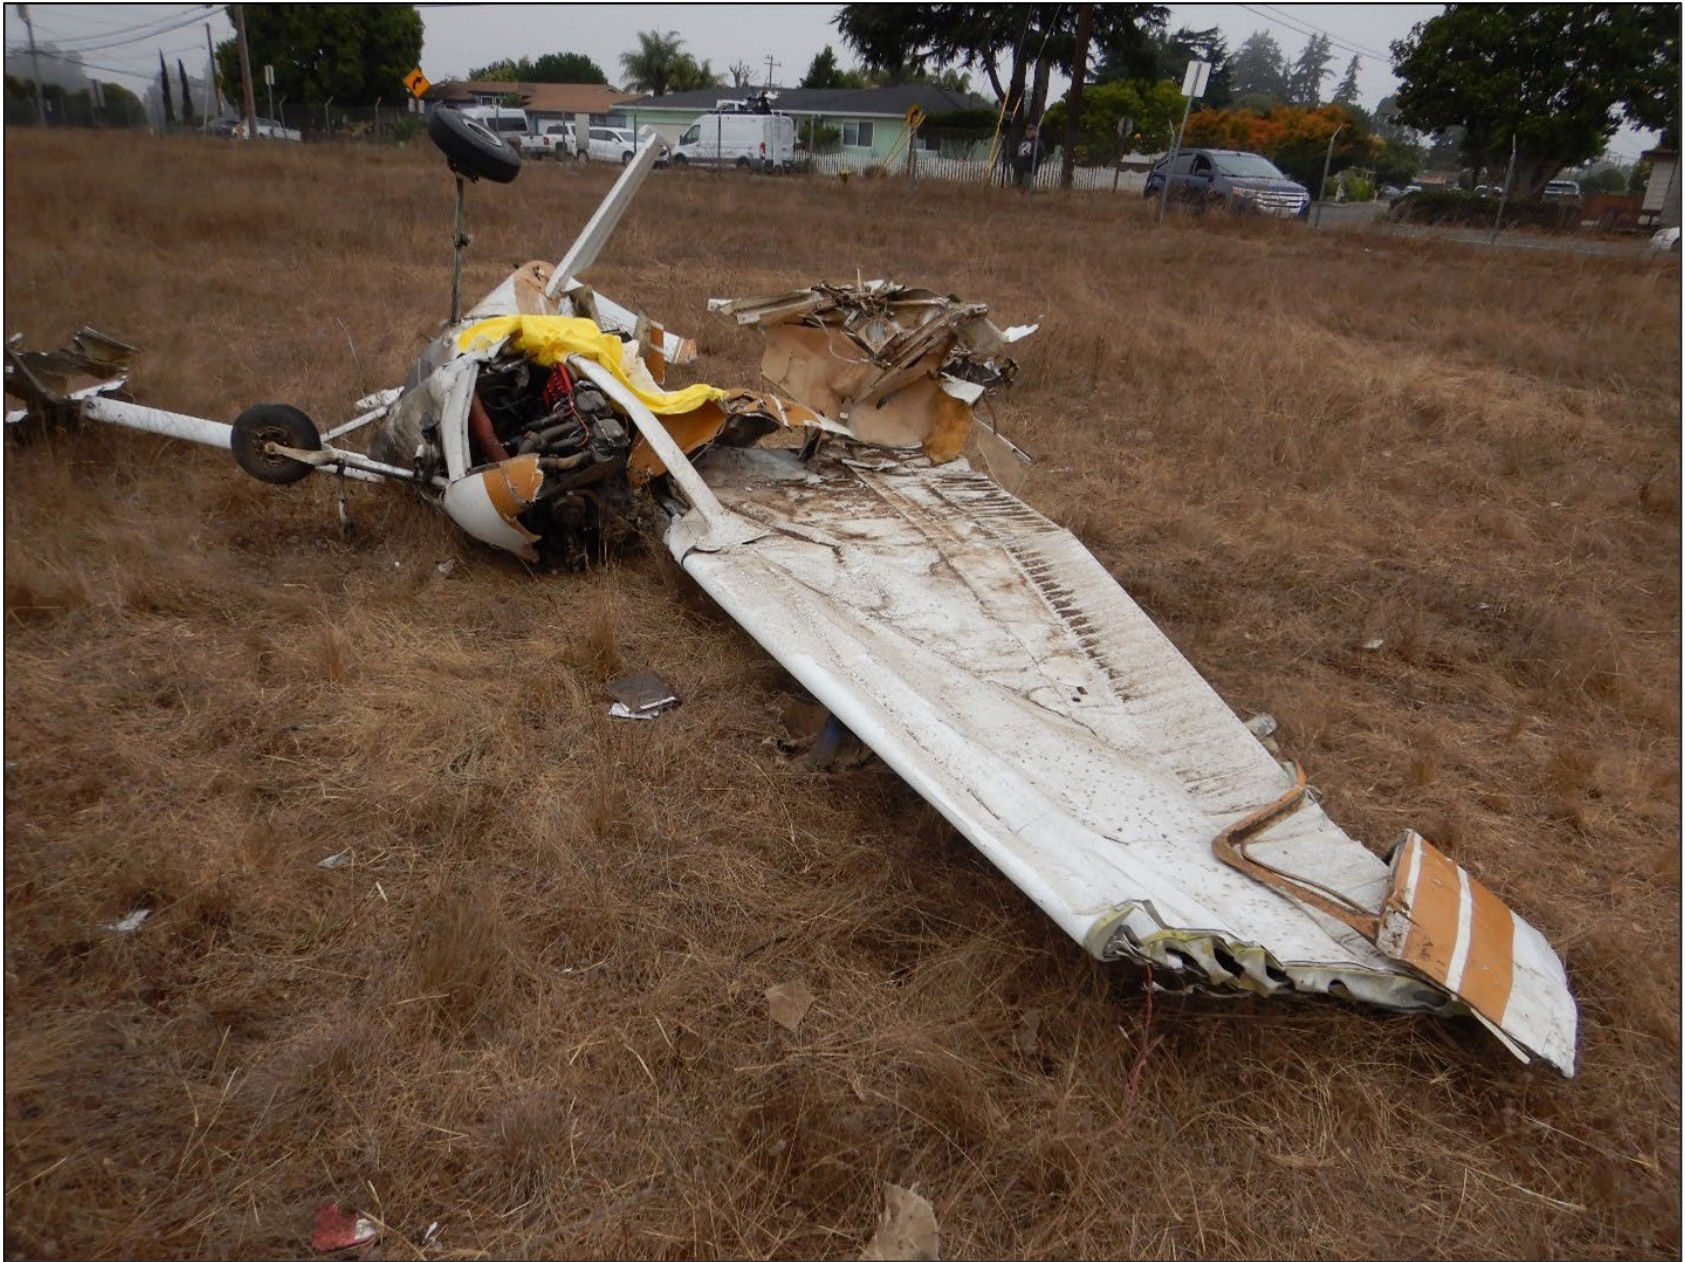
Photo 14 – Right wing.

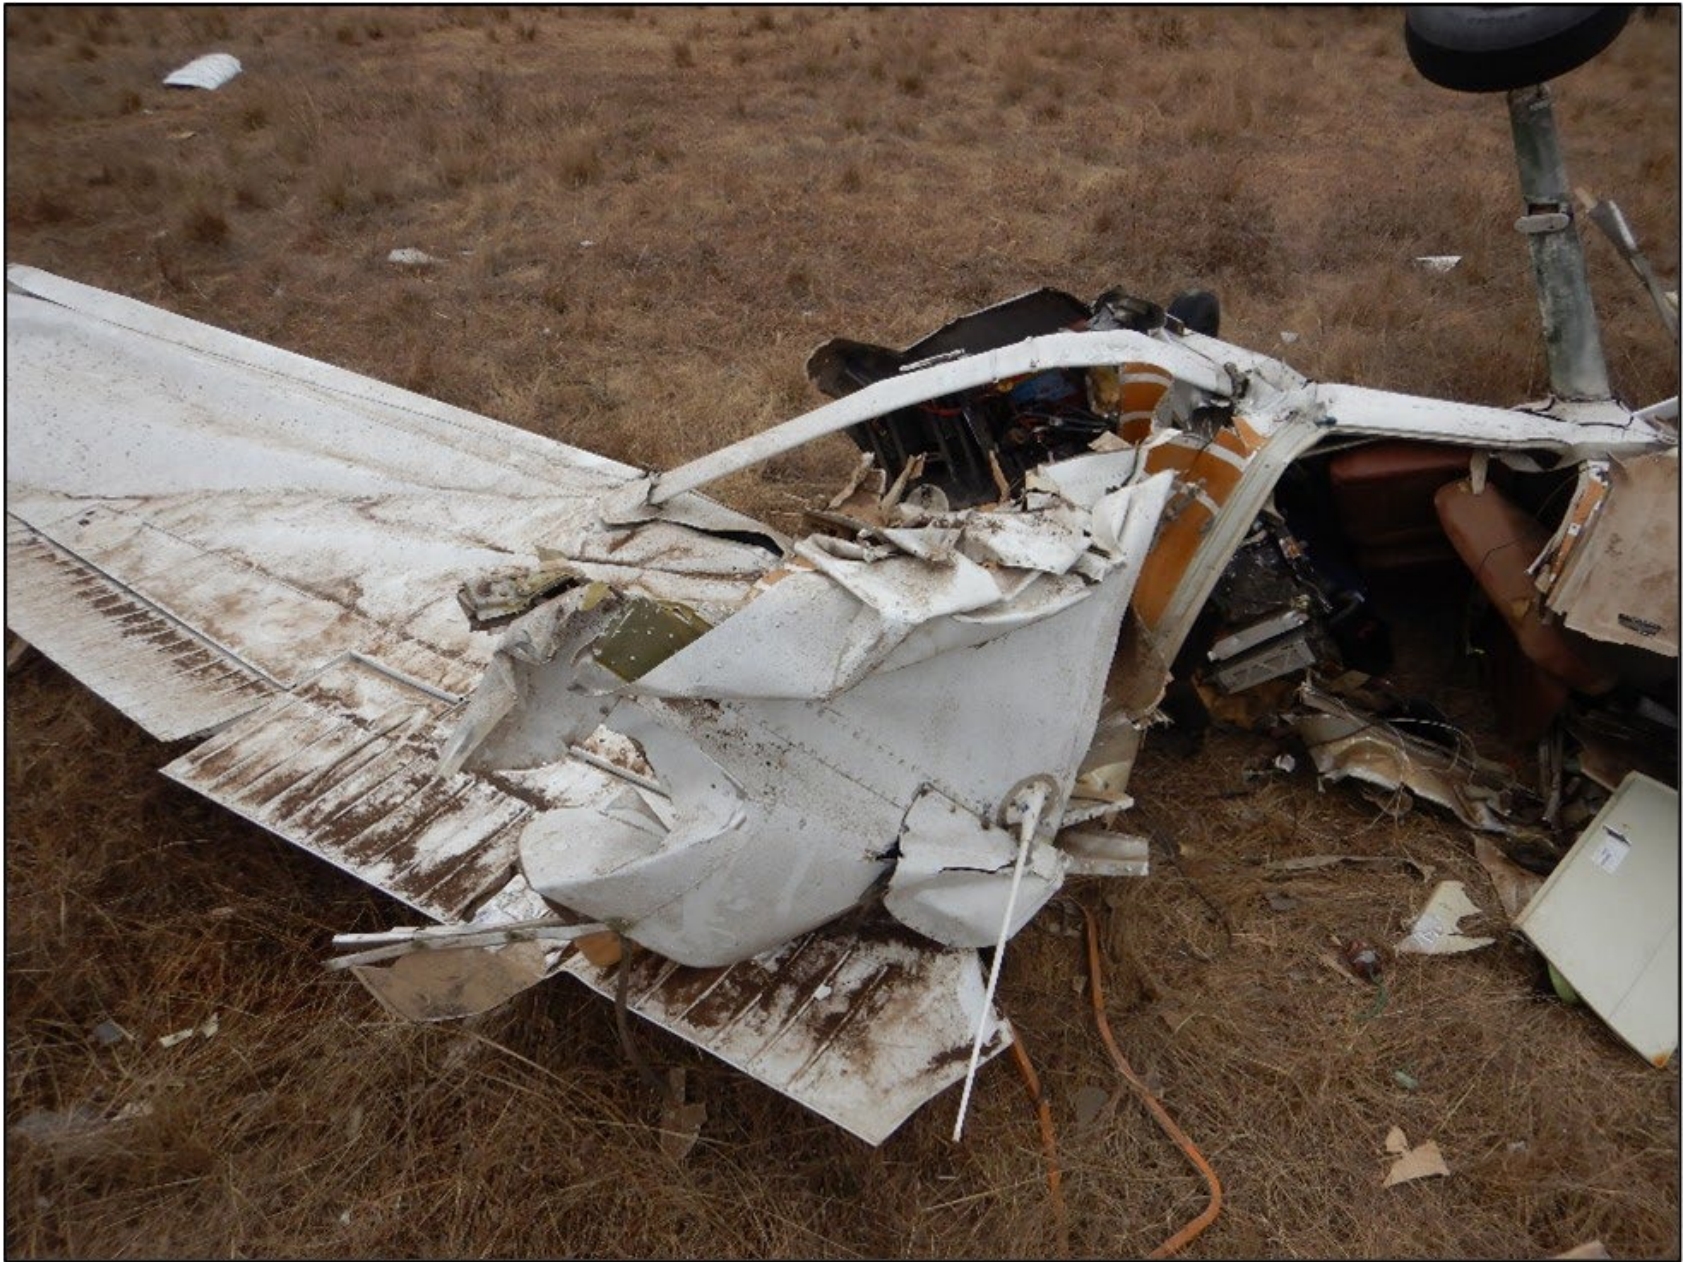
Photo 15 – Right wing, rear view.

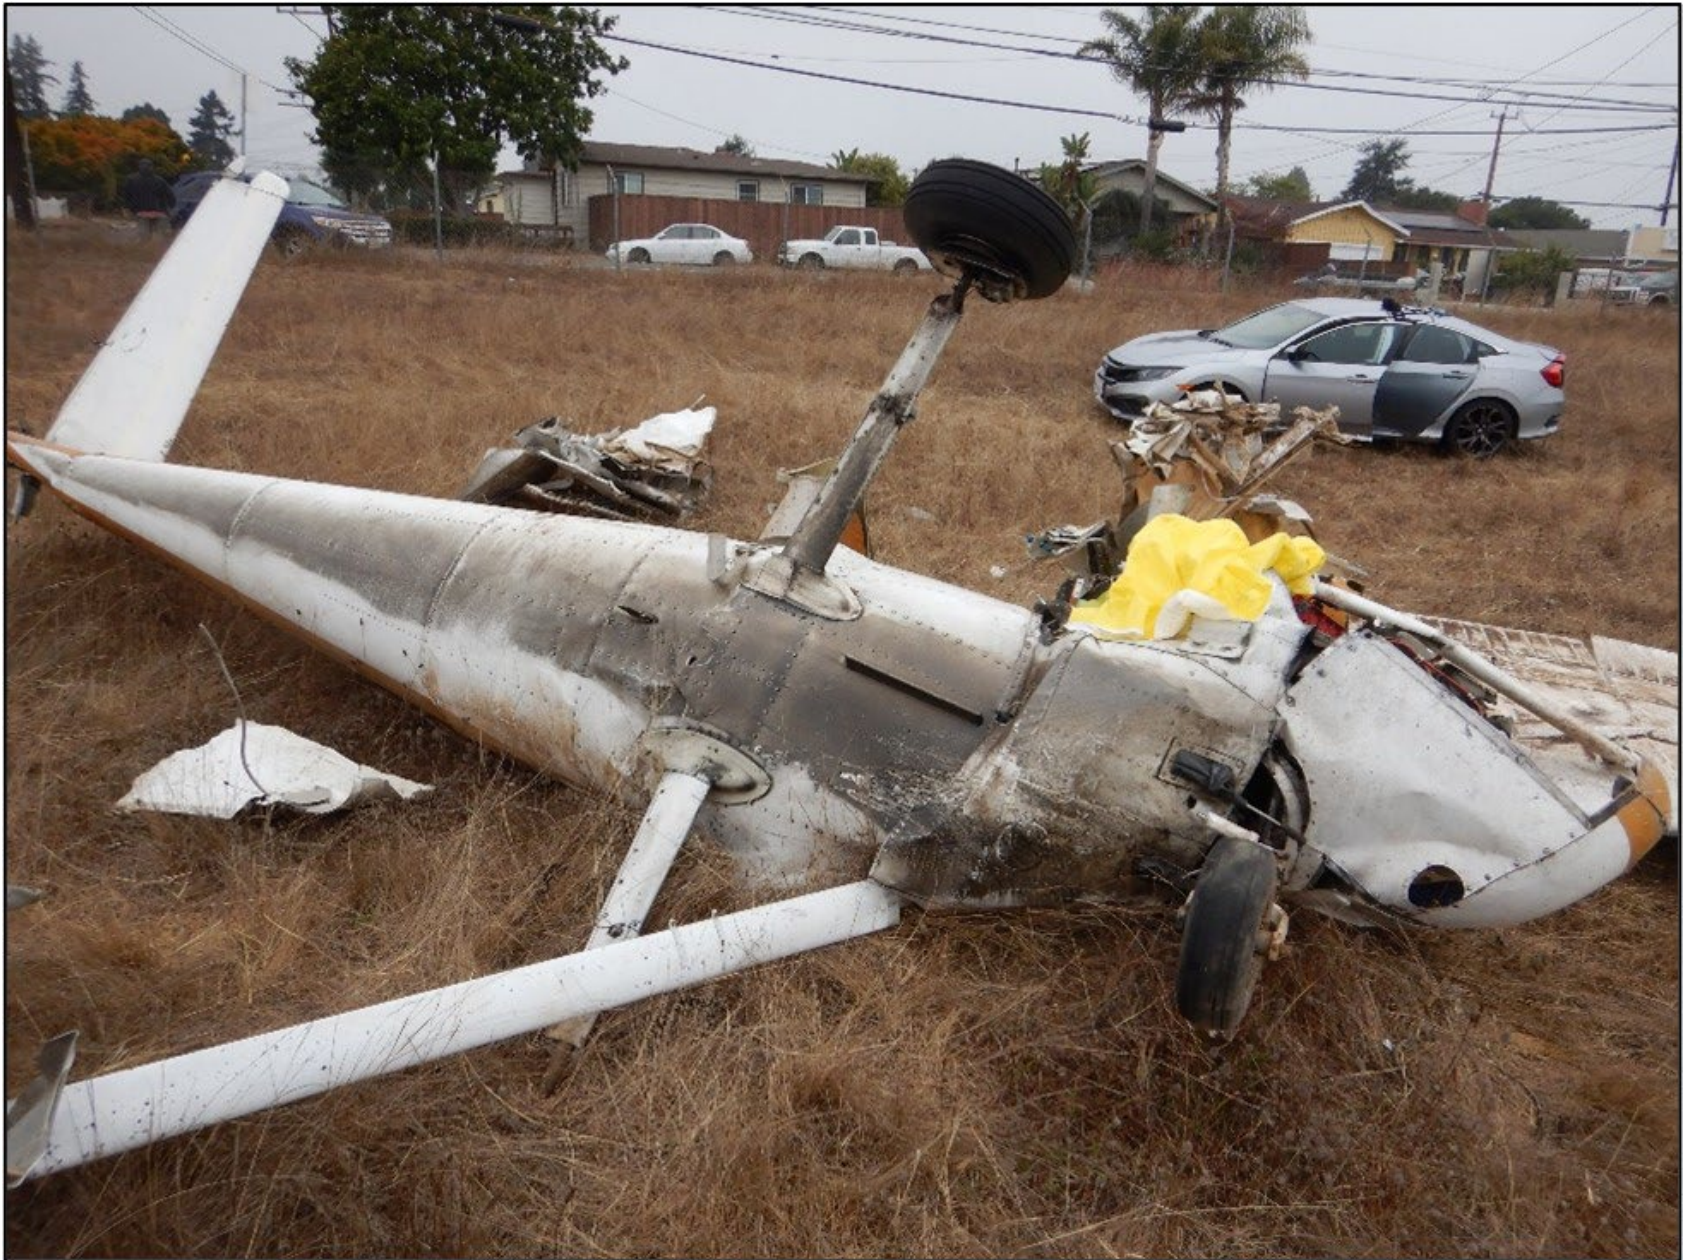
Photo 16 - Underside

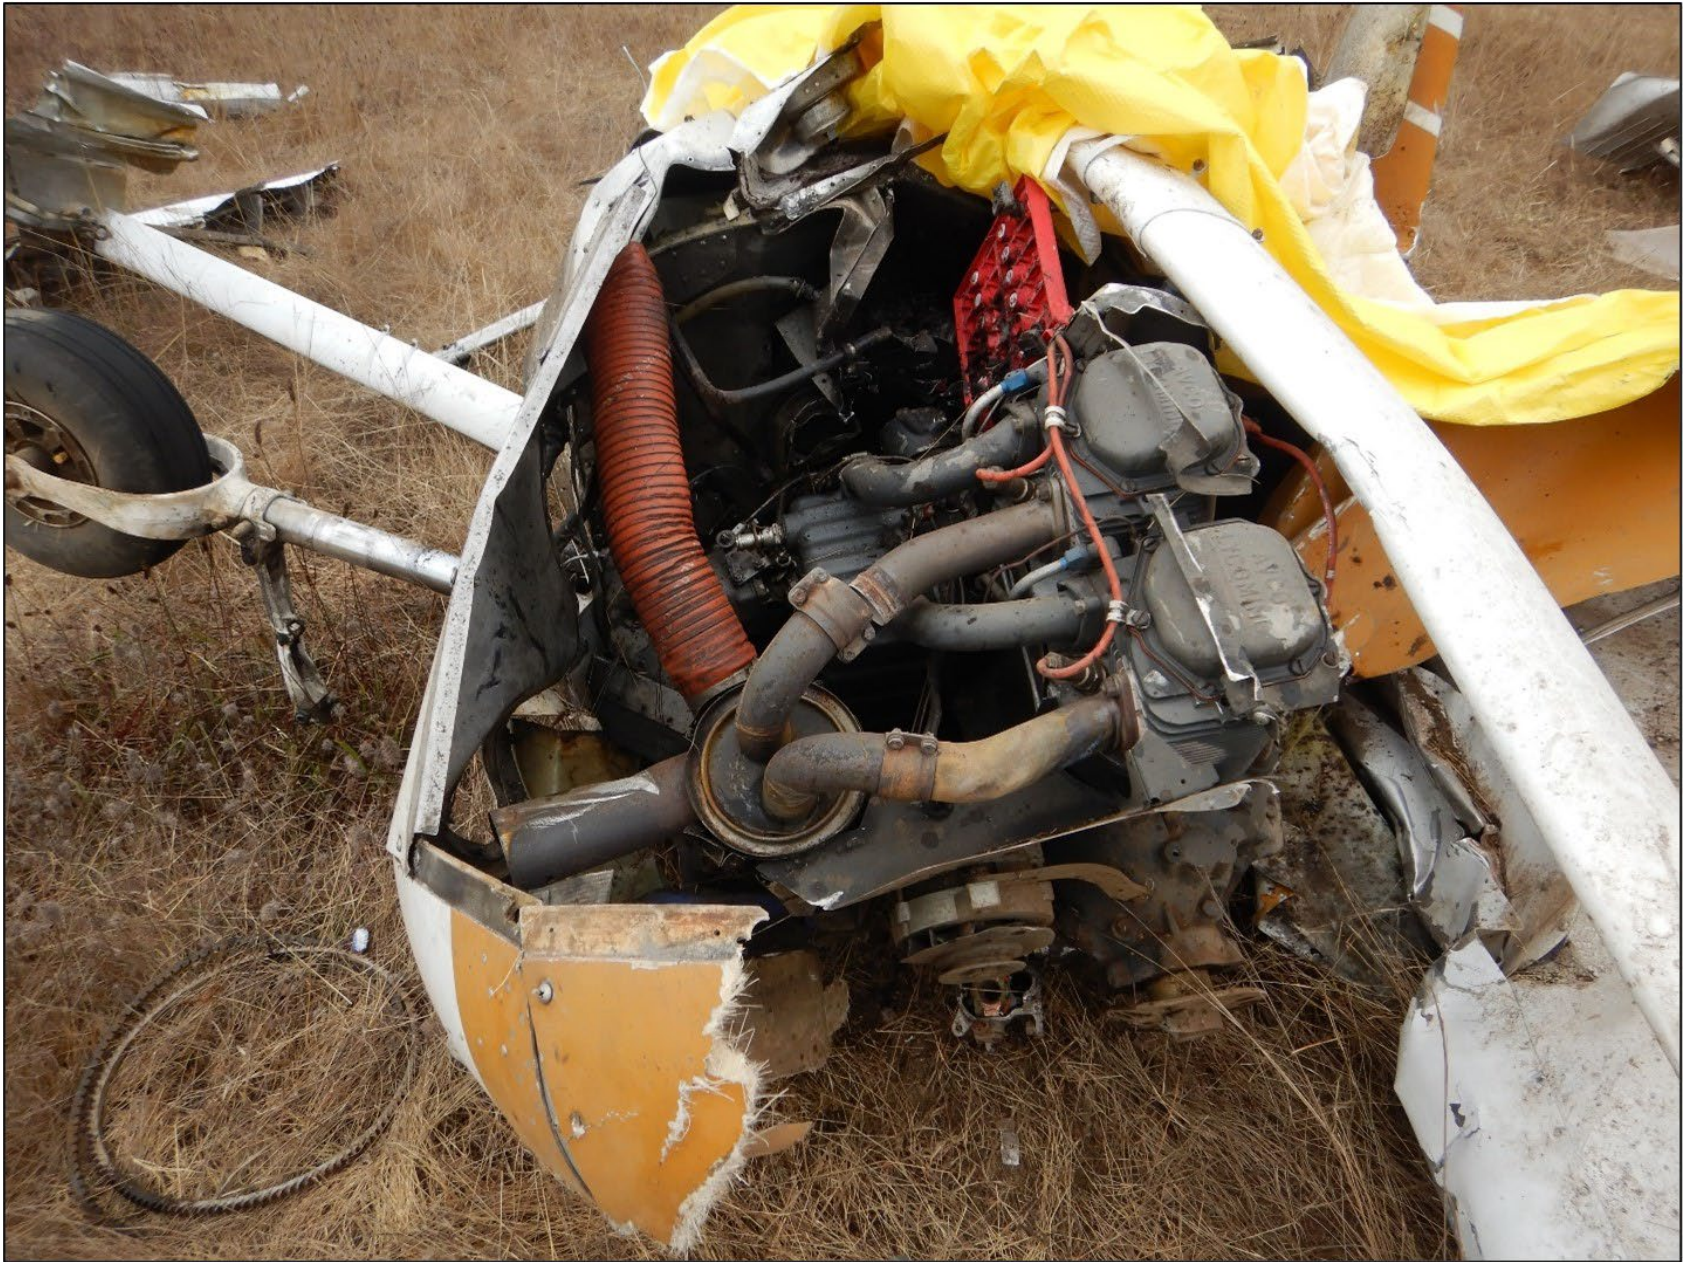
Photo 17 – Engine.

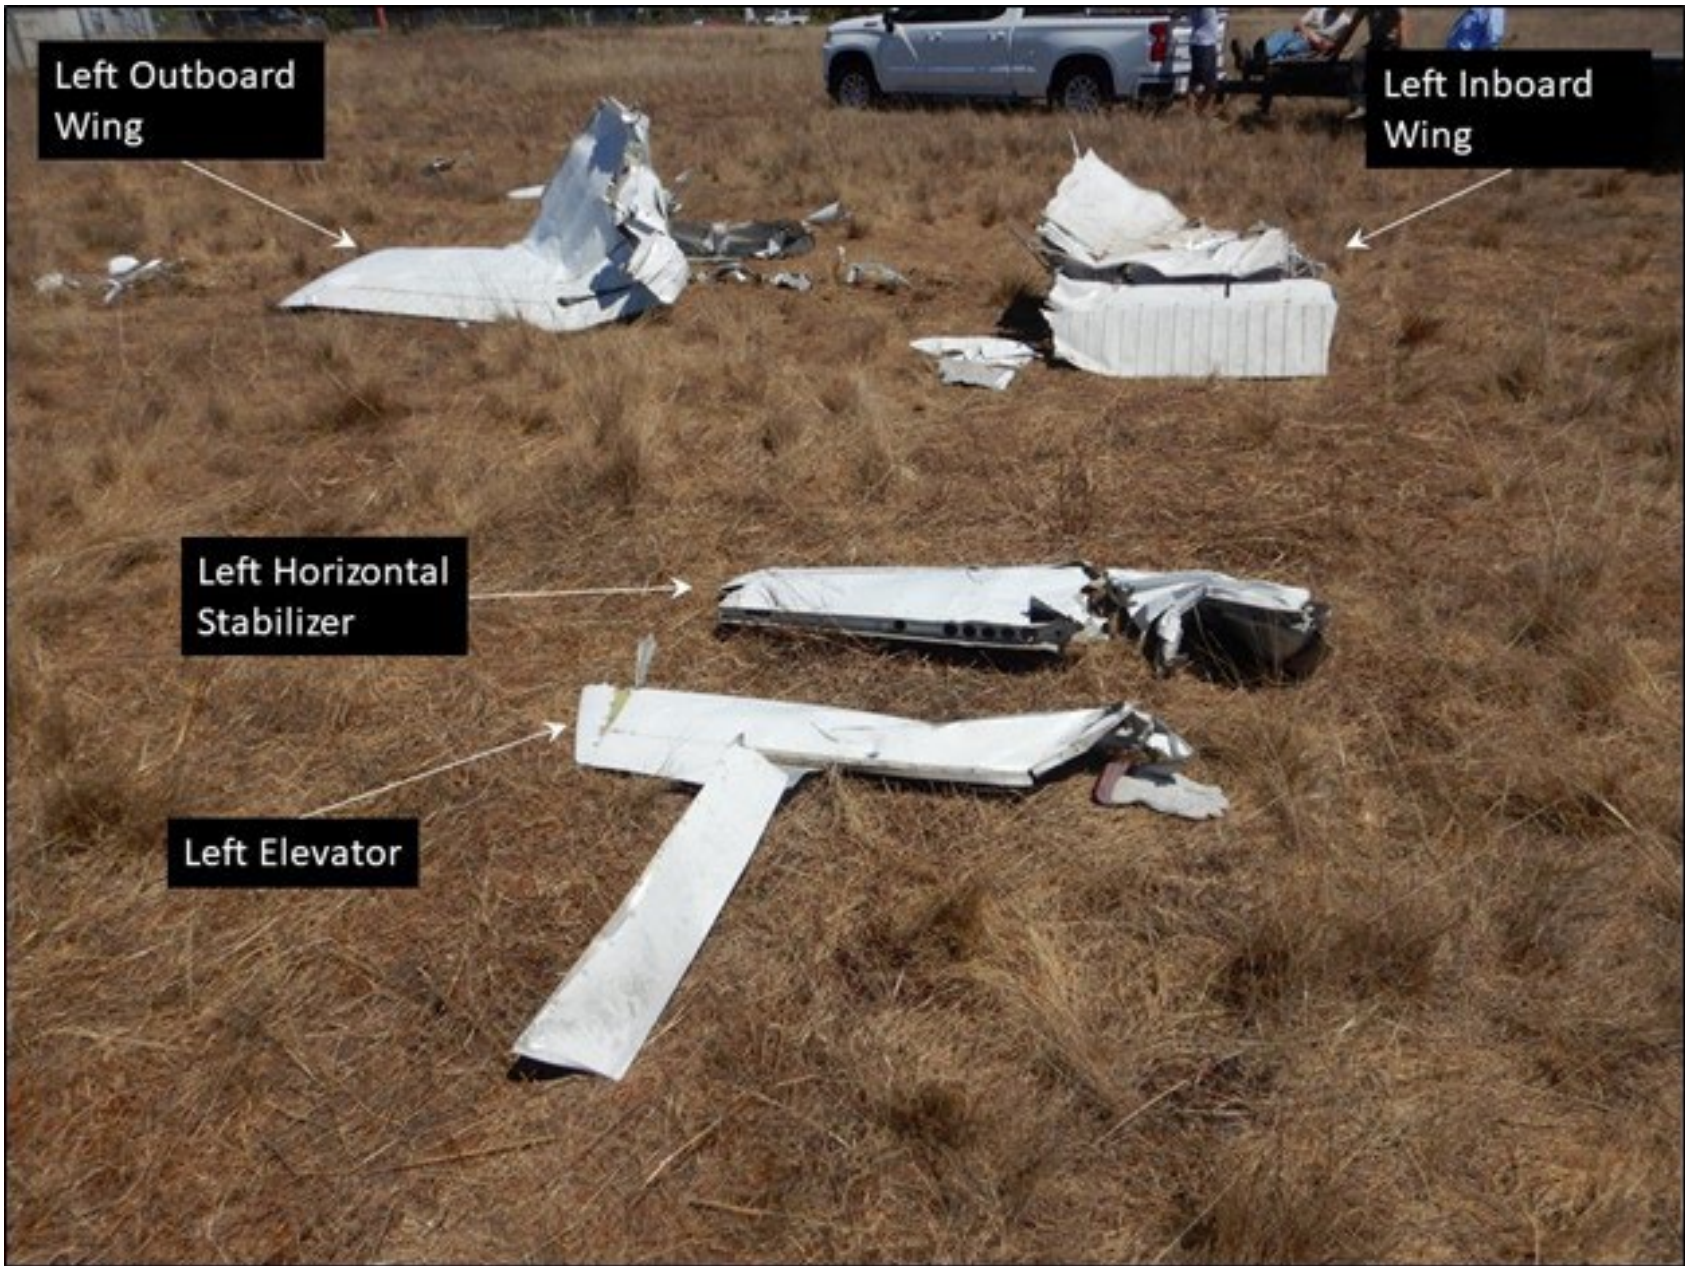
Photo 18 – Layout of the left wing, left horizontal stabilizer, and elevator

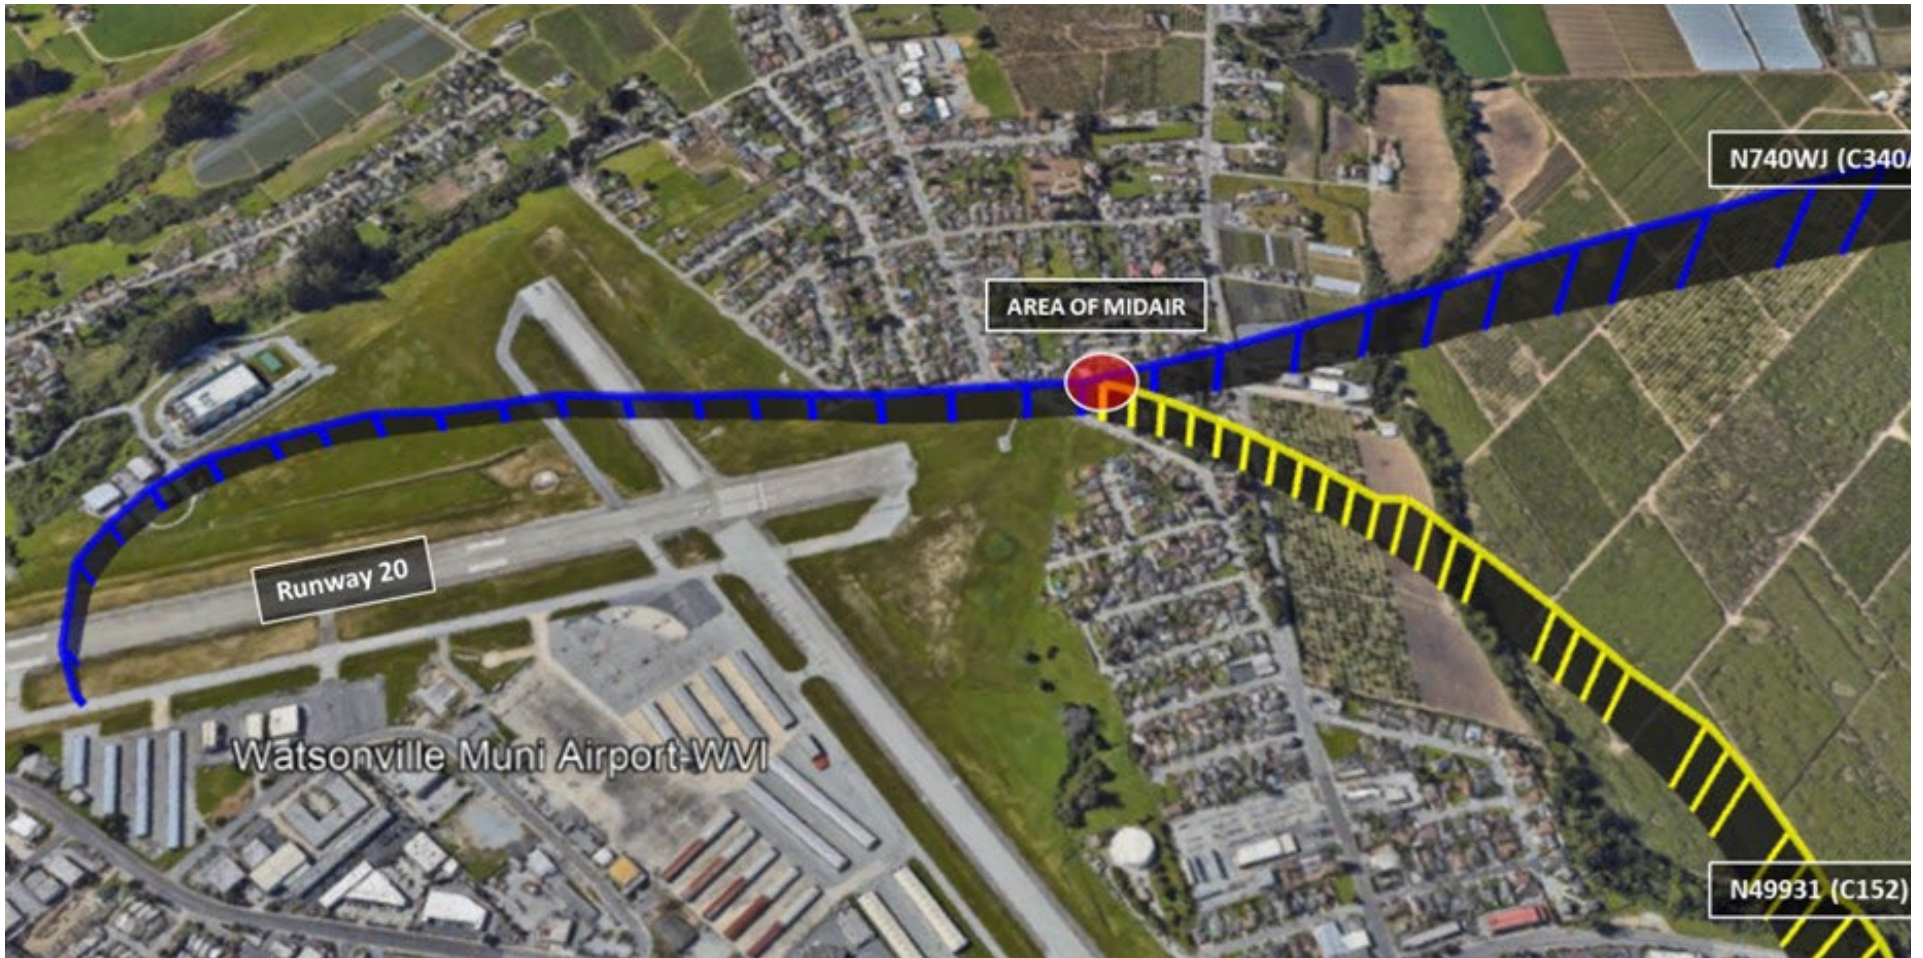
Photo 19 – Google Earth image with ADS-B data.

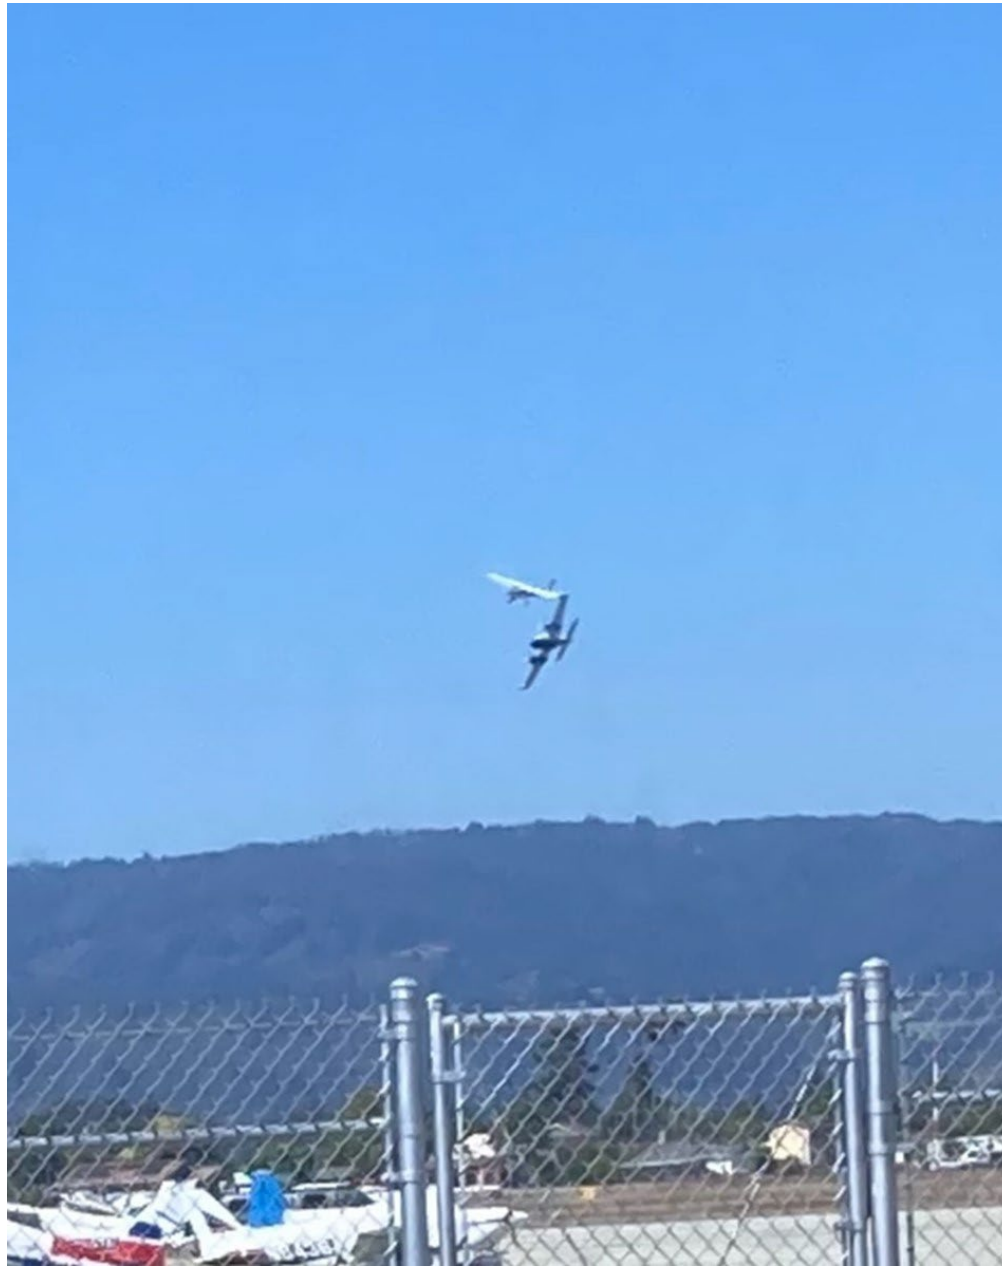
Photo 20 – Witness photo of airplanes before midair.
