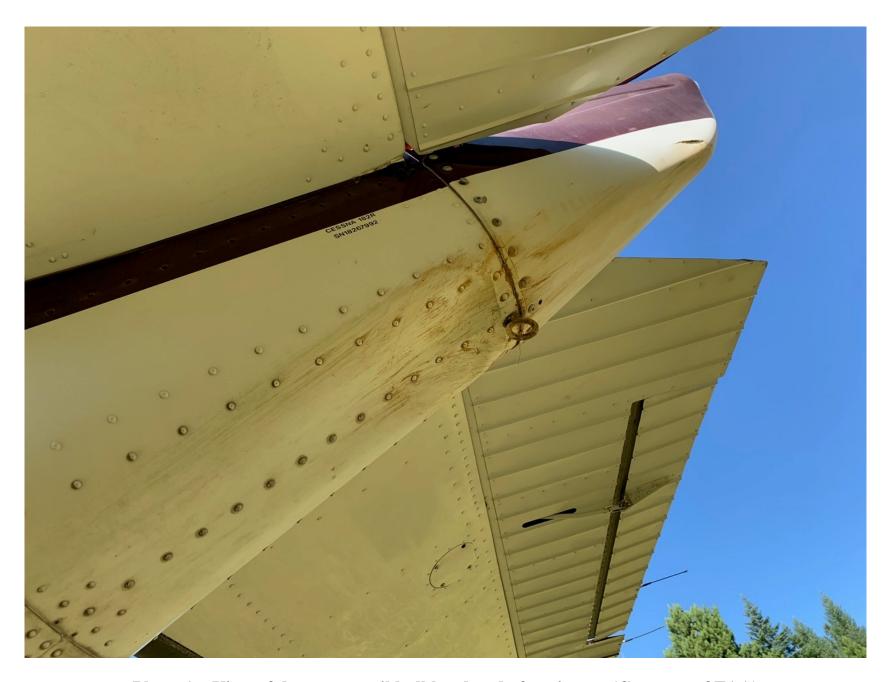
Photo 1 – View of damage to tail bulkhead and aft stringers (Courtesy of FAA)

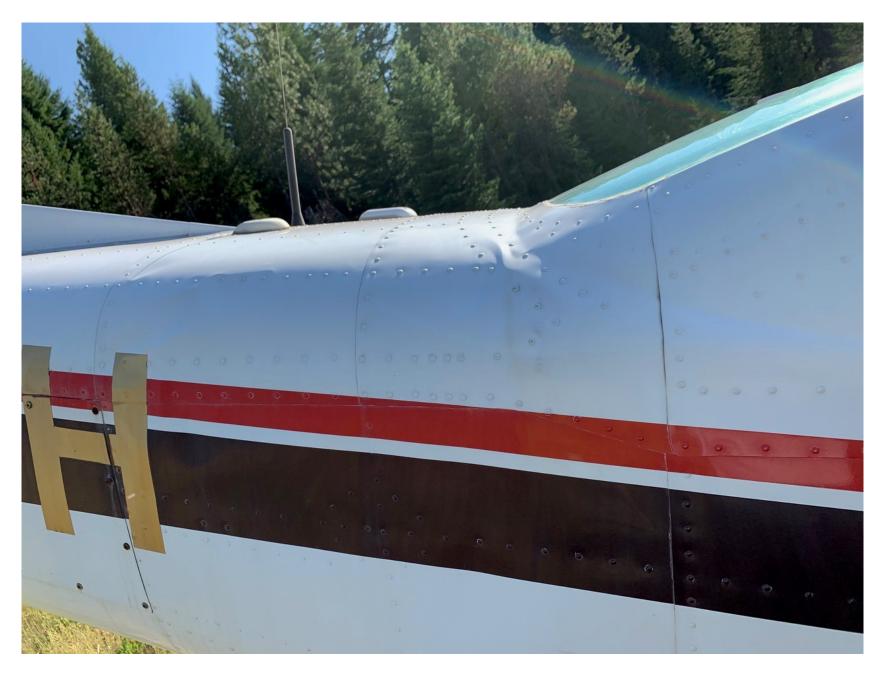
Photo 2- View of damage to the aft fuselage (Courtesy of FAA)
