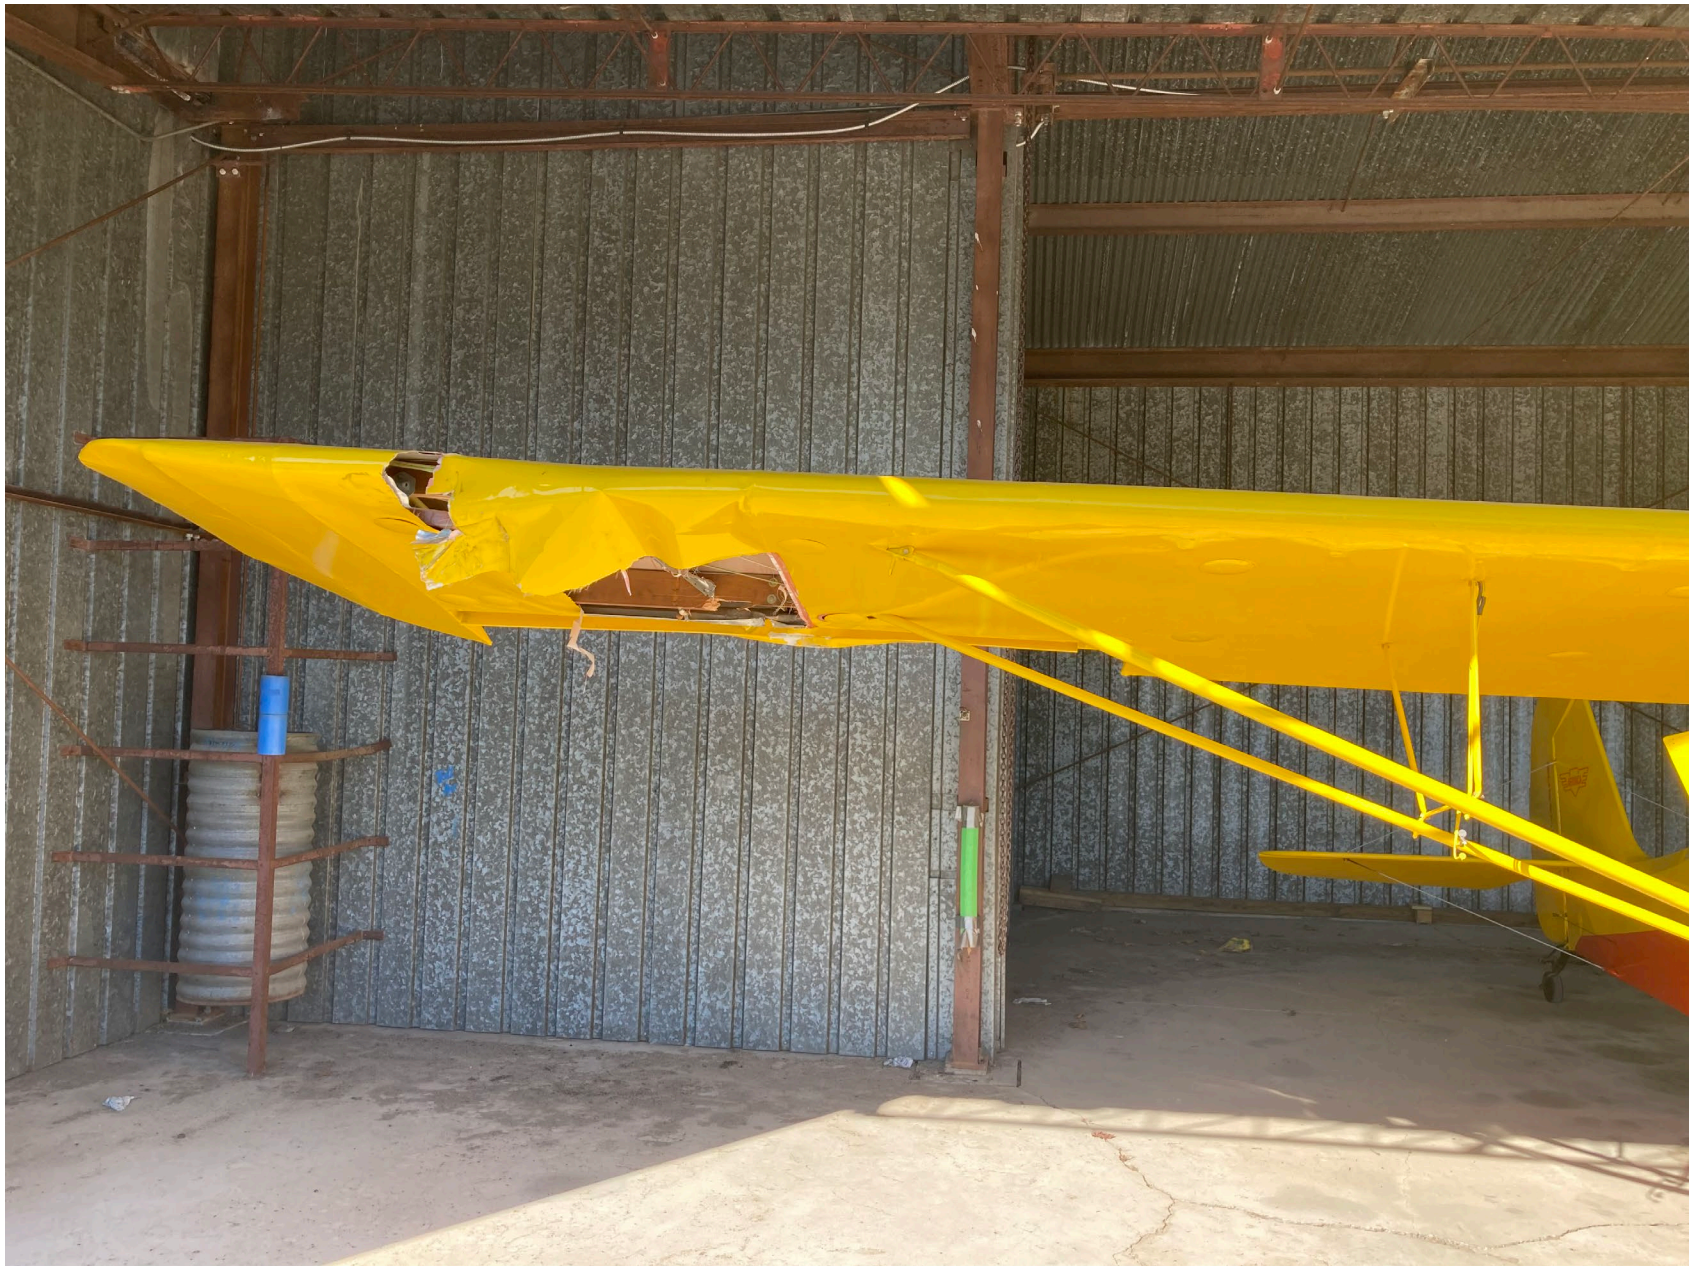
**Photo 1 – Right wing leading edge**

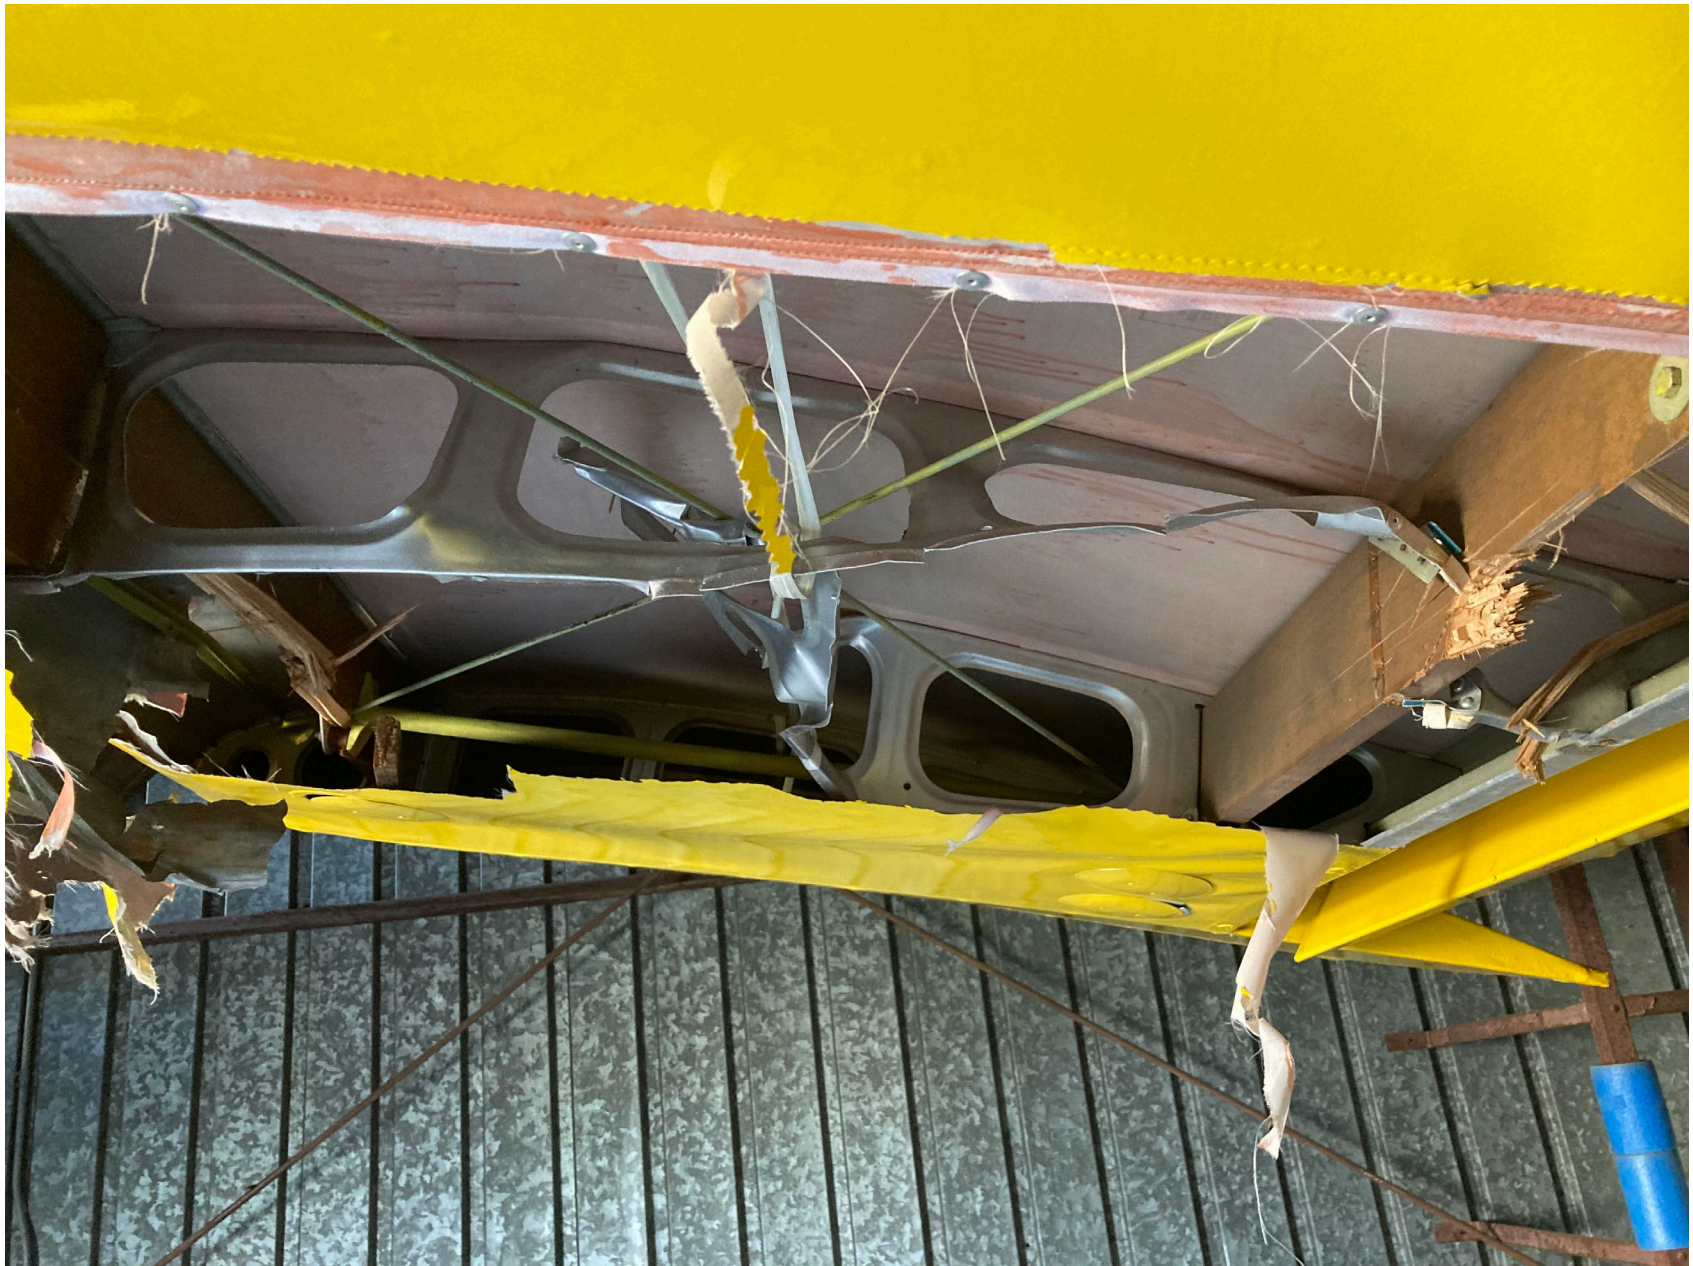
**Photo 2 – Right wing internal damage**
