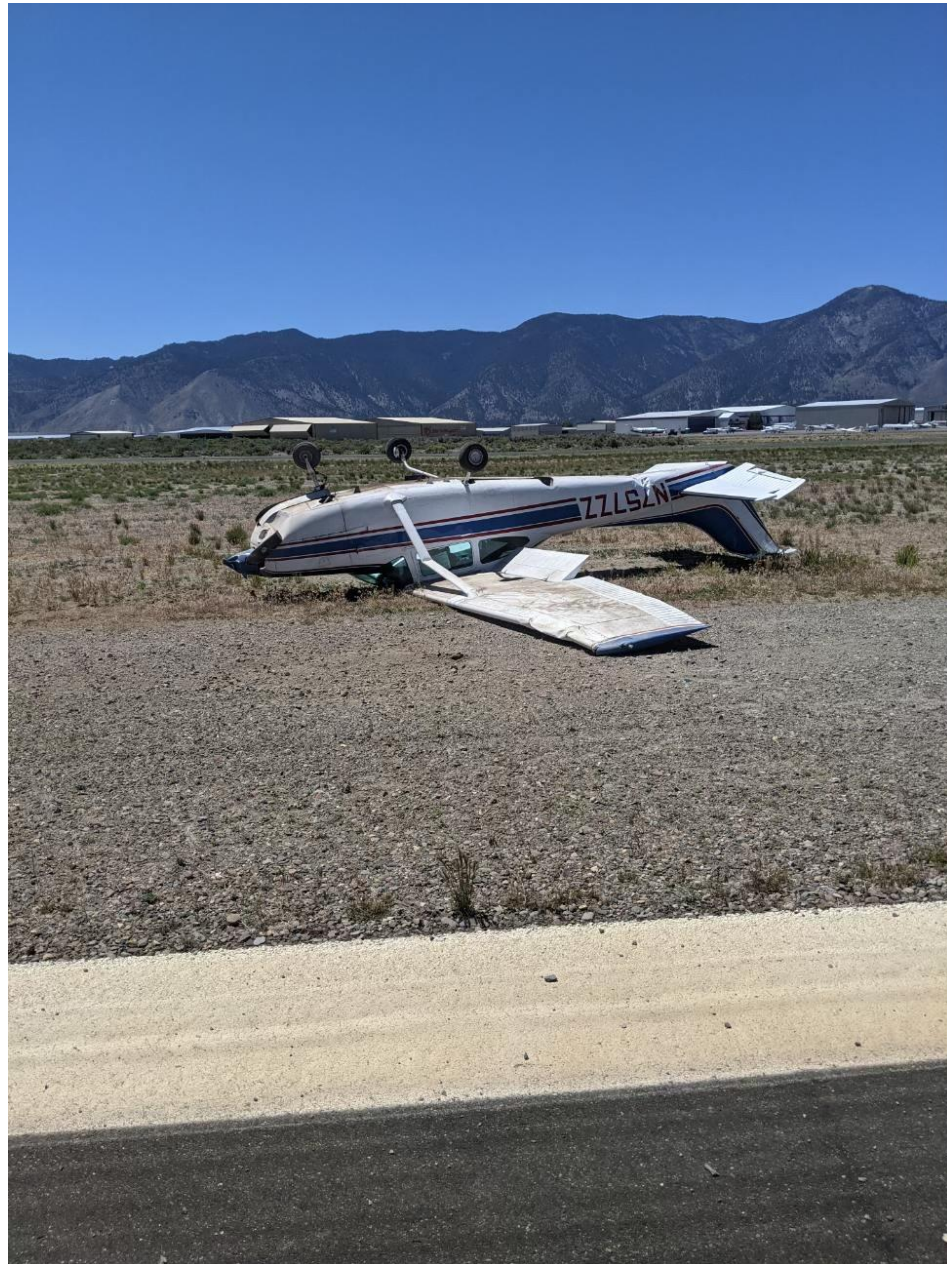
Photo 1 – View of the inverted airplane with damage to the right wing lift strut and empennage (Courtesy of FAA)

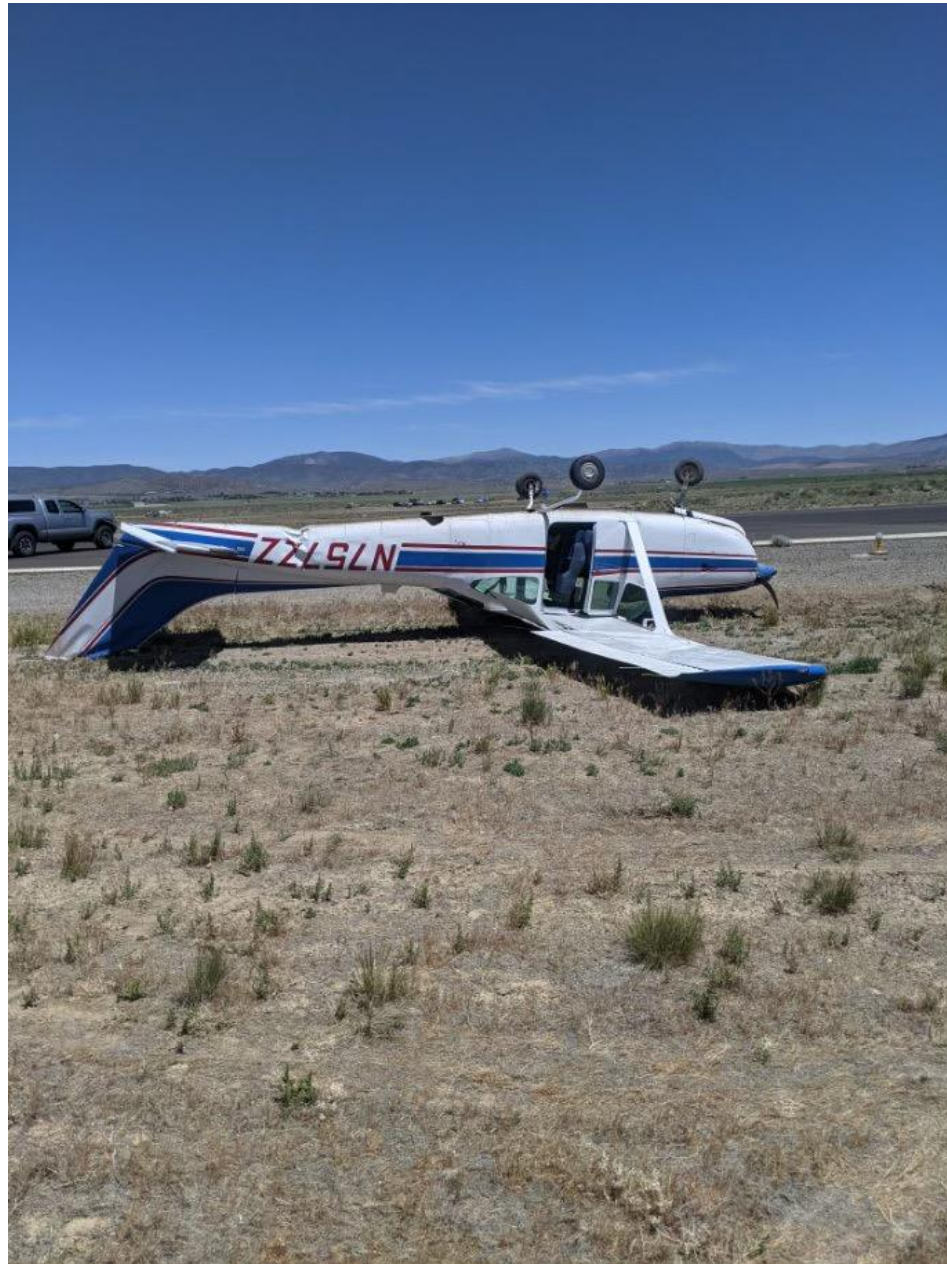
Photo 2 – View of the inverted airplane with damage to the empennage (Courtesy of FAA)
