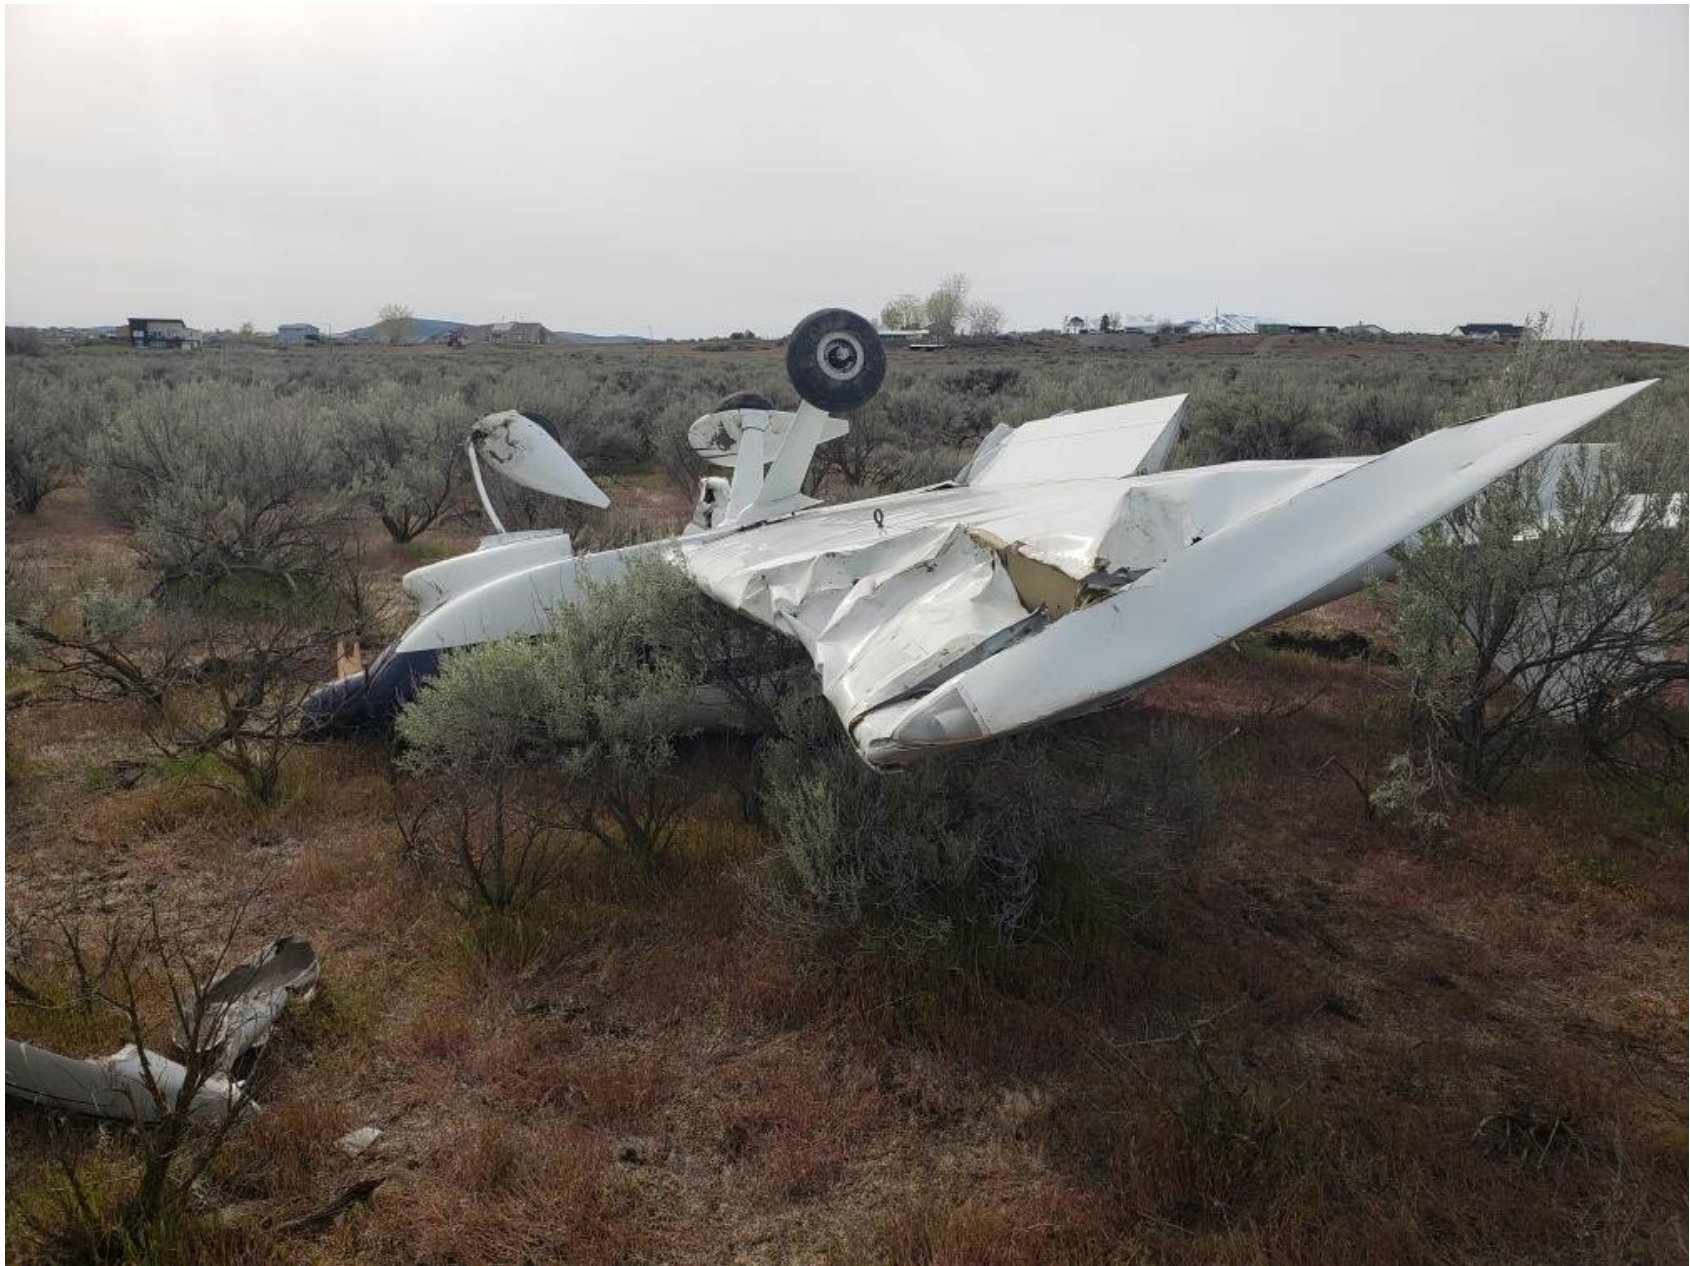
Photo 1 – N431SS, at the accident site, showing damage to the right wing. Photo courtesy of the pilot.

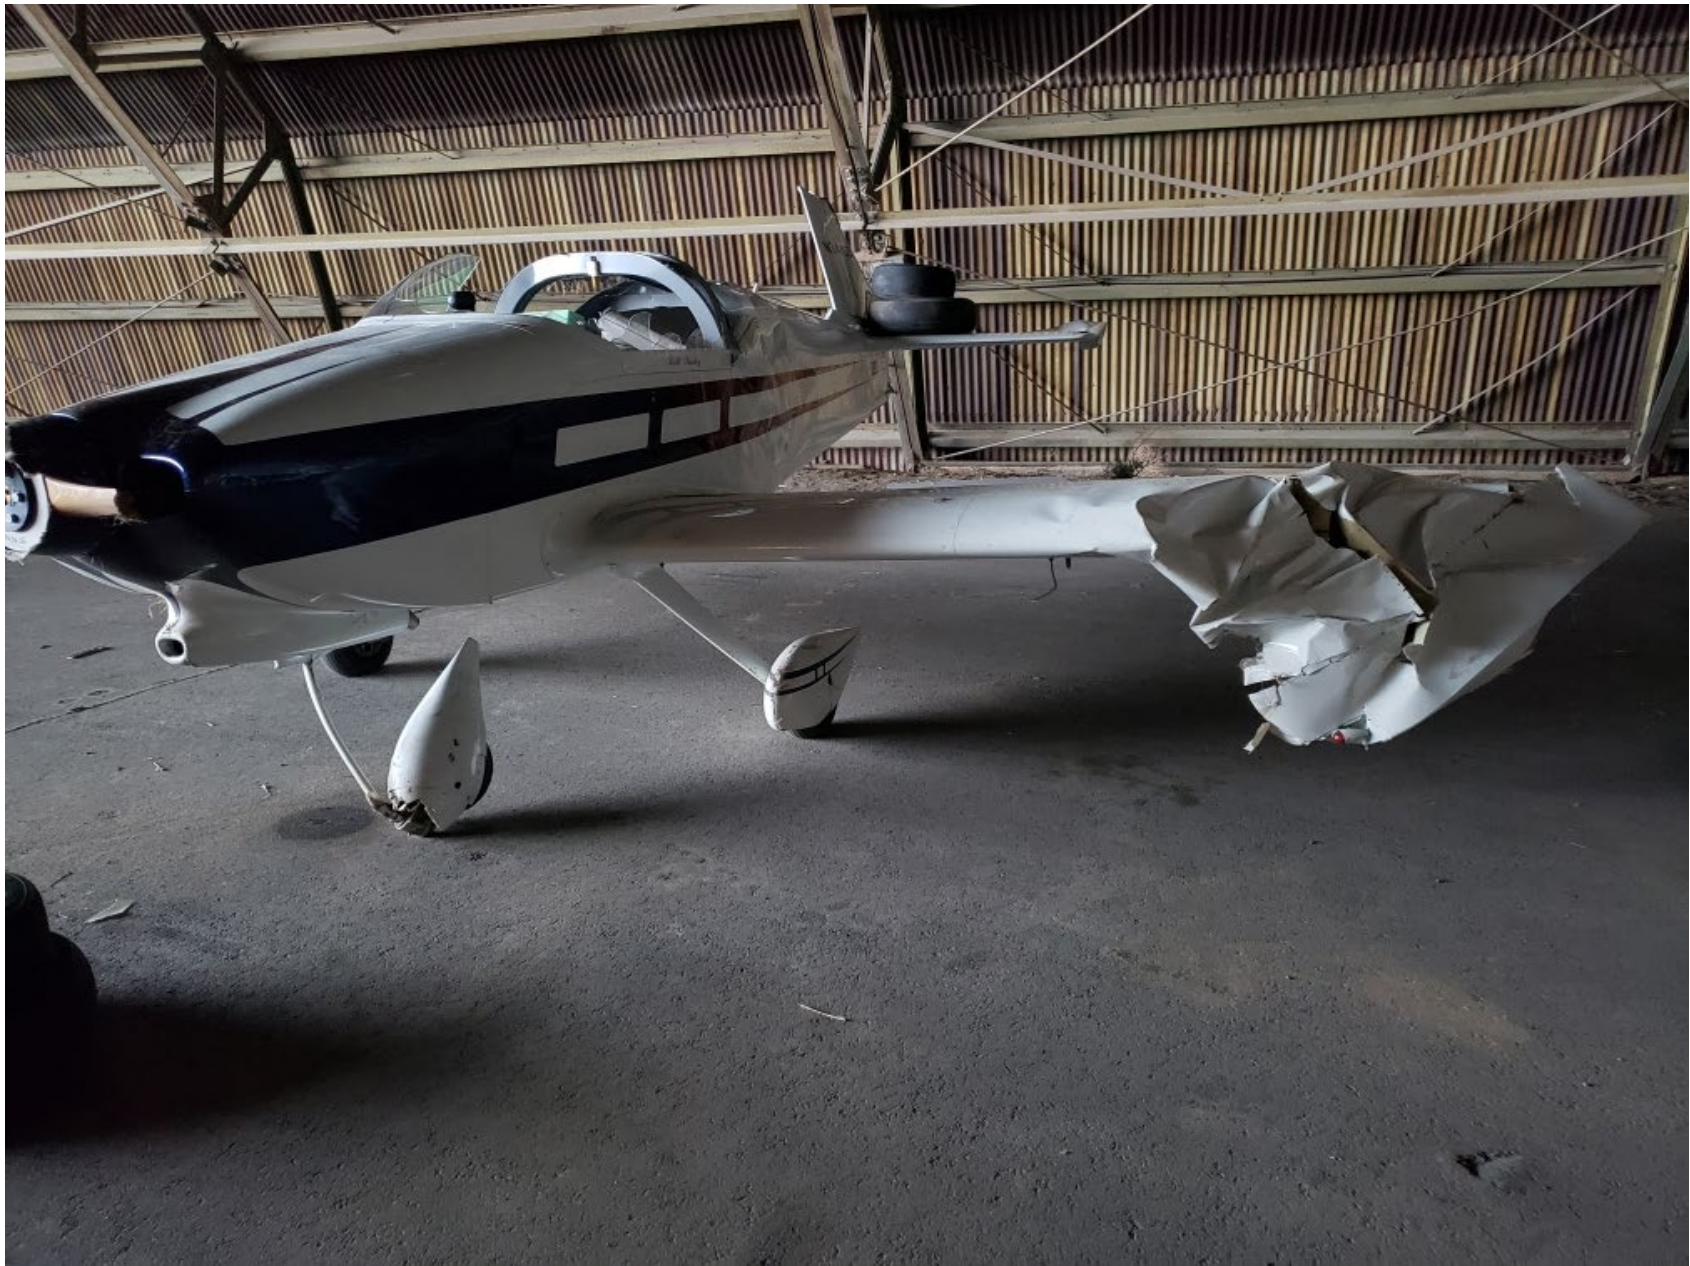
Photo 2 – Left view, showing damage to the left wing. Photo courtesy of the pilot.

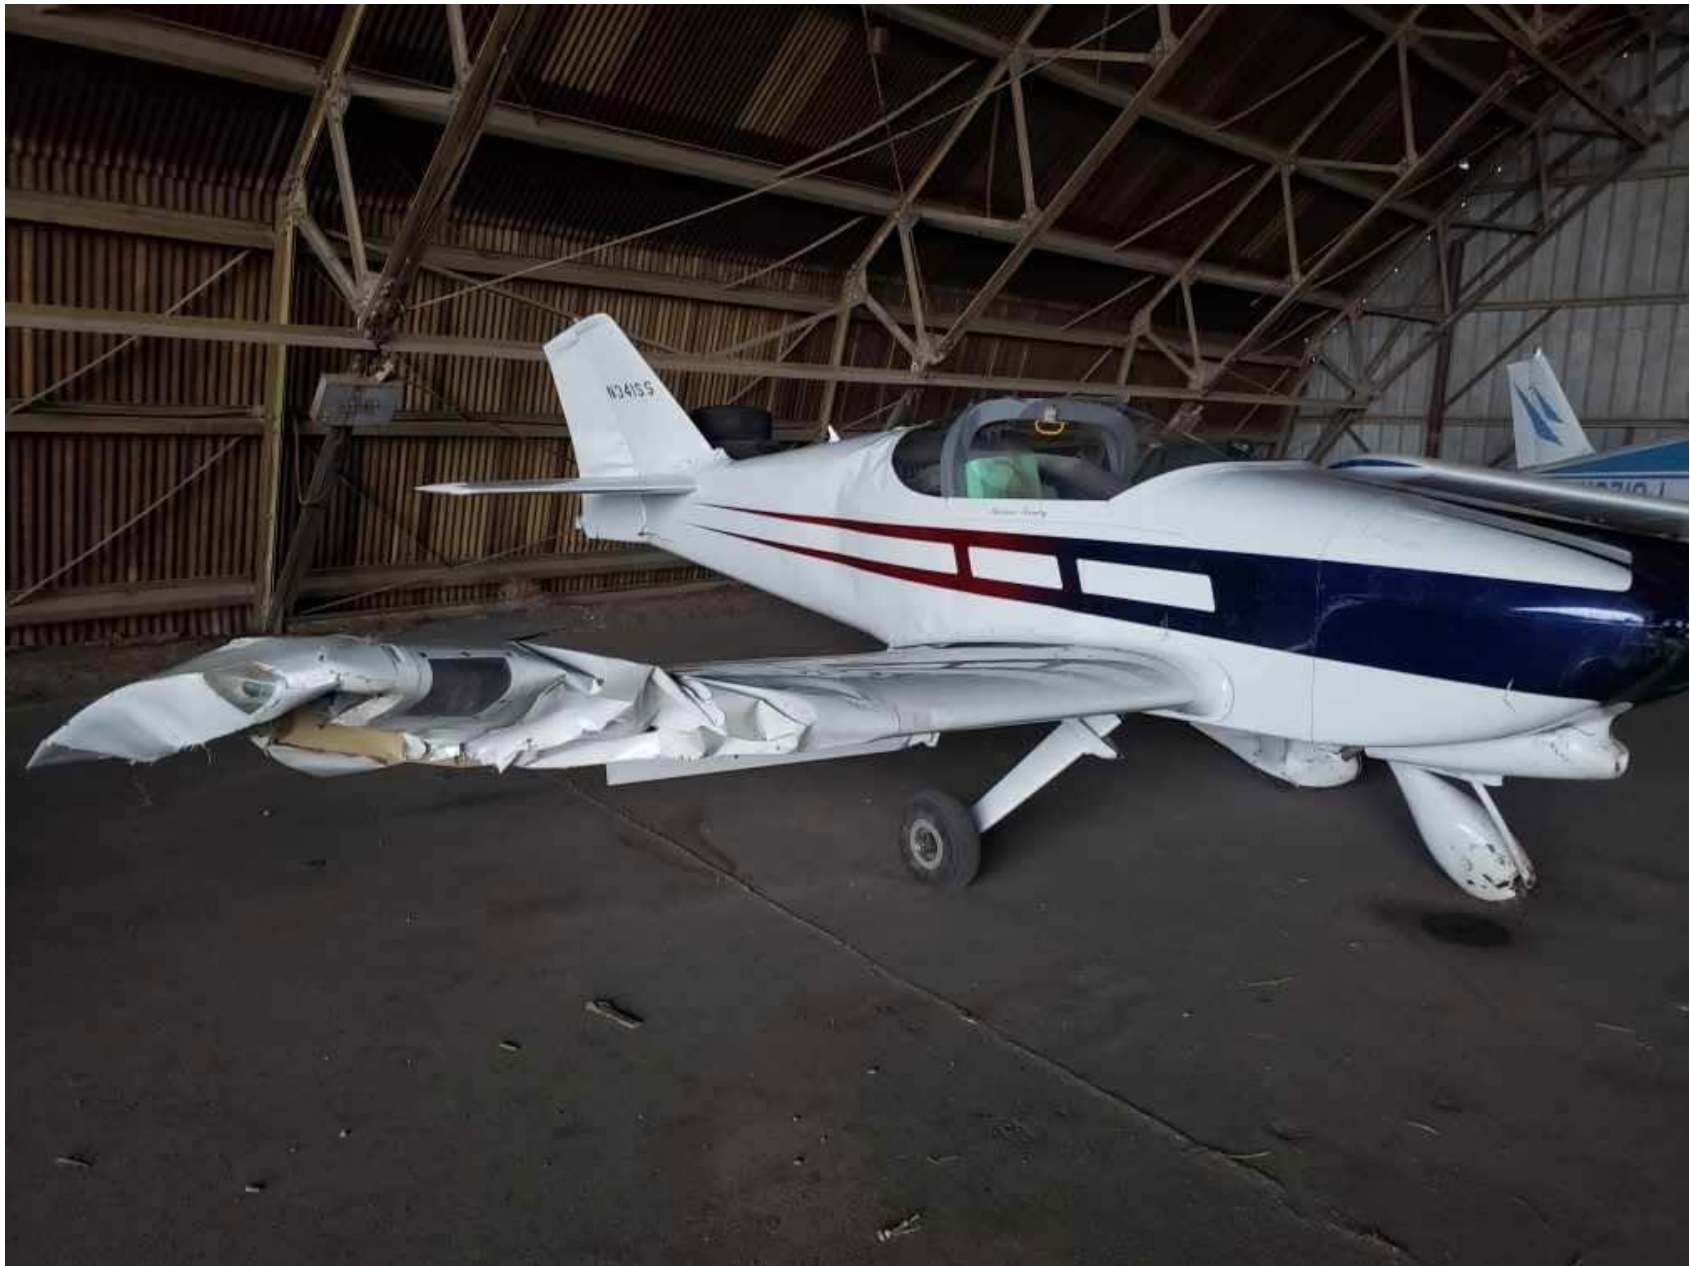
Photo 3 – Right view showing damage to the right wing, vertical stabilizer, and the rudder. Photo courtesy of the pilot.
