CEN22LA253

INVESTIGATION PHOTOGRAPHS

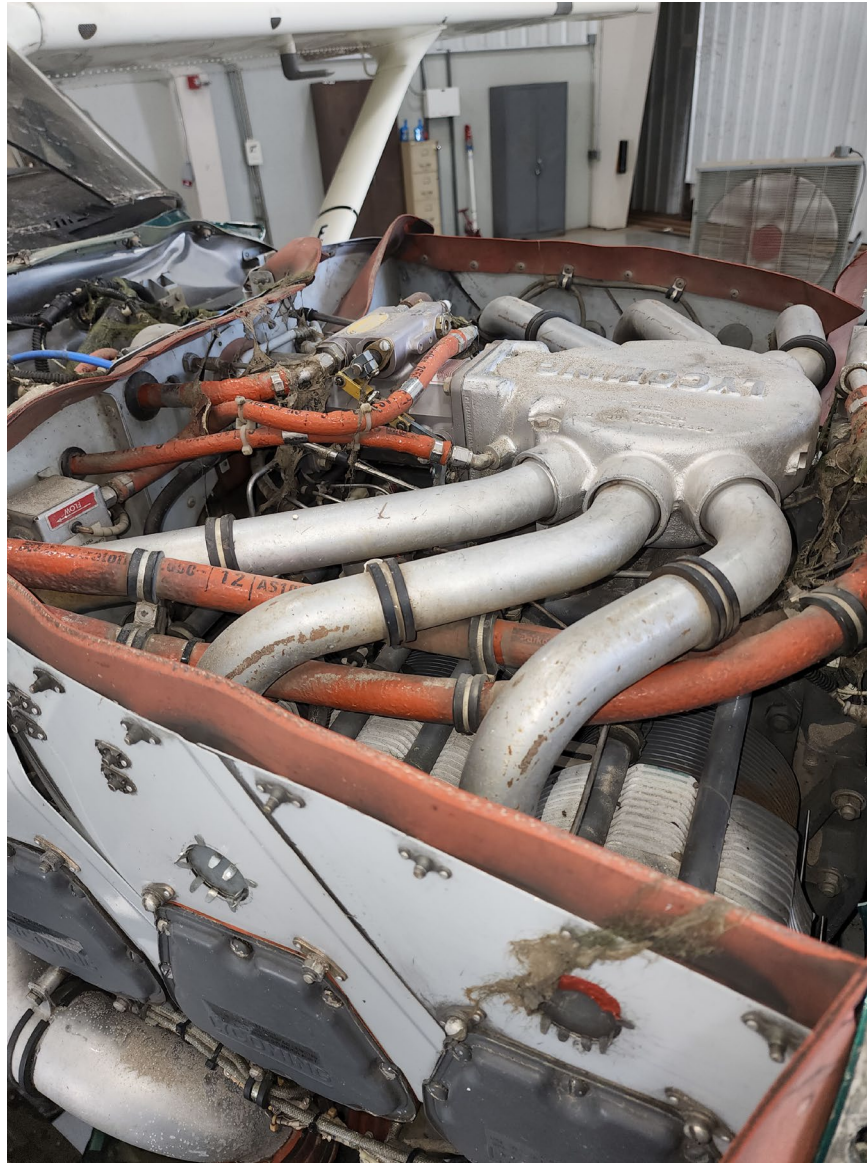
Photograph 1 - Top of engine after the accident (Courtesy of FAA)

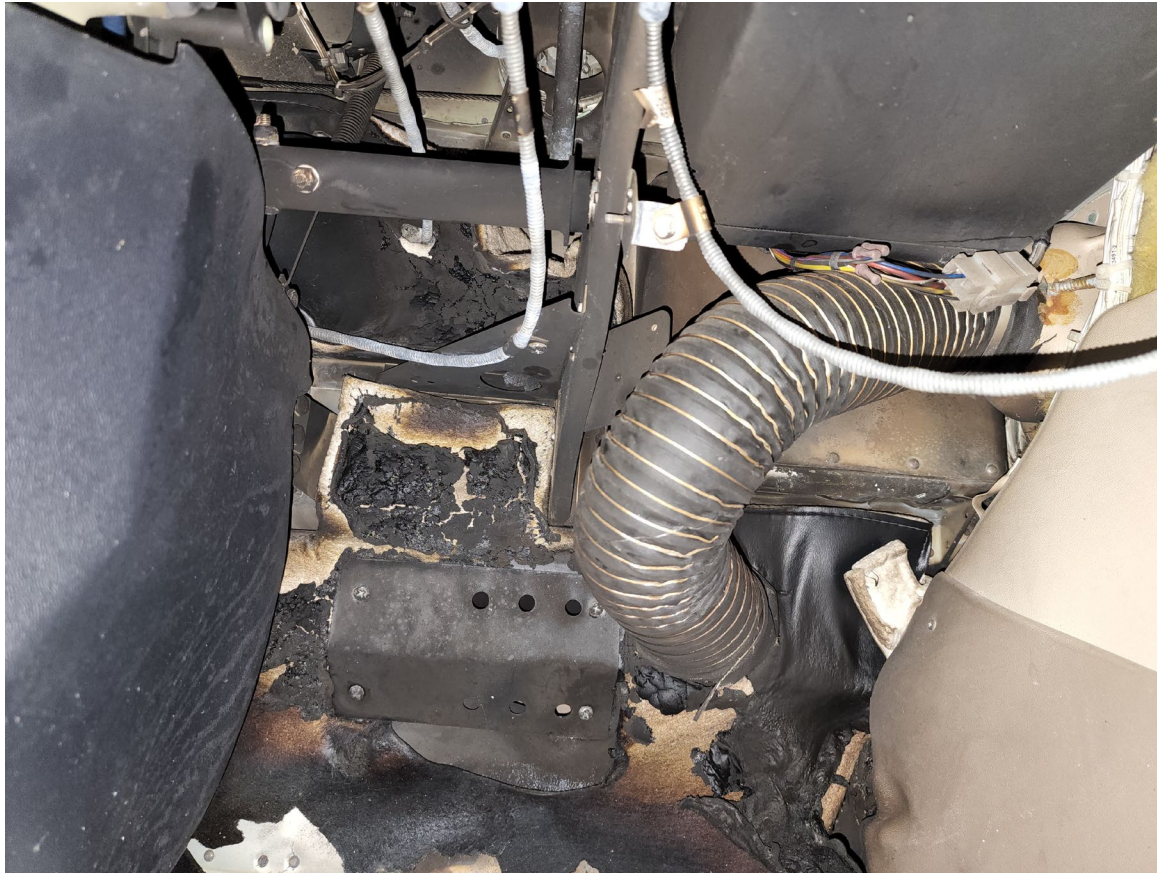
Photograph 2 - Firewall from inside cockpit (Courtesy of FAA)

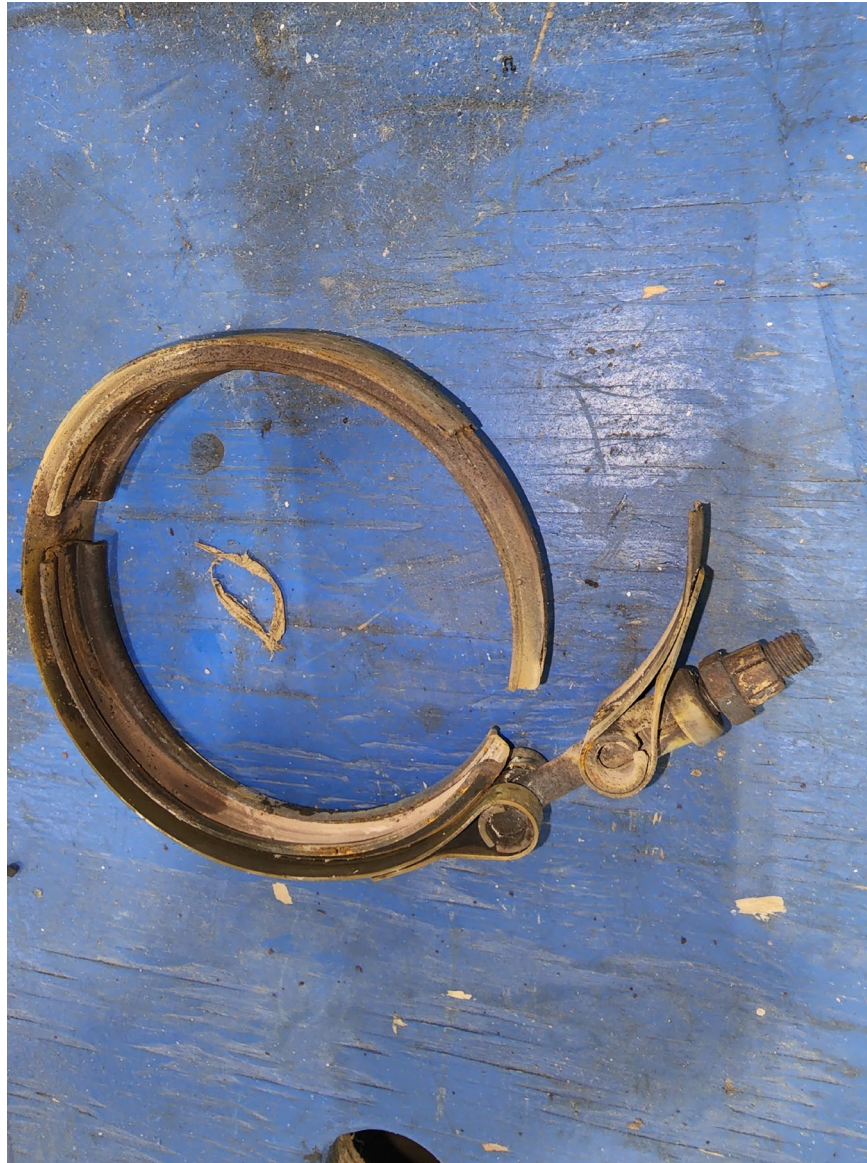
Photograph 3 - Fractured V-band clamp (Courtesy of FAA)

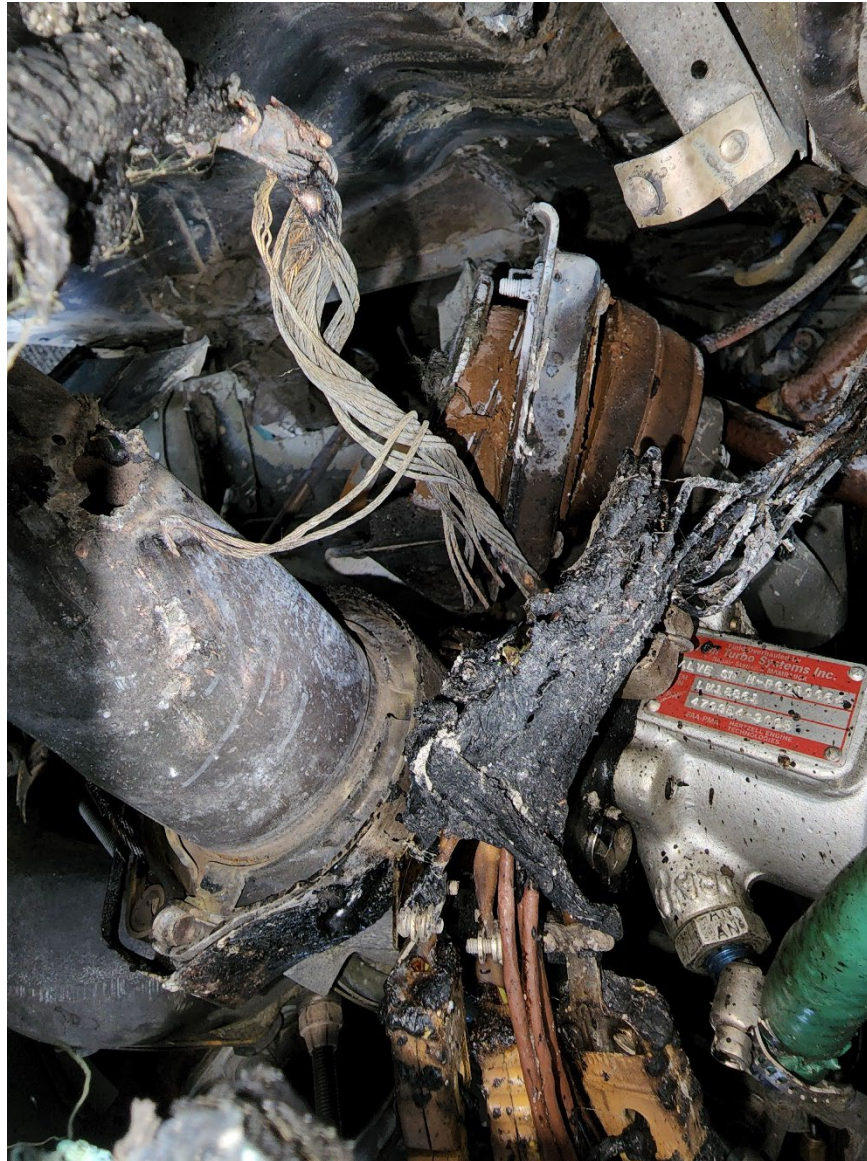
Photograph 4 - Engine accessory damage (Courtesy of FAA)

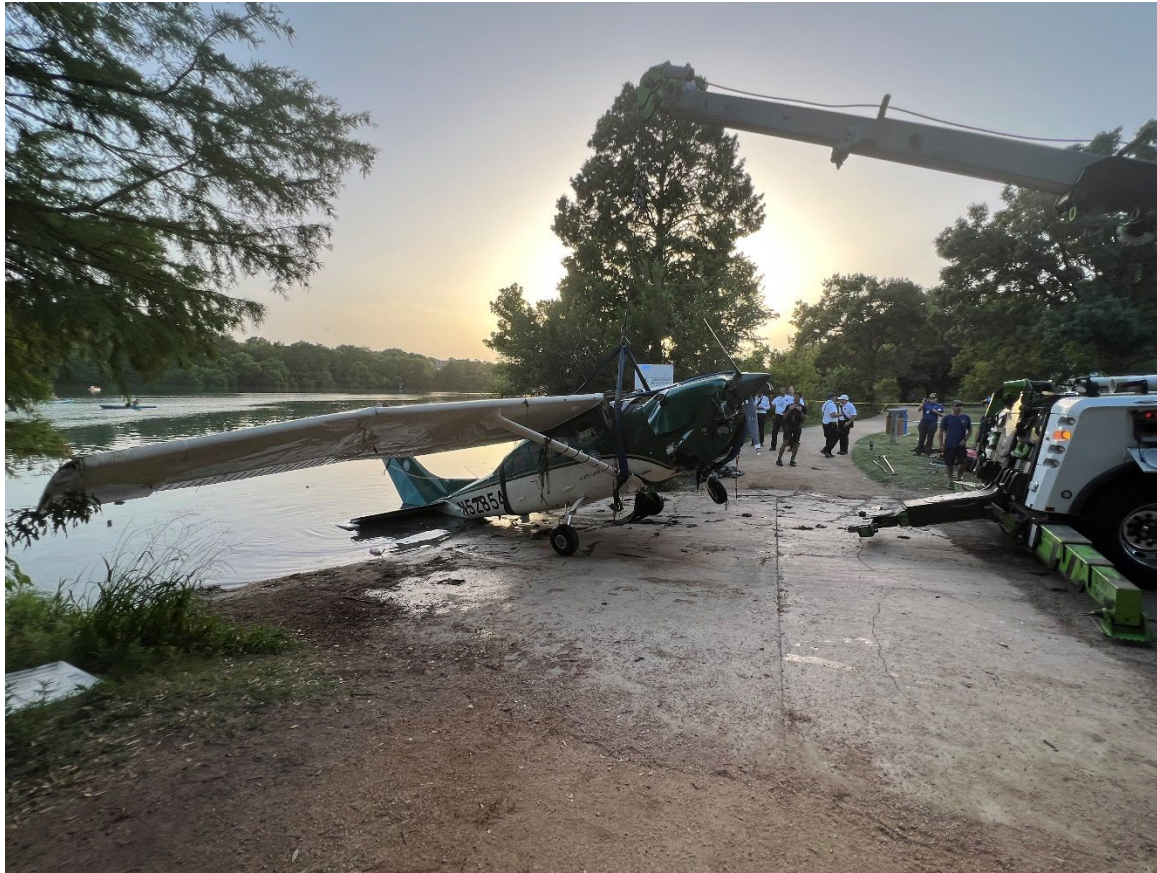
Photograph 5 - Airplane during recovery (Courtesy of FAA)
