CEN23LA128

INVESTIGATION PHOTOGRAPHS

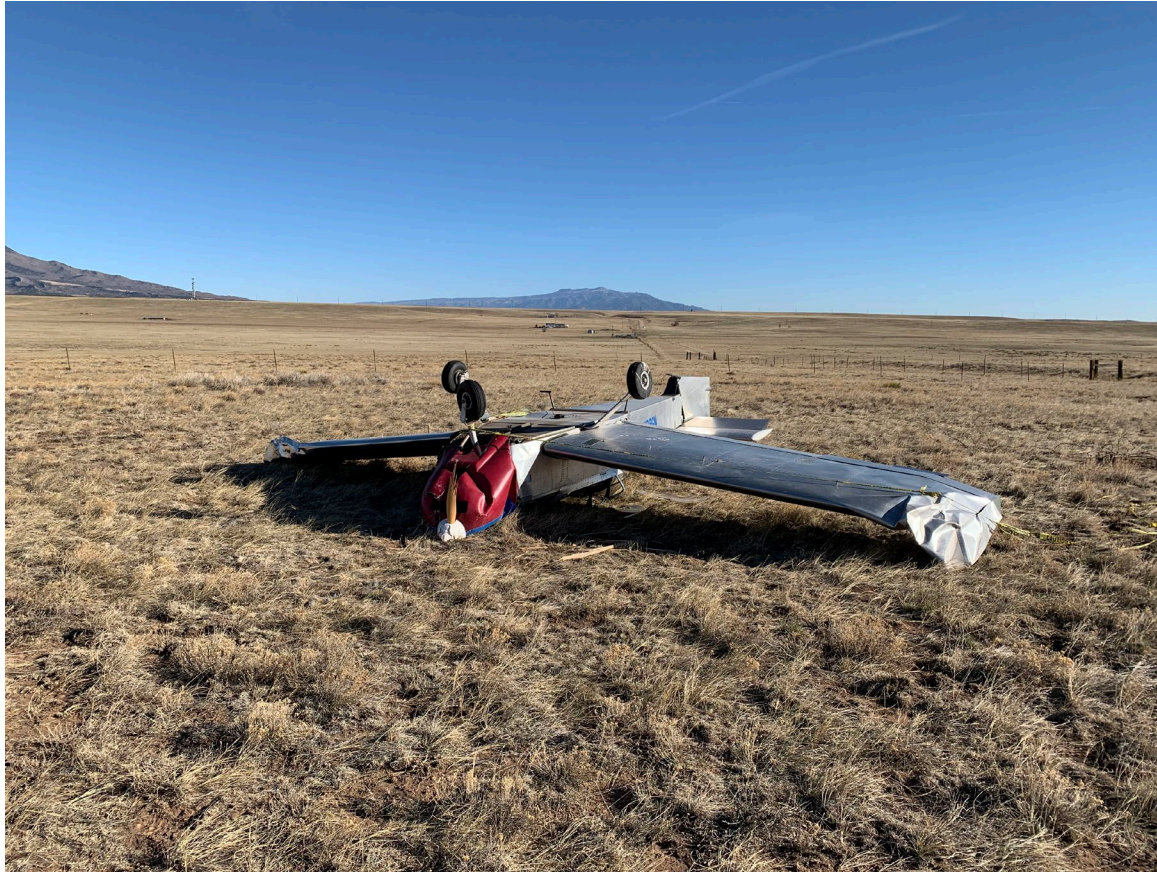
Photograph 1 - Front right side view of airplane at accident site (NTSB Photo)

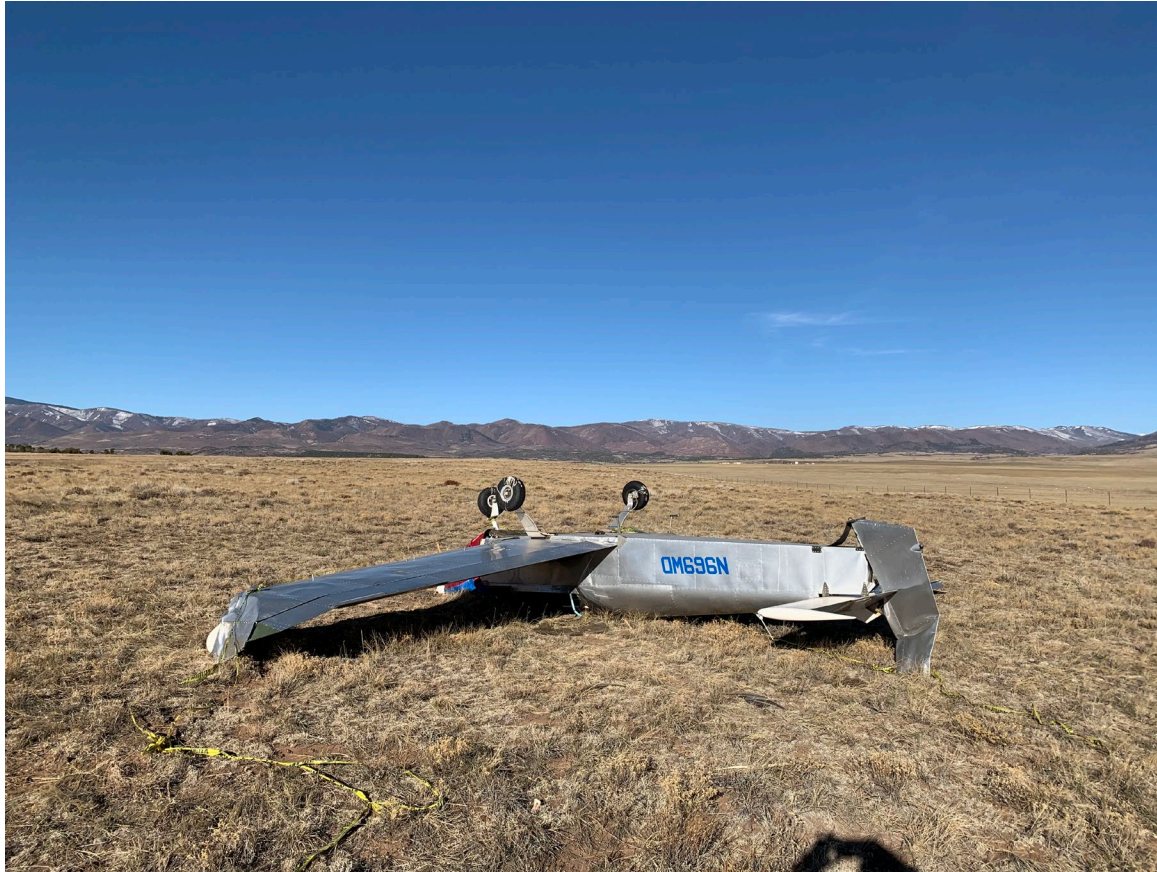
Photograph 2 - Rear right side view of airplane at accident site (NTSB Photo)

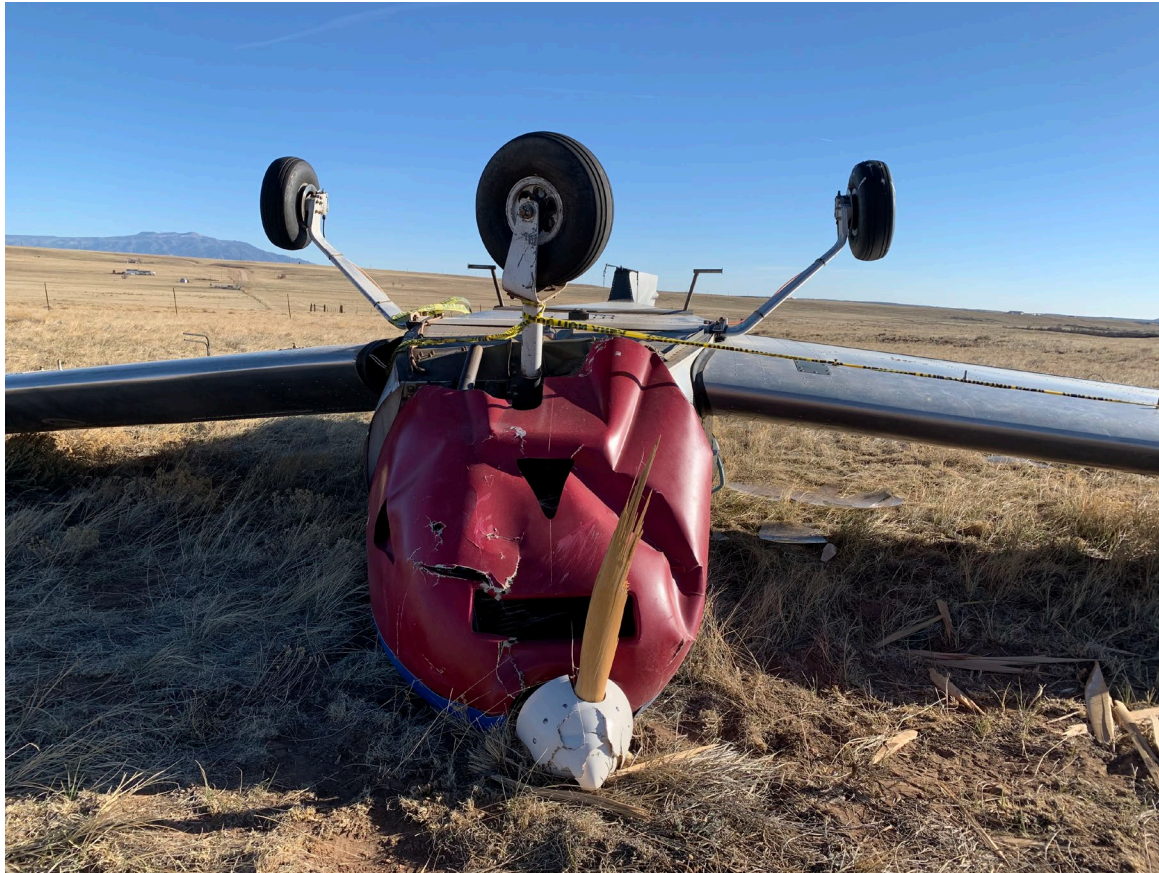
Photograph 3 - Front view of airplane at accident site (NTSB Photo)

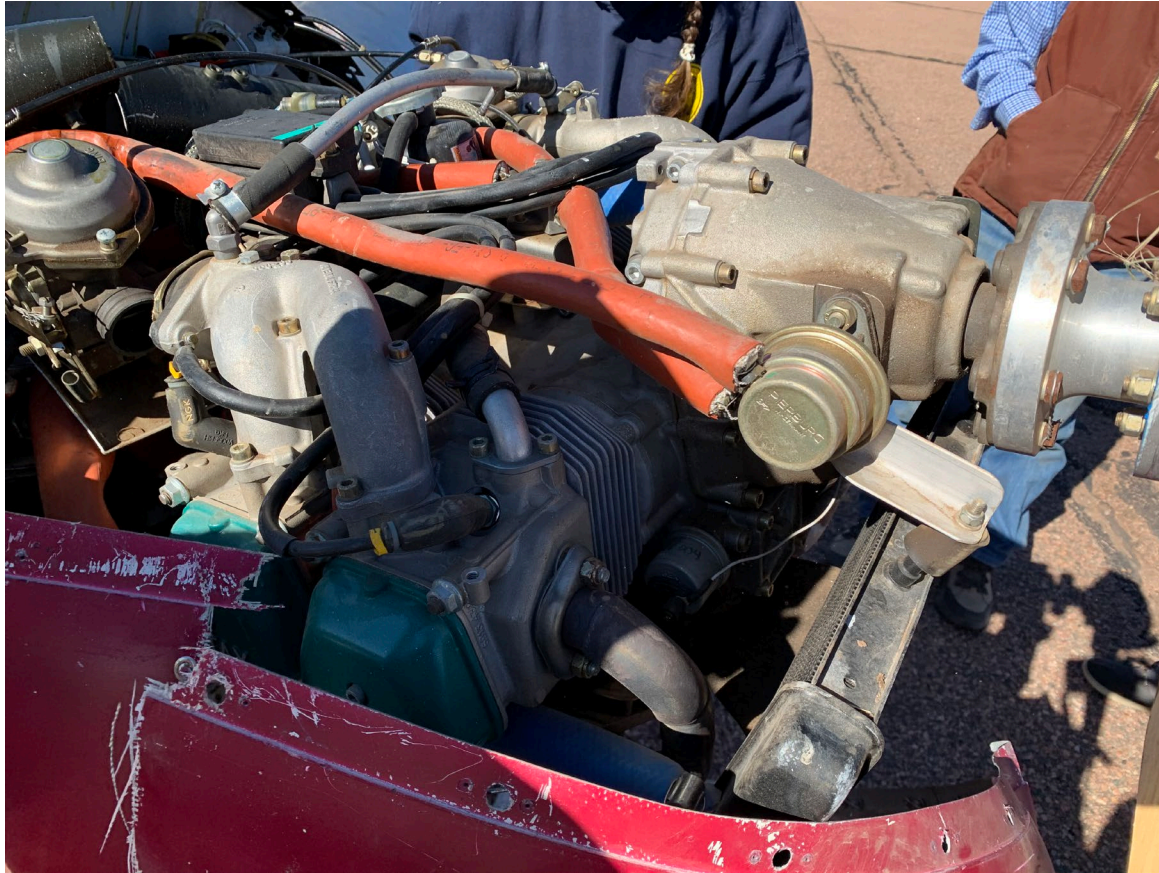
Photograph 4 - Airplane engine during examination (NTSB Photo)

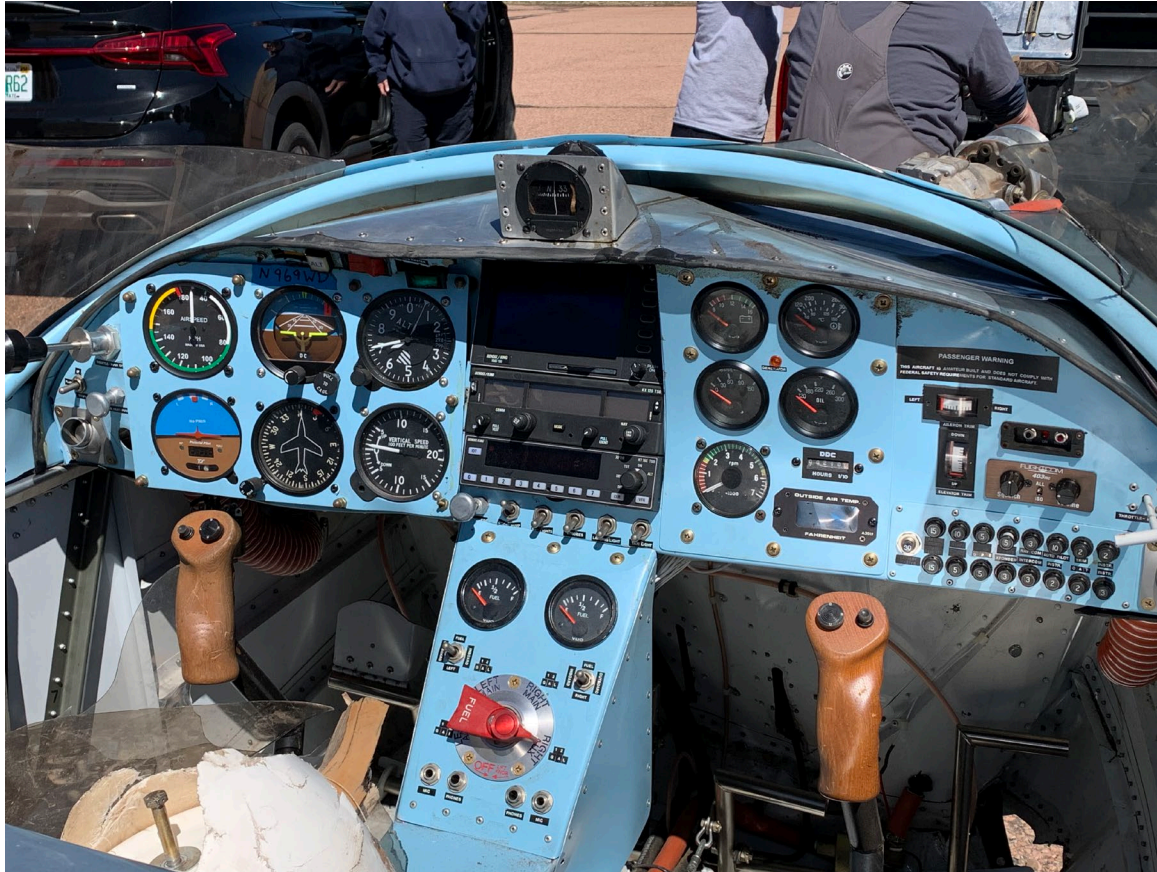
Photograph 5 - Airplane instrument panel during examination (NTSB Photo)
