Aircraft: N408RV  
Type: Vans RV8  
Serial #: 81144  
Owner/PIC: Roger Pierce

Event Date: 29 June, 2020  
Event Time: 1356 EDT/1756 UTC

MEMORANDUM for RECORD

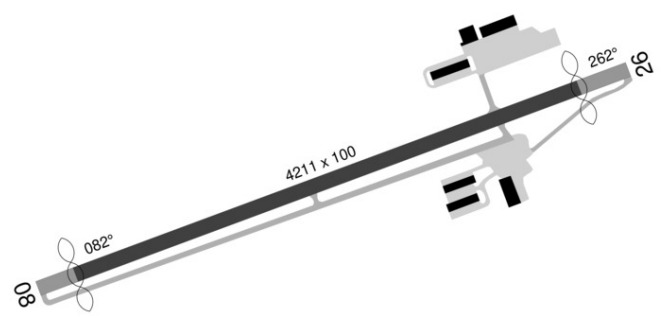
Attachment B

2. A large stand of trees extending nearly to the approach end of runway 08 appears to create unstable and turbulent winds at touchdown (see Attachment B).

3. There is only one windsock on the field, and it is on top of a hangar at the southeast end of airport, and partially obscured from view by trees and buildings when touching down on runway 08 (see Attachment B)
