KURT LEPPINS
Written Statement

OF ACCIDENT 275AK Aug 5, 2021

1) 2008 ROBINSON / N-775AK
R-44 Serial# 1875

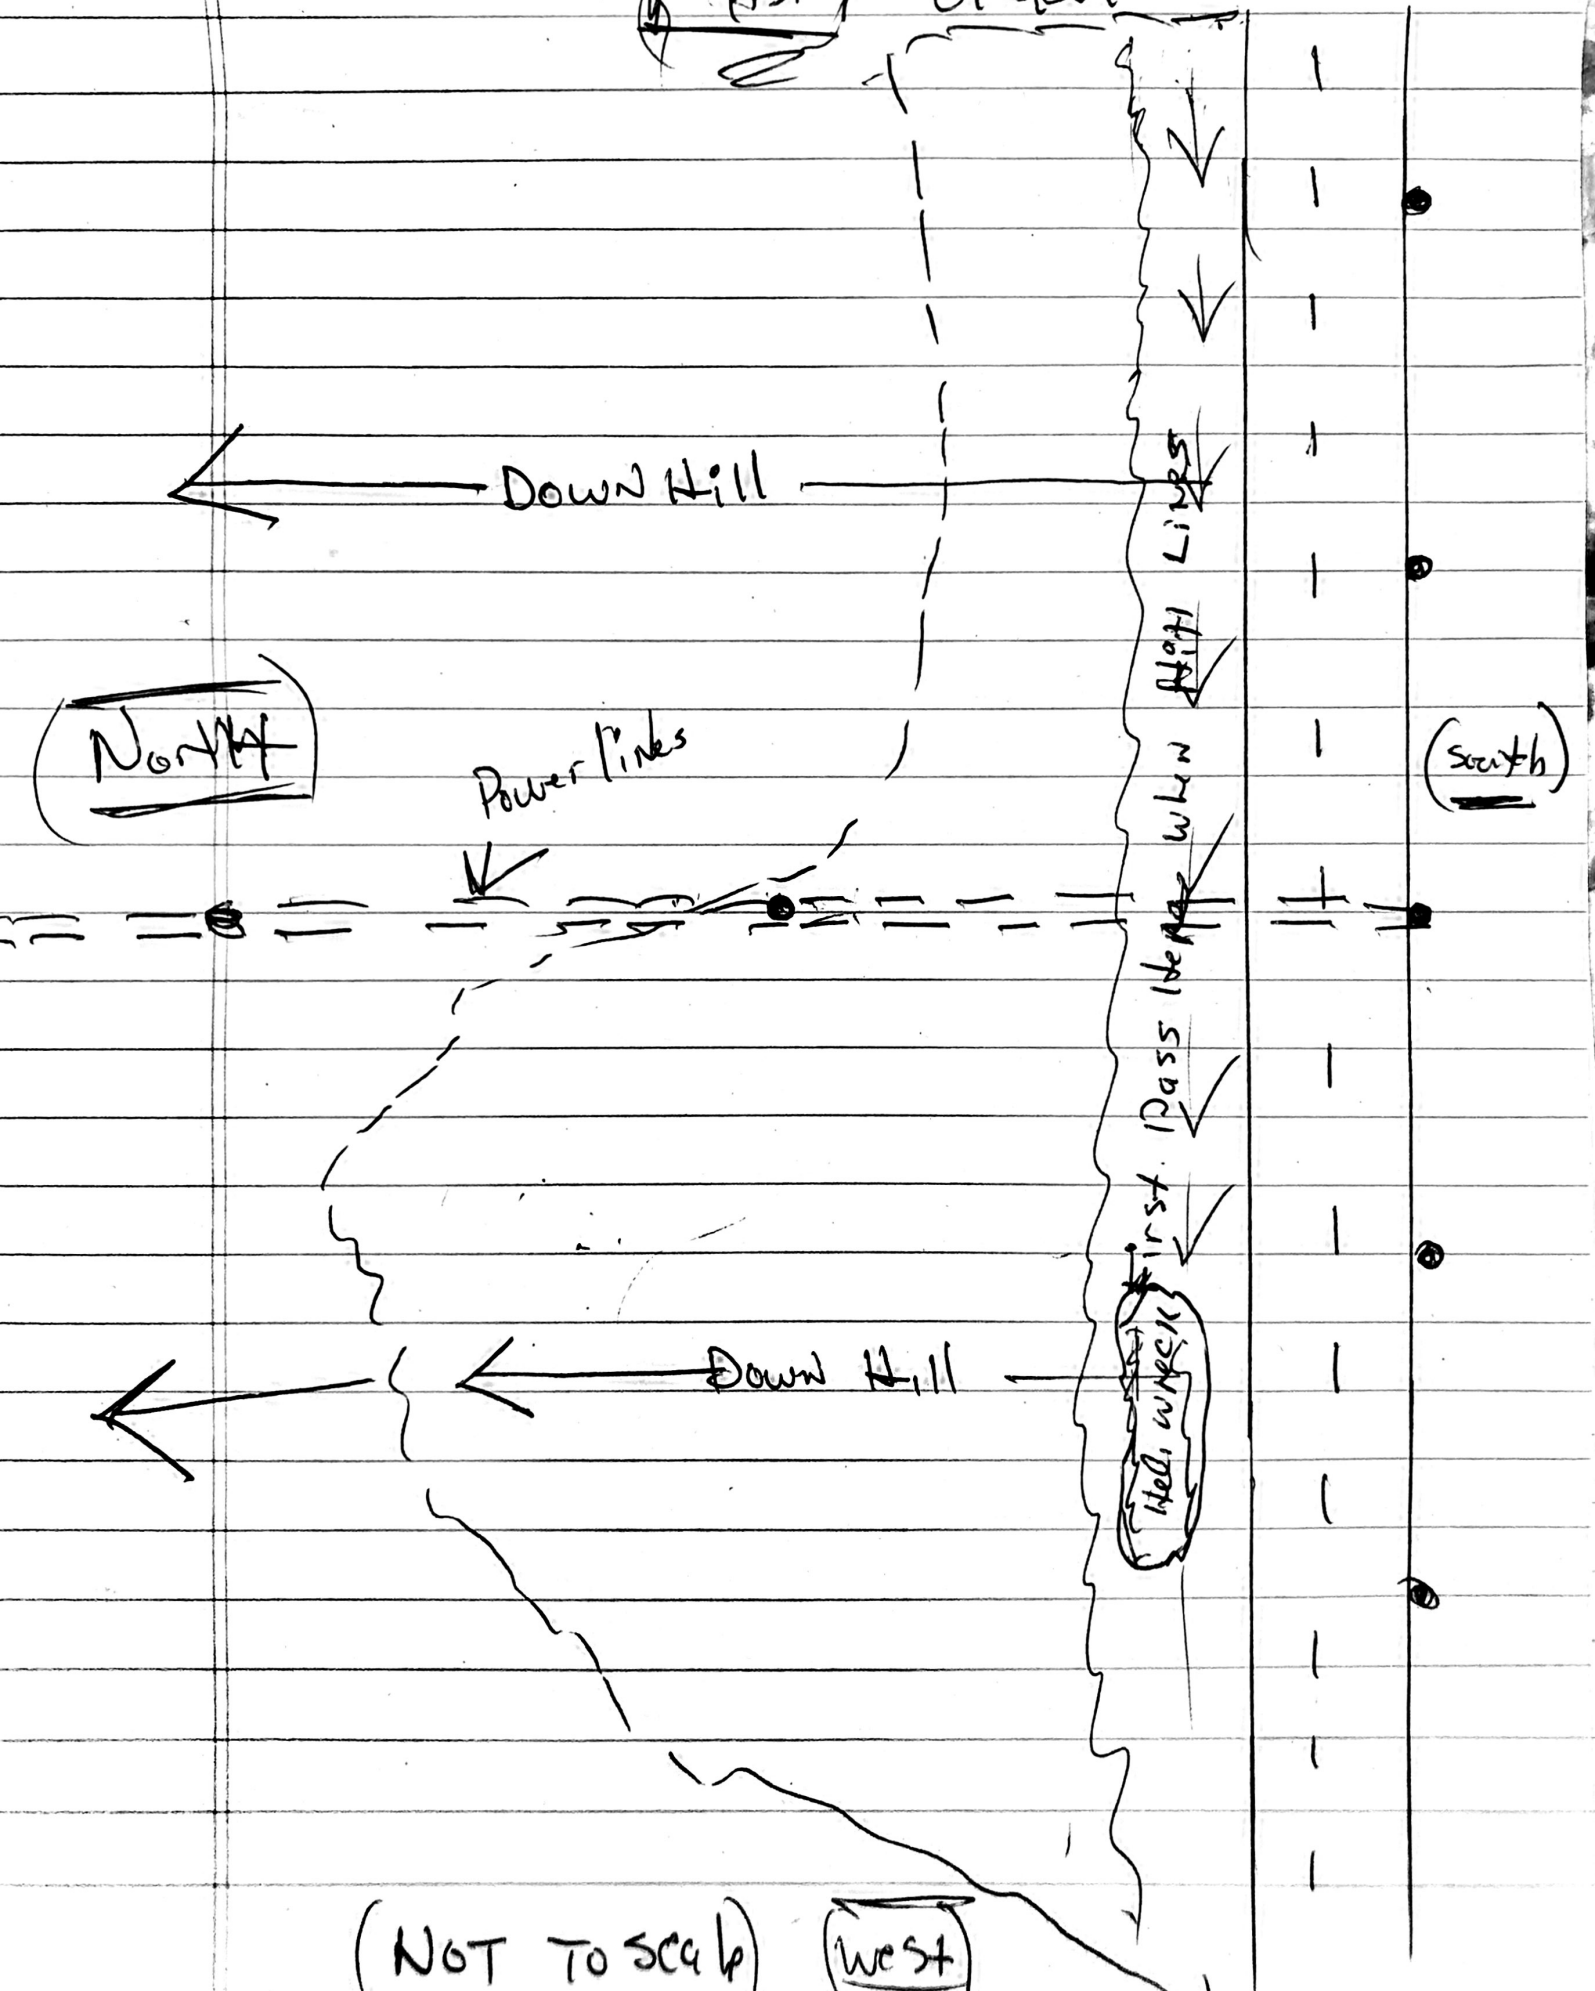
Leppings sketch of
 fire where wreck occurred
 8/5/21

I surveyed field to be sprayed at approx 7:30 AM flying from west to east. The sunrise was low in sky and in my eyes. I did not see any wires crossing field. I spray a couple other fields first then came back to that field approx 8:15 AM. And began spraying from east to west along side paved road. I heard a bang and instantly was in the corn field down. I exited helicopter immediately after unbuckling the seat belt. The road was on south side of field and there were power lines on south side road and after getting out of heli I observed one line crossing field from south to north, and one line tangled in helicopter. I was about 150-200 yds to west of line in the corn field. The road to south was a high point and field slope downhill to north. The power line pole in the field was near north edge of field and it did not go to any buildings. It went down hill further to the north, off into a valley. (See attached sketches)

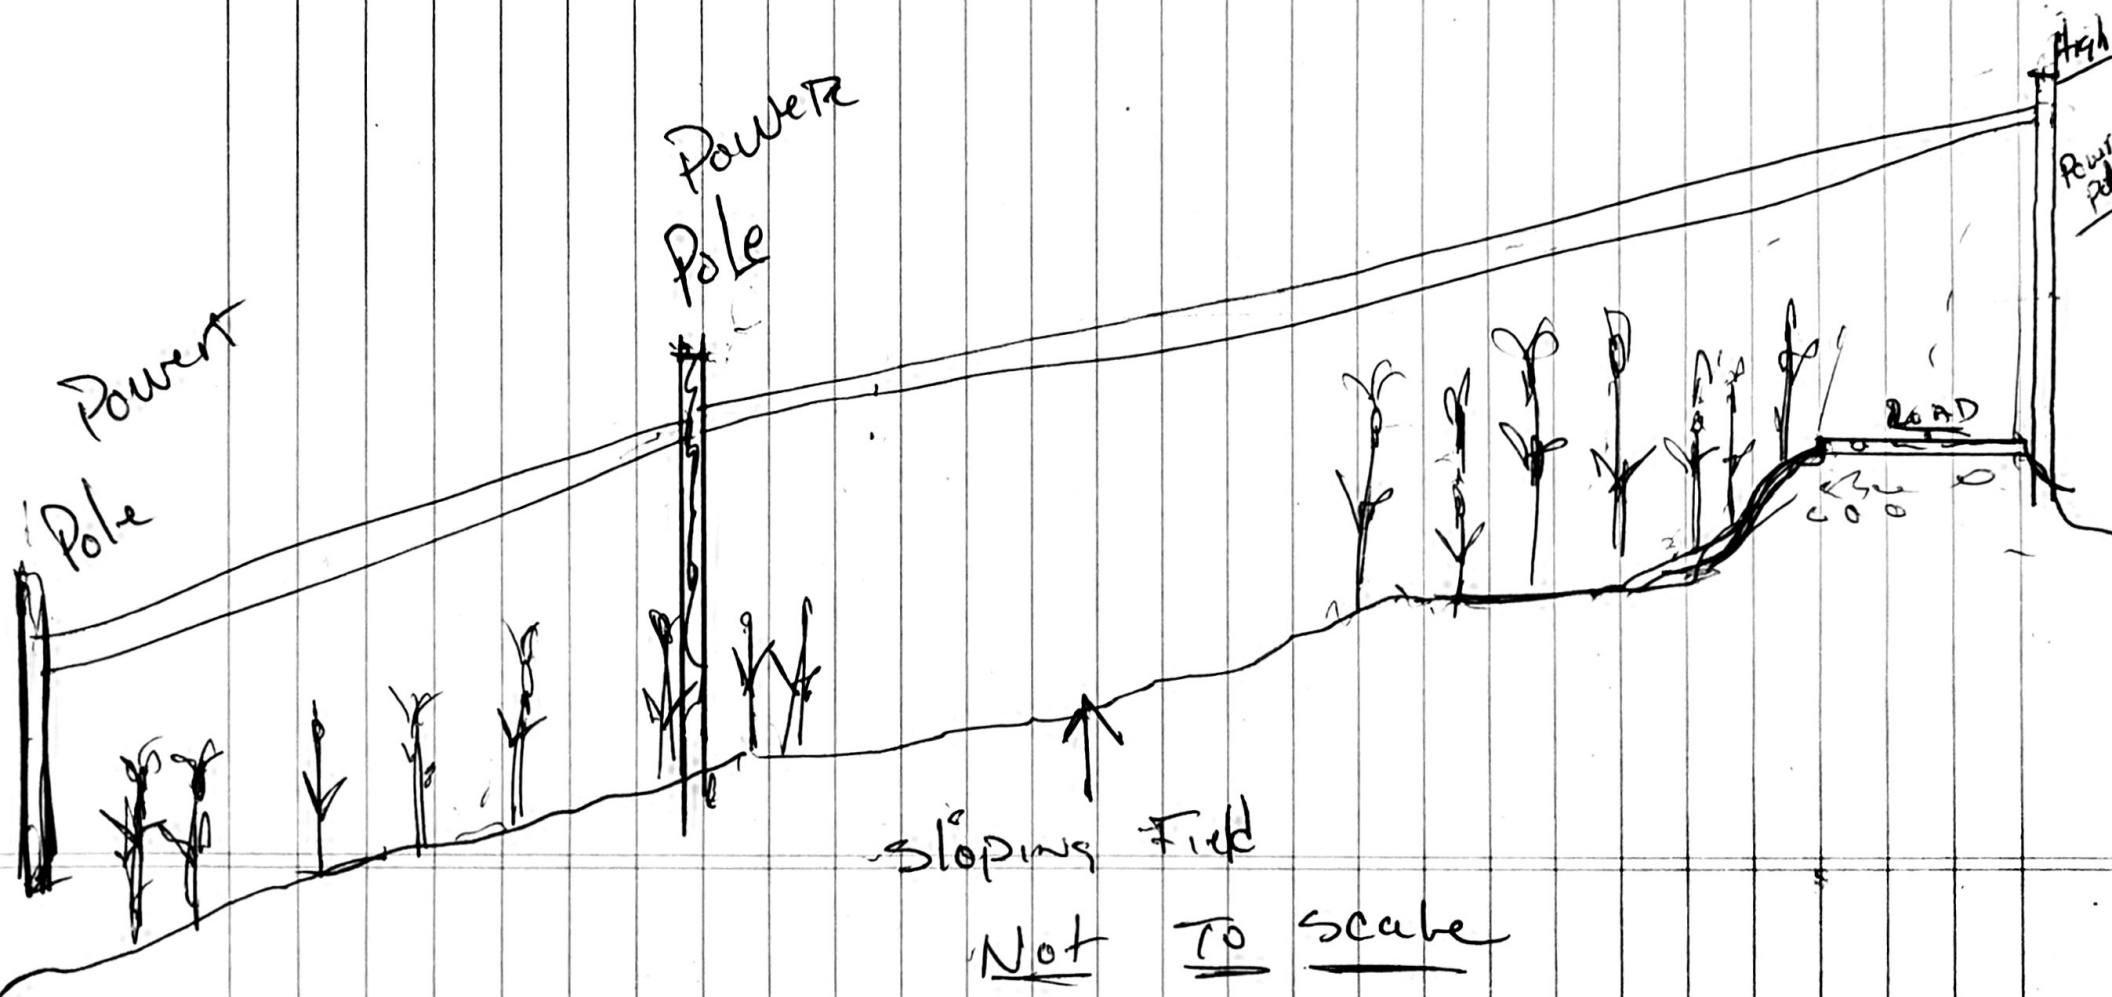
Profile of A
Field Kuntleppings N-775AK
CRASH #1
8/5/21

Sloping Field
Not To Scale
