Aqueos Subsea Pipe 3D Scan

Document Number: 21032-RP-001 Rev0

Aqueos have contracted DimEye Corp. to provide the 3D As-built CAD model and the 3D high accuracy Mapping of all damages of the Beta Pipe located in California (east of Long Beach). The Inspection took place on October 19th and 22nd, 2021, from the "Cronos" barge.

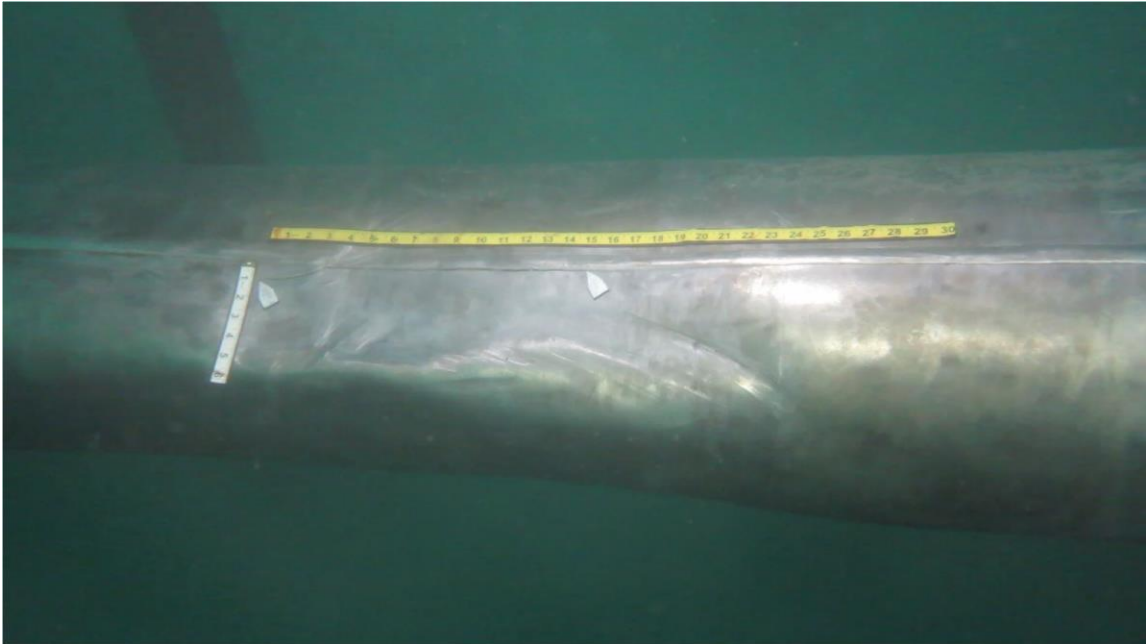
Figure 1: View of the pipe

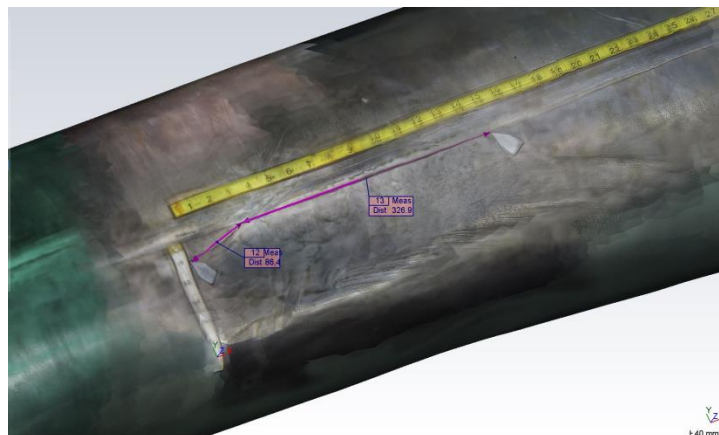
- Crack

Figure 12: Crack dimensions

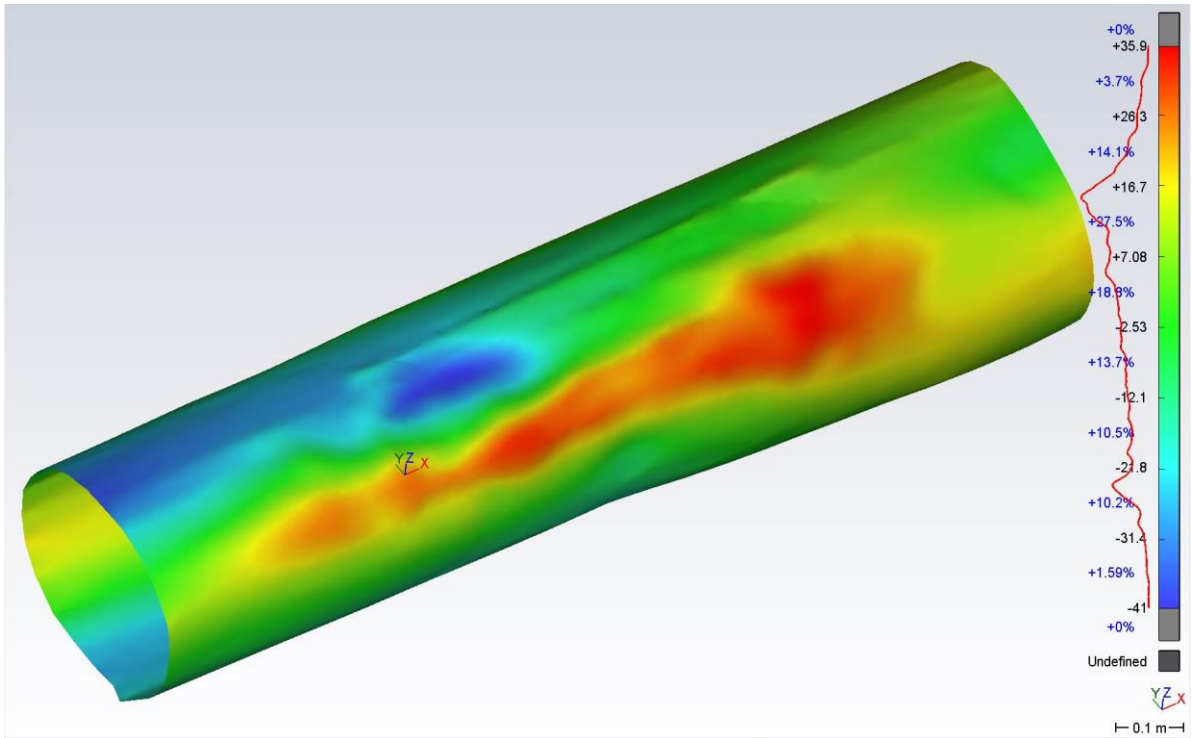
Global Comparison with Nominal Pipe

The percentages on the right correspond to the number of points with a deviation to nominal between the two values. For example, there are 3.7% points (on the top of the color bar) with a deviation between +26.3 mm and + 35.9 mm.

Dents are in blue, bumps in red.

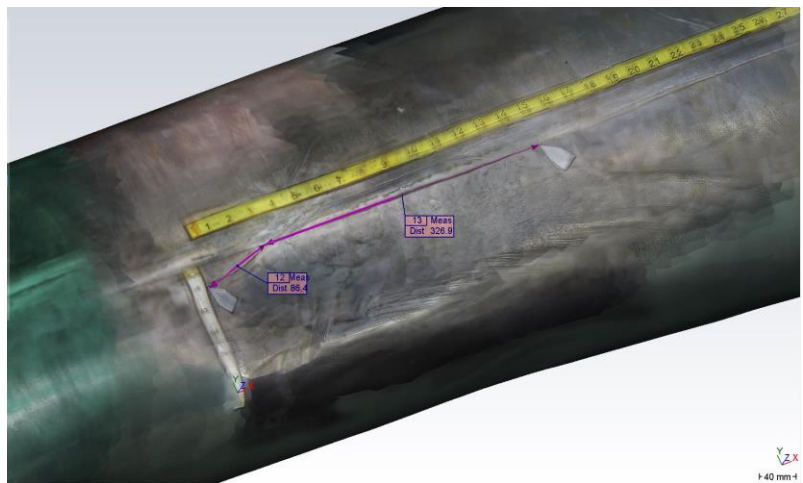
Dimensions of the crack

The length of the crack is 86 mm + 327 mm.
