National Transportation Safety Board

DCA22FM001

PIPELINE OPERATIONS

Group Chair's Factual Report

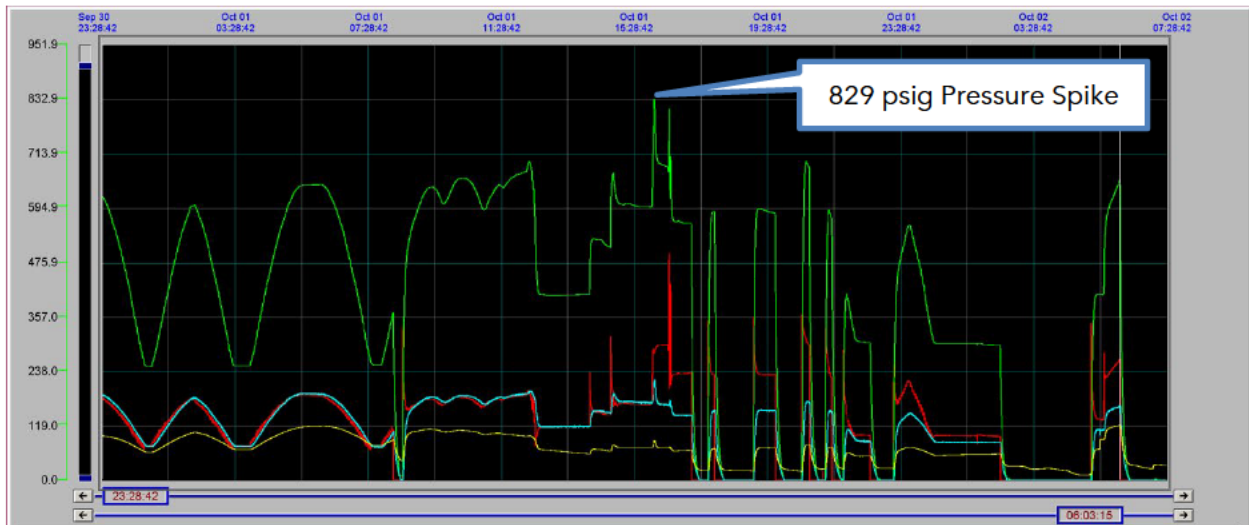
Figure 6. SCADA data showing the normal pattern up until about 07:28 on October 1 and the 829-psig pressure spike. The green line indicated the mainline pipeline pressure, the red line indicates the mainline total flow rate, the blue line indicates the raw flow rate into the pump station, and the yellow line indicates the pipeline inlet pressure.

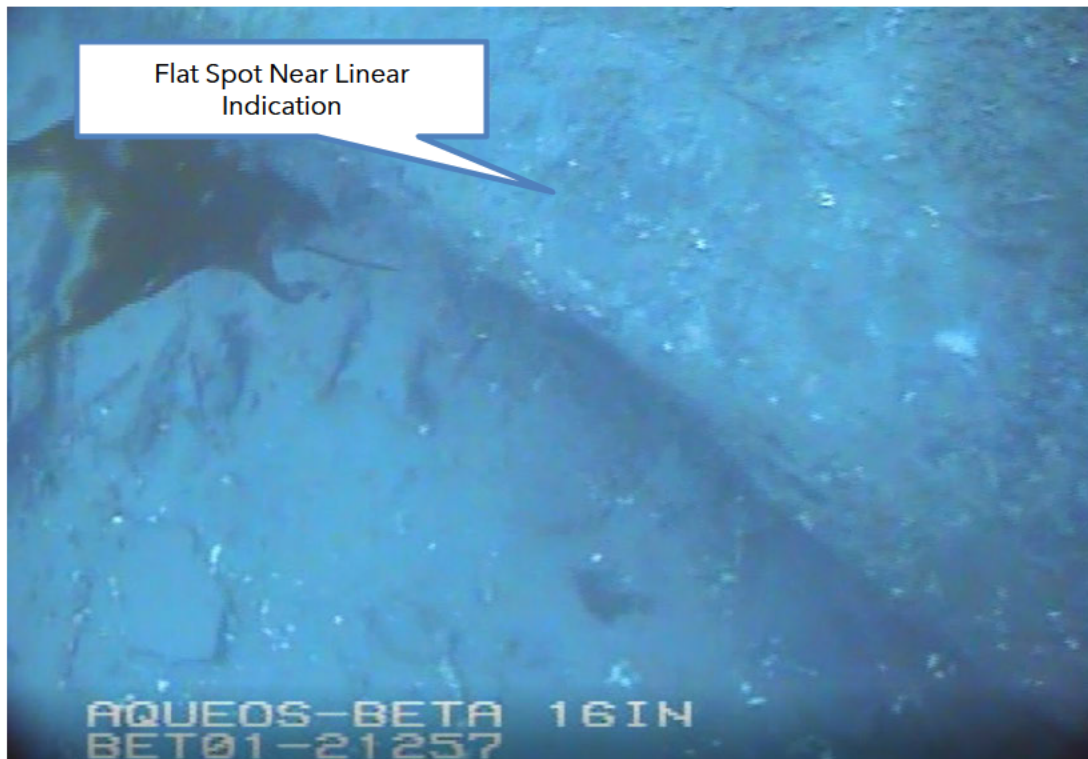
Figure 12. San Pedro Bay Pipeline linear indication with a Flat Spot in situ. Concrete rubble can be seen adjacent to the pipeline. Photograph by Beta Offshore, October 4, 2021.

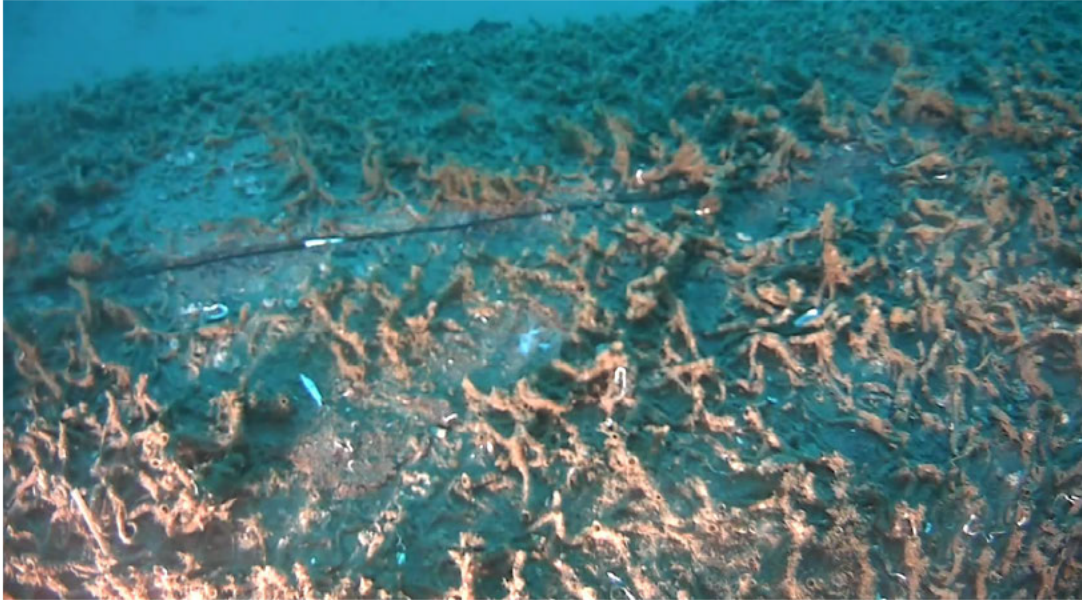
Figure 13. San Pedro Bay Pipeline linear indication at the release location with the coating in place. Marine growth is shown over the damaged portion of the pipeline. Photograph by Beta Offshore, October 4, 2021.

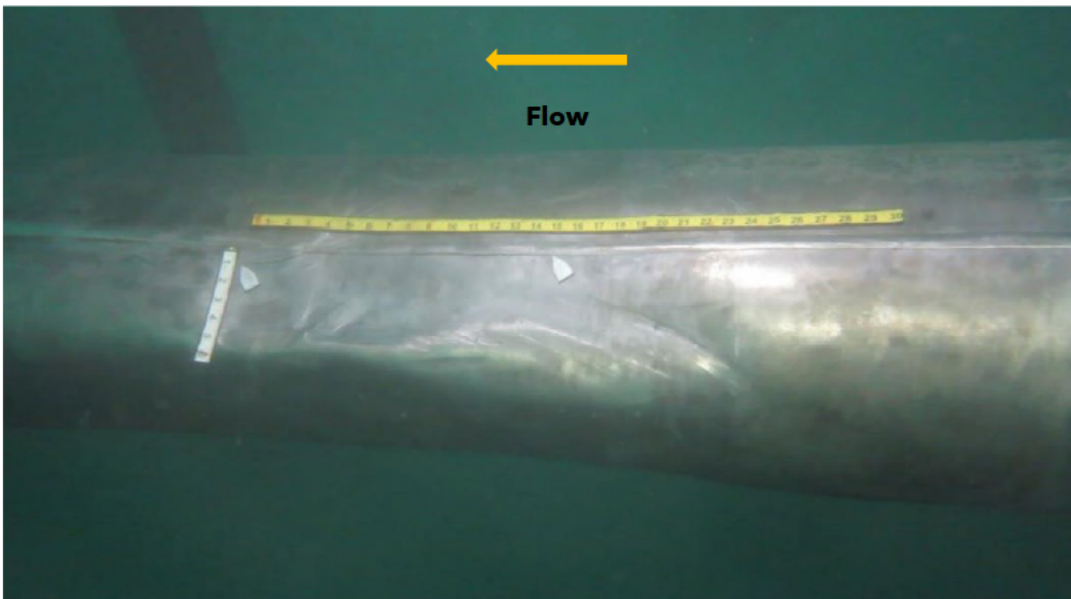
Figure 14. Underwater view of the San Pedro Bay Pipeline with the coating removed showing damage to the pipe. A flat spot was indicated that measured at 7-1/2 inches from the start of the linear indication. Photograph by Aqueos, October 19, 2021.

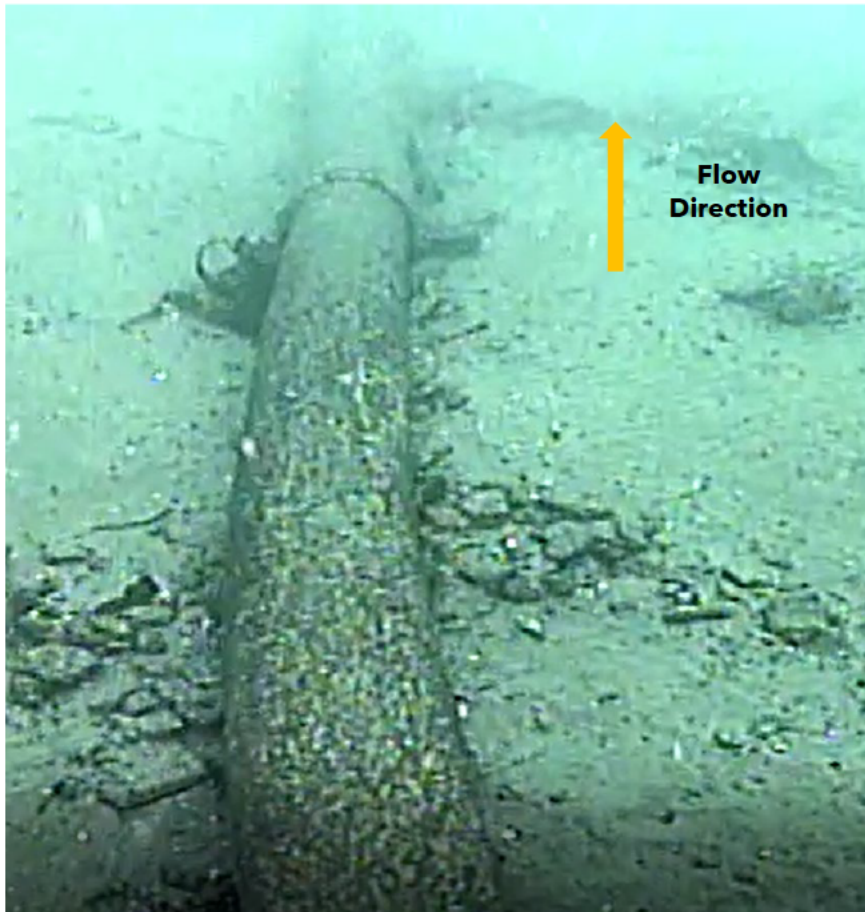
The ROV survey showed seven areas where the concrete coating had come off the pipe and bare steel was exposed. The survey covered 8,000 feet of pipeline, with no indications of oil released in those other areas. The previous ROV survey conducted in May 2020 showed no significant damage to the concrete casing along the full-

Figure 15. San Pedro Bay Pipeline with coating damage. Concrete coating can be seen sitting on the sea floor adjacent to the pipeline on both sides of the pipeline. Photograph by Beta Offshore.

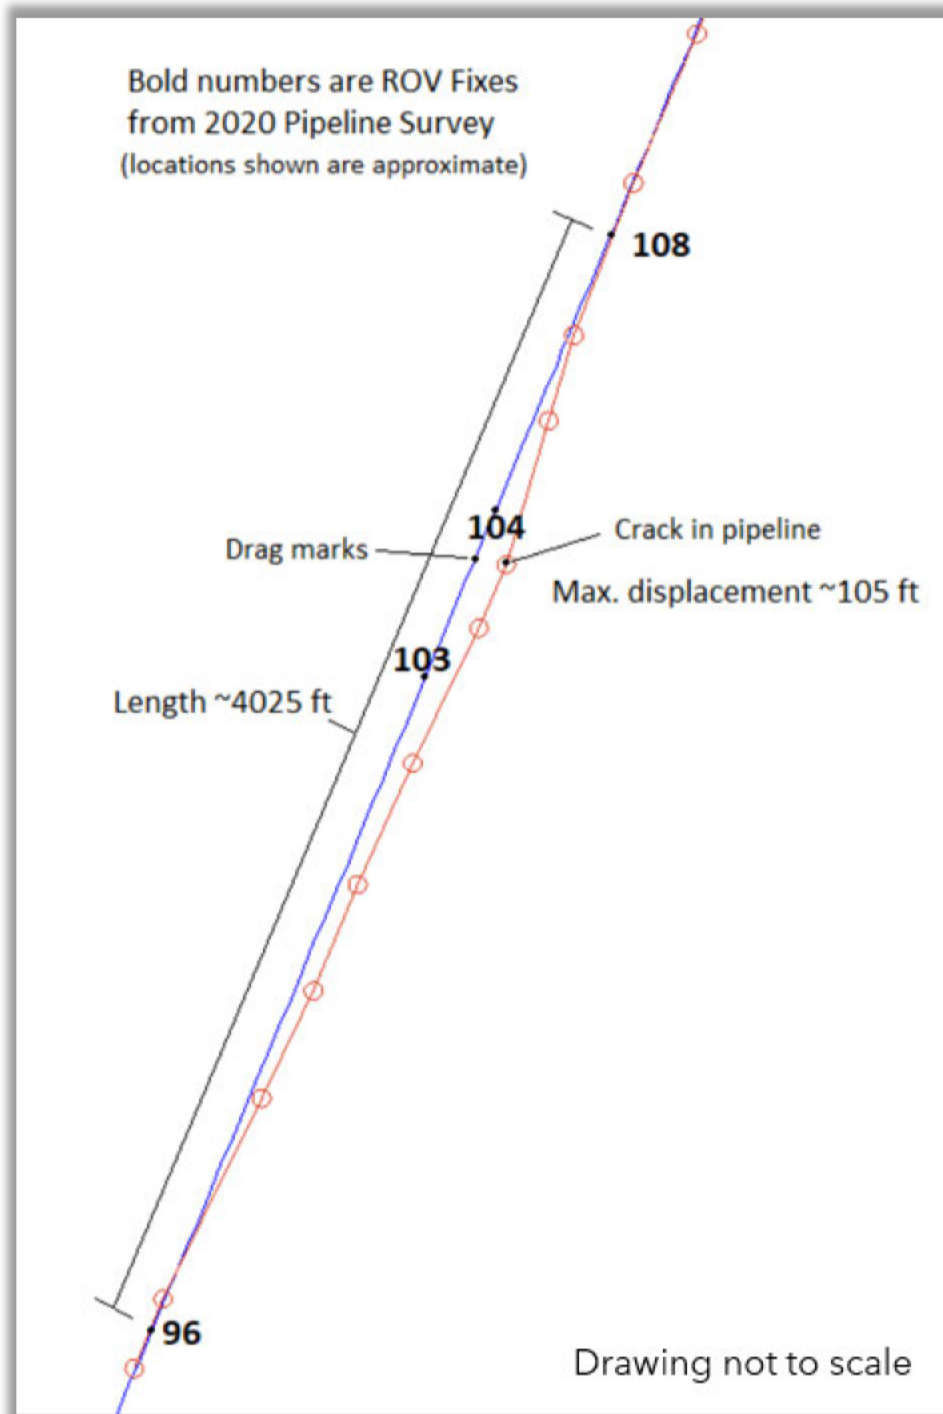
displacement of 105 feet over a portion of the pipeline from its original position on the right-of-way, and there was evidence of seabed scars/scouring adjacent to and in the vicinity of the damage (Figure 16). In the previous ROV survey the pipeline was positioned in the ROW.

Figure 16. Drawing of the San Pedro Bay Pipeline showing a 105-foot displacement from its original position on the Right-Of-Way. Illustration by Beta Offshore.

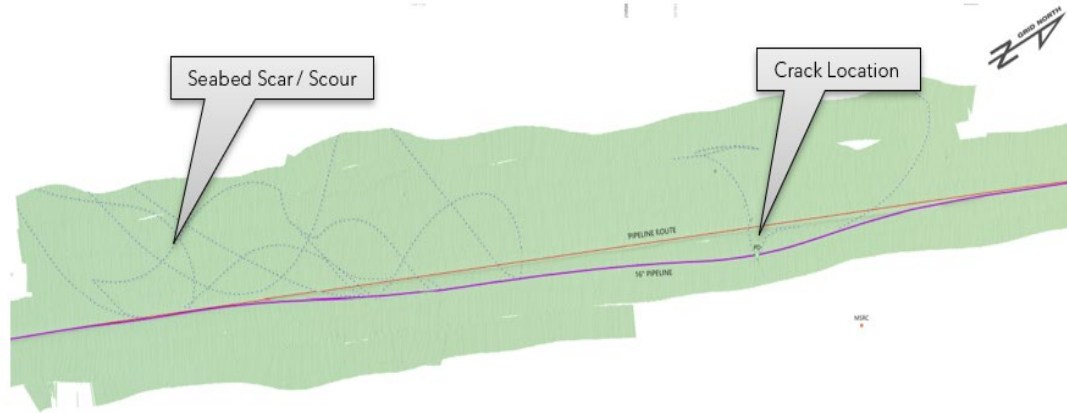
The survey identified several instances of seabed scarring/scouring at and near the pipeline as illustrated in Figure 17.

Figure 17. San Pedro Bay Pipeline original location and displacement. Scarring is noted by the dotted line in this graphic. Graphic by Beta Offshore.

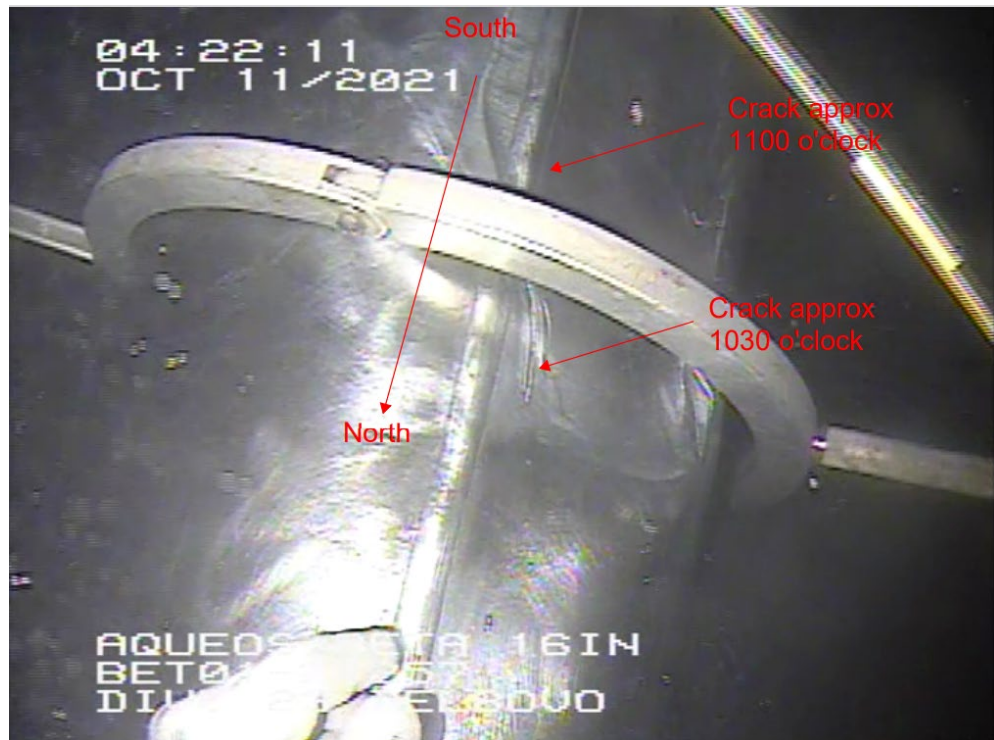
Beta Offshore’s contractor completed a detailed underwater pipeline survey on October 22, 2021, that reviewed the crack and pipe damage. They visually inspected over 4,000 feet of pipeline that had been displaced from its original location out to the end of the ROW limits. Crews conducted nondestructive testing utilizing ultrasonic and magnetic particle inspection of the failed section of pipeline.²⁹ They found indications of a crack with an overall measured length of 21- 3/8-inches. The longitudinal weld was located at the 11:00 o’clock position relative to the pipe at the failure location.³⁰ The circumferential profile showed the pipeline was out of round with a convex (dented) segment at the crack location. The crack was found at 10:30 through 11:00 o’clock position relative to the pipe facing north, and below the weld seam. See Figure 18. A punch mark was added to south side of linear indication to prevent further cracking and denotes the end of indication.

Figure 18. San Pedro Bay Pipeline Non-Destructive testing showing the crack location on the pipe. Photograph by Aqueos, October 11, 2021.

The contractor originally identified the crack required a repair and replacement. Inspectors found other anomalous indications during the review. On the other locations to the south of the crack, they conducted engineering analysis on the pipeline to prepare for temporary and permanent repairs.

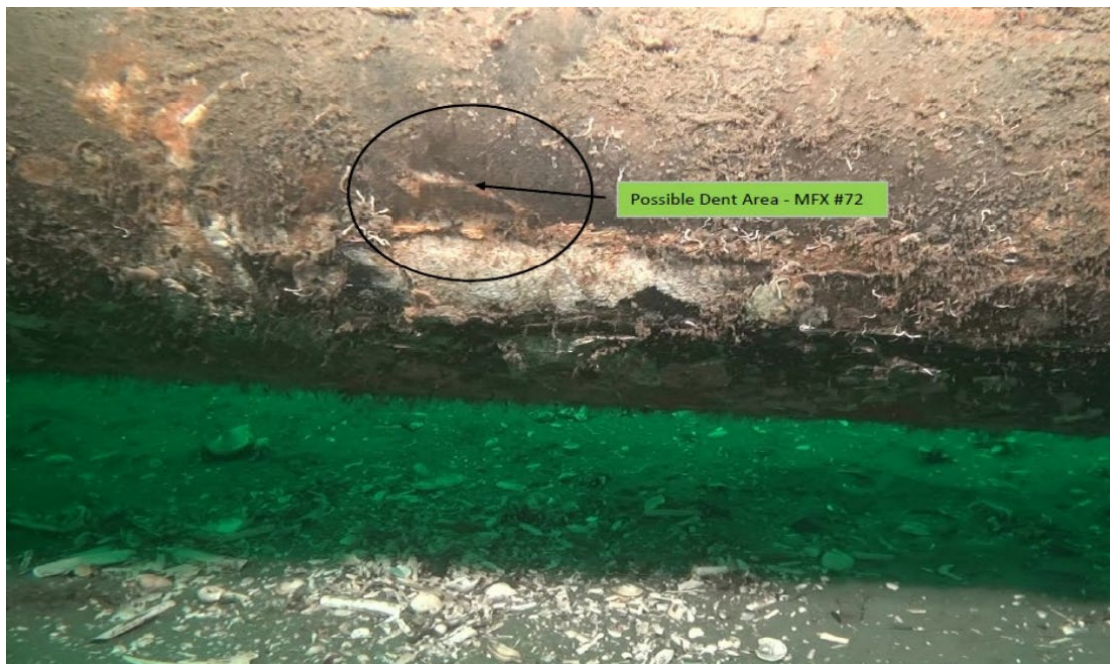
Figure 23. The October 2021 ROV survey showed a possible dent with missing coating. Photograph by Aqueos, October 15, 2021.
