**NATIONAL TRANSPORTATION SAFETY BOARD
OFFICE OF RAILROAD, PIPELINE, AND HAZARDOUS MATERIALS
INVESTIGATIONS
WASHINGTON, D.C. 20594**

**Pipeline Operations Group
Factual Report**

**Propane Pipeline Strike Near the EPIC Dock, Corpus Christi Ship Channel
Corpus Christi, Texas**

**NTSB# DCA20FM026
(99 Pages)**

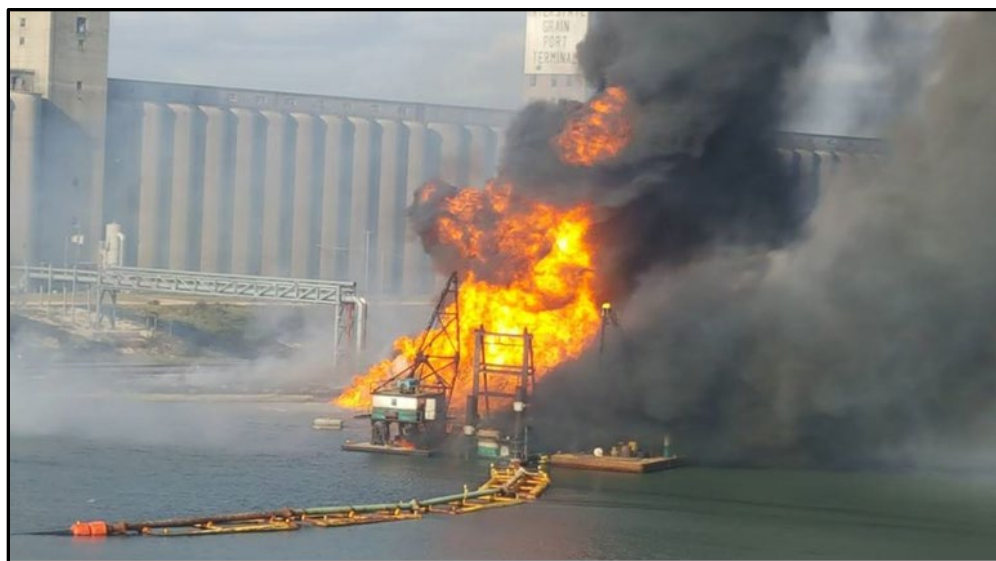
Figure 1. Accident scene, Corpus Christi Texas, August 21, 2020. USCG photograph.

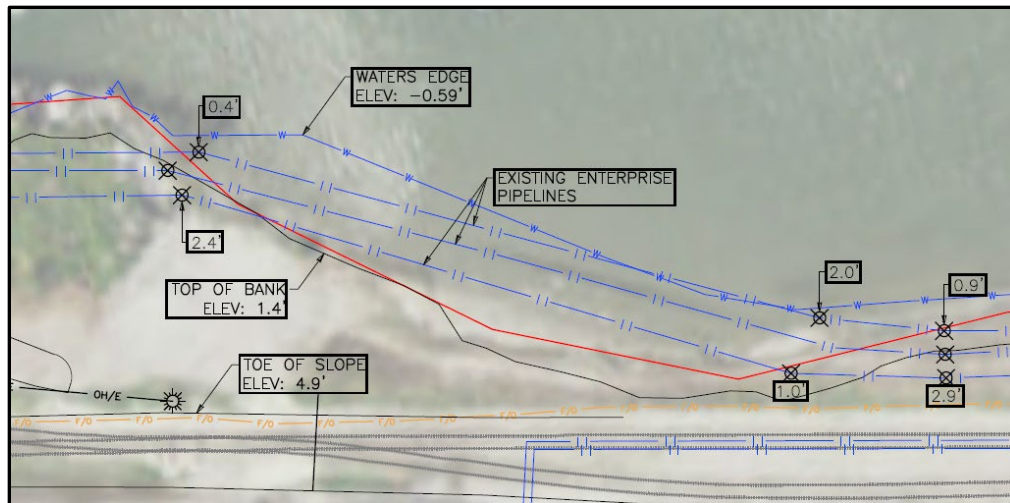
Figure 4. Excerpt of TMI Solutions LLC Survey of Existing Pipelines, EPIC POCCA Terminal, December 28, 2018. The numbered boxes indicate depth of cover on land. The blue water's edge line is Mean Lower Low Water.

On December 28, 2018, the TMI Solutions LLC depth of cover survey found the pipeline had 0.4 feet of cover on the west end of the water exposure at the point where the pipeline transitioned back onto land nearest the accident location. The pipeline had 2.0 feet of cover at the east end of the waterborne segment (see Figure 4, Section 5.1.1 of this report).

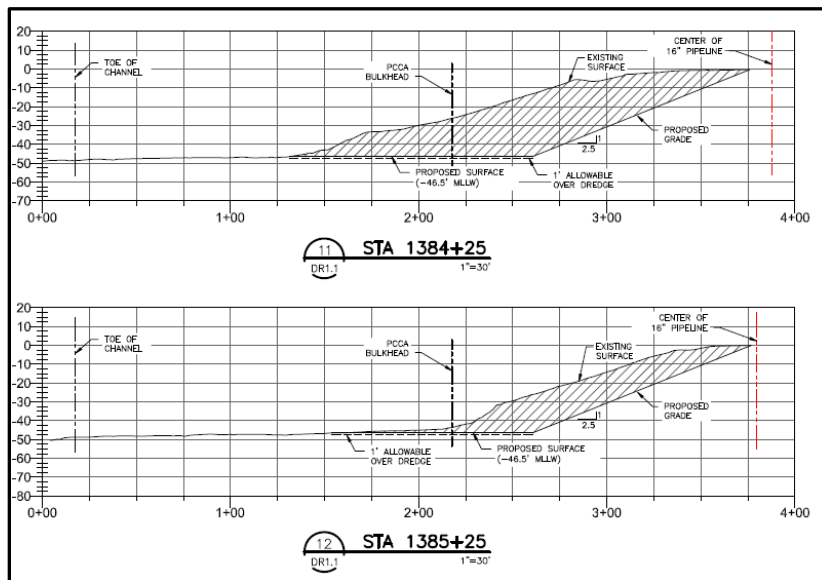
Figure 6. Excerpt of Schneider Engineering & Consultants EPIC Dock cross sections drawing prepared on August 24, 2020 from December 28, 2018 hydrographic survey data, indicating the closest proximity of Enterprise Products pipeline TX219 as determined by the design engineer and identified by a red line on the right side of each cross section. The hatched area denotes material to be dredged. The horizontal scale is shown in 25-foot increments. The design engineer reported that these drawings were the basis for his determination the pipeline clearance was 8 to 10 feet.

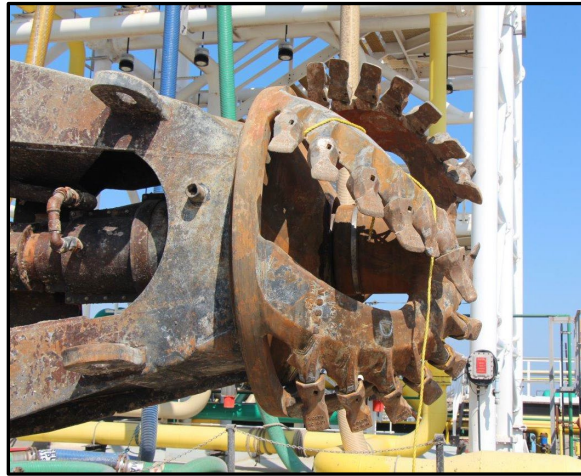
Figure 8. Post-accident photograph of the dredge *Waymon Boyd* cutterhead, September 17, 2020, courtesy U.S. Coast Guard.

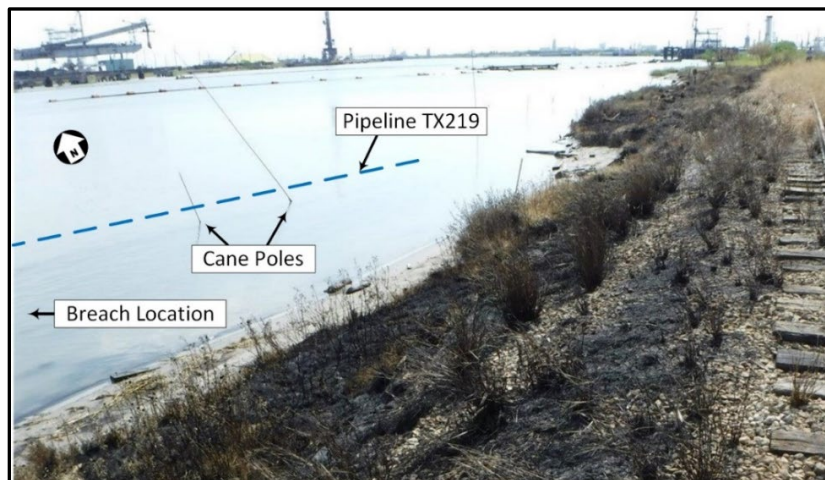
Figure 18. Annotated August 22, 2020 U.S. Coast Guard photograph of the accident scene showing two cane poles that had been placed on the shore-side of pipeline TX219. The right cane pole was identified as GPS 2289 in the subsequent Enterprise Products GPS survey of pipeline markers. The

breached pipe location is left of this image. The approximate location of TX219 is indicated by the dashed line.

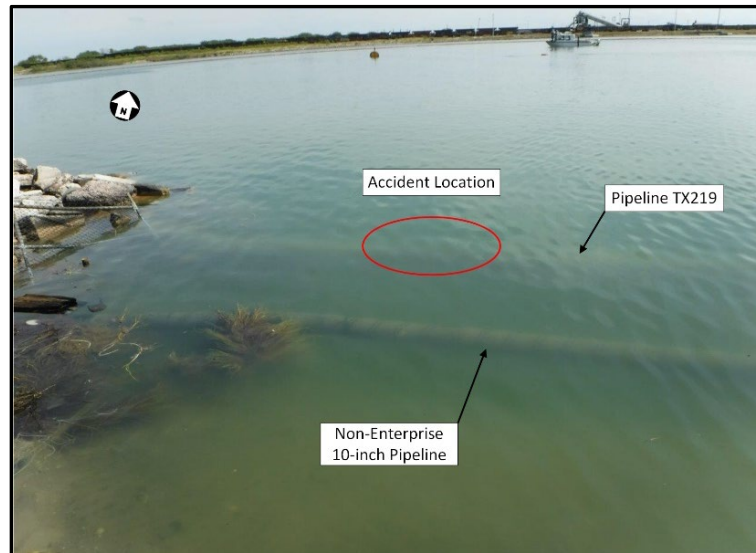
Figure 19. Approximate accident location showing two pipelines visible beneath the water surface. The furthest channelward is pipeline TX219. Closer to shore is a non-Enterprise Products abandoned 10-inch pipeline. There were no surviving temporary pipeline markers at the breached pipeline location. August 22, 2020, courtesy U.S. Coast Guard.

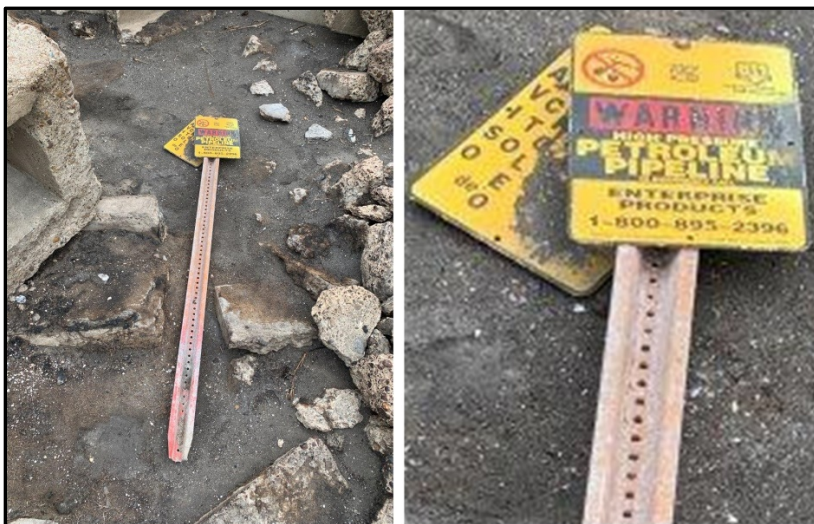
Figure 22. Downed permanent pipeline marker (GPS 2281-2282) near the accident location, September 14, 2020, U.S. Coast Guard photo.

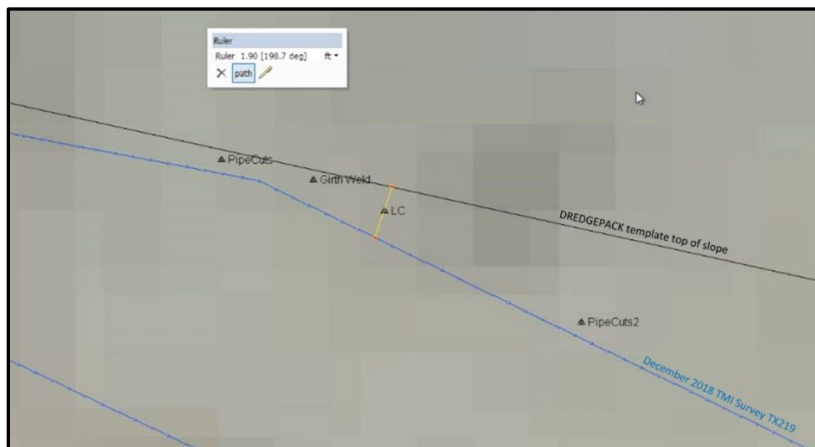
NTSB investigators also measured the distance in the HYPACK module between pipeline TX219 at the accident location as determined in the TMI LLC December 28, 2018 survey to the south border of the dredge template, finding a separation of 1.90 feet (Figure 27). Similarly, the measured distance from the point of damage (point “LC” in Figure 27) to the dredge template as determined from the 2016 ILI location data for the pipeline was 0.98 ft.

Figure 27. Distance measurement in the HYPACK 2018 module from the TMI Solutions LLC, December 28, 2018 pipeline TX219 survey location (blue line) to the edge of the Orion Group dredge template (black line) at the point of damage to the pipeline, or “LC” (location of contact 2’8” east of the girth weld), showing 1.90 feet of separation. The distance measured from point “LC” to the dredge template line was 0.98 feet. Courtesy HYPACK, a Xylem brand.

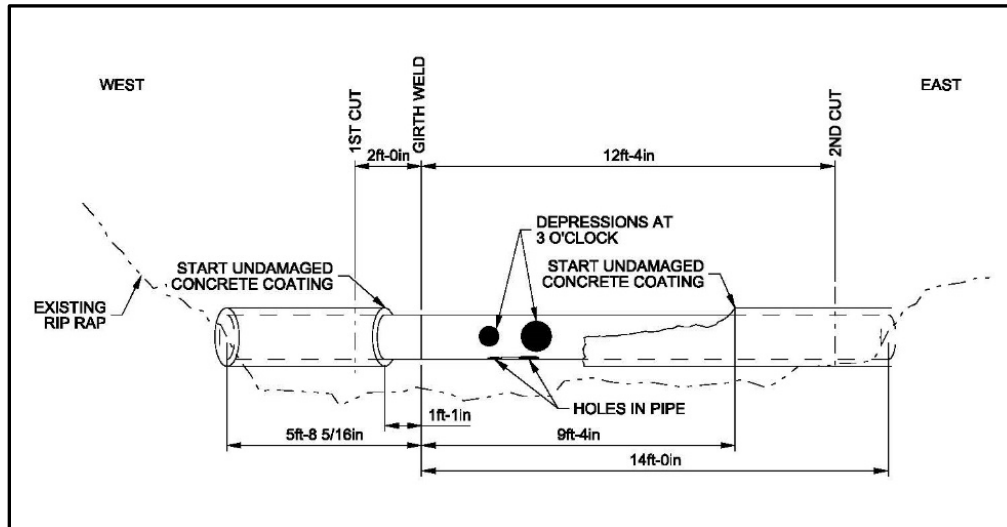
Figure 29. Drawing of the damaged pipeline segment and agreed upon location for cuts. Courtesy, Enterprise Products.

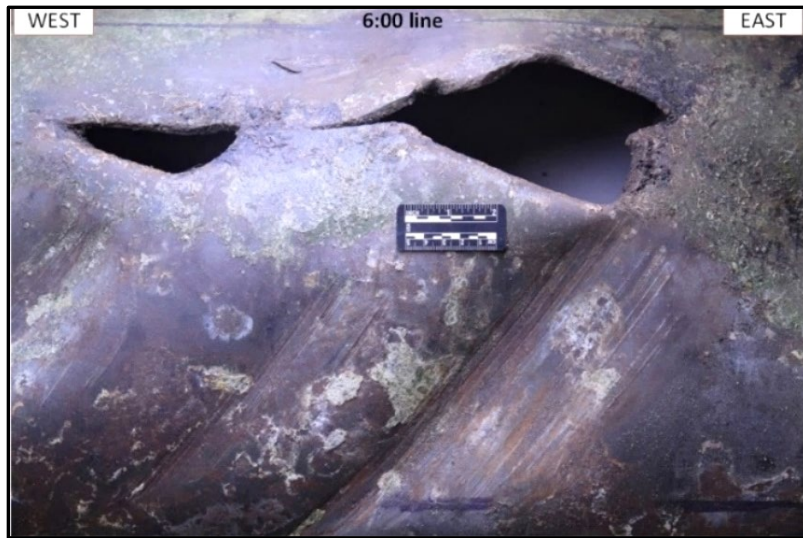
On December 10, 2020, upon uncrating the pipeline evidence at the NTSB laboratory facilities, investigators noted the pipeline segment damage consisted of five gouges, three dents, and two punctures with a fracture that intersected both punctures. Inward metal deformation, or lips of steel, were folded into the interior of the pipe (Figures 32 and 33). Pipe wall puncture damage was located between 31.3 inches and 45.5 inches east of girth weld 444000. All damage to the pipe, including punctures, gouges, dents, and fracture, occurred within a region between 25.5 inches and 57.8 inches east of girth weld 444000. As much as a 10-foot 5-inch length of the concrete coating was missing from the pipe in the general area of the damage (Figure 29). For further details of the pipeline segment and associated evidence examinations see NTSB Materials Laboratory Factual Report No. 21-022 contained in the docket for this investigation.

Figure 32. Pipeline breaching damage, exterior pipe wall surface. NTSB preliminary examination photograph after superficial surface cleaning, December 10, 2020.

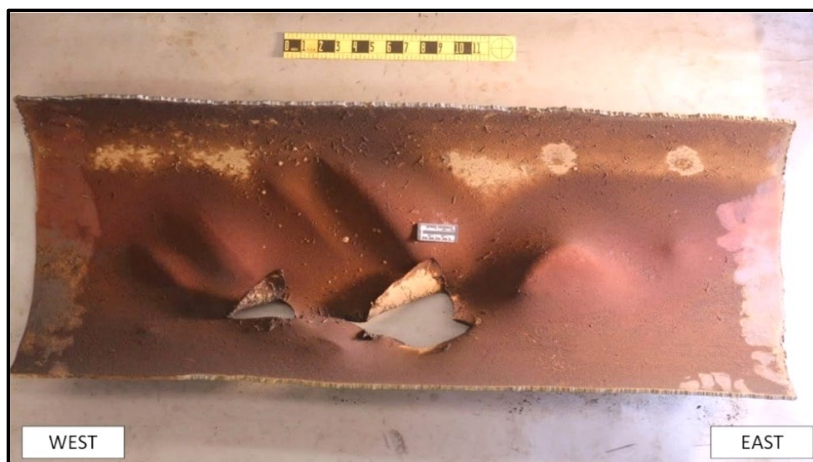
Figure 33. Interior surface of pipeline coupon encompassing all visible damage. NTSB preliminary examination photograph, December 10, 2020.
