National Transportation Safety Board

Group Chairman's Factual Report of the Investigation

Natural Gas Pipeline Rupture and Fire

Hillsboro, Kentucky

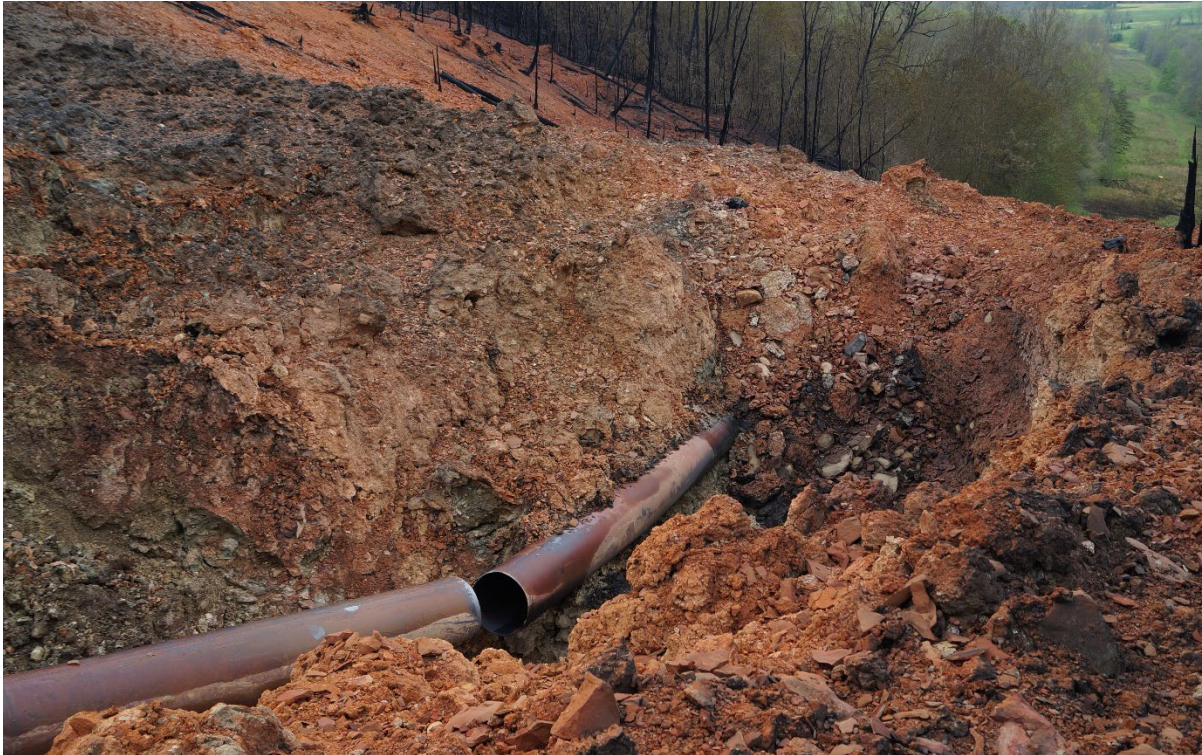
The pipeline rupture resulted in a fire which burned vegetation over approximately 5 acres of heavily forested land. The rupture occurred at a girth weld with no ejection of pipe. No structures were damaged.

Figure 4. Accident Site Post-Rupture, Taken 5/5/2020 (Courtesy of PHMSA)

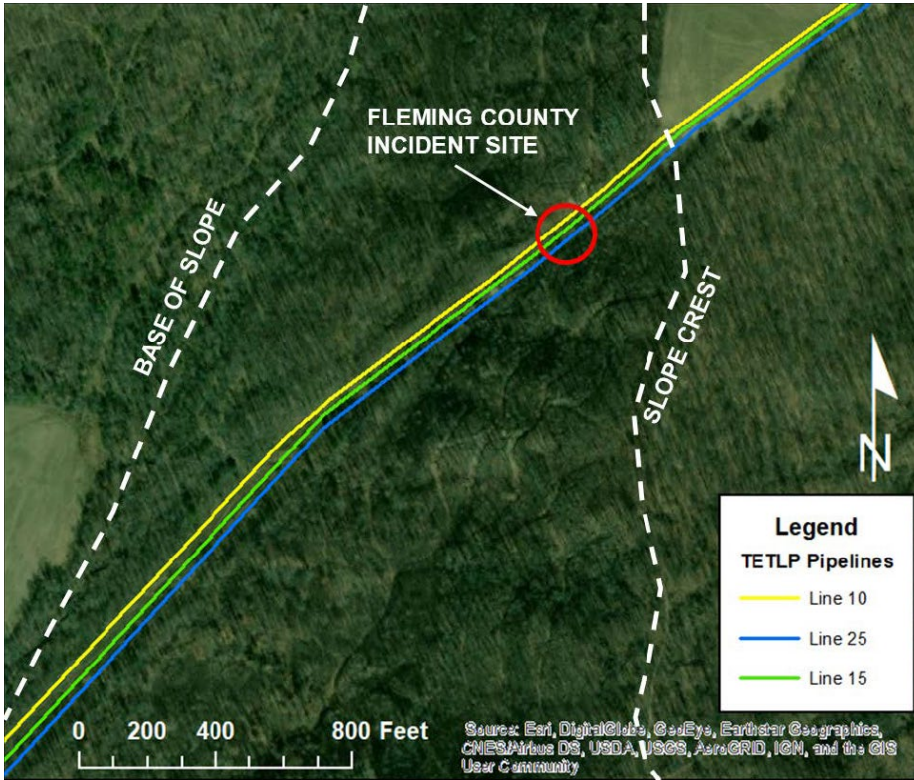
Figure 5. Accident Location (Identified as "Fleming County Incident Site")⁴

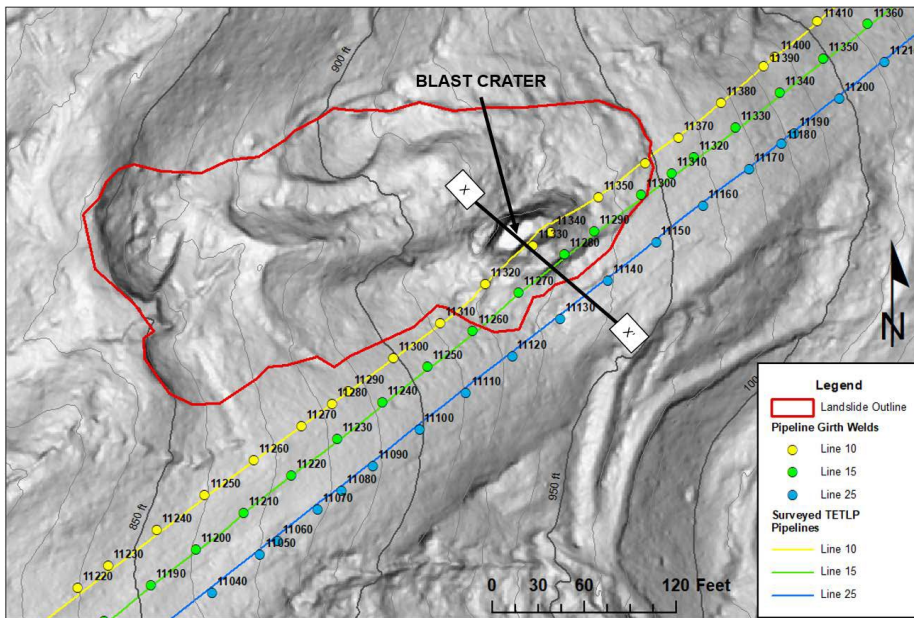
BGC performed field-based and desktop studies, concluding that Line 10 was installed within a landslide feature that was accelerating, causing a rapid increase in pipe strain in the months preceding the rupture. BGC indicated that the large acceleration in the 6 months prior to this accident was likely driven by a combination of high levels of precipitation, pre-existing cracks, additional ground water conveyance along the pipeline trenches, and loading associated with grading activities. The work BGC completed is summarized below.⁴

BGC mapped the landslide at the accident site by documenting and surveying ground cracks, scarps and toe bulges on and downslope of the pipeline corridor on May 7-9, 2020.⁵⁹ The approximate accident and landslide locations are shown in Figure 5 and Figure 6, respectively. A cross-section of the three pipelines near the rupture location is shown in Figure 7.

Figure 6. BGC Defined Landslide Location Relative to Lines 10, 15, and 25⁴

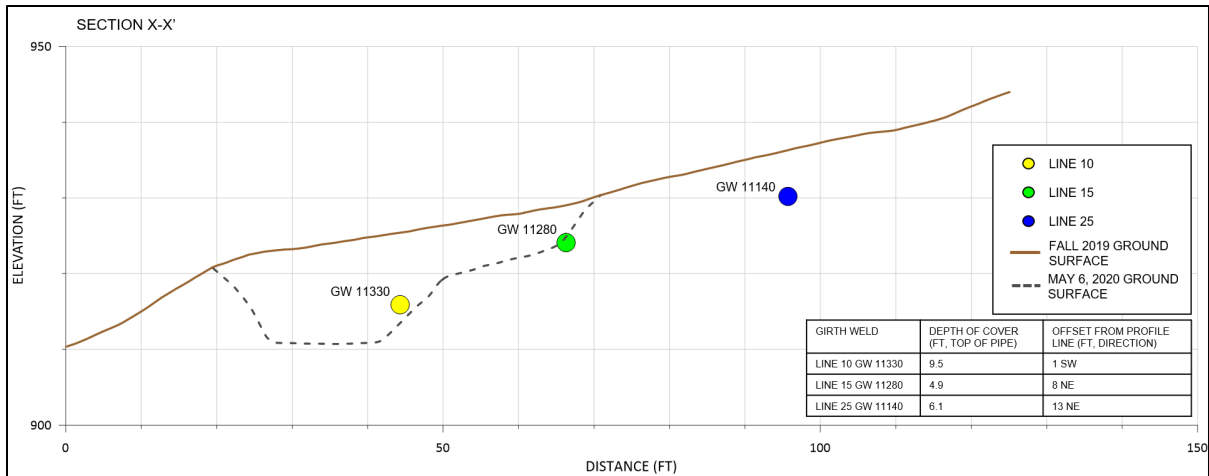
Figure 7. BGC Estimated Cross-Section of Line 10, 15, and 25, Corresponds to Figure 6⁴

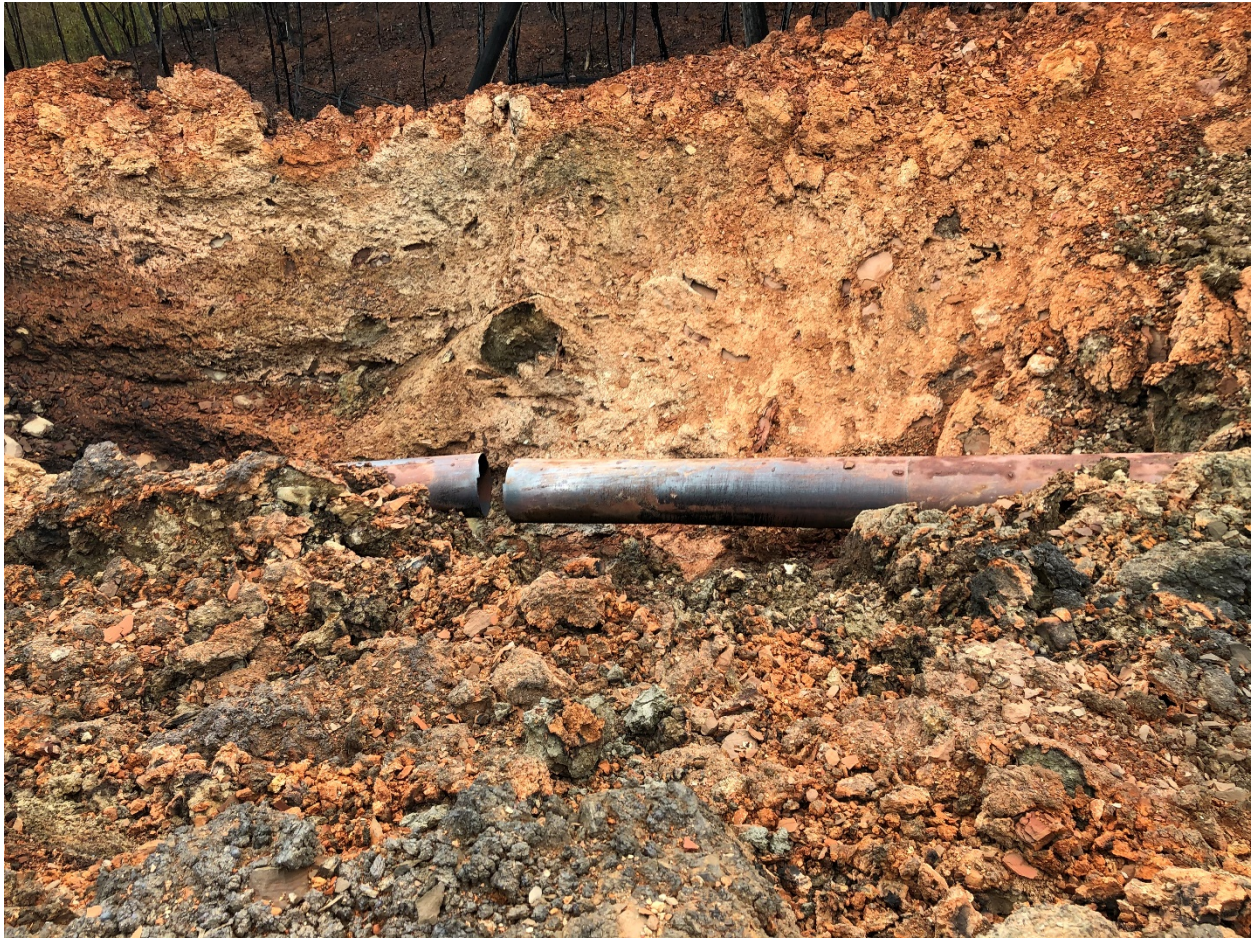
Based on the work completed by DNV and SES, DNV concluded that the girth weld failure was the result of ductile overload from forces induced by land movement that exceeded the tensile strain capacity of the weld.

Figure 8. Ruptured girth weld, taken May 5, 2020 at 12:11PM (Courtesy of Enbridge)

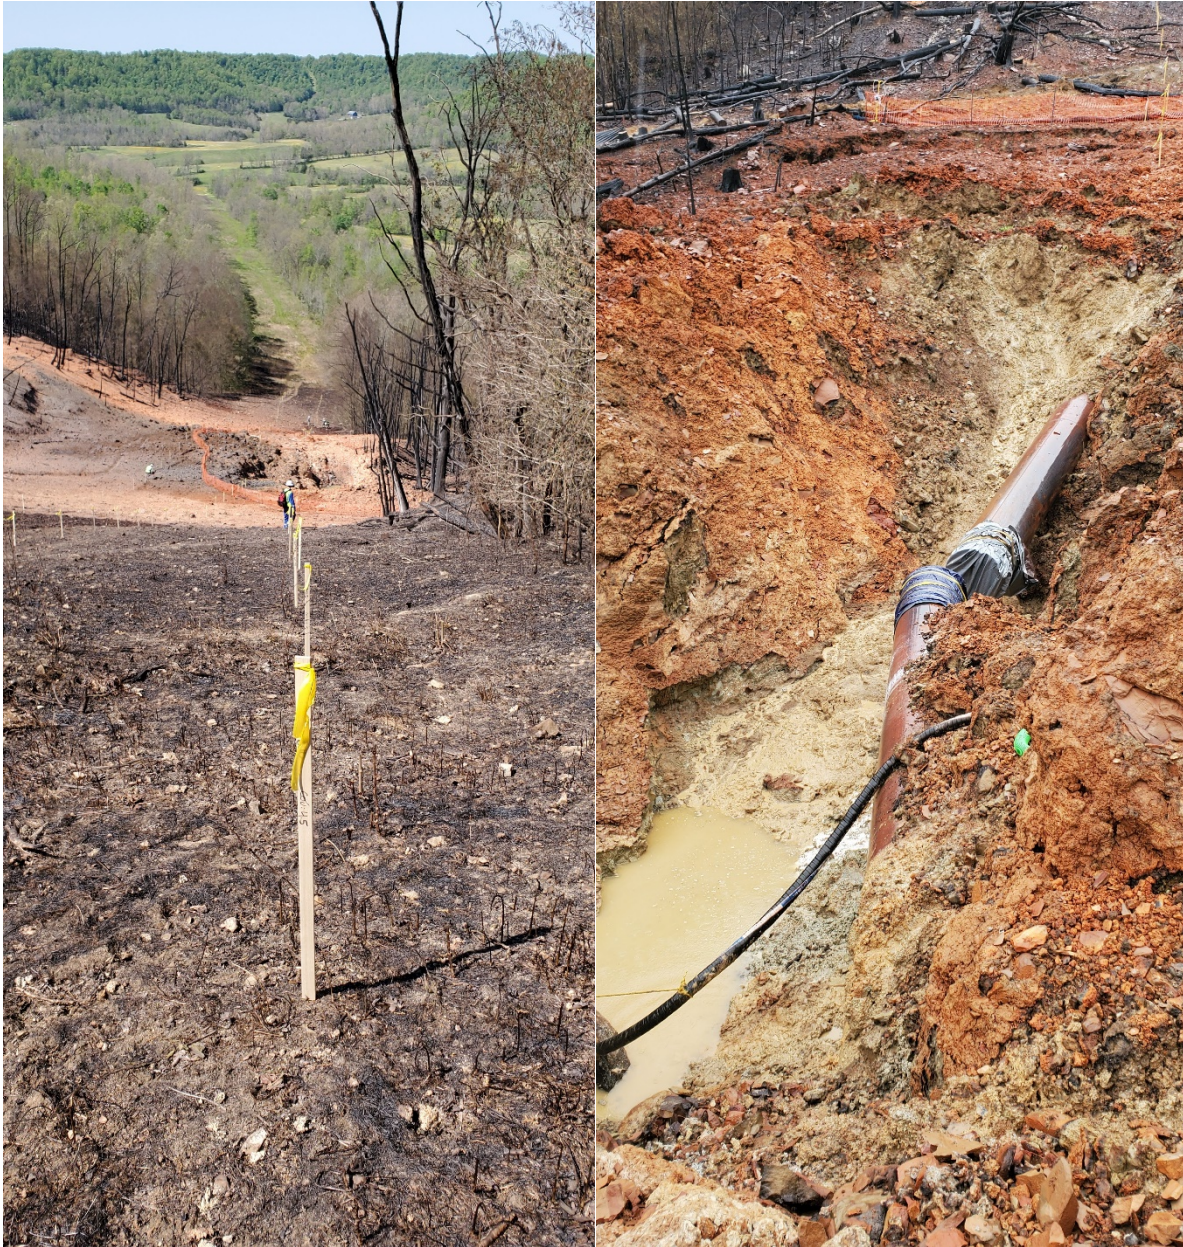
Figure 9. Left, Line 10 right-of-way after locating, taken May 7, 2020 at 11:21AM. Right, Line 10 failure location with fracture surfaces protected, taken May 8, 2020 at 2:48PM (Courtesy of BGC)

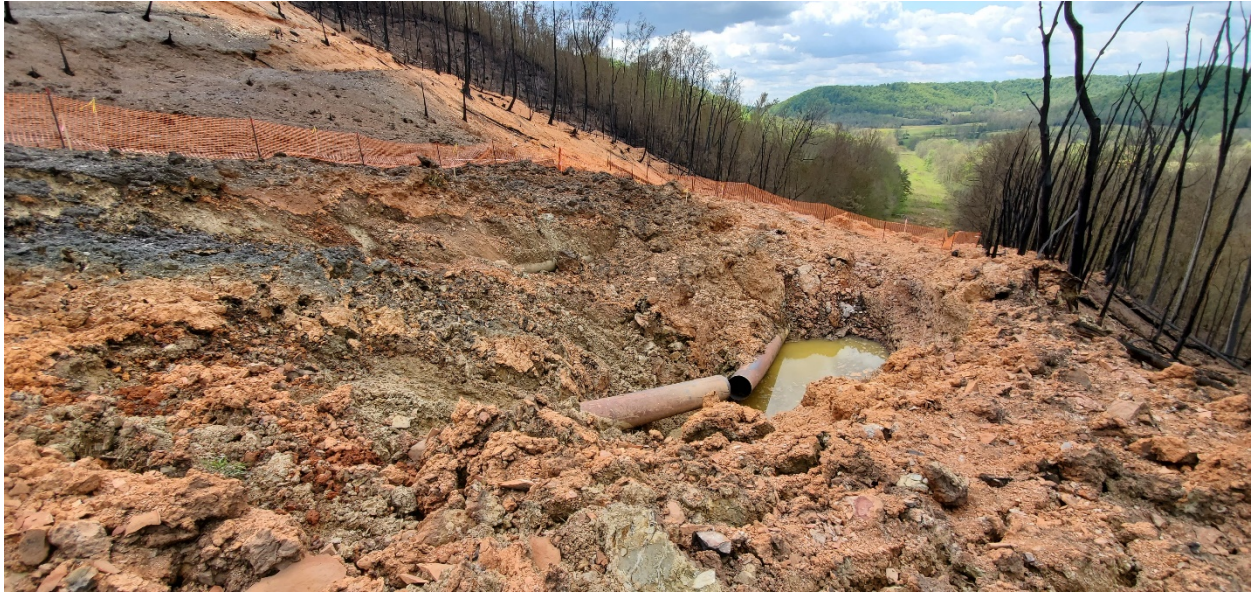
Figure 10. Site surrounding ruptured girth weld, taken May 7, 2020 at 1:42PM (Courtesy of BGC)

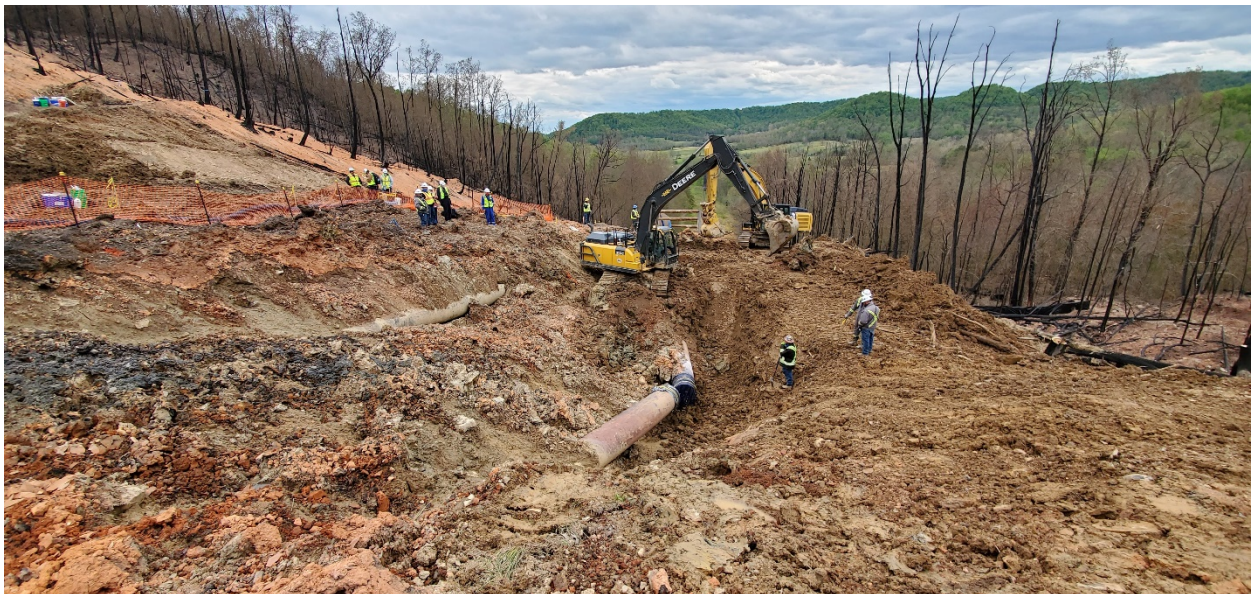
Figure 11. Site surrounding ruptured girth weld during excavation, taken May 11, 2020 at 4:57PM (Courtesy of BGC)
