**Fern Hollow Bridge Collapse Investigation**

**Photographs Used in Board Meeting Presentations**

**Pittsburgh, Pennsylvania**

**HWY22MH003**

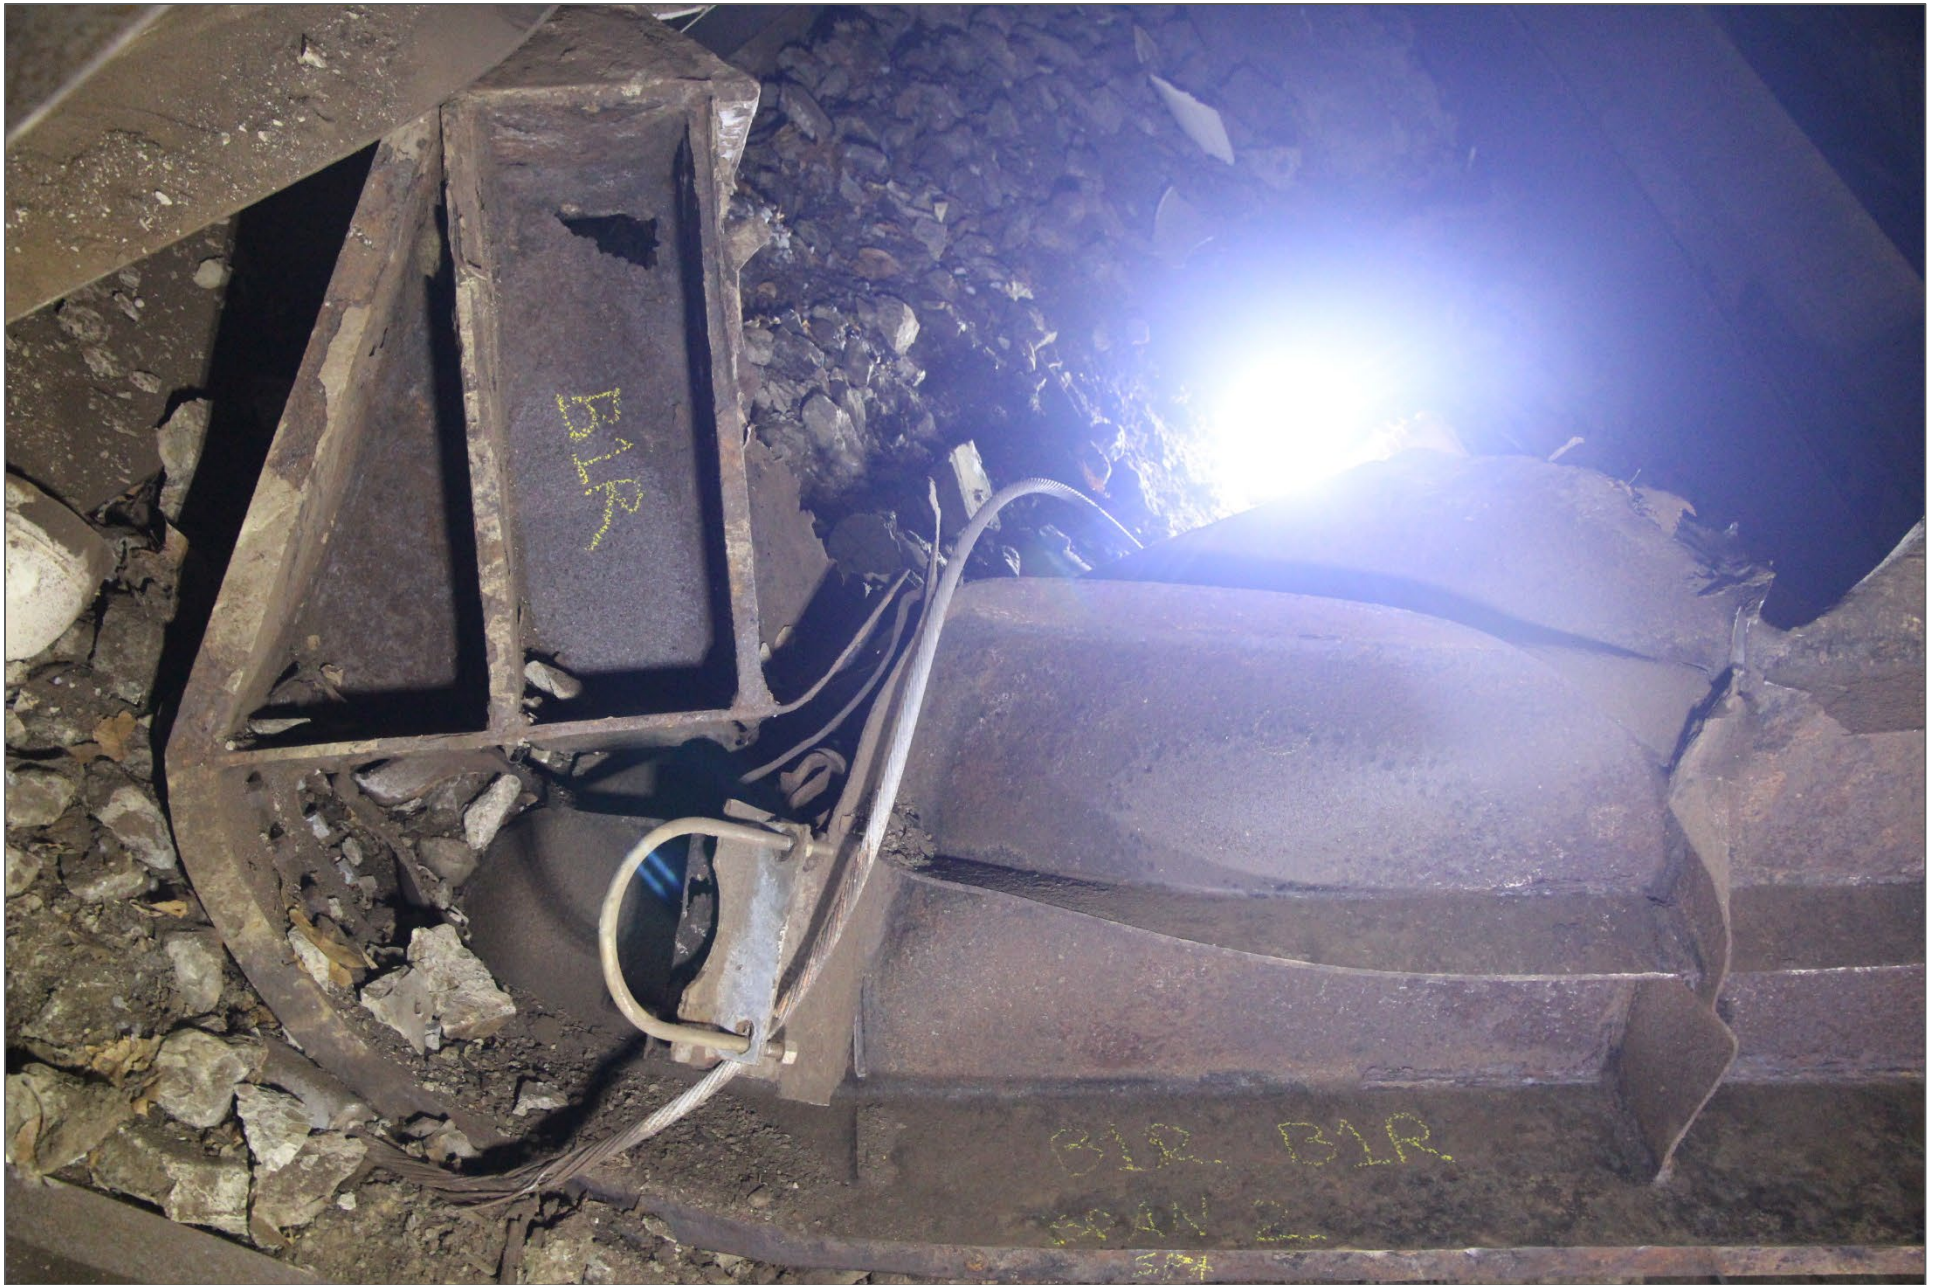
Materials Laboratory Photograph 1 – Southwest Leg Under Collapsed Structure

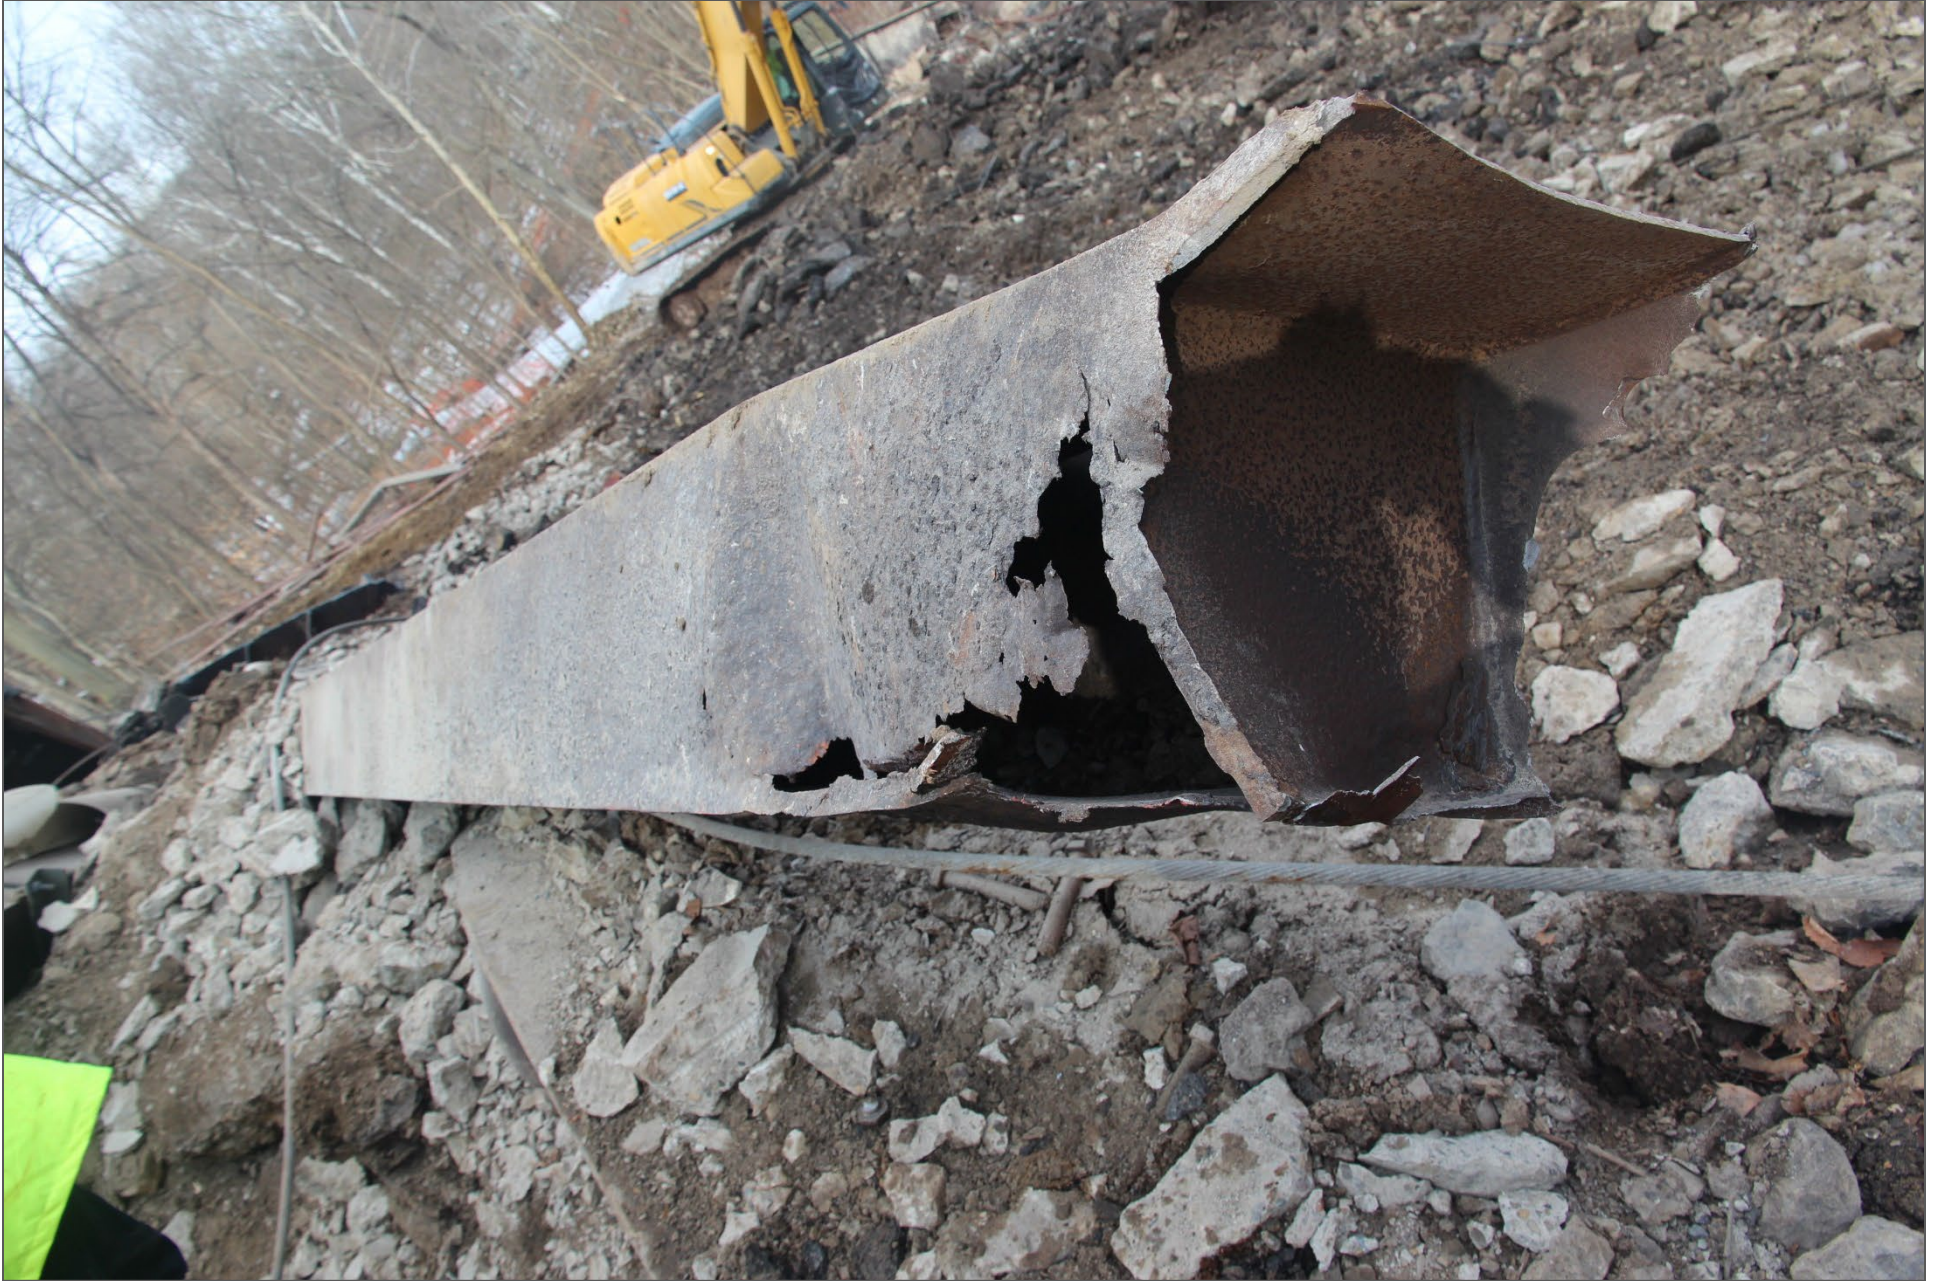
Materials Laboratory Photograph 2 – Portion of Upper Cross-Bracing on West End of Bridge

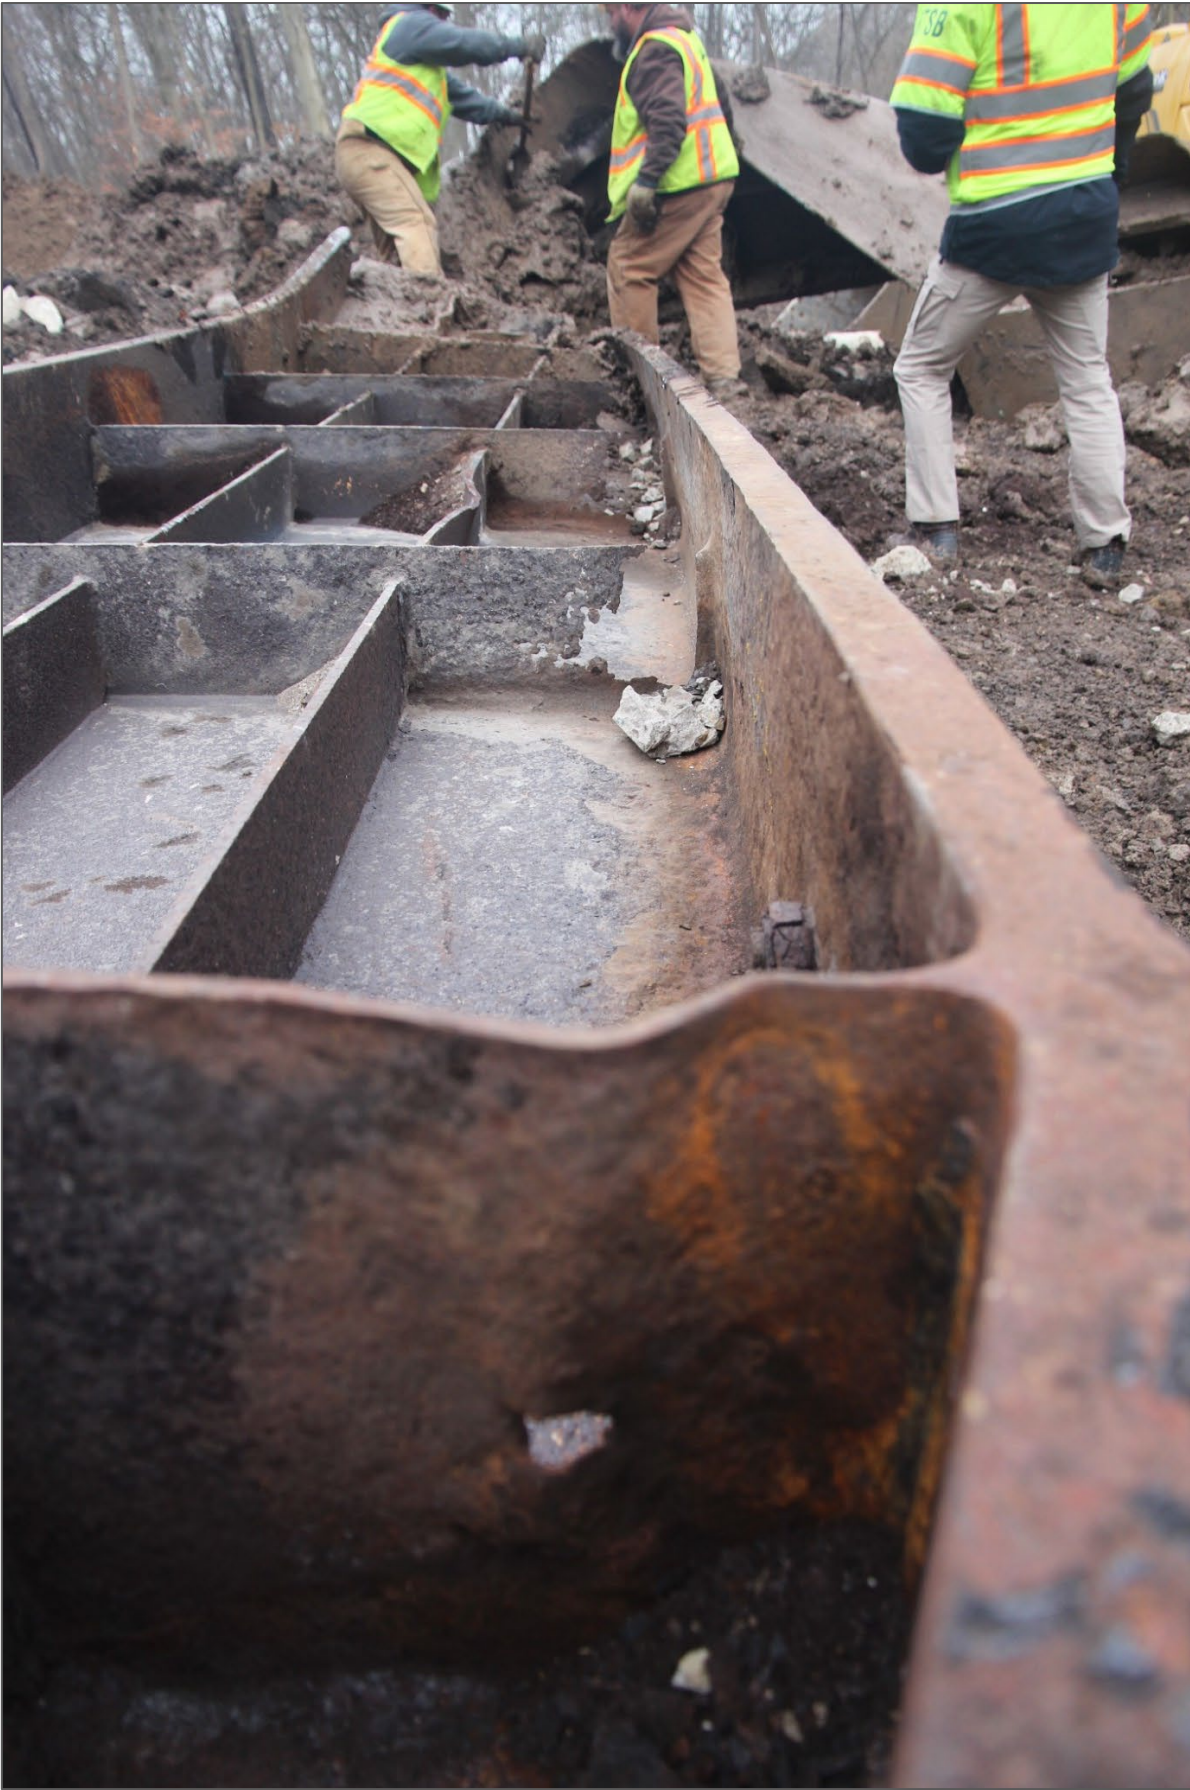
Materials Laboratory Photograph 3 – Northwest Leg Showing Longitudinal Stiffeners, Transverse Stiffeners, and Transverse Tie Plate

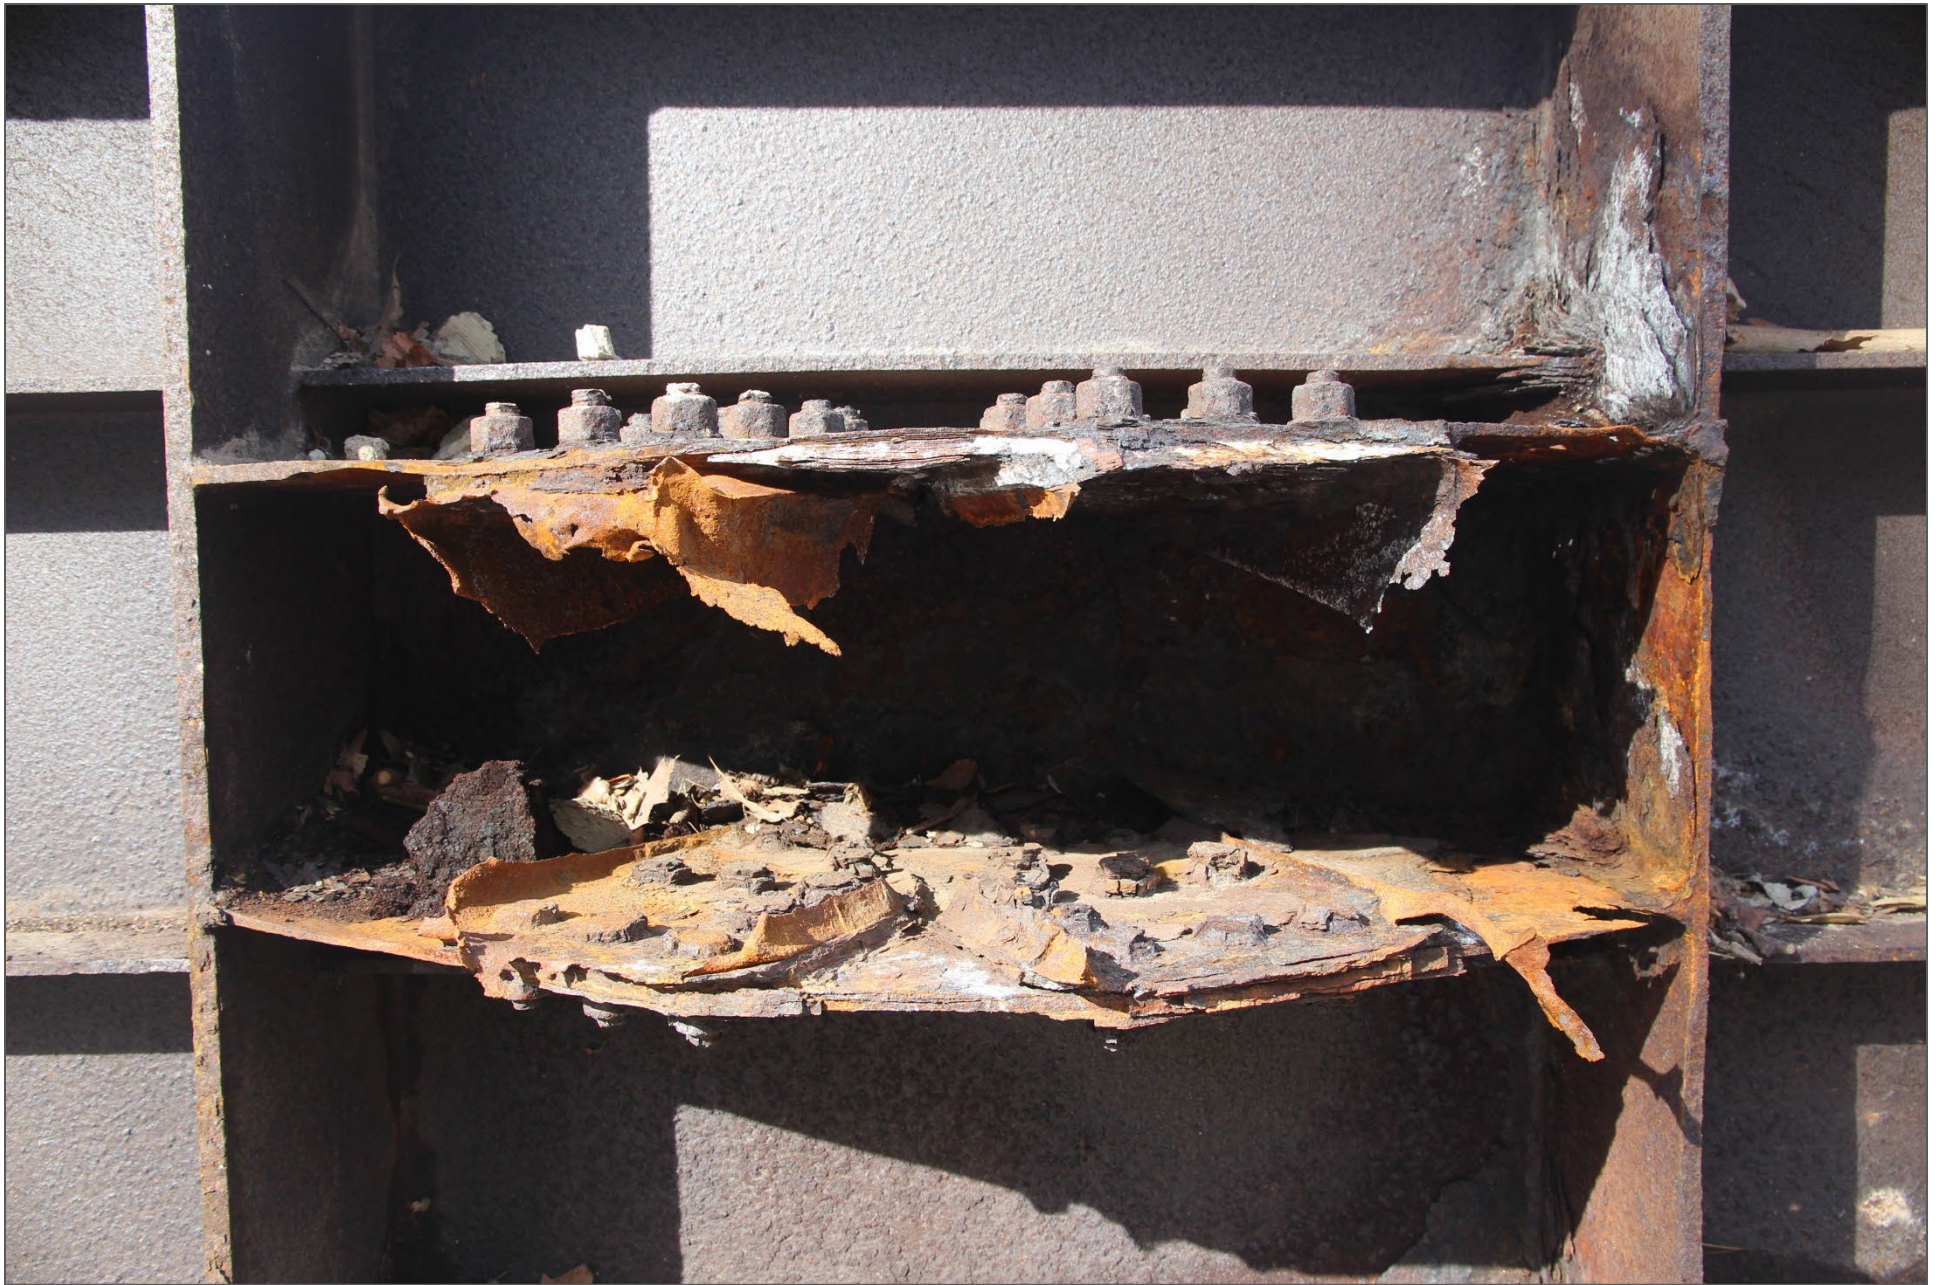
Materials Laboratory Photograph 4 – Northeast Leg, Mid-length Cross-brace Connection

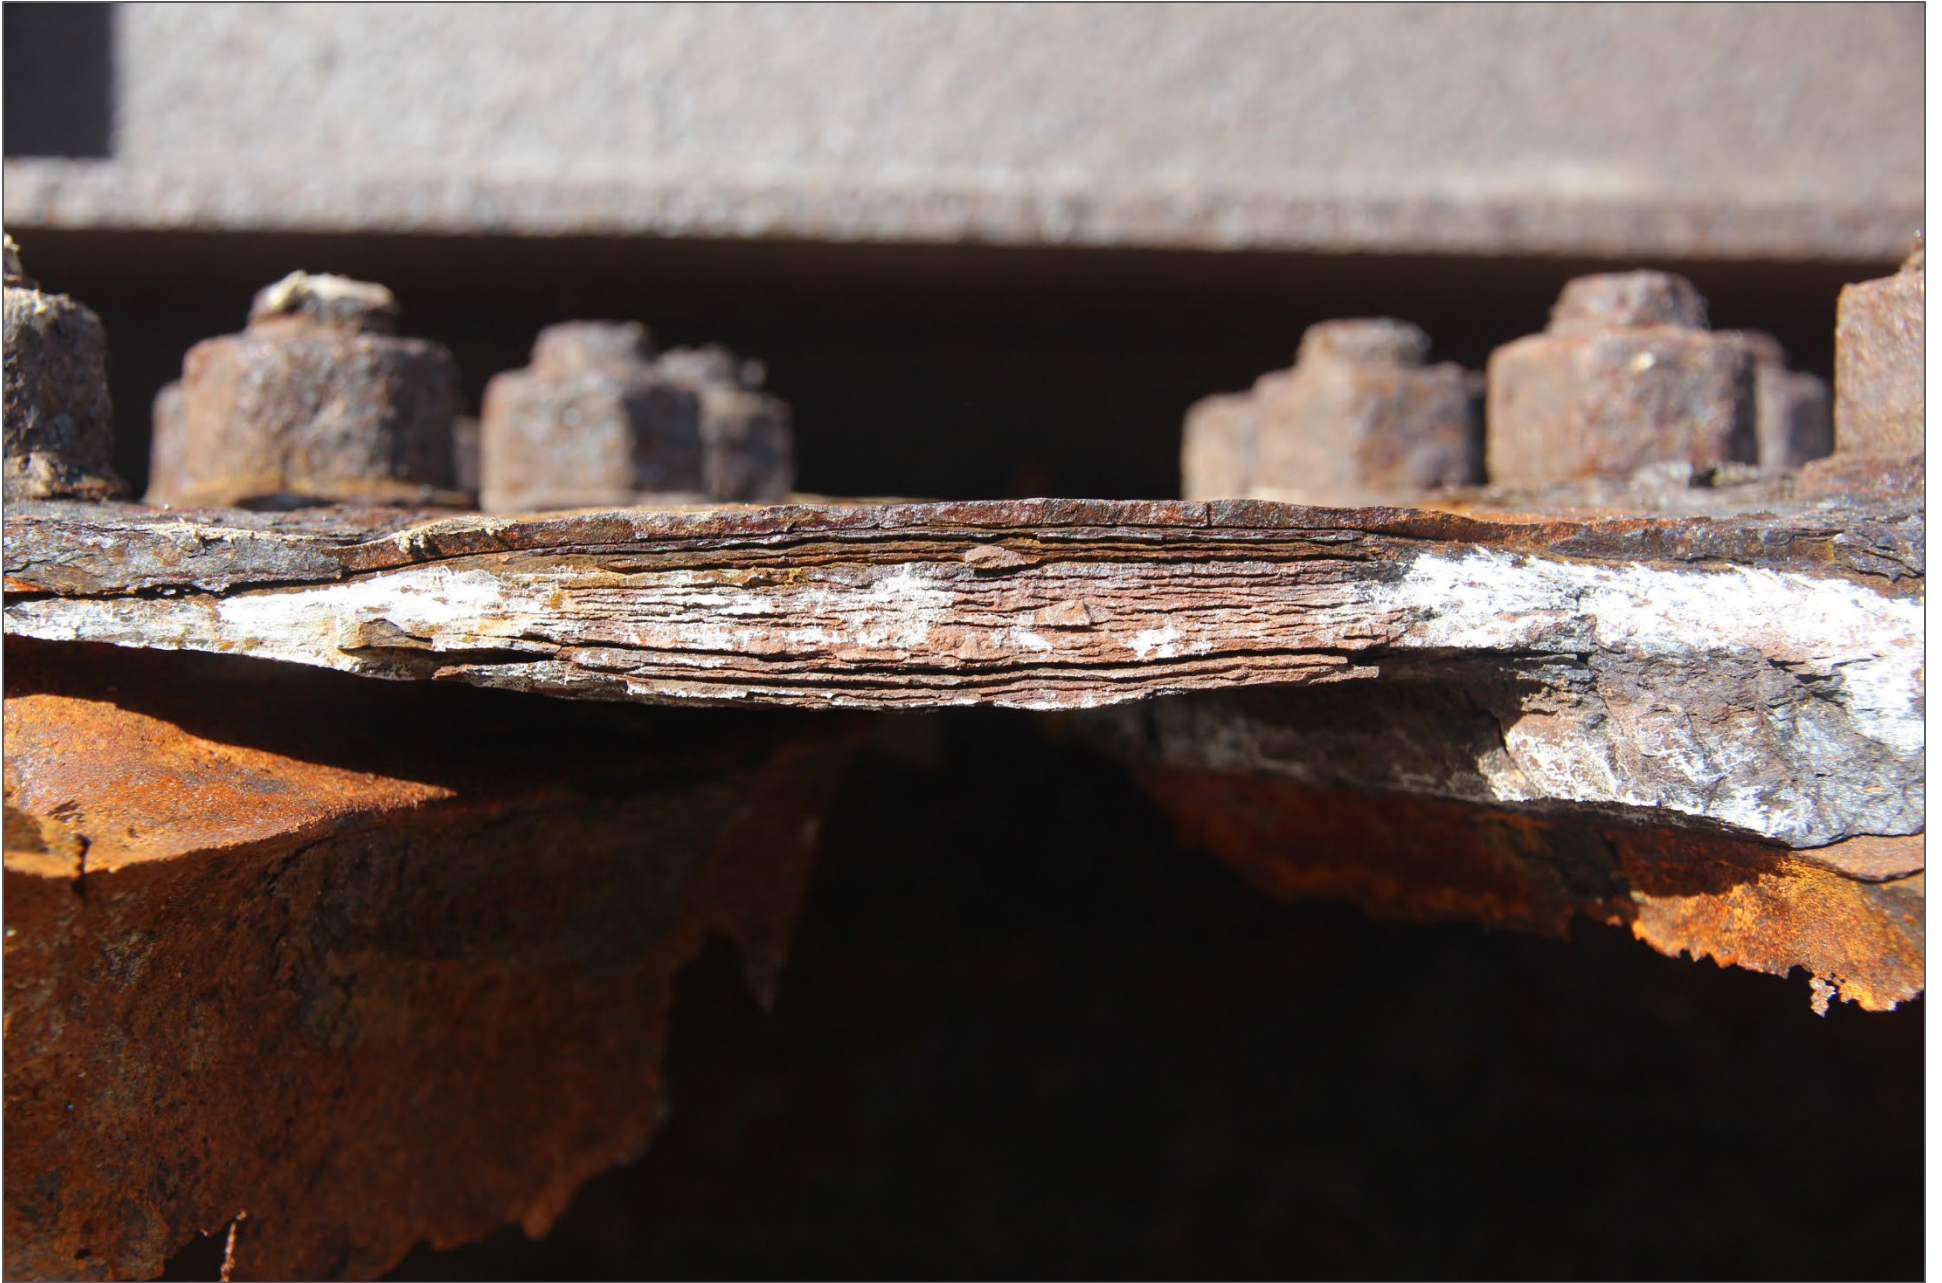
Materials Laboratory Photograph 5 – Closeup Image of Northeast Leg, Mid-length Cross-brace Connection

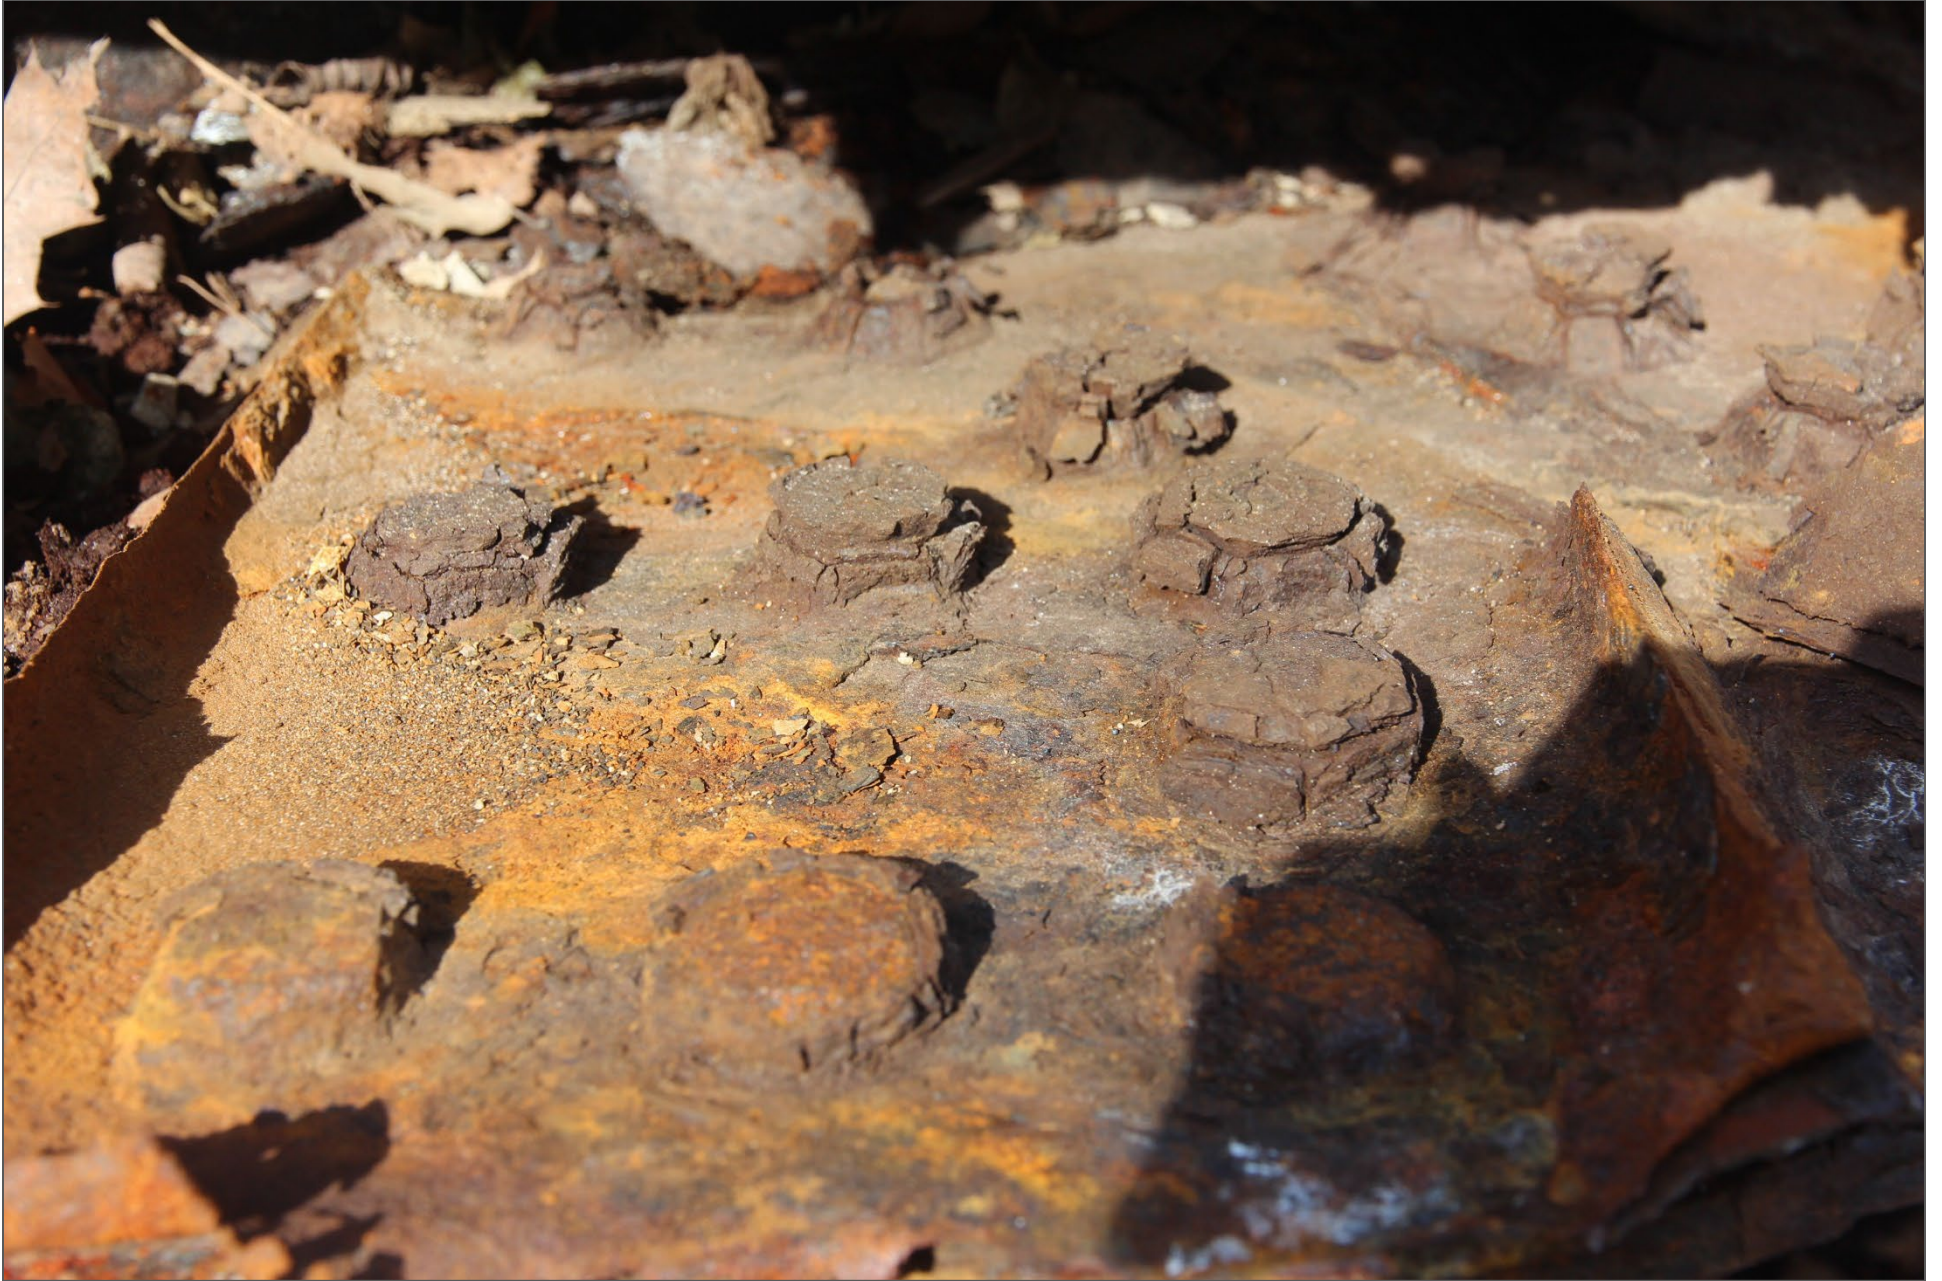
Materials Laboratory Photograph 6 – Closeup Image of Northeast Leg, Mid-length Cross-brace Connection

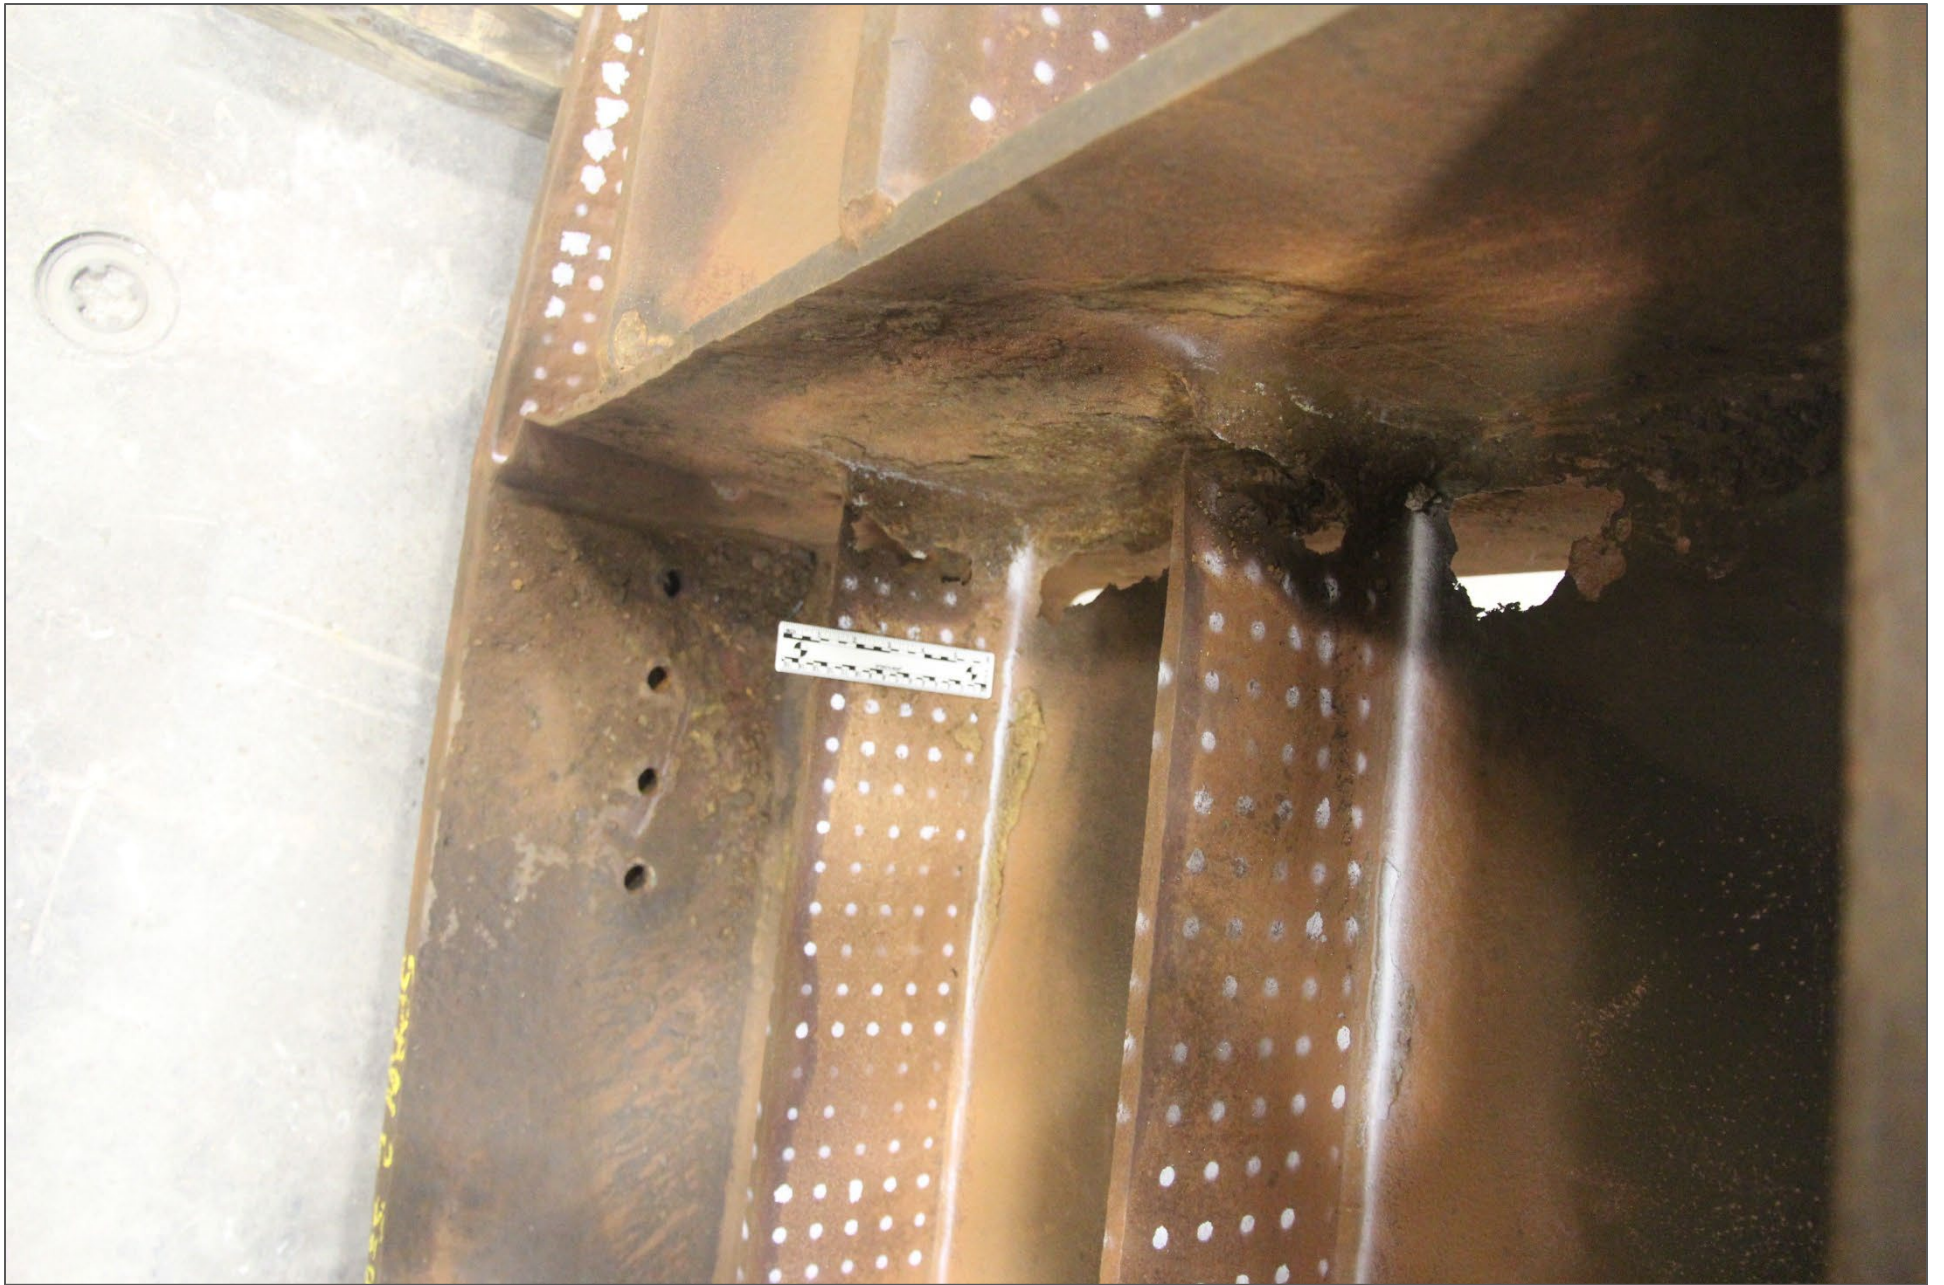
Materials Laboratory Photograph 7 – Northwest Leg, Showing Longitudinal Stiffeners Just Above Transverse Tie Plate

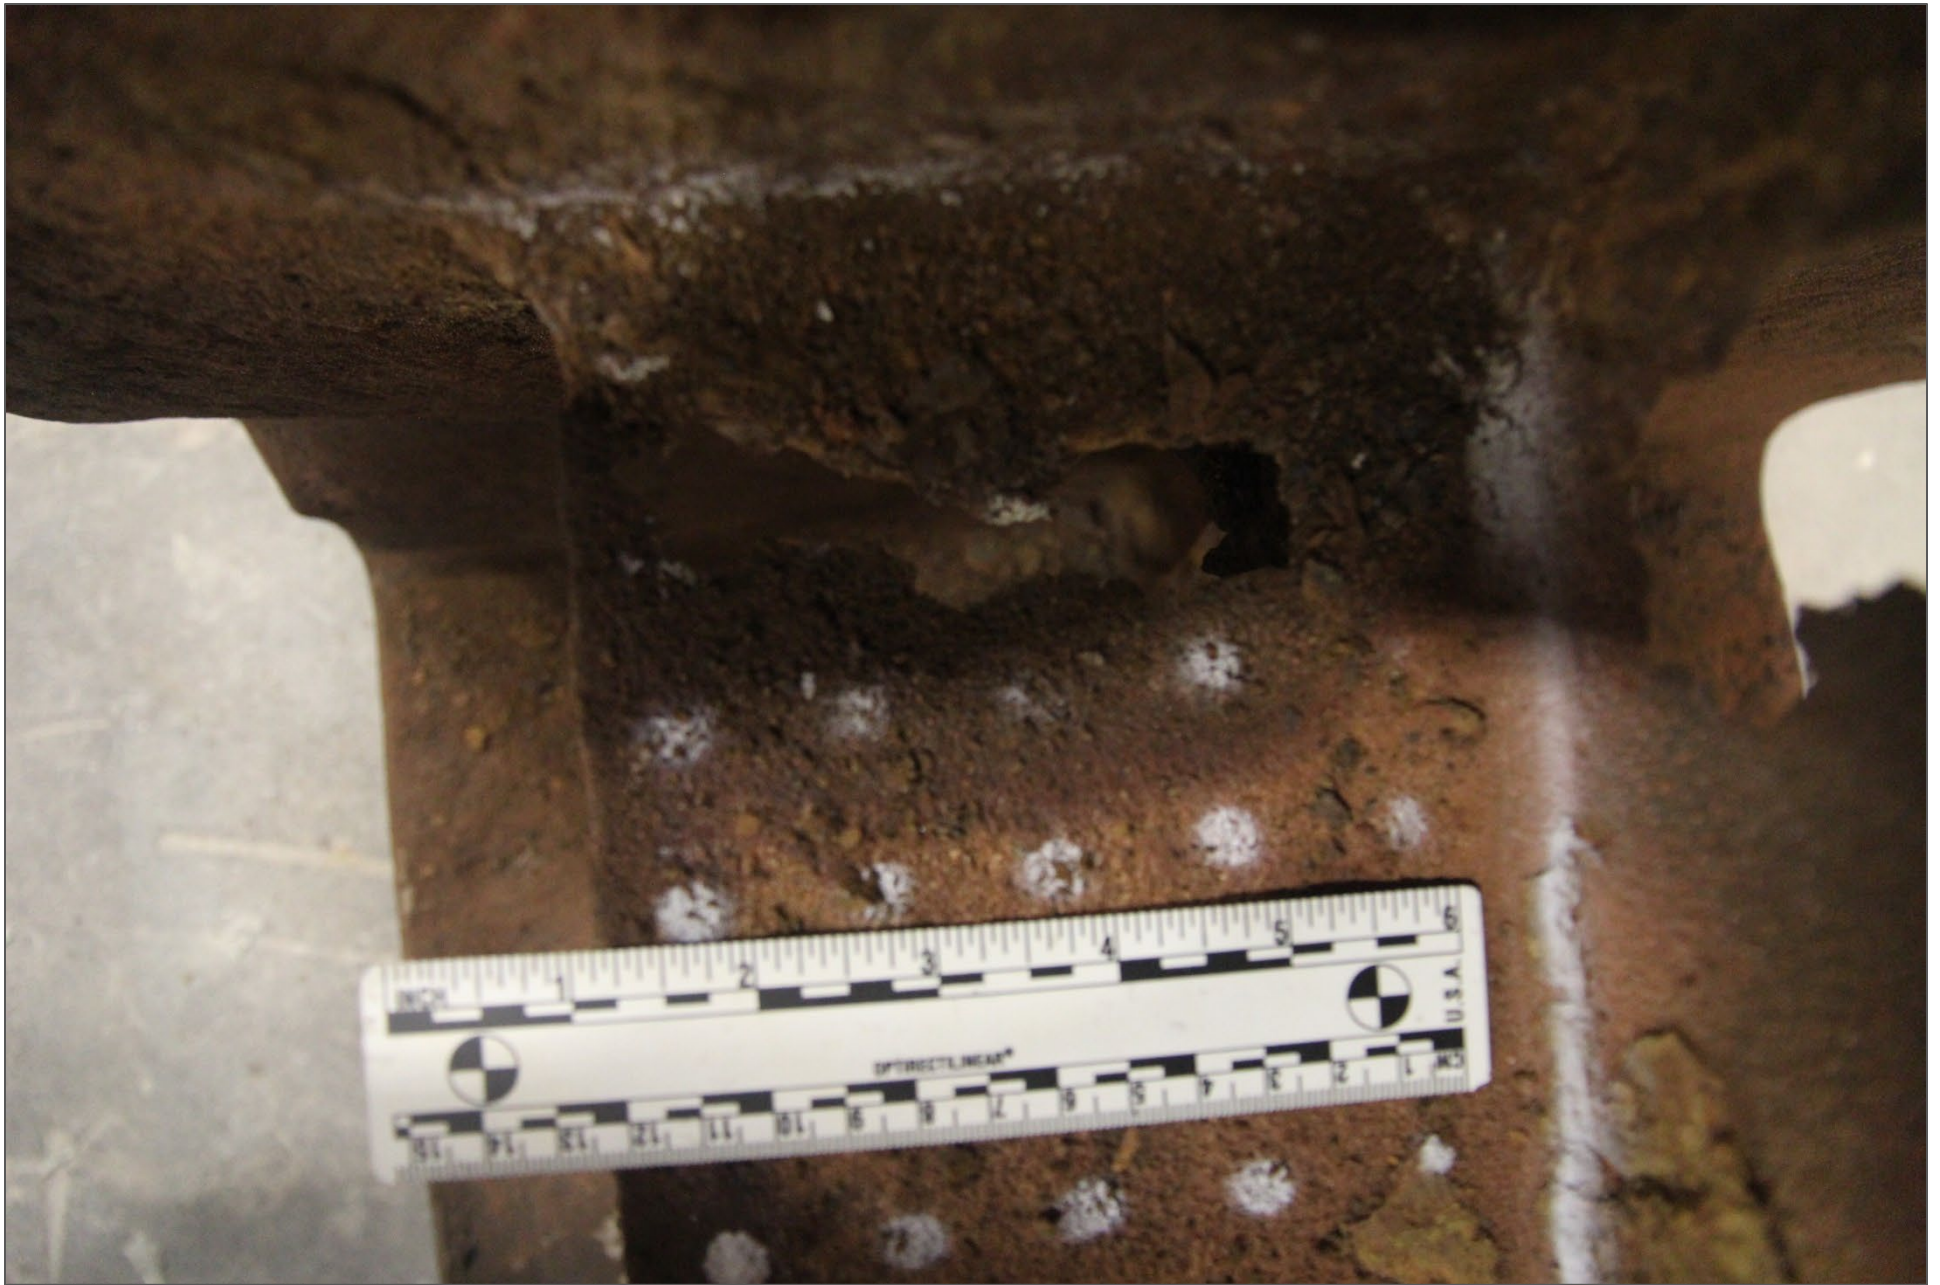
Materials Laboratory Photograph 8 – Closeup of Northwest Leg, Showing Longitudinal Stiffeners Just Above Transverse Tie Plate
