MASSACHUSETTS
BAY
TRANSPORTATION
AUTHORITY

Impound Report # 21251

Consist Moved with Person Caught between Doors

RED LINE ENGINEERING

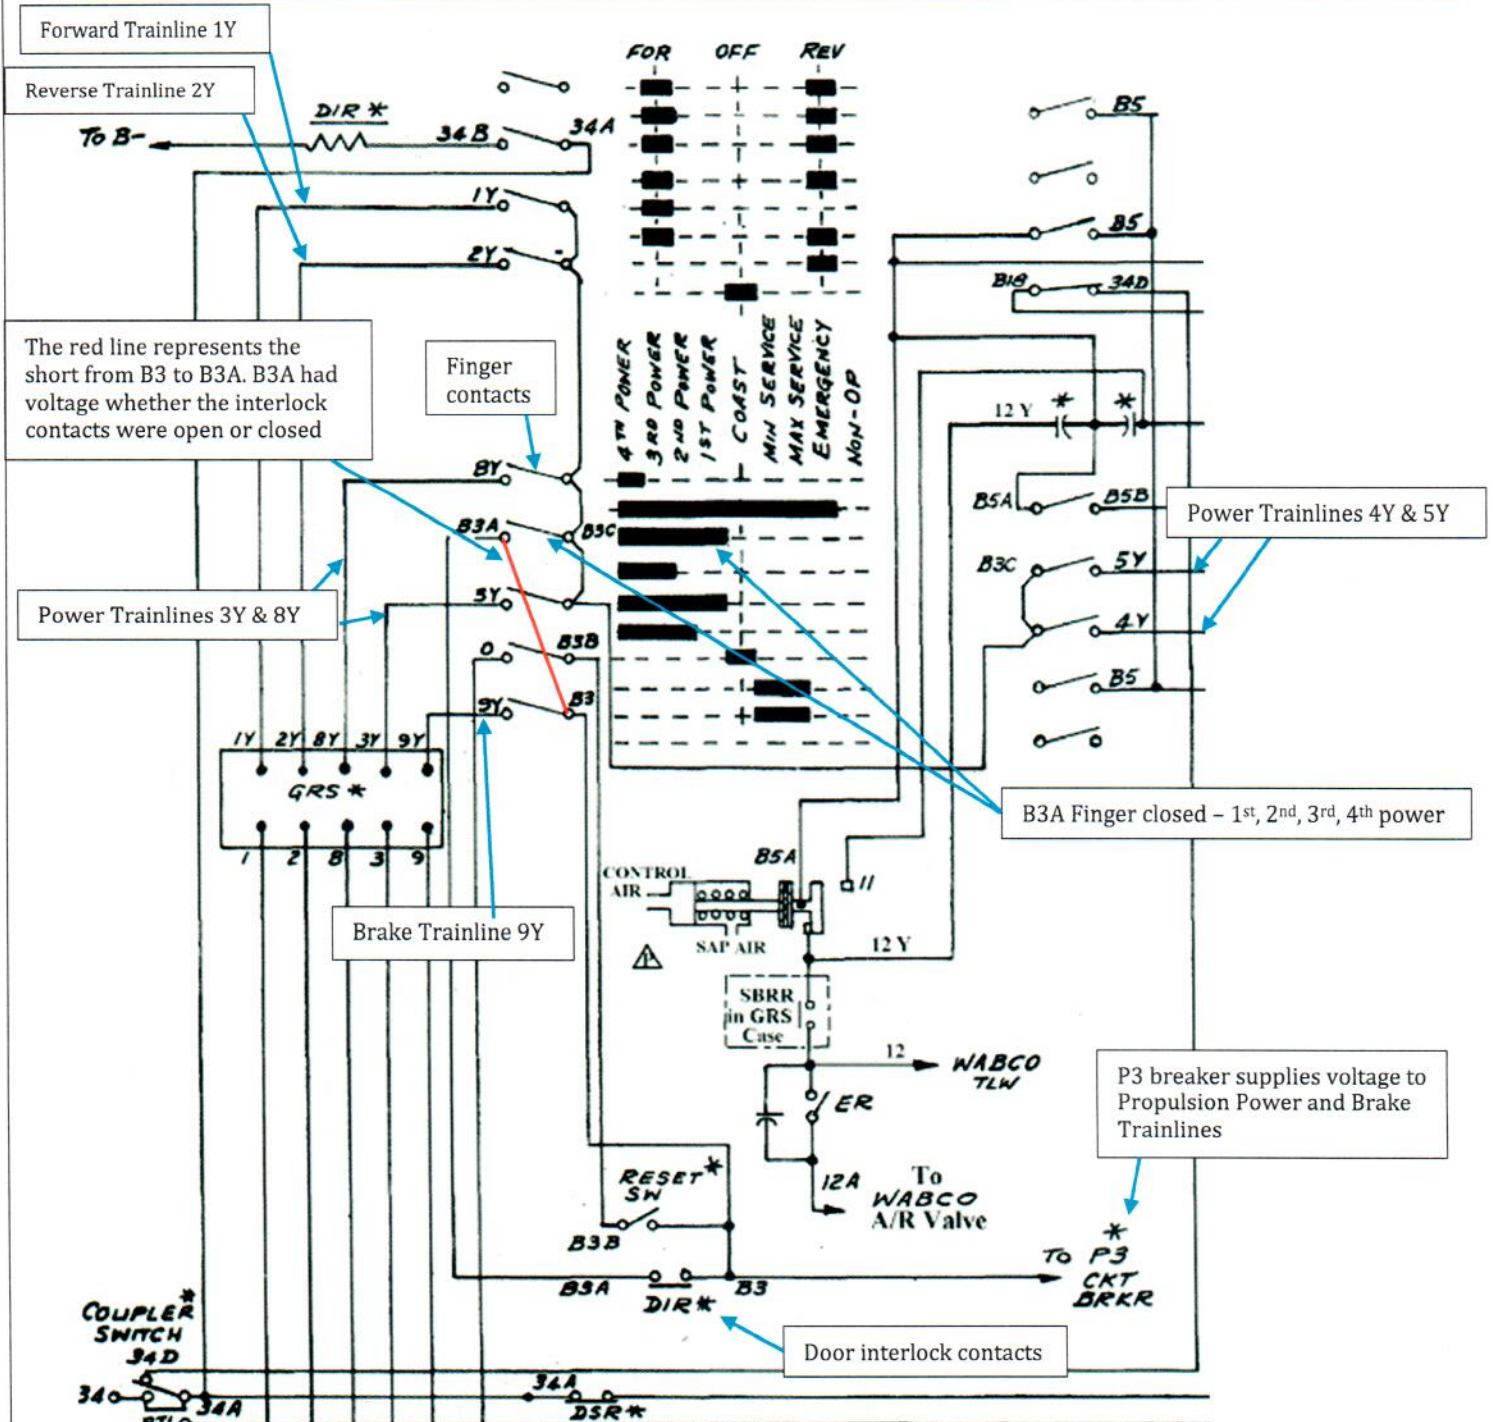
- 7.4** The B3.4 wire, which is attached to the B3 contact stud on the Cineston left terminal block, was found chafed and shorted to the B3A finger mounting screw (figure 2). The mounting screw is not insulated by design from the B3A finger contact.

- 7.5** The short from B3 to B3A acted like a jumper across the door interlock contacts when the Cineston controller was in a power position. Voltage was always applied to the reverser contacts and propulsion power finger contacts regardless of side door and interlock status.

Figure 1: Cineston Controller wiring schematic - Short from B3.4 Wire to the B3A finger mounting

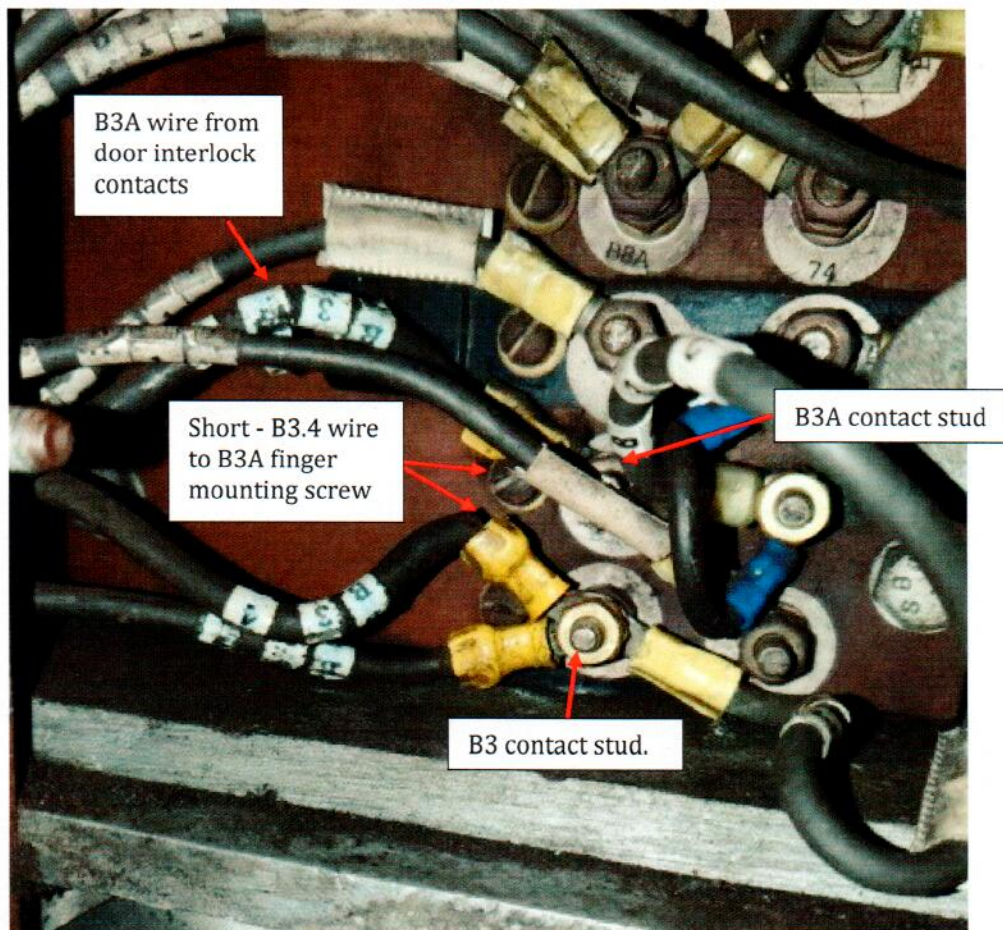
- A finger contact bridges two side by side contact studs on the Cineston terminal. When the Cineston is rotated into a power position, the B3A finger contact “bridges” voltage between the B3A and B3C contact studs. The B3C contact stud then connects voltage to each power stud contact via jumpers. The voltages are then “bridged” from the power stud contacts to the associated trainline by finger contacts actuated by the Cineston power position selected.

Figure 2: Cineston Controller left side terminal wiring – B3.4 shorted to the B3A finger mounting screw

- 8.1 The short from the B3.4 power wire to the B3A finger mounting screw on the left terminal of the Cineston controller in car 1511 bypassed the door interlock contacts allowing the consist to move via the Cineston in car 1511 regardless of side door status.

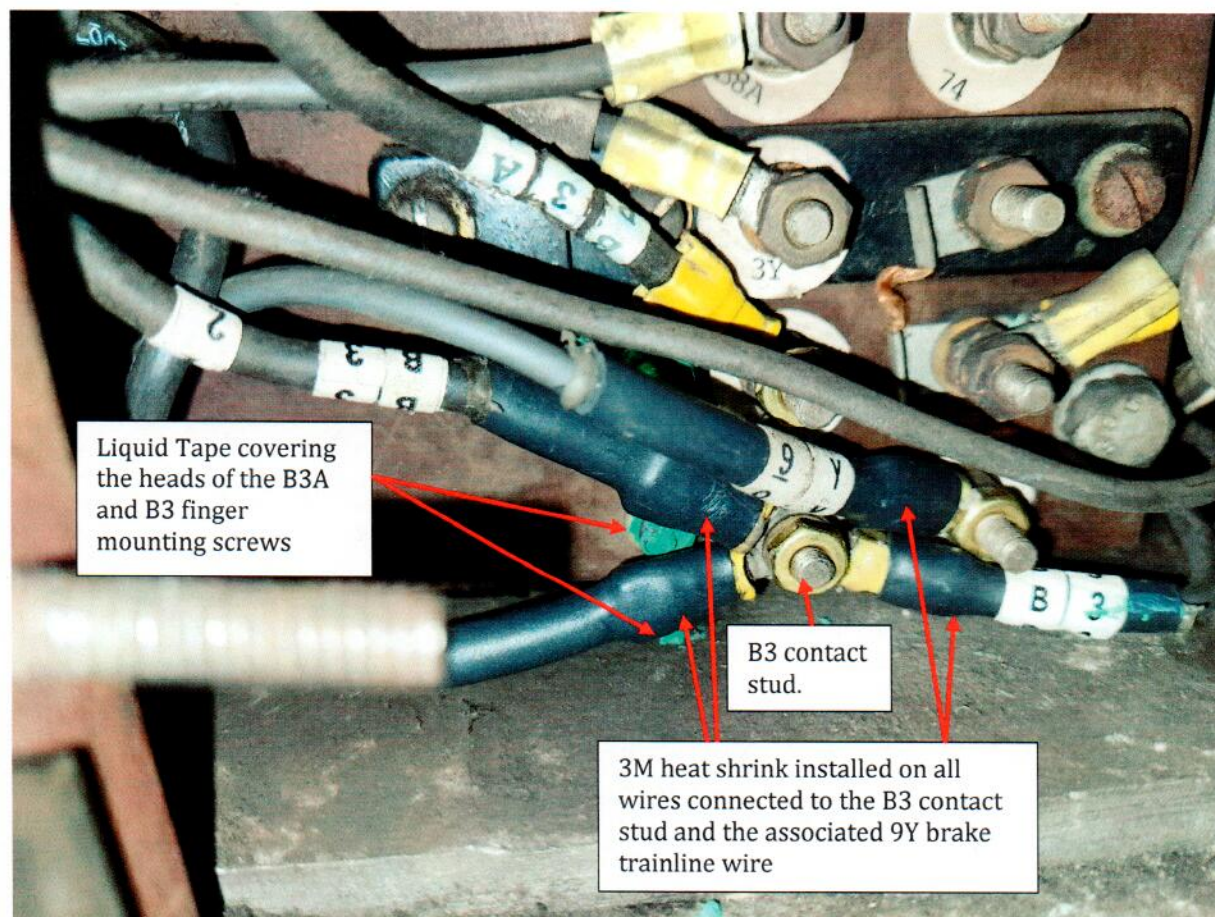
Figure 3: Cineston Controller left side terminal wiring – heat shrink applied to B3 power wires

10.1 The following repair procedure to be completed on the entire fleet of 1500 and 1600 series trains (figures 3 & 4).

- Each connection on the B3 contact stud will be removed and a 2" long piece of 3M heat shrink was installed over the end of each crimp connector and wire.
- A jam nut was installed on the B3 contact stud to push the B3 wire connectors away from the B3A and B3 finger mounting screws.
- Electrically isolating Liquid Tape was used to cover the entire heads of the B3A and B3 finger mounting screws.
- The function of the door interlock to be verified for proper operation after the repair.

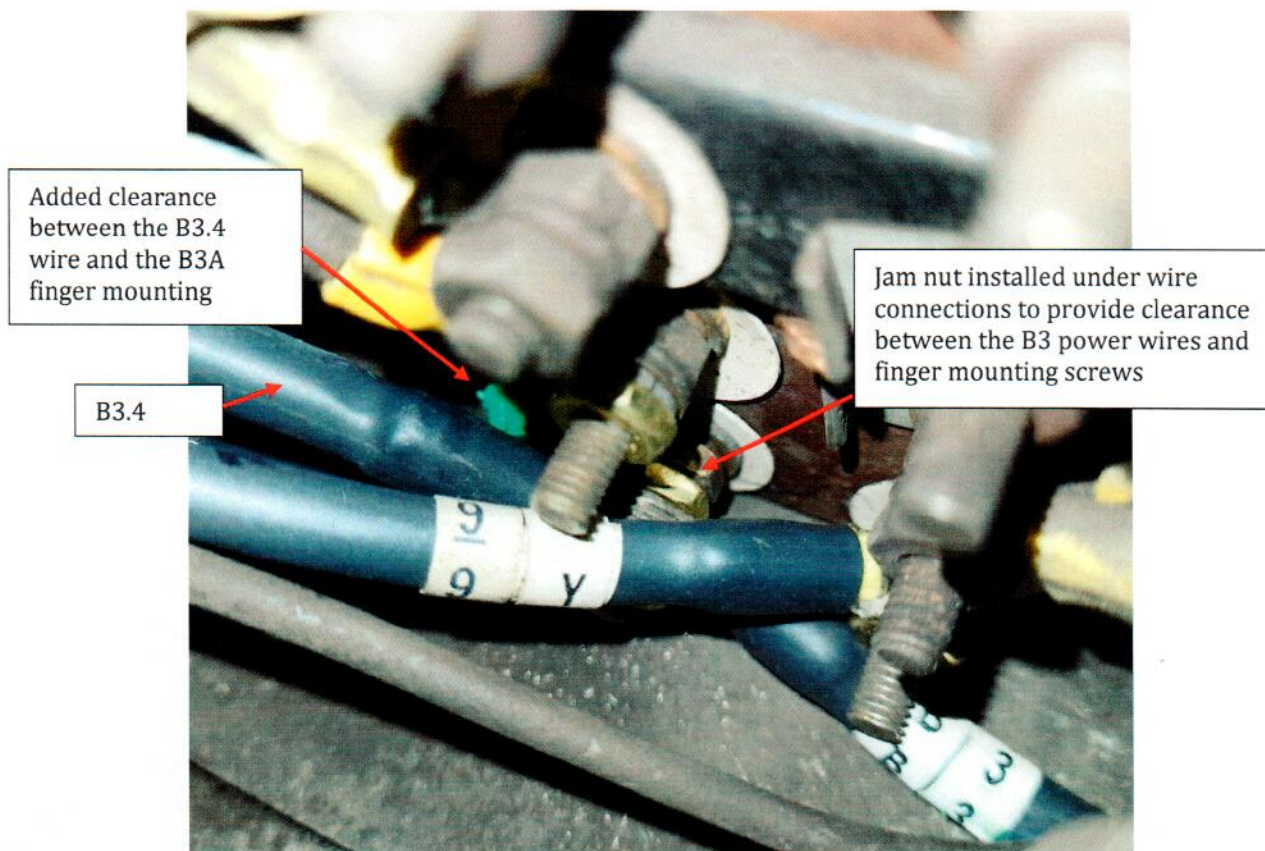
Figure 4: Cineston Controller left side terminal wiring – Jam nut installed to create clearance

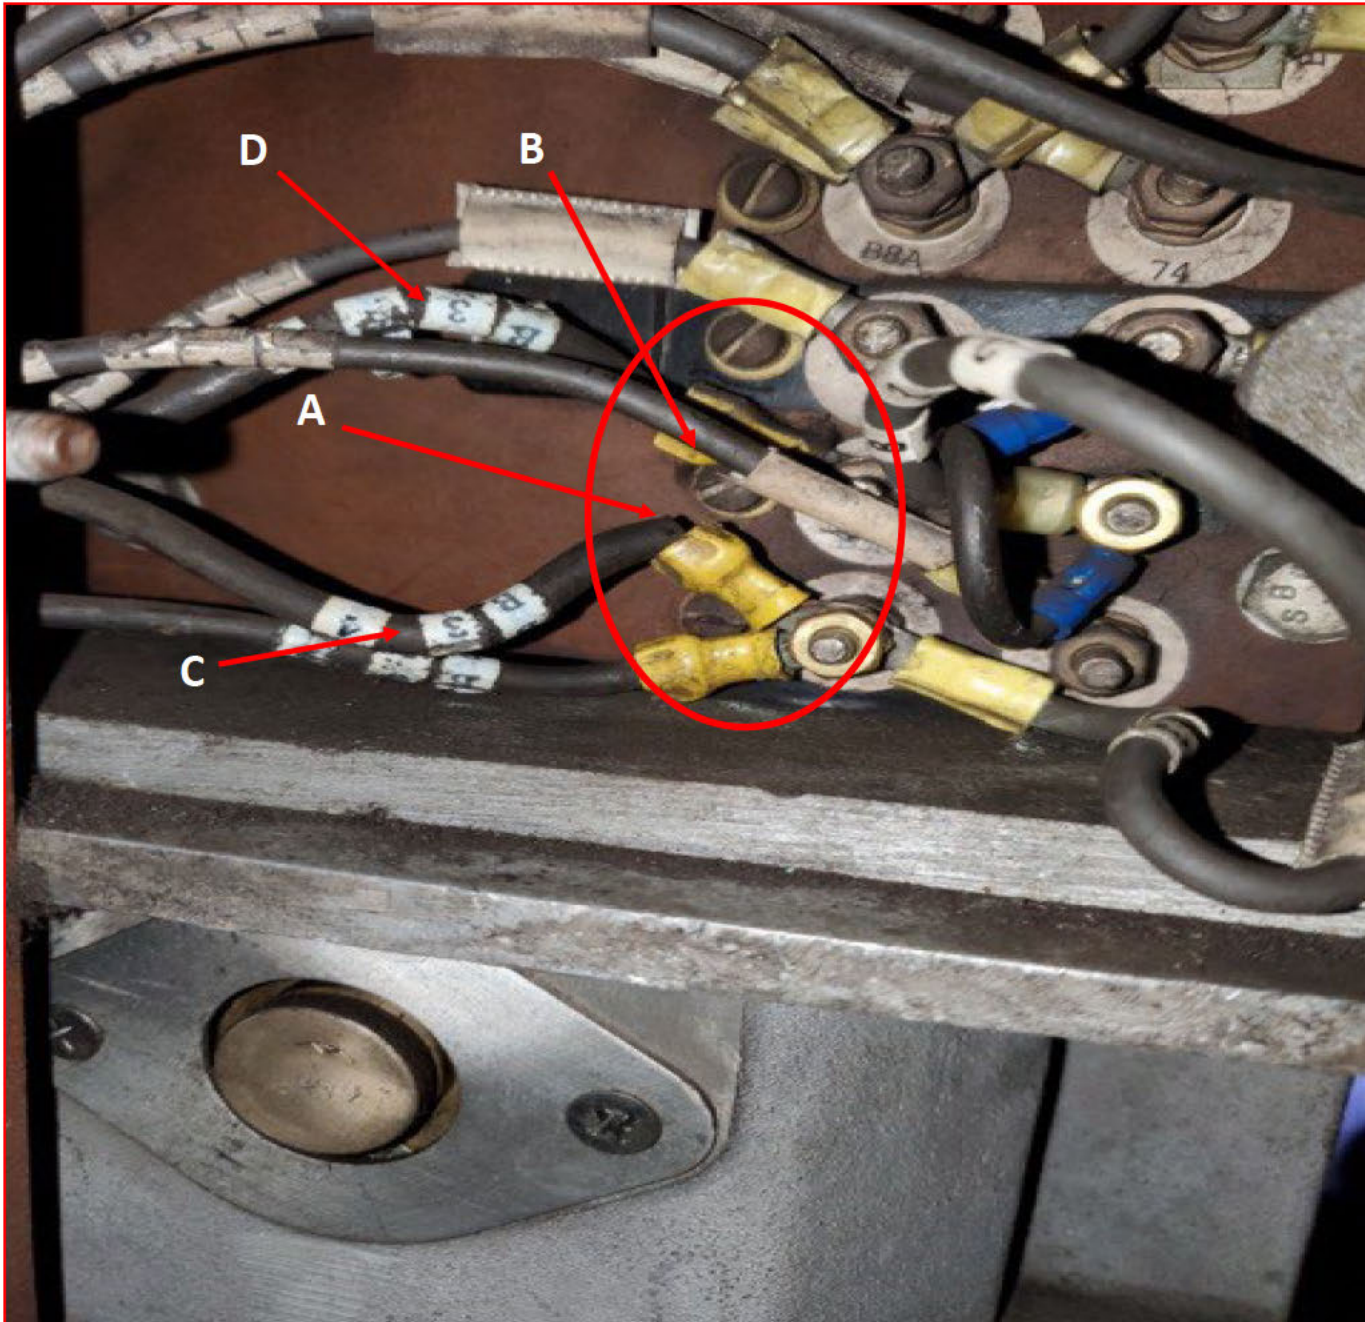
A – This is the shows the wire at the Terminal Connector Insulation Sleeve which showed Chafing and exposed Wire

B – This is the Mounting Screw for the Finger Contactor. This Screw is electrically connected to the Finger Contactor and when the wire B3.4 shorted to the Screw it provided power to B3A

C – This shows the Wire B3.4 Designation from the previous Schematic. Wire B3.4 is just the wire designation for the B3 Wire showing the fourth wire of the wire run

D – This shows the B3A Wire Designation on the Wire that was shorted to Wire B3.4 through the Contact Finger Screw. This is Point C on the previous schematic
