NATIONAL TRANSPORTATION SAFETY BOARD
Office of Aviation Safety
Washington, D.C. 20594

POWERPLANTS GROUP CHAIRMAN'S FACTUAL REPORT

NTSB No: DCA05MA004

Location: Kirksville Regional Airport, Kirksville, Missouri
Date: October 19, 2004
Time: 1945 CDT
Aircraft: American Connection Flight 5966, BAe Systems Jetstream 3201, N875JX

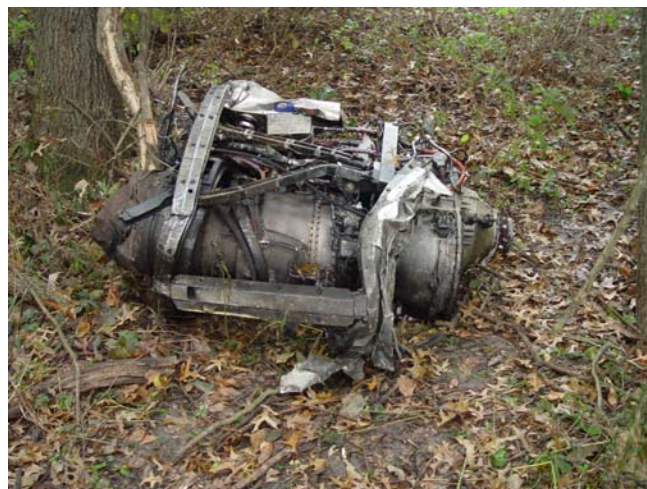
Both engines were found separated from the airplane and both propellers had separated from their respective engines. The right engine, along with both propellers, was recovered within the main airplane wreckage area while the left engine (**Photo 1**) was recovered just forward of the main wreckage area in the general direction of flight.

PHOTO 1: LT ENG JETTISONED FROM CRASH SITE

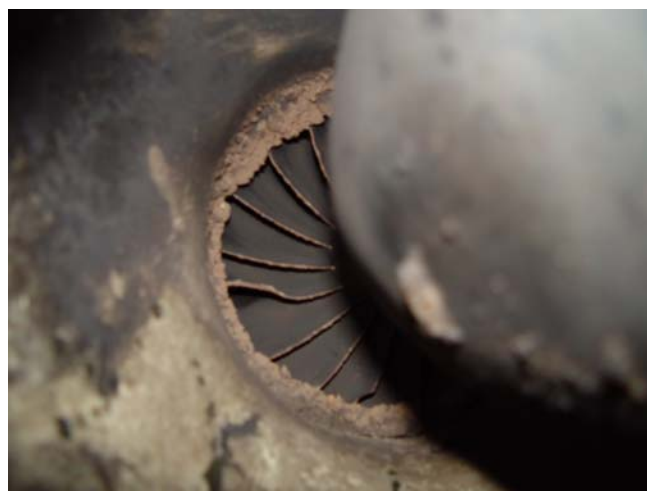
The airframe inlet shroud (duct) was torn from the engine inlet duct allowing an internal examination of the 1st-stage impeller. The engine inlet duct was intact and it contained dirt. The P2/T2 inlet sensor was intact but was covered in dirt. Leading edge impact marks were noted on the 1st-stage impeller and some blades exhibited bends in the direction opposite rotation (**Photo 2**). The exhaust duct tailpipe assembly was torn, ripped, and pushed radially inwards almost closing off the back end; however, a portion of the power section of the 3rd-stage power turbine rotor was visible. Light metal splatter (shiny specks of metallic material) was noted on the suction side of the 3rd-stage power turbine blades. No visible signs of tip rub or circumferential shroud wear were noted.

PHOTO 2: LT ENG 1ST-STAGE IMPELLER DAMAGE

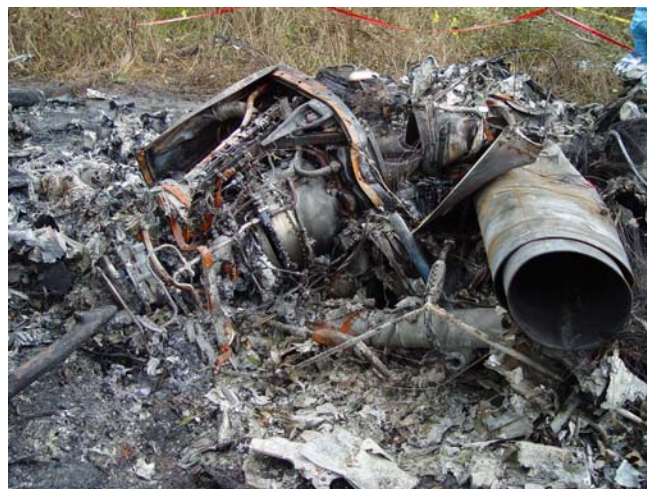
The right engine, as documented in the maintenance records, SN P-66360C, PN 3103380-53, could not be confirmed by examination of the engine because the data plate was completely destroyed during the post-impact fire, as was the accessory gearbox housing on which the data plate is affixed (**Photo 3**). The right engine was recovered in the main wreckage area in the general location of the right wing. Examination of the engine in-situ revealed extensive fire damage; however, none of the cases that remained exhibited any uncontainments or breaches. The combustor plenum was buckled at the 12:00 o'clock position but the ignitor plug remained installed.

PHOTO 3: RT ENG AT MAIN WRECKAGE SITE

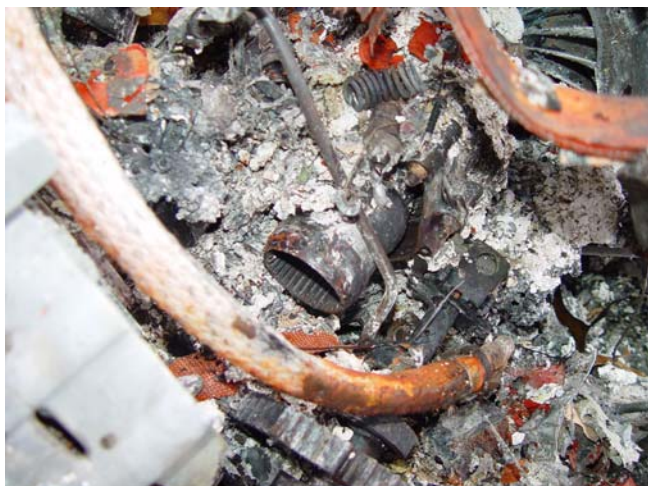
Fire heavily damaged and/or consumed many of the engine parts and the extent of the post-crash fire damage was as follows: 1) the nacelle sheet metal totally consumed, 2) no airframe inlet was visible – consumed, 3) the reduction gearbox (nose cone)⁴ and accessory gearbox housings were melted, 4) numerous accessory gearbox gears were fire damaged and found loose (**Photos 4 and 5**), 5) the intermediate housing front and aft portions were present but approximately 50% was melted, 6) the propeller pitch control housing was consumed by fire; however, the control shaft was recovered loose, and 7) the ignitor box was burned and only the shell remained.

PHOTO 4: ACCESSORY GEARBOX DAMAGE

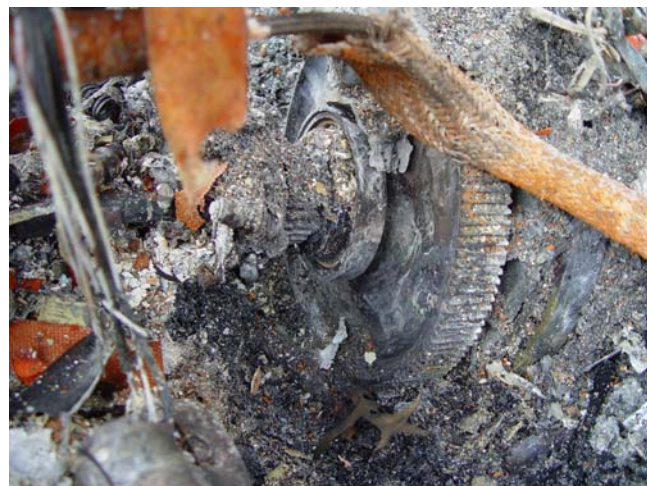
⁴ With the loss of the nose cone housing, the internal gears were exposed and the spur & helical gear assembly appeared visually intact. The spur & helical gear assembly is commonly referred to as the sun/bull gear and is comprised of a spur drive gearshaft, referred to as the sun gear, and splined spur gearshaft, referred to as the bull gear. The sun gear consists of a forward gear that drives the planet gears and an aft gear that drives the accessory gears.

PHOTO 5: BULL GEAR

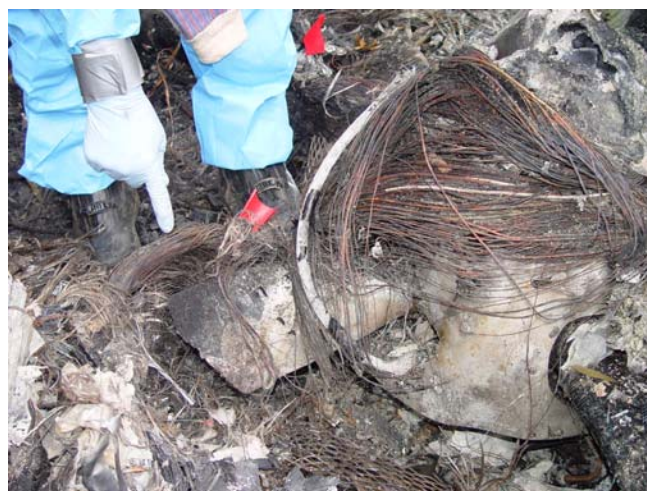
The left propeller⁵ was found upright resting on its propeller blades with one entire propeller blade missing while the right propeller was found face down (spinner shell down) with all the blade still attached (**Photo 6**). One relatively intact propeller blade, with a small piece of its tip missing, was recovered near the main wreckage site, just aft and to the right of the general direction of flight. This blade was bent in an “S”-shape configuration and the leading edge of the blade exhibited a blunt impact mark and was pushed aft. Within that leading impact mark, a tear was observed and within the tear was what appeared to be fragments of wood. Two pieces of propeller blade tips were recovered some distance away from the main wreckage area. They both were located aft and to the right of the general direction of flight (See

PHOTO 6: LT PROP IN WRECKAGE AREA

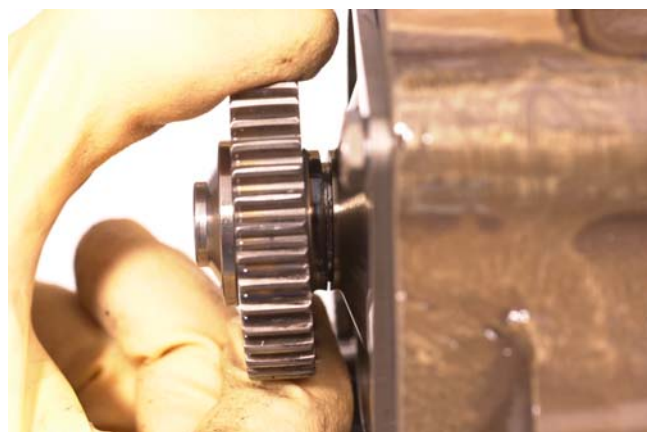
The torque shaft assembly (high speed pinion shaft drive) was fractured at the drive spline gear end (aft end) at the designed shear point location (**Photo 7**). Although the high speed pinion gear was seized within its carrier and not disassembled, no visual damage was observed on any of the exposed teeth. The splined coupling, which connects the high speed pinion assembly (torque shaft assembly) to the tie shaft (shouldered main shaft), was intact and still installed in the accessory drive housing assembly. The feather valve boss, which is integral to the accessory drive housing assembly, exhibited a light impact mark across its front face; however, no corresponding impact marks were noted on the outer race of the sun/bull gear aft bearing.

PHOTO 7: FRACTURED TORQUE SHAFT ASSEMBLY

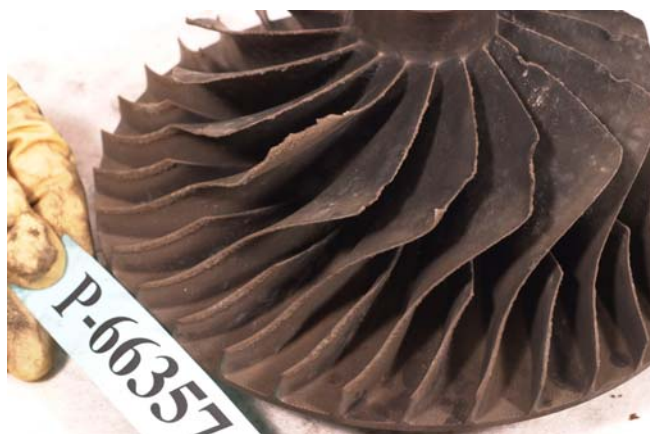
Disassembly of the compressor revealed dirt and vegetation throughout the entire compressor section.⁶ The 1st-stage impeller shroud exhibited impact marks and gouges in the inducer portion of the shroud. The leading edges of the 1st-stage impeller blade inducers exhibited impact damage, some were missing airfoil material, and approximately nine blades were bent in the direction opposite rotation (**Photo 8**). No damage was observed on the aft curvic coupling teeth of the 1st-stage impeller. Four diffuser assembly (cross-over assembly) vanes exhibited leading edge damage. The 2nd-stage impeller shroud exhibited 360° rotational rub at the inducer/exducer transition radius and all the 2nd-stage impeller blades exhibited corresponding rotation rub along their shroud line edge (**Photo 9**). The forward hub portion of the 2nd-stage impeller exhibited 360° rotational rub corresponding to rub was observed on the inner diameter of the 1st-stage diffuser bore. No damage was observed on the forward or aft coupling teeth of the 2nd-stage impeller. Metal

PHOTO 8: 1ST-STAGE IMPELLER DAMAGE

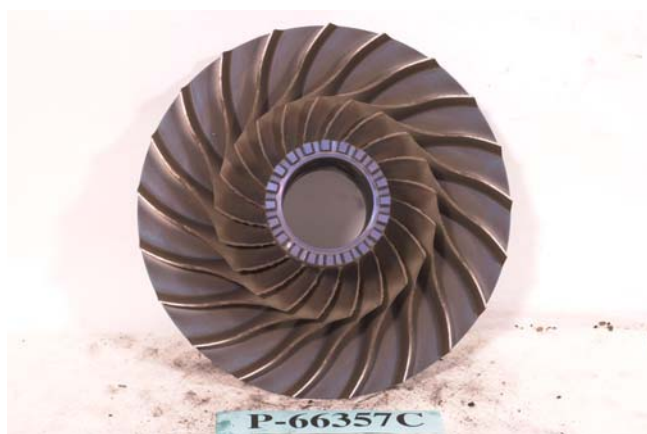
PHOTO 9: 2ND-STAGE IMPELLER DAMAGE

spray was on the pressure side of the 2nd-stage exducer impeller blades as well as on the vanes of the 2nd-stage diffuser assembly. The tie shaft exhibited no visual distress and the oil transfer tube remained installed.

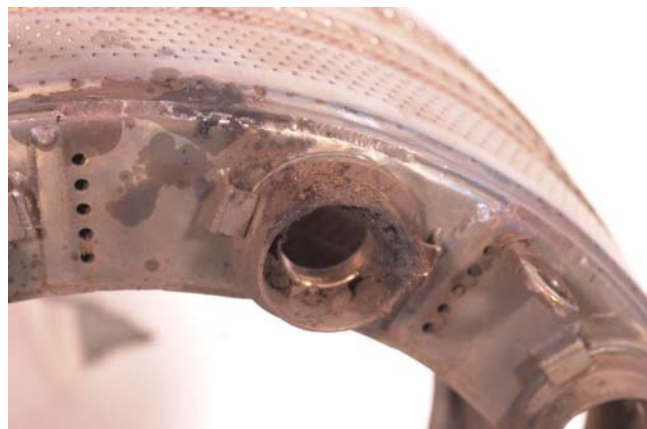
Disassembly of the combustion section revealed dirt was heavily deposited on the inner wall of the plenum, and dirt/vegetation debris was packed into the cooling holes of the combustion chamber and into the fuel nozzle swirlers (**Photo 10**). The plenum was buckled inwards at both igniter bosses locations (11:30 and 5:00 o'clock positions) and at the anti-ice boss (5:00 o'clock position). The forward fuel drain boss was fractured/torn approximately 180° around the weld. The combustion chamber was undamaged as was the inner and outer transition liners. Charred dirt/vegetation was found lodged in the cooling holes of the inner transition liner (turbine interstage liner seal assembly). Metal spray deposits were observed on the dome of the outer transition liner.

PHOTO 10: DEBRIS IN COMBUSTION CHAMBER

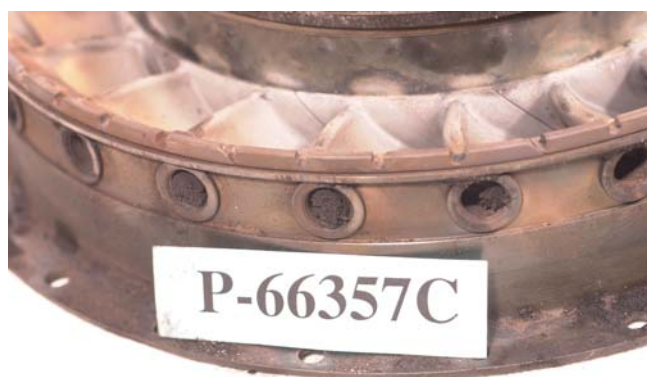
The forward face outer diameter of the rotating air seal & coupling assembly (center curvic) exhibited 360° rotational rub. No damage was observed on the forward and aft curvic coupling teeth. All the vanes of the 1st-stage turbine nozzle assembly were present and intact. Debris was packed into the cooling air holes located in the outer diameter of the vane shroud (**Photo 11**). Metal spray was observed on the suction side of the nozzle vanes. The 1st-stage turbine rotor assembly was intact and all the blades remained installed in the disk. The trailing edge platforms of the blades, as well as the blade tips themselves, exhibited 360° rotational rub. Metal spray was noted on the suction side of all the blades airfoils. No damage was observed on the forward or aft coupling teeth of the 1st-stage turbine rotor disk. Nine of the twelve 1st-stage turbine blades outer shroud segments exhibited rotational rub.

PHOTO 11: DEBRIS IN SHROUD COOLING HOLES

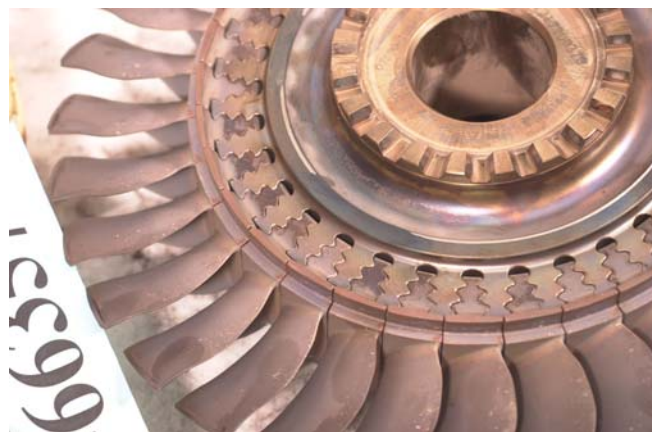
All the vanes of the 2nd-stage turbine nozzle assembly were present and intact. Some of the vanes exhibited some leading edge cracks, coating loss, and slight erosion. Light rotational rub was noted on the front face of the leading edge inner platform of the 2nd-stage turbine nozzle assembly corresponding to rub observed on the 1st-stage turbine blade trailing edge platform. Metal spray was observed on the suction side of all the 2nd-stage turbine nozzle vanes. An approximately 180° arc of rotational rub was observed on the 2nd-stage turbine shroud. The 2nd-stage turbine rotor assembly was intact and all blades remained installed in the disk. Rotational rub was noted on the tips of the 2nd-stage turbine blades corresponding to rub observed on the 2nd-stage turbine shroud. Some 2nd-stage turbine blades also exhibited rub on the aft face of the trailing edge inner platform. Metal spray was noted on the suction side of all the blades airfoils as well as on the trailing edge inner platform. The disk balance flange (aft face) exhibited rotational rub almost 360° around (**Photo 12**). No damage was observed on the forward or aft curvic coupling teeth of the 2nd-stage turbine rotor disk.

PHOTO 12: ROTATIONAL RUB ON 2ND DISK

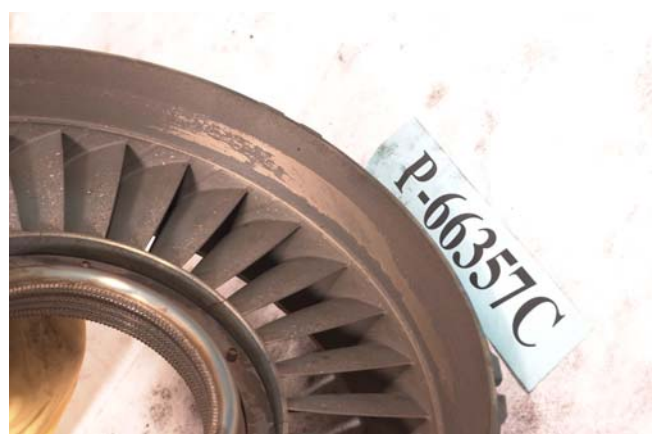
All the vanes of the 3rd-stage turbine nozzle assembly were present and intact. Rotational rub was noted on the front face of the inner abrasible air seal corresponding to rotational rub observed on the 2nd-stage disk balance flange. The front attachment flange of the inner abrasible seal exhibited some light sporadic rub marks near the outer edges corresponding to rub marks observed on the 2nd-stage turbine blade trailing edge inner platform. Metal spray was noted on both the suction and pressure sides of the vanes. An approximately 180° arc of rub was observed on the 3rd-stage turbine shroud (**Photo 13**). The 3rd-stage turbine rotor assembly was intact and all the blades remained installed in the disk. All the 3rd-stage turbine blades exhibited tip rub and an approximately 135°

PHOTO 13: RUB & METAL SPRAY ON 3RD SHROUD

rotational rub was observed on the aft face of the trailing edge blade platforms. Metal spray was observed on both the suction and pressure side of all the blades airfoils. No damage was observed on the forward or aft curvic coupling teeth of the 3rd-stage rotor disk. The rear bearing housing forward face exhibited an approximately 135° rotational rub corresponding to rub observed on the 3rd-stage turbine blade trailing edge platforms. The rear face of the aft curvic coupling exhibited an approximately 90° rotational scoring arc in two places and one of the four turbine seal assembly bolt heads exhibited a corresponding light rub mark.

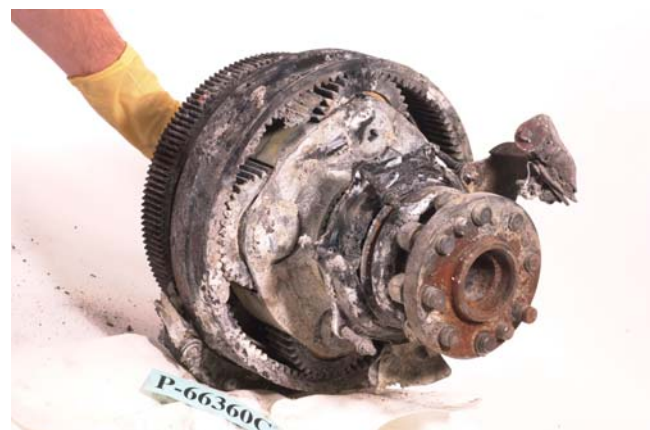
The nose cone assembly, the intermediate housing & gear assembly diaphragm, and the accessory drive housing assembly were all consumed by fire. All the recovered accessory and reduction gears were found loose, separate from the engine. The propeller shaft, the planet carrier & gear assembly, the internal stationary gear, and the sun/bull gear assembly were all recovered as a single unit, was covered in a white powder and exhibited varying amounts of corrosion (**Photo 14**). No attempt was made to separate the unit into its individual parts; however, all the individual pieces appeared visually to be intact, none of the exposed gear teeth exhibited any significant damage, and all the gears were seized together and could not be rotated by hand. All the propeller shaft attachment studs remained installed and intact.

PHOTO 14: PROPELLER SHAFT, PLANET GEAR, & SUN/BULL GEAR UNIT

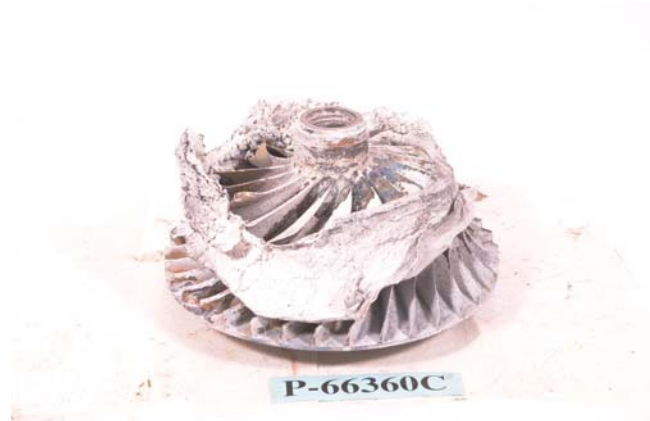
As a general observation, white powder covered the 1st-stage compressor impeller, shroud, and diffuser. The compressor group assembly was turned by hand with some resistance and the turbine group rotated along with the compressor group. With the accessory drive housing assembly completely consumed by fire, the 1st-stage compressor shroud, impeller, and diffuser were all exposed. The tie shaft was found still installed in its normal position, extended out the front end of the 1st-stage impeller bore, and the oil transfer tube remained installed within it. Heat distress was noted on the forward spline of the tie shaft. Removal of the 1st-stage compressor group from the engine exposed the entire tie shaft and no additional anomalies were noted. The 1st-stage compressor shroud was almost completely consumed by fire and the remains of the shroud were melted onto the 1st-stage impeller blades (**Photo 15**). The leading edges of the 1st-stage impeller blade inducers exhibited impact damage, some were missing airfoil material, and approximately seven blades were bent in the direction opposite rotation. All the 1st-stage impeller blade airfoils exhibited heat discoloration. Rotational scoring through 360° was observed on the OD of the impeller aft bore (**Photo 16**). No damage was noted on the aft curvic coupling teeth. The diffuser assembly was heavily damaged, melted, crushed, and partially consumed by fire.

PHOTO 15: 1ST STAGE SHROUD AND IMPELLER

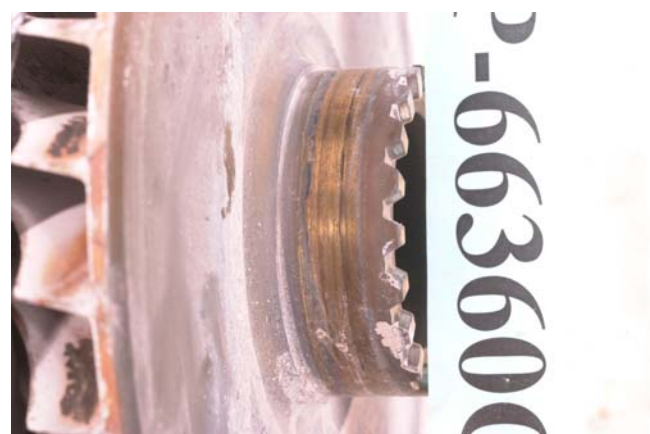
PHOTO 16: SCORING ON 1ST STAGE IMPELLER HUB

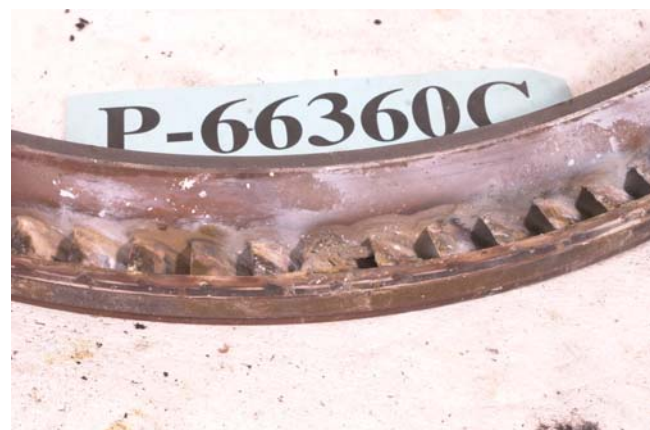
The compressor housing assembly remained intact. Fibrous debris, dirt, and white powder was observed on the compressor diffuser duct, throughout the 2nd-stage compressor diffuser vane assembly passages, and on the leading edges of many of the deswirl vanes (**Photo 17**). The 2nd-stage impeller shroud exhibited 360° rotational rub at both the inducer and exducer locations and all the 2nd-stage impeller blades exhibited corresponding rotation rub along the shroud line edge. Static impact marks were also observed on top of the 2nd-stage impeller shroud rotational rub mark at the exducer location. All the 2nd-stage impeller blades exhibited rotation rub along the shroud line edge and a 360° rotational rub on the outer diameter of the forward hub. No damage was observed on the forward or aft coupling teeth of the 2nd-stage impeller.

PHOTO 17: DEBRIS IN THE 2ND-STAGE DIFFUSER

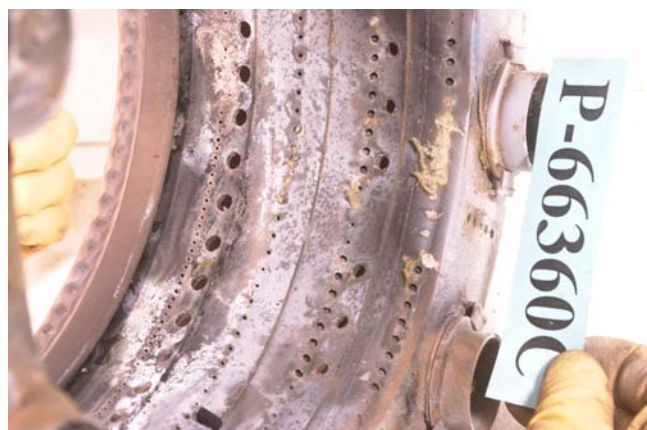
The combustion plenum was deformed, buckled, twisted clockwise at the 1:00 o'clock position, and covered with a white powder residue. Disassembly of the combustion section revealed dirt/vegetation debris packed into the large cooling holes of the combustion chamber, charred debris in the large cooling holes of the inner transition liner, and dirt on the outer transition liner dome (**Photo 18**).

PHOTO 18: DEBRIS LODGED IN COOLING HOLES

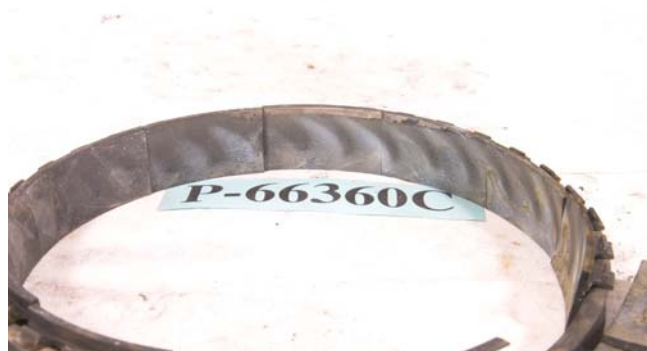
As a general observation, a white powdery substance coated most of the turbine section parts. The rotating air seal & coupling assembly exhibited no damage and the forward and aft curvic coupling teeth were intact. All the vanes of the 1st-stage turbine nozzle assembly were present and intact. Three vanes exhibited axial leading edge cracks and one vane exhibited slight leading edge erosion. Nearly all the vanes exhibited trailing edge axial cracks. Metal spray was observed on the suction side of the nozzle vanes. Two of the eight piston ring housing-to-baffle attachment bolts were missing. The 1st-stage turbine rotor assembly was intact and all the blades remained installed in the disk. All the blades tips exhibited rotational rub at the trailing edge and erosion near the leading edge. Slight metal spray was noted on the suction side of the blade airfoils. The disk aft face exhibited rotational rub at the corner of the face-to-web transition radius. No damage was observed on the forward or aft coupling teeth of the 1st-stage turbine rotor disk. Eight of the twelve 1st-stage turbine shroud segments exhibited rotational rub (**Photo 19**).

PHOTO 19: SCORED 1ST-STAGE SHROUD SEGMENTS

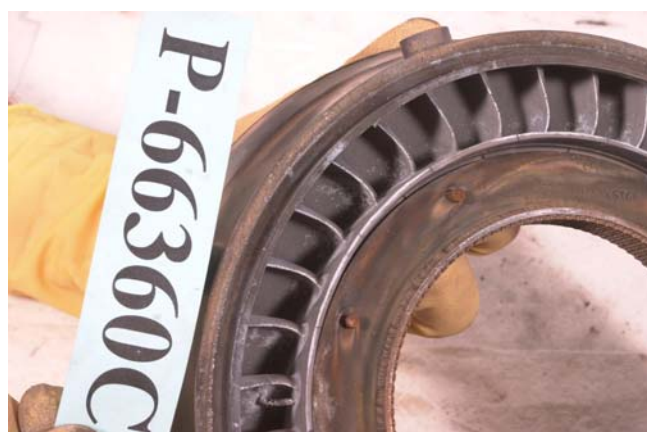
All the vanes of the 2nd-stage turbine nozzle vane assembly were present and intact. Fibrous debris was observed wrapped around the leading edge of three vanes (**Photo 20**). Some of the 2nd-stage turbine nozzle vanes exhibited leading edge cracks, coating loss, and slight erosion while one vane exhibited an axial trailing edge crack. Slight metal spray was observed on the suction side of all the nozzle vanes. Two 30° arcs of light rotational rub were noted on the forward face of the seal corresponding to rub observed on the 1st-stage turbine disk face-to-web radius. An approximate 45° arc of rotational rub was observed on the 2nd-stage turbine shroud. The 2nd-stage turbine rotor assembly was intact, and all the blades remained installed in the disk. Light rotational rub was noted on some of the tips of the 2nd-stage turbine blades, but not all, corresponding to rub observed on the 2nd-stage turbine shroud. Metal spray was noted on the suction side of all the 2nd-stage turbine blade airfoils. Light rotational rub was observed on the aft balance flange of the disk. No damage was observed on the forward or aft curvic coupling teeth of the 2nd-stage turbine rotor disk.

PHOTO 20: FIBROUS DEBRIS IN 2ND-STAGE NOZZLE

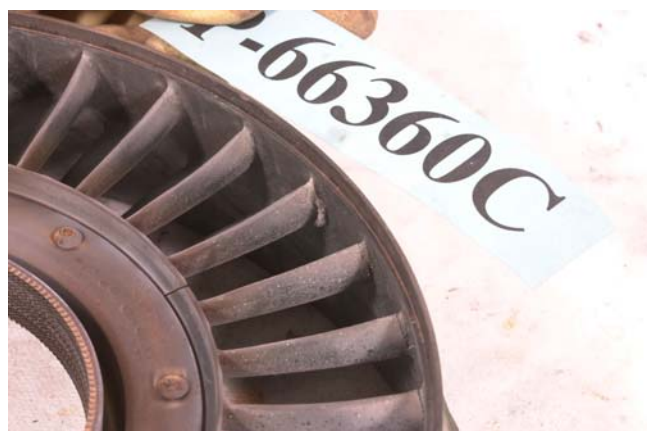
All the vanes of the 3rd-stage turbine nozzle assembly were present and intact. Three consecutive nozzle vanes exhibited airfoil axial cracks and one of the vanes had some leading edge erosion and material loss. Some 3rd-stage turbine nozzle vanes exhibited airfoil coating loss near the outer shroud. Metal spray was noted on the suction side of the vanes (**Photo 21**). A light approximate 60° arc of rotational rub was noted on the forward face of the 3rd-stage turbine nozzle air seal corresponding to rub observed on the 2nd-stage rotor disk aft face. The 3rd-stage turbine rotor assembly was intact and all the blades remained installed in the disk. No rub marks were visibly noted on the blades or on the disk. No damage was observed on the forward or aft curvic coupling teeth of the 3rd-stage rotor disk. No damage or wear was observed on both the rear bearing housing and the aft curvic coupling.

PHOTO 21: METAL SPRAY ON VANE AIRFOILS

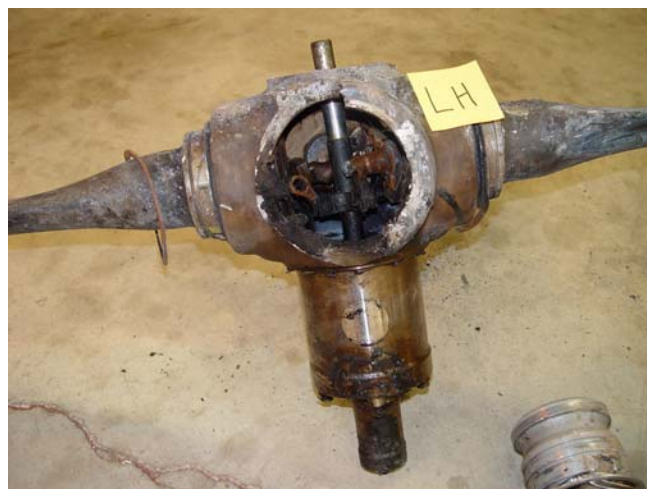
The spinner shell and the bulkhead assembly, which houses the slip ring assembly, were missing from the propeller assembly. Propeller blades Nos. 1, 2, and 4 all remained installed in the hub and the No. 3 blade was recovered separate from the hub (**Photo 22**). The No. 3 blade socket was fractured from the rest of the hub while the No. 1 blade socket was partially fractured but primarily intact. Several pieces of the hub were recovered loose at the crash site. Both the pitch change cylinder and the spring housing (feather/reversing spring) remained attached to the front of the hub and were intact. The front end of the piston rod assembly protruded approximately 0.027-inches out past the front of the spring housing. The aft portion of the piston rod assembly stuck out of the back of the hub but was bent so two measurements were taken from the hub aft face to the aft end of the piston rod assembly. The exposed length of the piston rod assembly measured approximately 1.273 and 1.207-inches respectively (**Photo 23**). The phonolic bushing was missing from the aft side of the hub. The “Beta” tube was found fractured within the piston rod assembly but the beta lock was still in place. The “Beta” tube projection out the front of the piston rod assembly was approximately 10 threads.⁸

PHOTO 22: LEFT PROPELLER

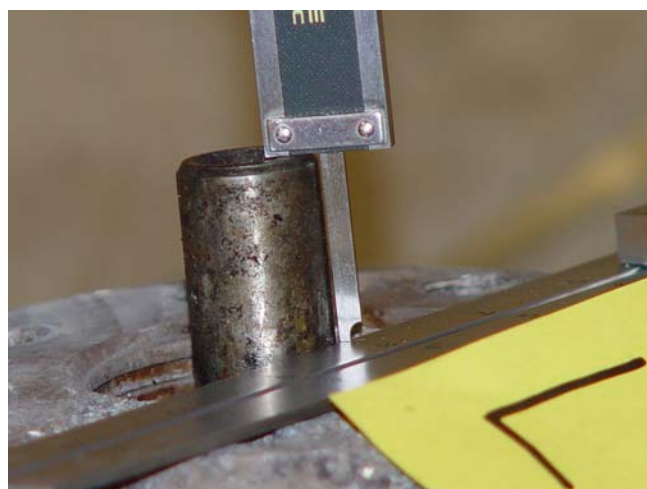
PHOTO 23: PISTON ROD LENGTH (BACK OF HUB)

⁸ This is the “Beta” tube projection length set during assembly.

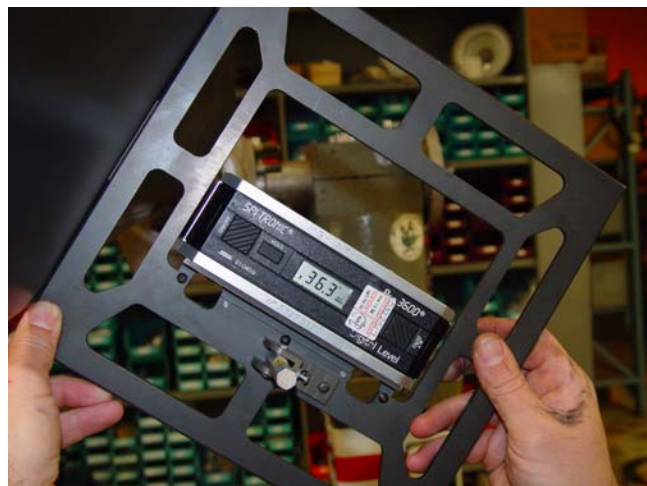
The measurement of the exposed aft length of the piston rod assembly from the accident propeller was transferred to a propeller mock-up of the same make and model as the accident propeller to determine an approximate blade pitch angle. Since two measurements were taken due to the damage to the piston rod assembly, the average exposed piston length of 1.240-inches was used. A blade pitch angle of 36.3° on the mock-up corresponded to the 1.240-inch aft protrusion of the piston rod assembly (**Photo 24**).⁹ The forward protrusion of the piston rod past the spring housing on the mock-up measured 0.027-inches, which corresponded with the length that was measured on the accident propeller.

PHOTO 24: BLADE ANGLE MEASUREMENT

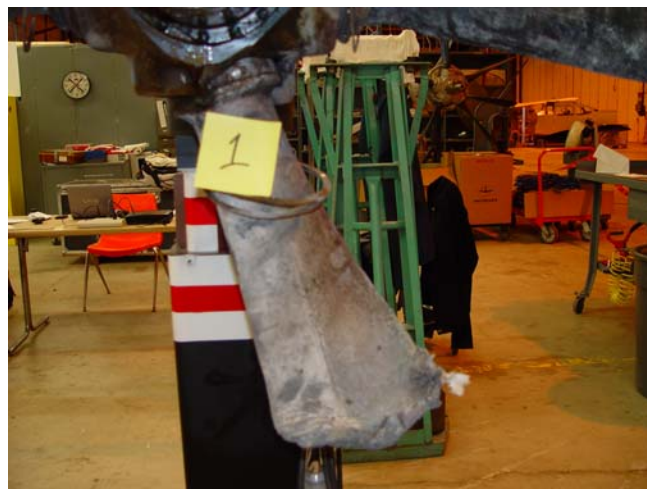
Blade No. 1 remained installed in the hub but was fractured and the fracture surface had melted and resolidified (**Photo 25**). Approximately the outboard 18-inches of the blade was missing and the remaining part of the end of the blade was bent and curled in the direction opposite rotation. The shim pack¹⁰ remained installed. The counterweight no longer remained attached to the butt of the blade and the counterweight hole was damaged and distorted. No longer installed on the bottom of the blade butt was the actuating pin.

PHOTO 25: BLADE 1 MISSING TIP

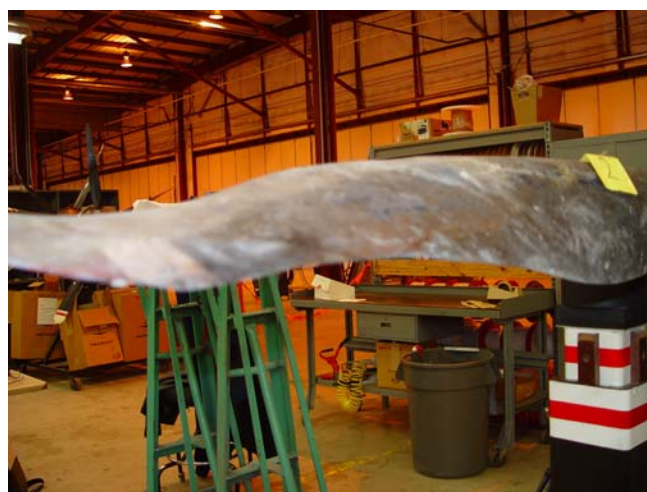
Blade No. 2 (**Photo 26**) remained installed in the hub, was intact, and the tip was bent and curled in the direction opposite rotation and twisted towards a decreasing pitch angle (towards reverse). The shim pack was dislodged. The counterweight no longer remained attached to the butt of the blade and the counterweight hole was damaged and distorted. No longer installed on the bottom of the blade butt was the actuating pin.

PHOTO 26: BLADE 2 BENT AND CURLED

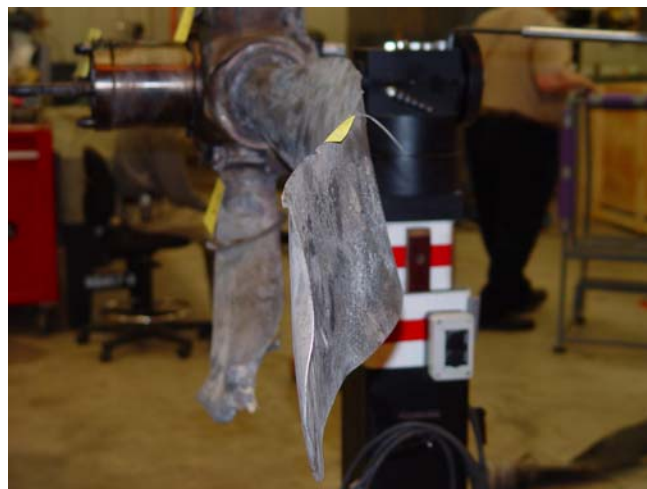
Blade No. 4 remained installed in the hub, was intact, and blade tip was bent and curled in the direction opposite rotation and towards a decreasing pitch angle (**Photo 27**). A large round bottom soft body impact mark at approximately the 38 to 39-inch blade station was noted on the leading edge of the blade while several soft body impact marks were noted along the trailing edge of the blade with the trailing edge folded over towards both the pressure and suction sides of the blade. The shim pack was dislodged. The counterweight no longer remained attached to the butt of the blade and the counterweight hole was damaged and distorted. No longer installed on the bottom of the blade butt was the actuating pin

PHOTO 27: BLADE 4 BENT AND CURLED

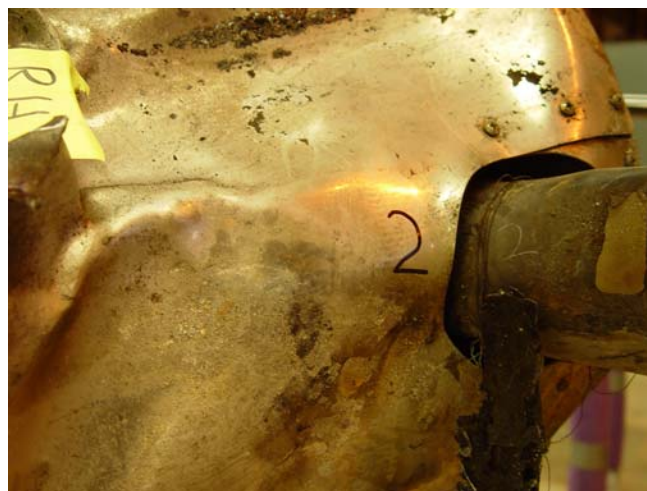
The spinner shell and the bulkhead assembly remained installed on the propeller assembly. The spinner shell exhibited several impact marks, two counterweight impression marks - one at the No. 1 blade position and the other at the No. 2 blade position - and was torn at the No. 4 blade position exposing the No. 1 blade counterweight (**Photo 28**).

PHOTO 28: COUNTERWEIGHT IMPRESSION

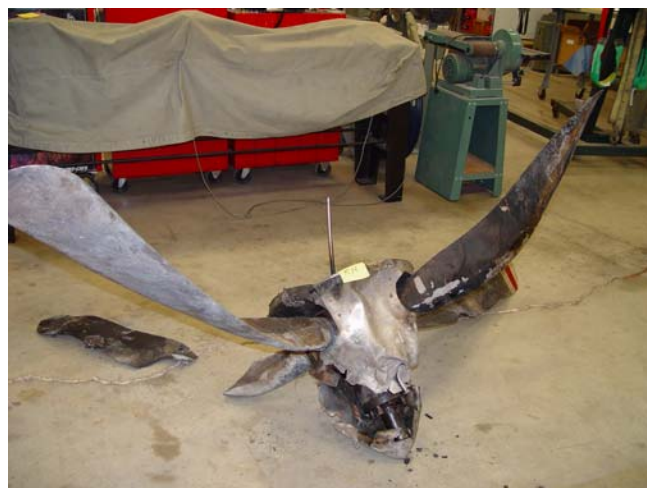
All the propeller blades remained installed in the hub and the hub was intact (**Photo 29**). Both the pitch change cylinder and the spring housing (feather/reversing spring) remained attached to the front of the hub and were intact. The front end of the piston rod assembly was retracted approximately 0.354-inches into the front of the spring housing while the aft portion of the piston rod assembly was fairly straight and stuck out the back of the hub approximately 1.441-inches. The exposed aft portion of the piston rod assembly was measured in the same manner as what was described for the No. 1 propeller (See section 5.2.1 As-Received Condition). The phonolic bushing remained installed on the aft side of the hub. The “Beta” tube was fractured at its metering holes, what remained was bent, and the beta lock was still in place. The “Beta” tube projection out the front of the piston rod assembly was approximately 11 threads.

PHOTO 29: RIGHT PROPELLER

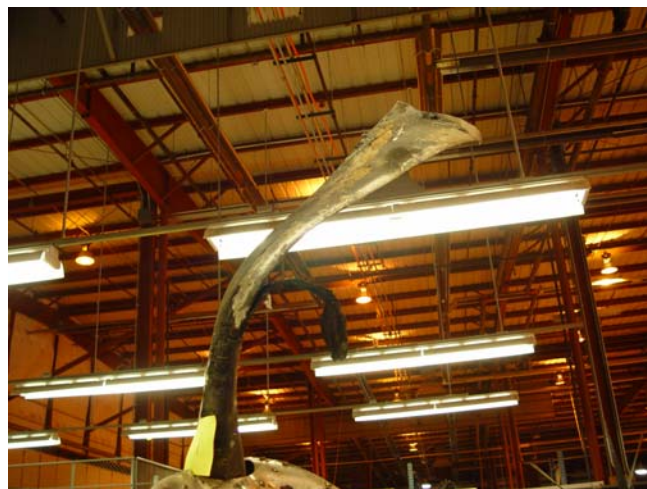
Blade No. 1 remained installed in the hub, a piece of the blade tip was missing, and the outer portion of the blade was bent and curled in the direction opposite rotation and twisted towards a decreasing pitch angle (**Photo 30**). The blade tip leading edge exhibited a pronounced curl towards a decreased pitch angle. The shim pack remained installed. The counterweight remained attached to the butt of the blade and the spinner shell was folded over leaving an impression on the spinner shell. Visual comparison of the counterweight impression mark in the spinner shell with the propeller mock-up placed in roughly the same position indicated that the propeller blade was not in reverse or in feather, but in a position within the normal operating range. The actuating pin remained installed on the bottom of the blade butt.

PHOTO 30: BLADE 1 BENT AND CURLED

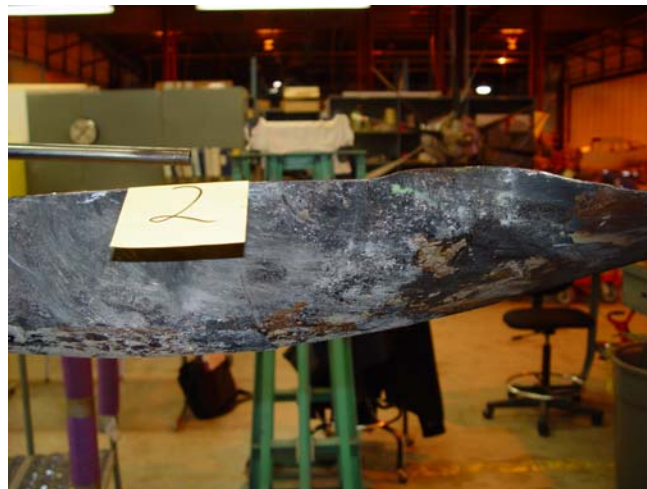
Blade No. 2 remained installed in the hub, was intact, and was found past the normal reverse position (leading edge pointing aft). The blade was bent and curled in the direction opposite rotation and twisted toward a decreasing pitch angle (**Photo 31**). One smooth round bottom soft body impact mark was noted on the leading edge camber side near the blade tip while three smooth round bottom soft body impact marks inboard of the leading edge mark were noted on the trailing edge. The shim pack was dislodged. The counterweight remained attached to the butt of the blade and the spinner shell was folded over leaving an impression on the spinner shell corresponding to the blade in the reverse pitch position. No longer installed on the bottom of the blade butt was the actuating pin.

PHOTO 31: BLADE 2 TWISTED

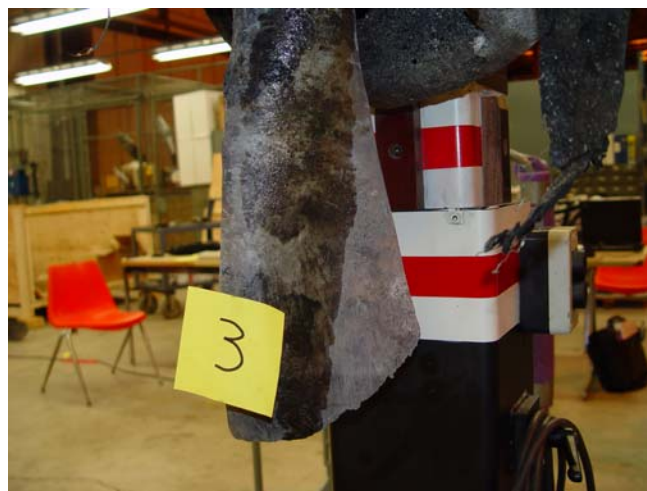
Blade No. 3 remained installed in the hub but was fractured, approximately the outboard 16 to 18-inches of the blade was missing and the remaining part of the end of the blade was bent and curled in the direction opposite rotation and twisted towards decrease pitch angle at the fracture location (**Photo 32**). The shim pack was dislodged. The counterweight no longer remained attached to the butt of the blade and the counterweight hole was damaged and distorted but was found within the spinner shell. The actuating pin remained installed on the bottom of the blade butt.

PHOTO 32: BLADE 3 FRACTURED

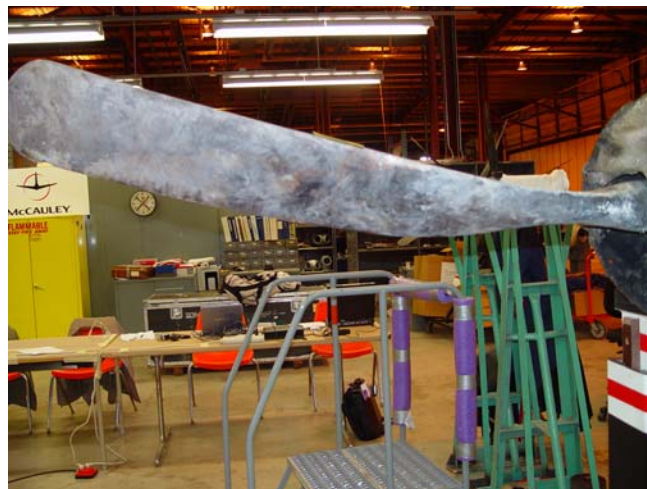
Blade No. 4 remained installed in the hub, was intact, and blade tip was bent and curled in the direction opposite rotation and towards a decreasing pitch angle. The blade trailing edge exhibited a jagged impact mark about 4-inches from the blade tip and the tip was bent forward at the impact location. The shim pack remained installed. The counterweight remained attached to the butt of the blade and the actuating pin remained installed on the bottom of the blade butt.

PHOTO 33: BLADE 4 BENT AND TWISTED
