**NATIONAL TRANSPORTATION SAFETY BOARD**

**Attachment 1 –Airbus Analysis of Thrust Reverser Surface Residue**

**DCA18LA163**

## A330 MSN 578 DAL fire event- Analysis of Surface residue

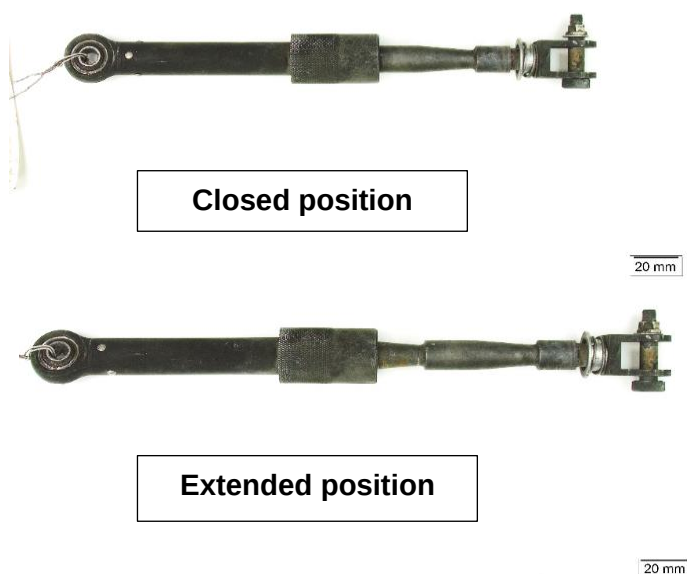
**Figure 3: Visual inspection of PRD – RHS up ratchet actuator**

- PRD LHS lwr: Visual examination of the ratchet actuators from the detached door presented soot residue on the whole surface indicating that the ratchet was extended during the fire.

The ratchet actuators from the detached PRD –RHS up have been visual inspected presenting no fracture however in the extended position, soot residue could be observed along the whole shaft (see Figure 3).

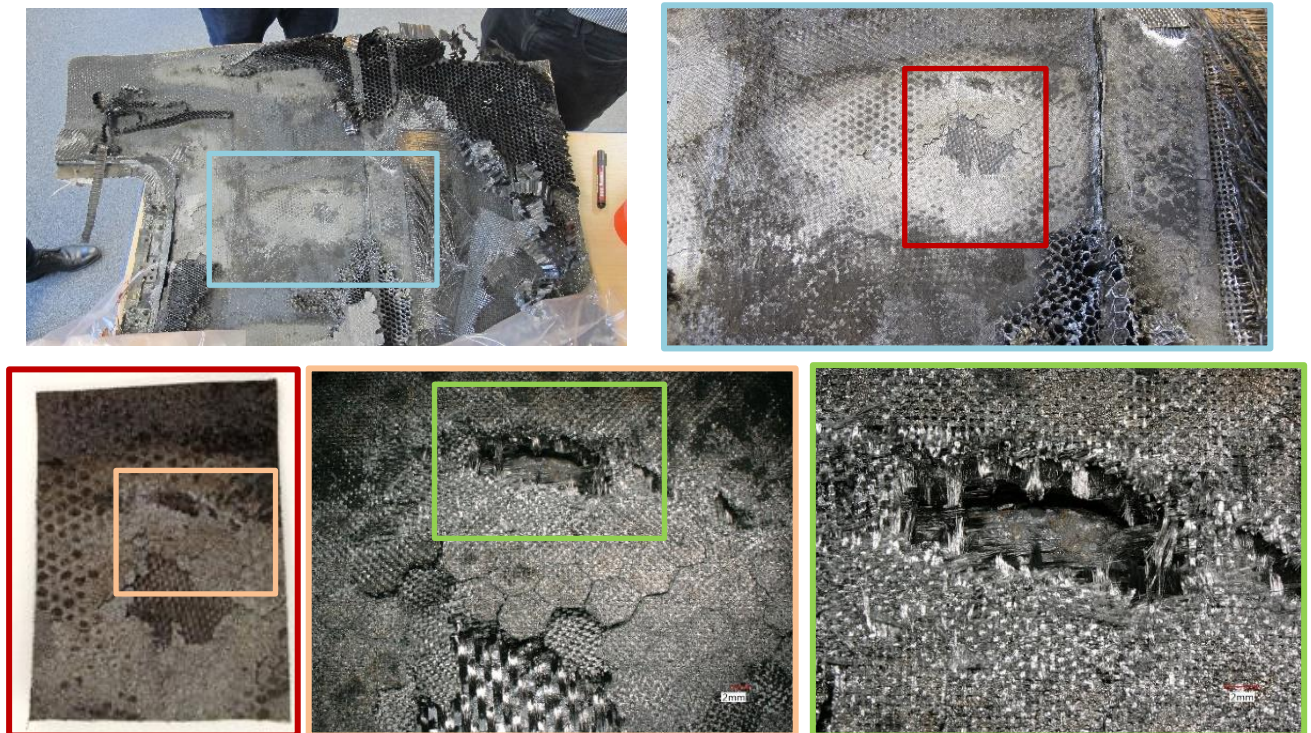
**Figure 4. Cowling inner side- Honeycomb sample extracted from the area affected by material loss**

- Cowling: The honeycomb sample extracted from the event location has presented complete thermal degradation and delamination.
- Constrain of the fractographical examination: The high level of contamination with soot prevented a detailed analysis of the fracture surfaces of all samples of interest.

The honeycomb presented delamination and is thermal degraded at the inner skin (see Figure 4). However no damage indicating an impact could be observed on the outer skin of the cowling (see Figure 5).

The matrix was found to be degraded (loss of resin) that's why no further fractographic examination was not possible.

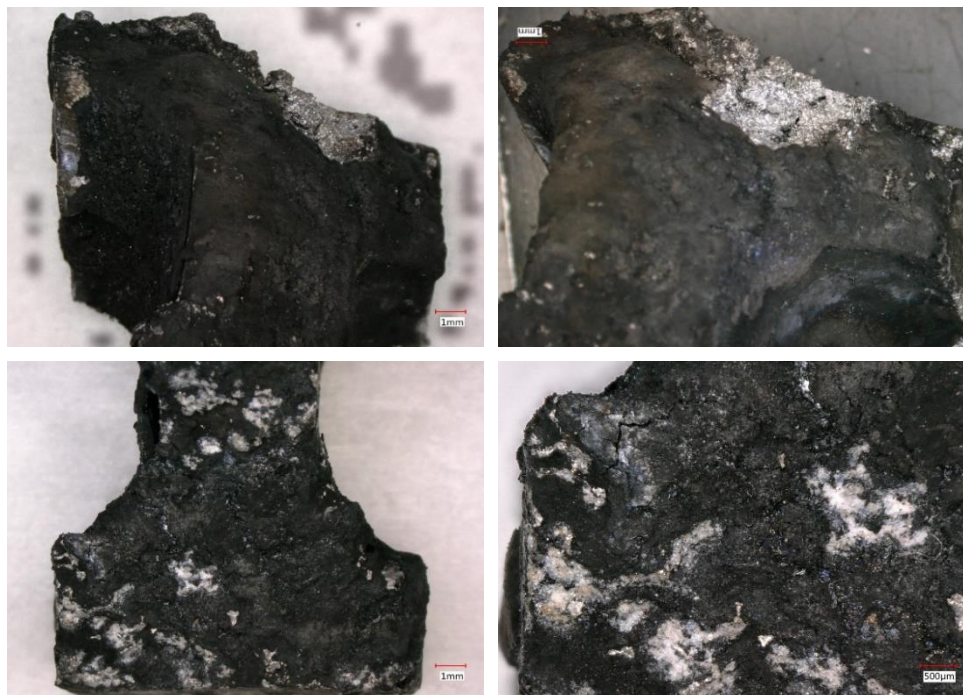
**Figure 6: Left hand hinge from Hydraulic Access door-RHS- Zoom in on contamination**

The fracture surfaces of the 2 broken hinges was heavily contaminated with soot and with a white residue. Close to the main fracture surfaces, secondary cracks are present in both hinges (see Figure 11)

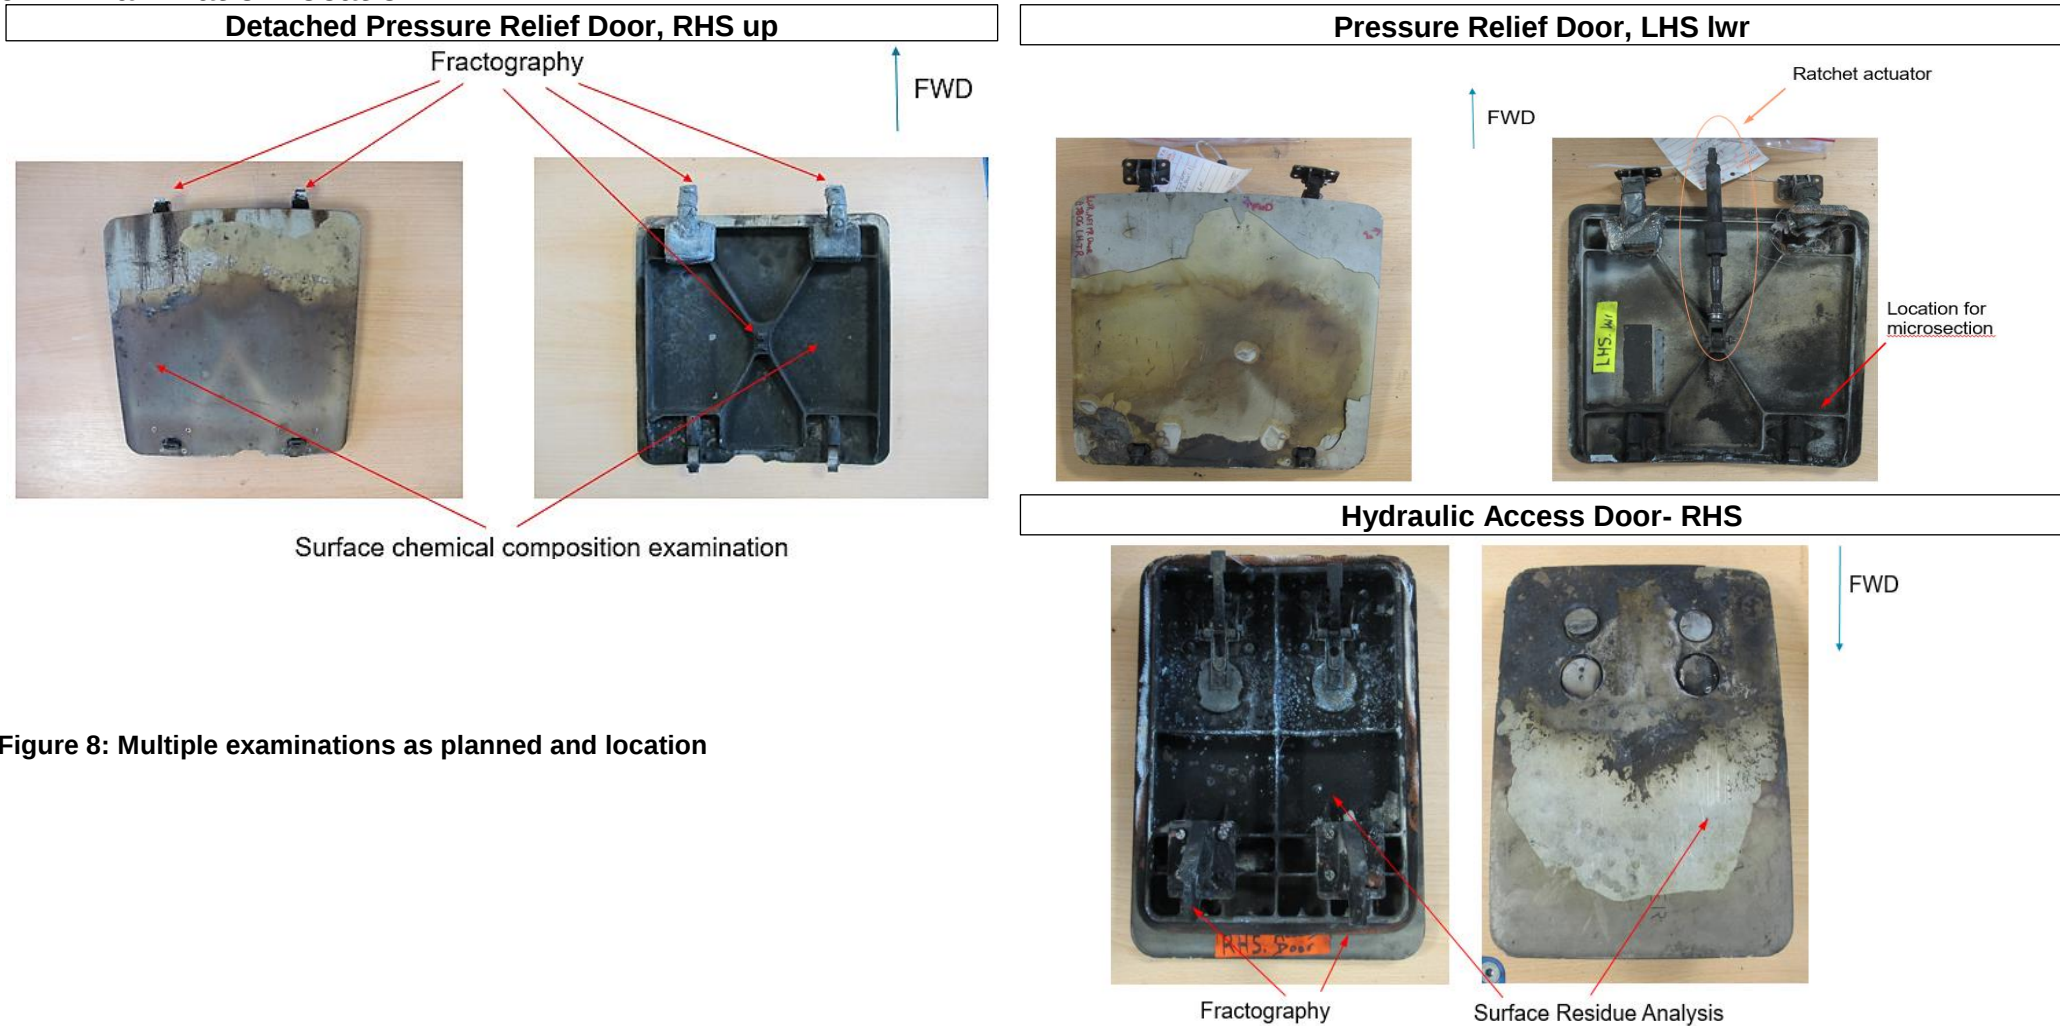
Figure 8: Multiple examinations as planned and location

The inner surface presented heavy contamination with black residue (see Figure 8).

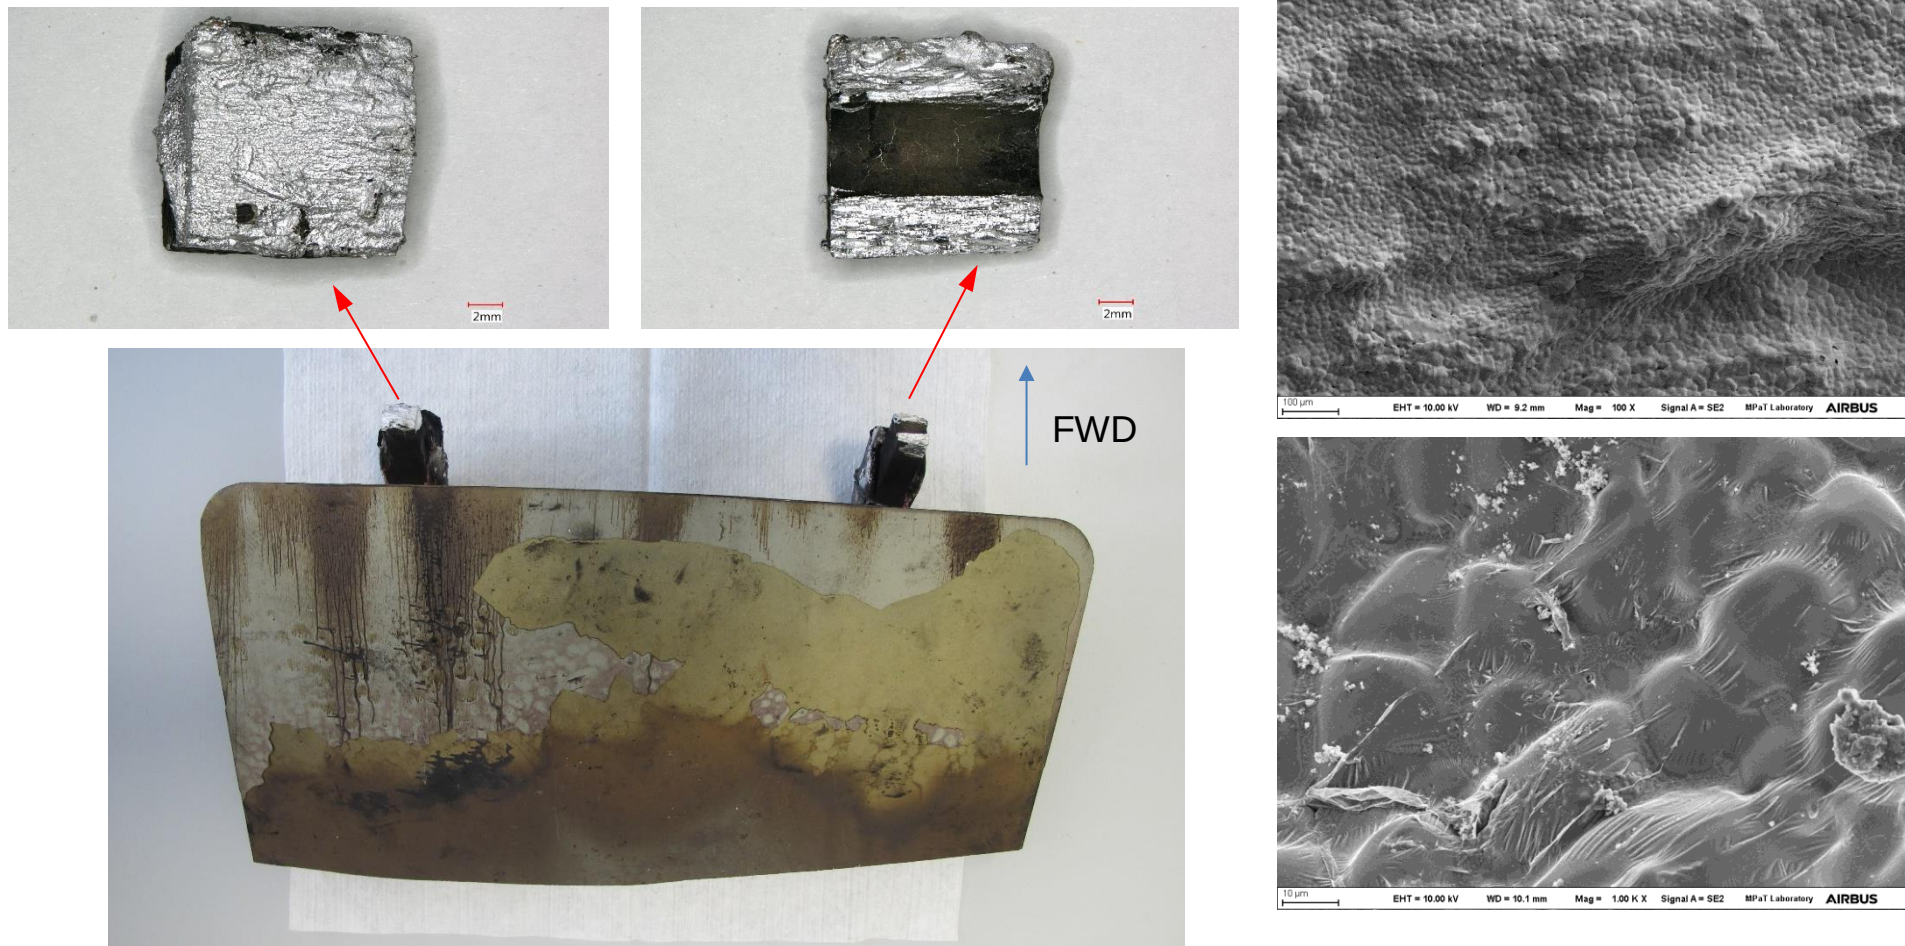
**Figure 9: Fractography of 2 hinges from the Detached PRD -RHS up**

- PRD – RHS up: The fractographical examination performed on the 2 hinges from the detached door presented characteristics of a free-solidified surface - suggesting that the fracture could have occurred at an early stage of the fire event.

The fracture surface has a shiny appearance.

It presented a typical character of a free-solidified surface (see Figure 9).

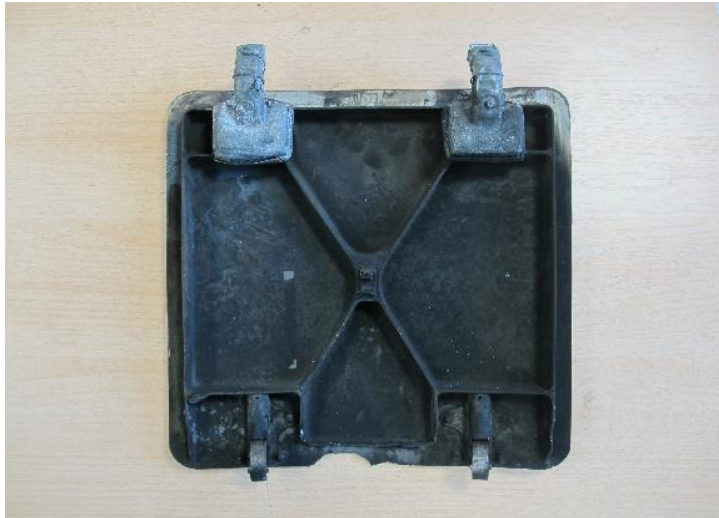
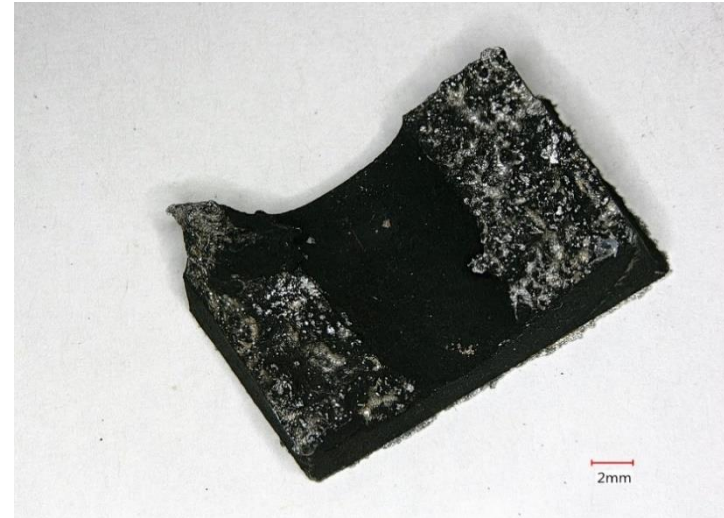
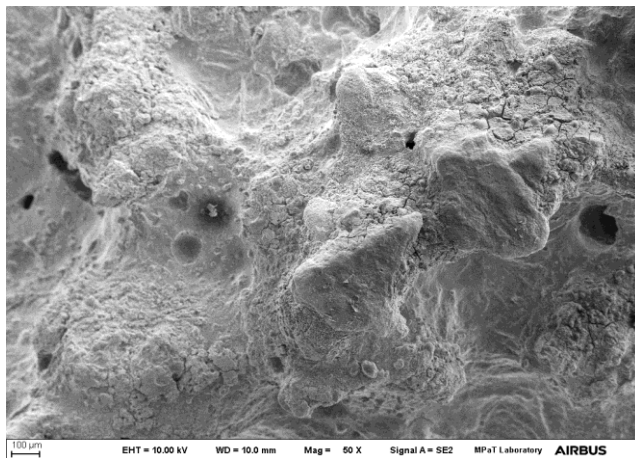
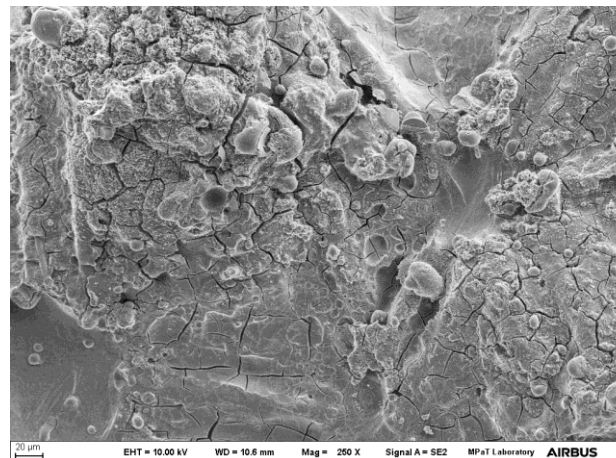
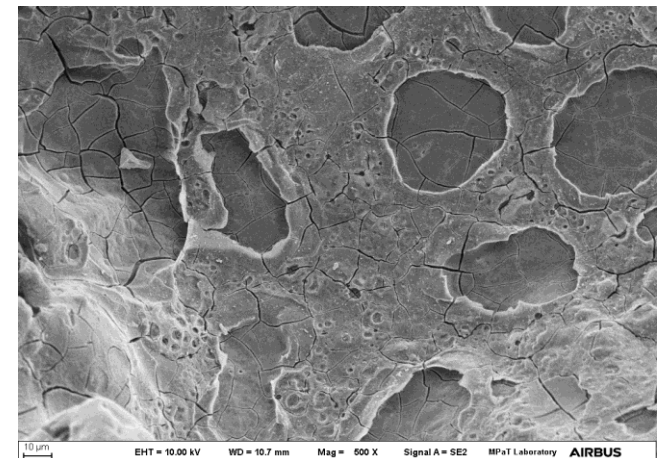
**Figure 10: Fractography of the Ratchet fitting hinge from the PRD– up**

The entire fracture surface is distinctly covered with residue. Intense cleaning performed in laboratory was not able to remove the residue. Consequently no detailed analysis of the fracture surface could be performed.

The fracture showed in some areas typical characteristics of a free- solidified surface which are partially covered by residues of at least two layers (see Figure 10).

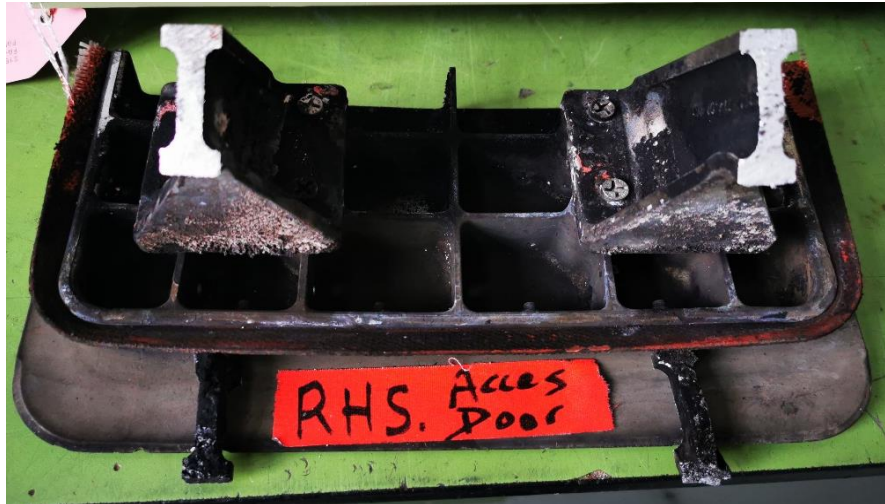
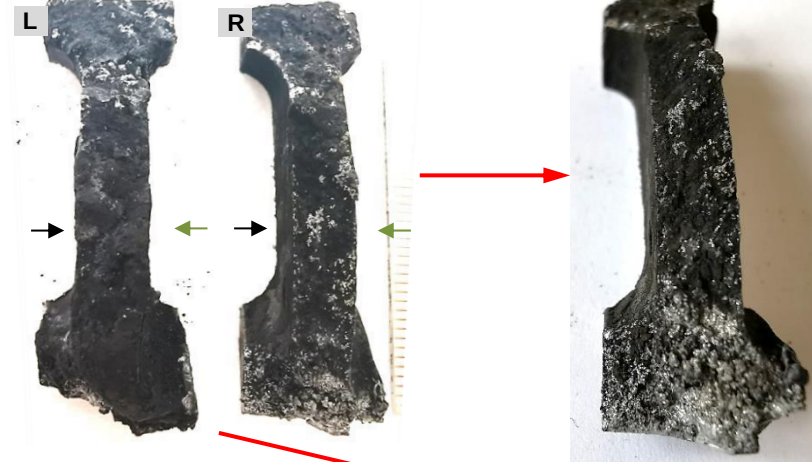
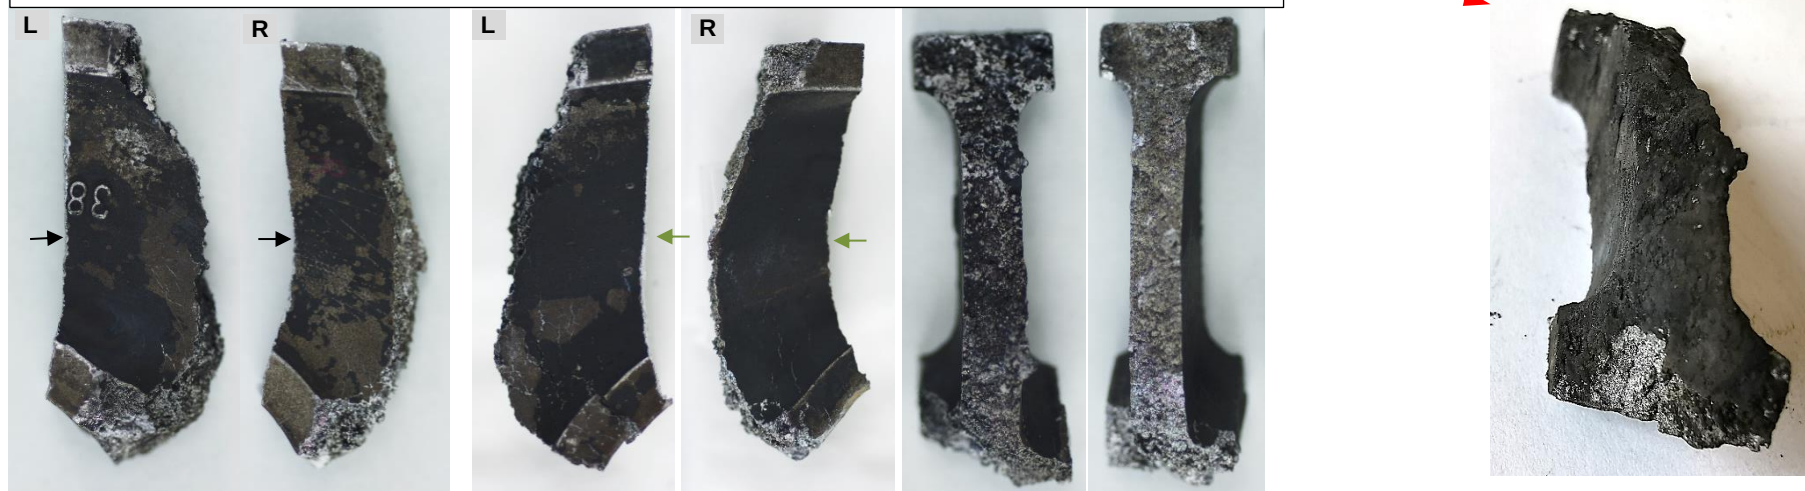
Figure 11: RHS Hydraulic access door hinges extracted for fractographic examination

- HAD -RHS: The 2 broken hinges have been examined via microscopy and showing multiple secondary cracks – suggesting a forced detachment of the door while the material was degraded.

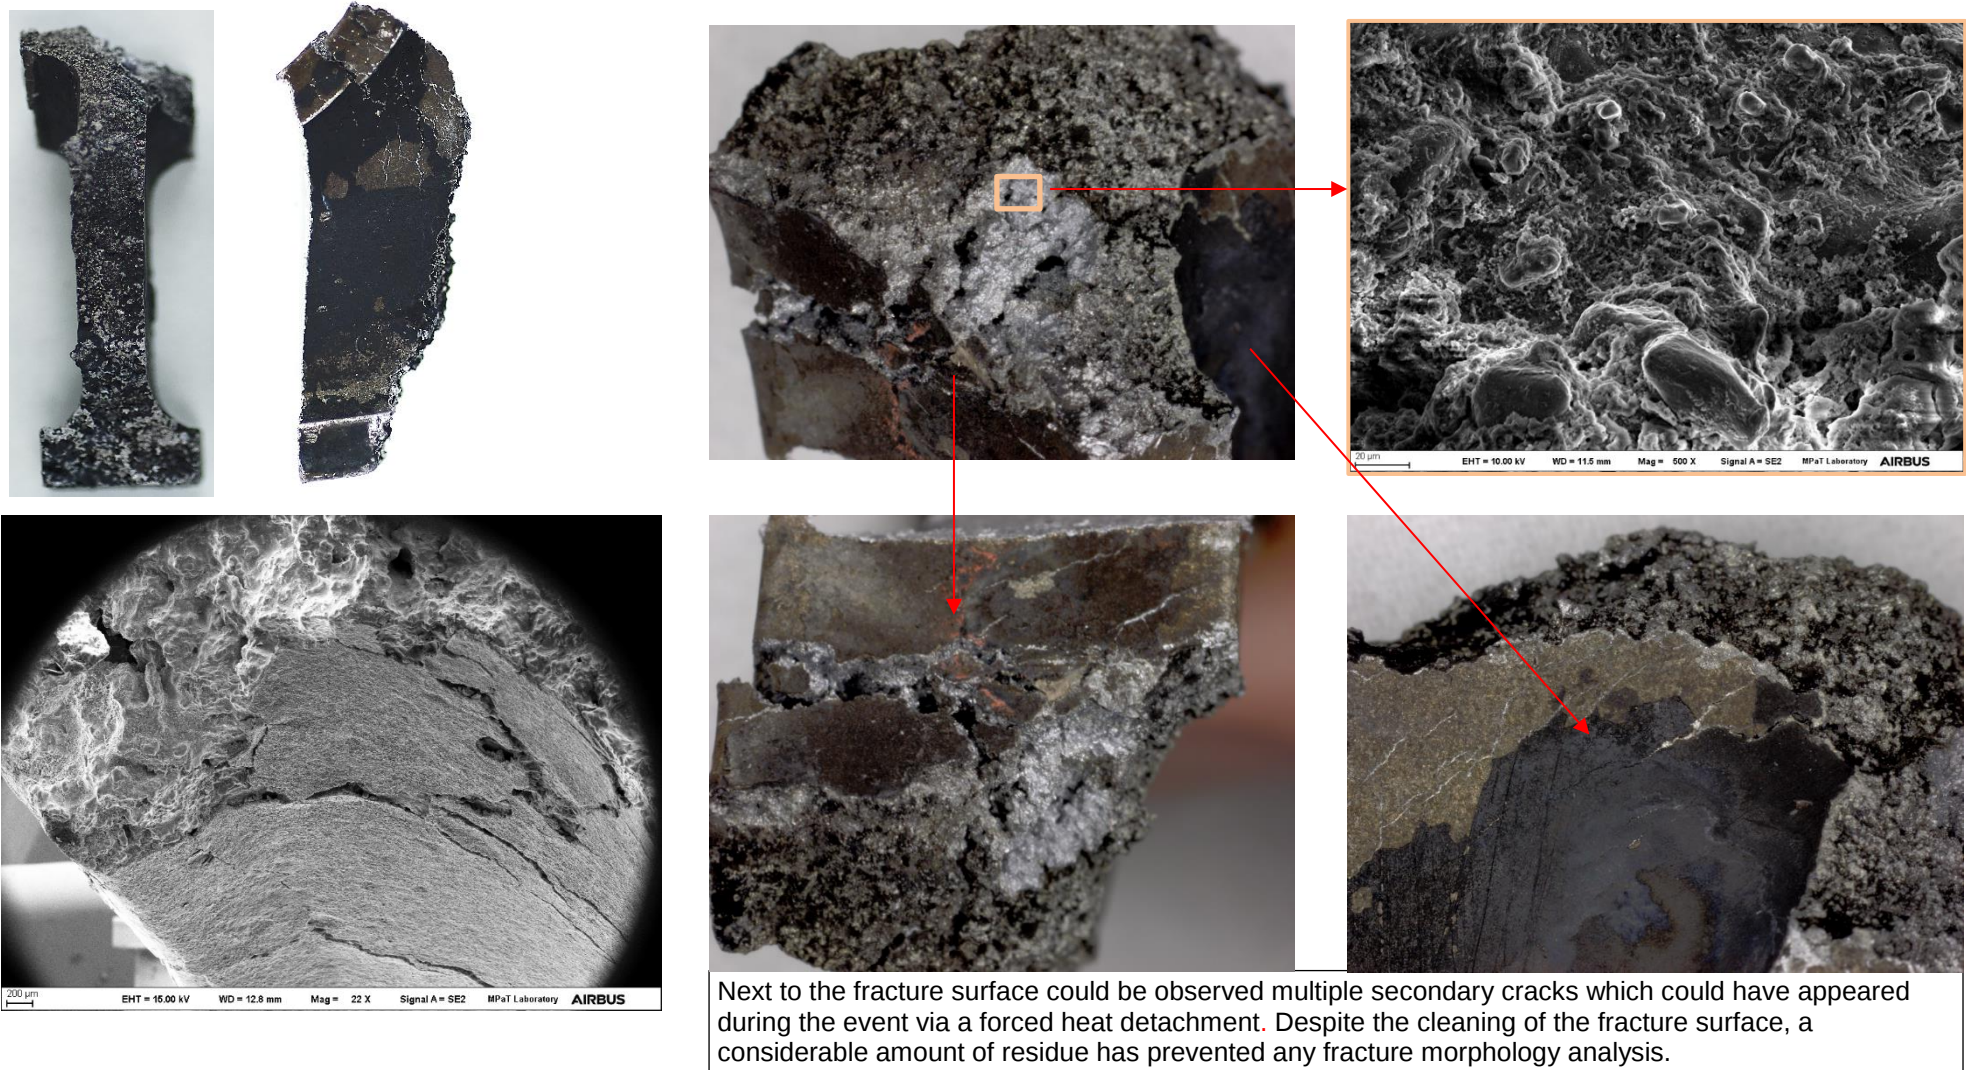
**Figure 12: Fractography of the RHS Hydraulic access door hinge Left hand side**

Despite the multiple attempts of cleaning the fracture surface, the remaining contamination has prevented the observation of any morphology or recording any conclusive information (see Figure 12 and Figure 13).

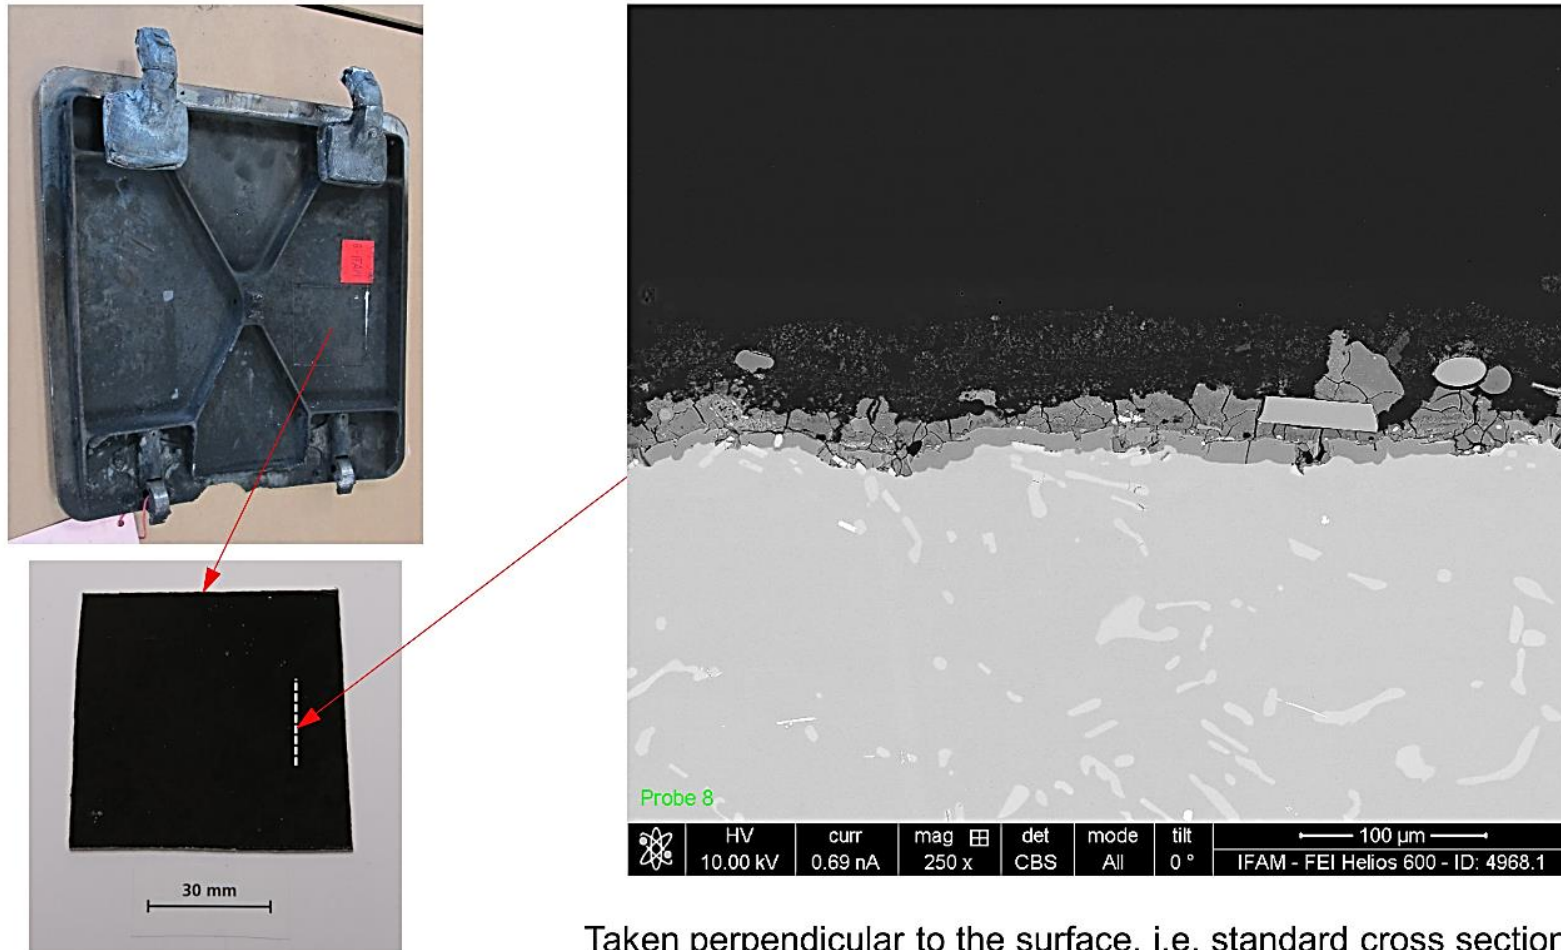
**Figure 14: Examination plain area #1 from the detached PRD- RHS up**

- PRD – RHS and LHS: The surface analysis of samples extracted from both has showed rich layers of Phosphorus and Oxygen on top of the SAA protection which can be associated with remains of Skydrol hydraulic fluid burned in the event.

During the examination two layers have been identified (see Figure 14) and based on the chemical examination in both cases the following observations have been made:

- A Phosphorus and Oxygen rich layer is covering the sulfuric acid anodization (SAA) of the protection scheme.

- The Phosphorus and Oxygen rich layer is partly in direct contact with the base material (Al-casting)
- A Carbon rich residue with low amount of Oxygen can be observed mainly on top of the Phosphorus and Oxygen rich layer.

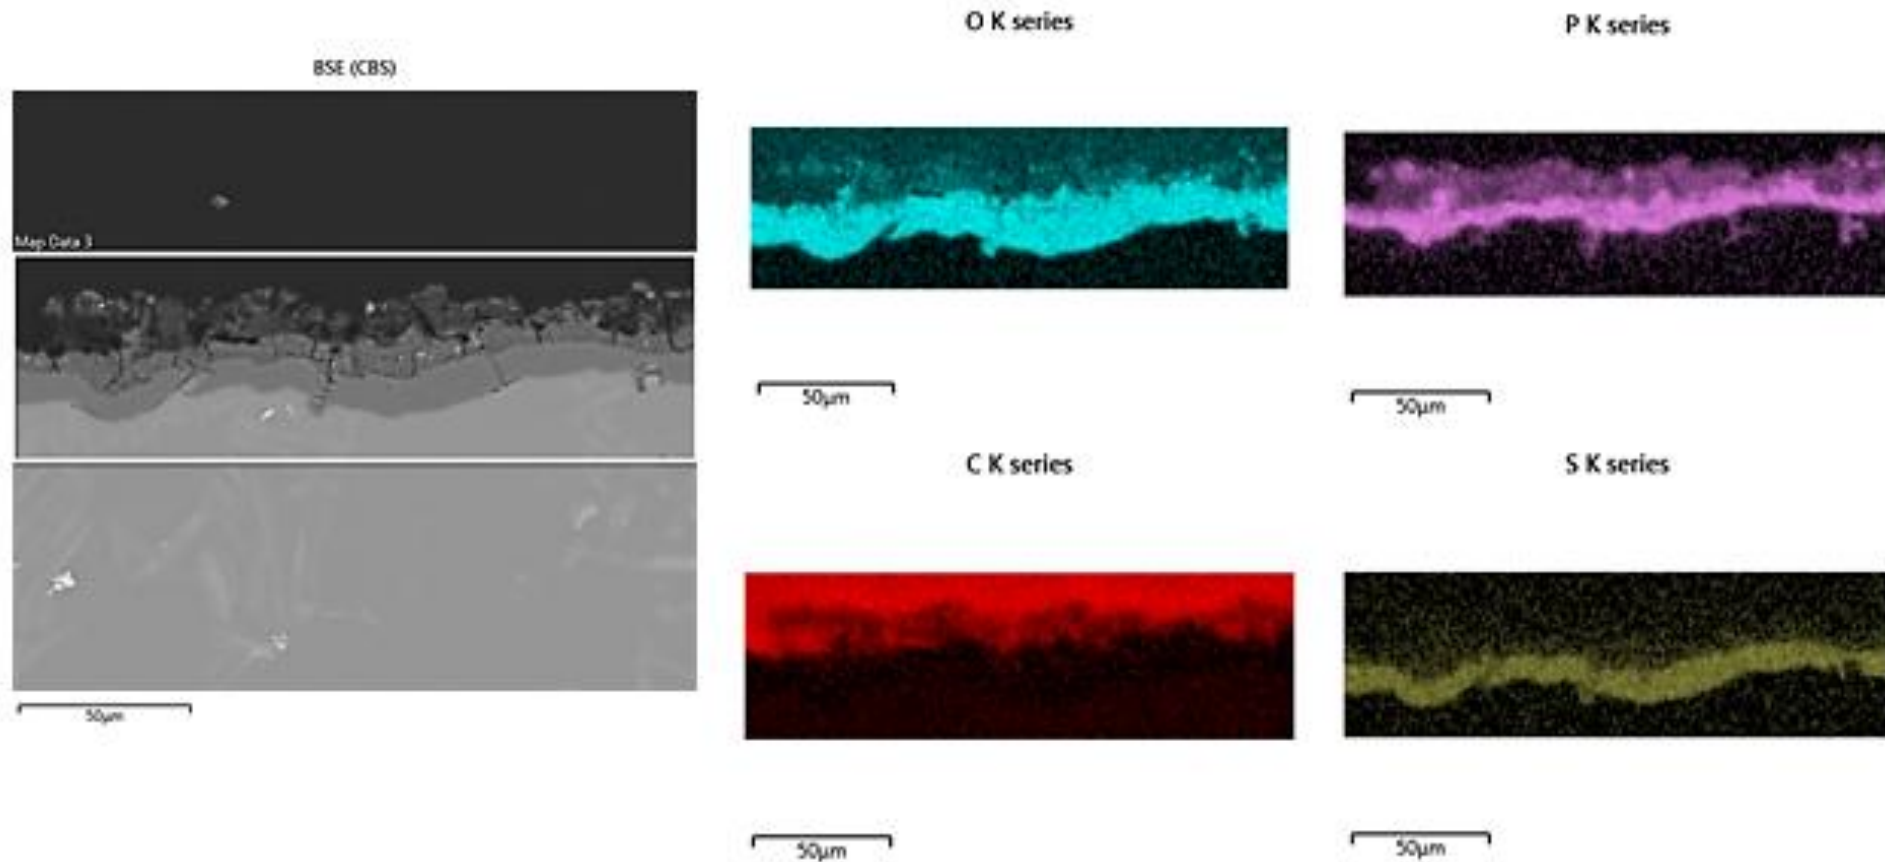
Figure 18: PRD -RHS lwr; reinforcement bar, examination area- Chemical composition

The chemical components found were comparable with the PRD RHS up. However, the formation of the layer was less pronounced (see Figure 18).

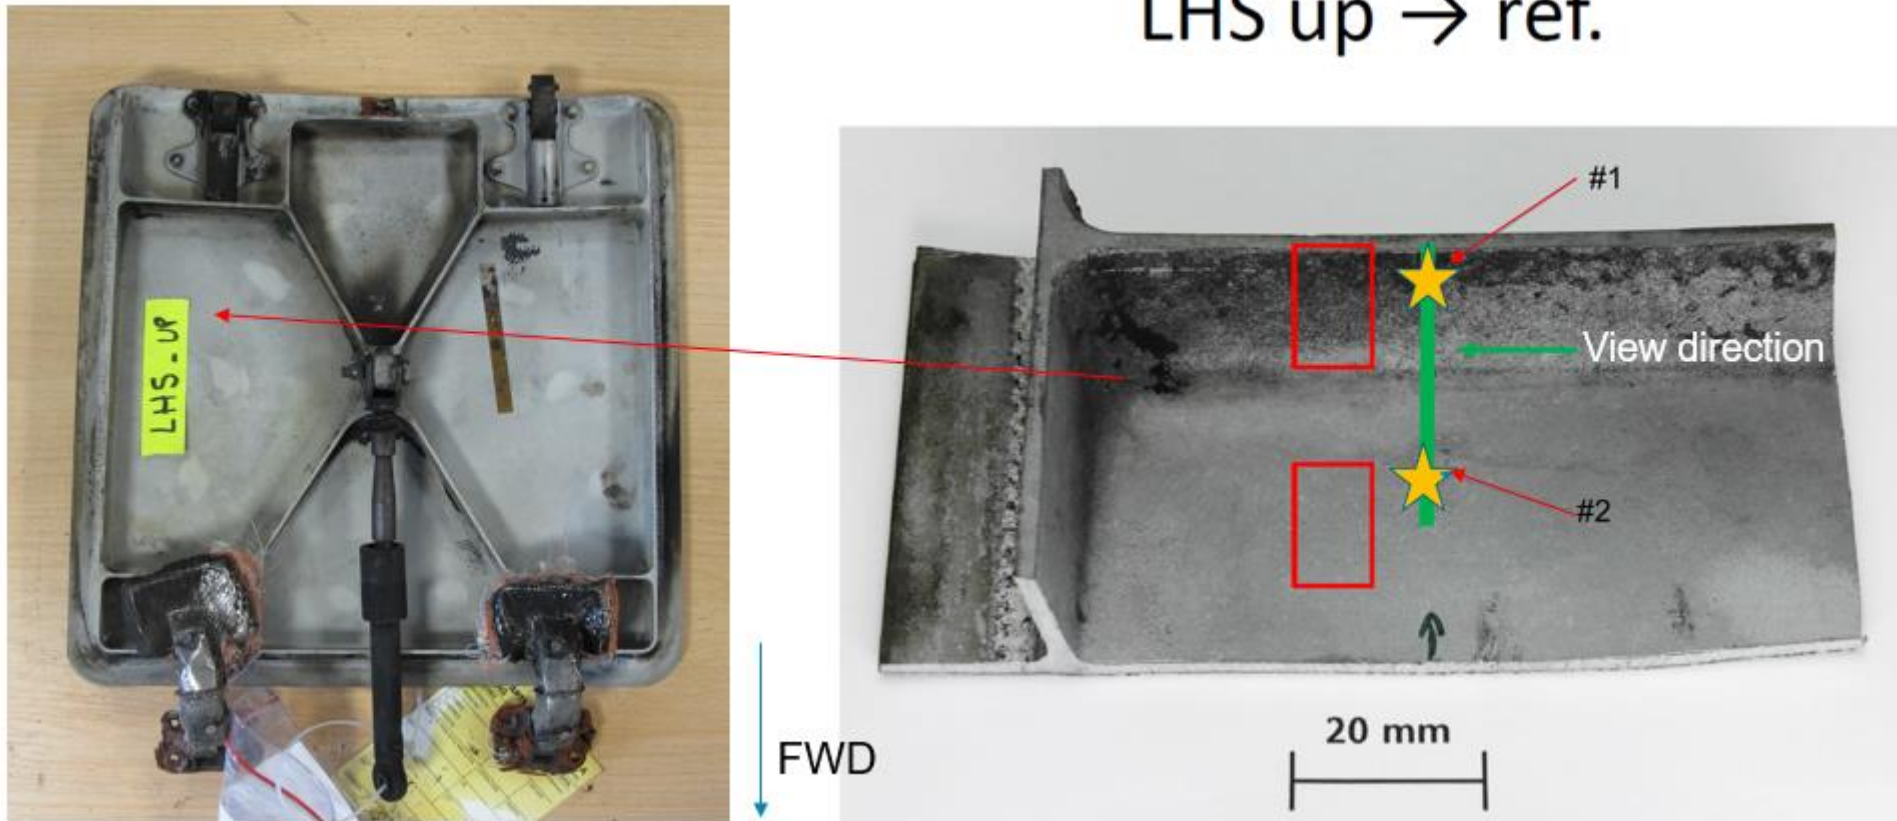
Figure 19: Pressure Relief Door, LHS up

Two samples have been extracted from this PRD which has been consider being a reference due to its low level of residual contamination (see Figure 19).

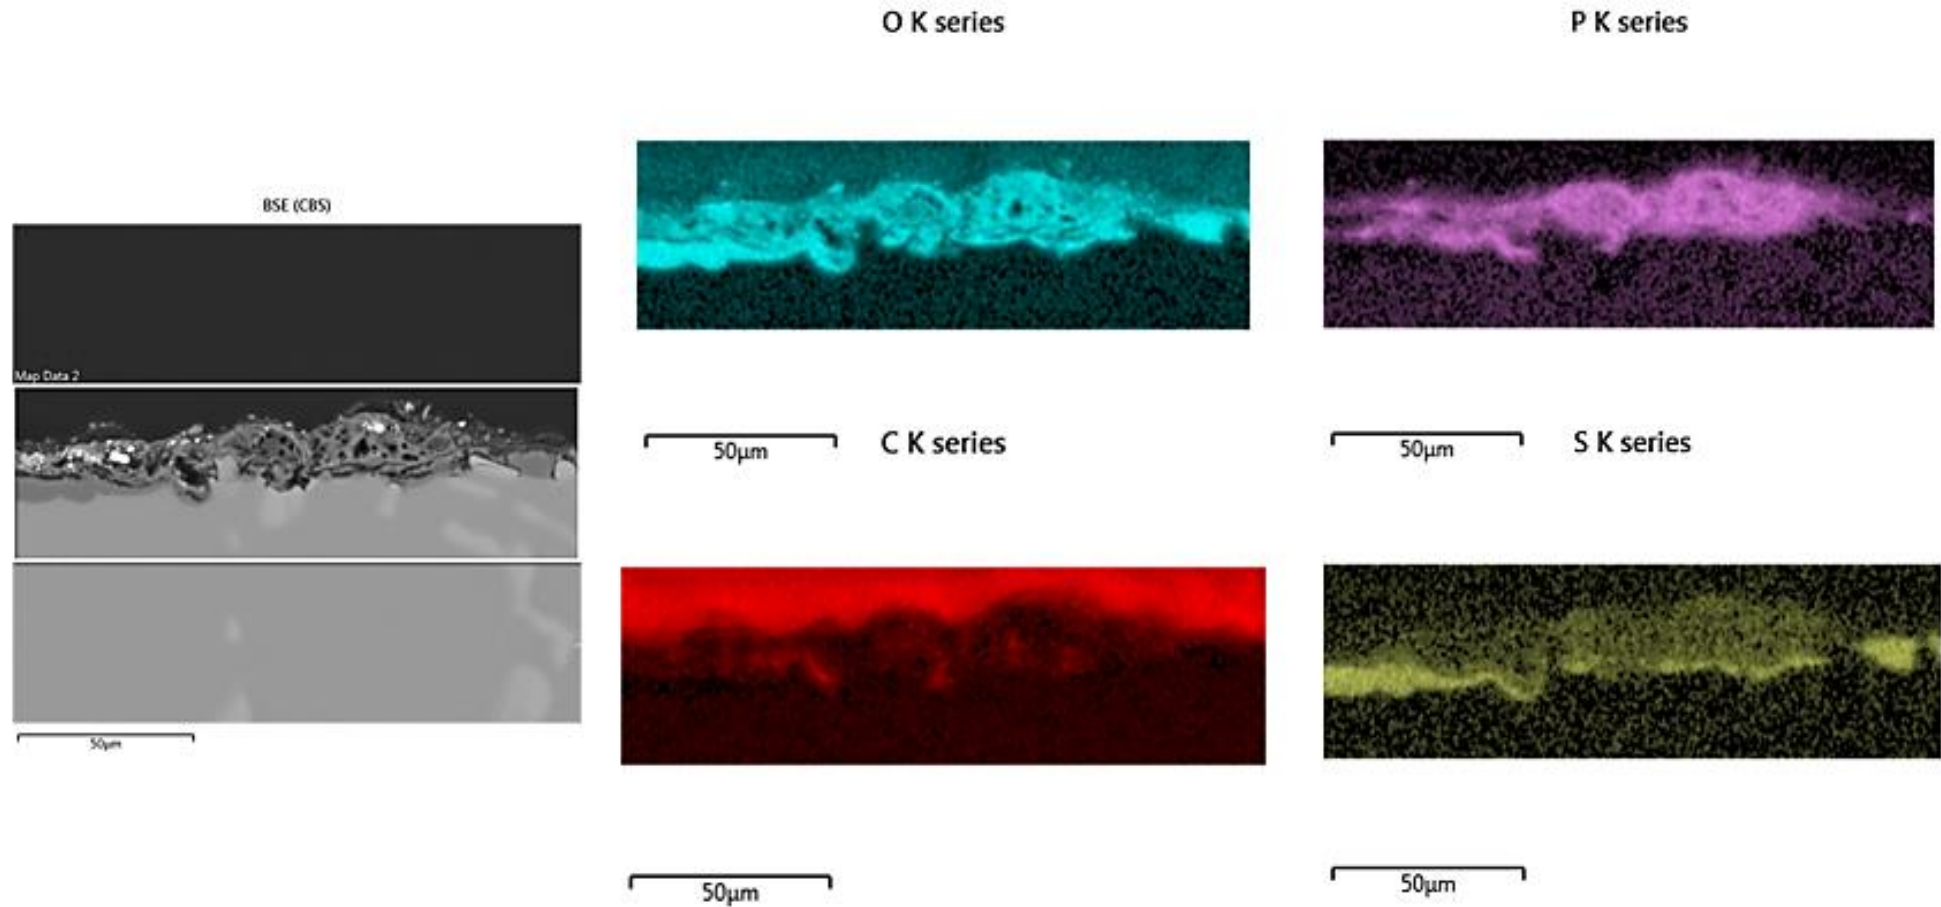
Figure 20: PRD -LHS up; plain area #1 as reference- Chemical composition

Sample #1 presented a locally reduced thickness of the SAA layer with additional Phosphorus and Oxygen residues in a layer like appearance on top (see Figure 20).

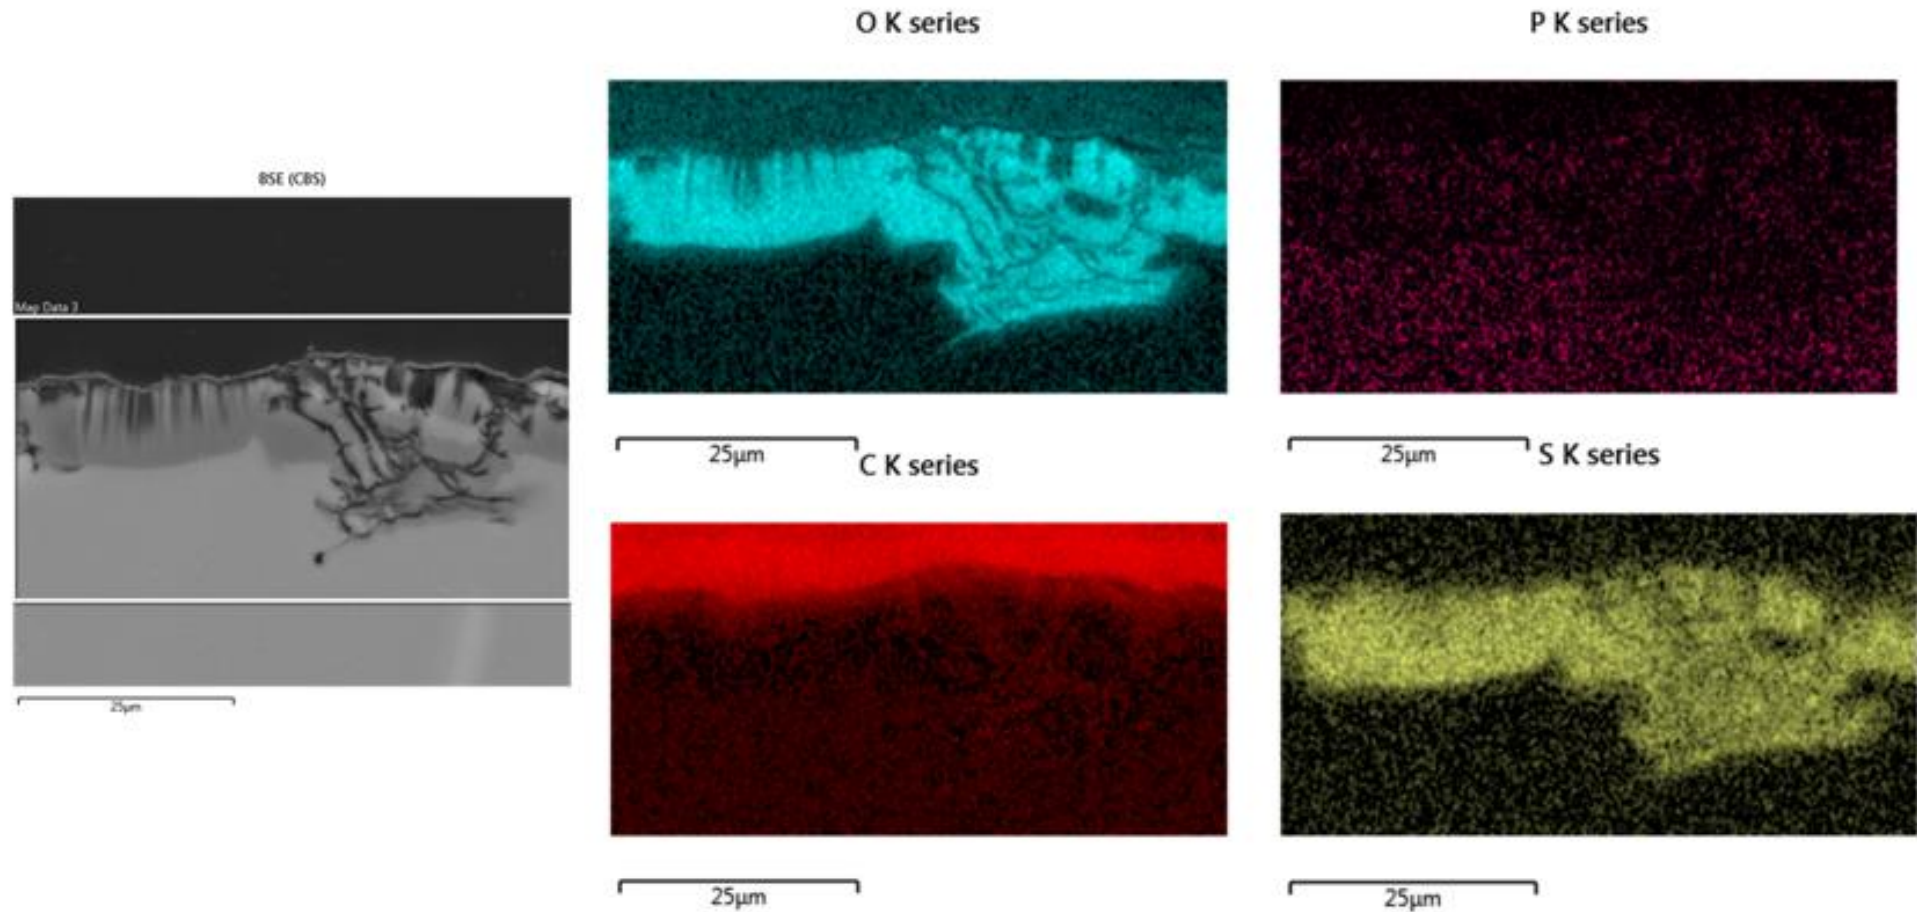
Figure 21: PRD -LHS up; reinforcement bar area #2 as reference- Chemical composition

Sample #2 presented a locally damaged SAA layer. The Phosphorus content of the residue is only slightly above the detection limit therefore no localization was possible (see Figure 21).

The Carbon content observed was only part of the mounting resin.

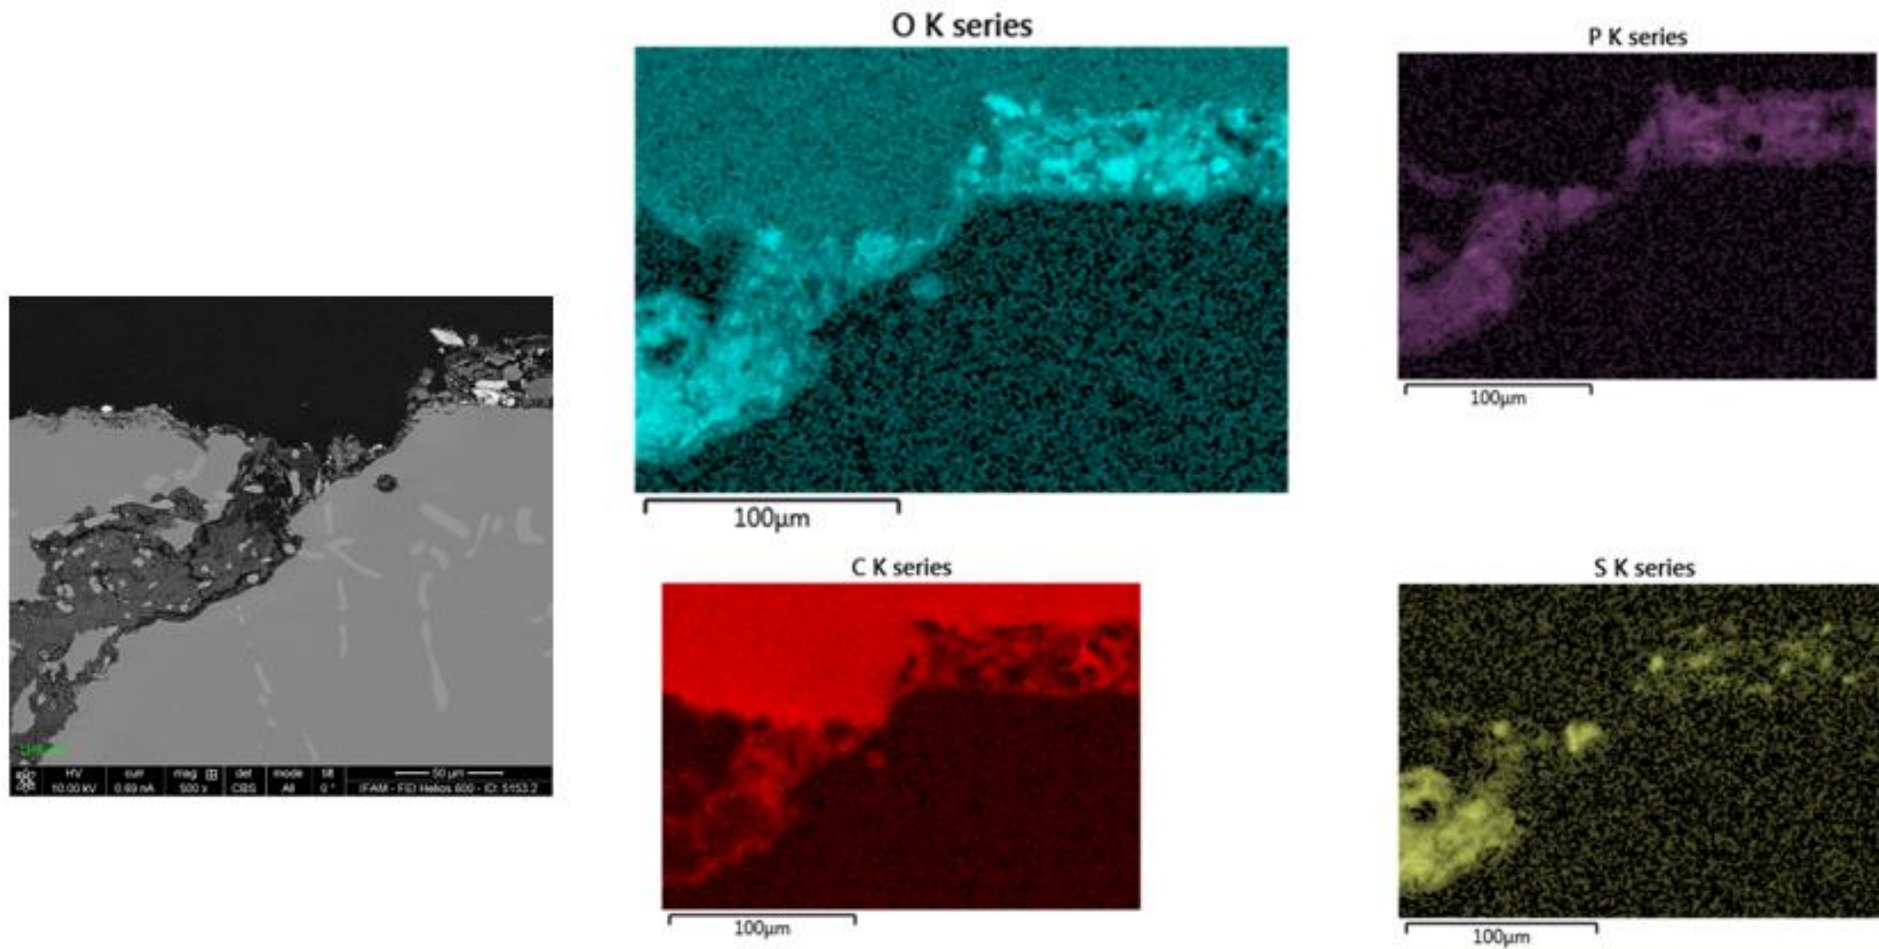
Figure 23: PRD -LHS lwr; reinforcement bar, examination area- Chemical composition

For this sample the residues did not presented a layer-like appearance. The found residues were rich in Phosphorus and Oxygen.
