**NATIONAL TRANSPORTATION SAFETY BOARD**

**Attachment 1 –Airbus Analysis of Thrust Reverser Surface Residue**

**DCA18LA163**

## A330 MSN 578 DAL fire event- Analysis of Surface residue

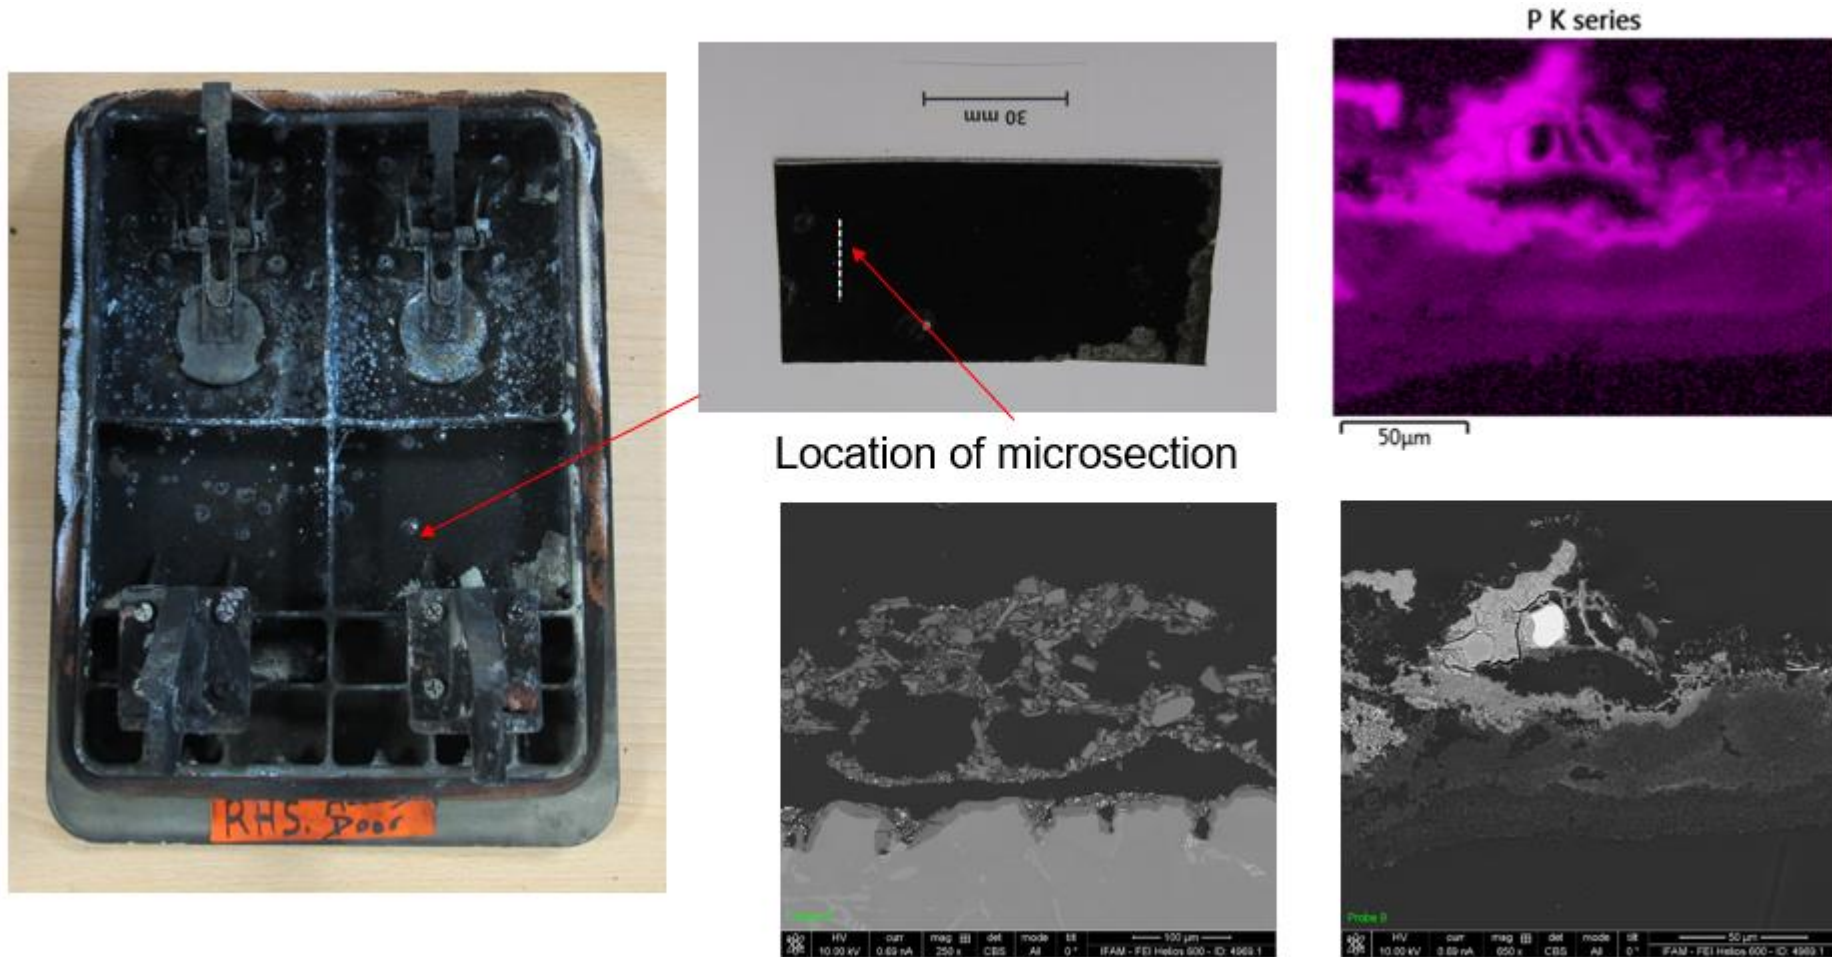
Figure 24: Hydraulic access door RHS - Chemical composition

Following the analysis of the sample extracted from the hydraulic access door, Phosphorus has been showed however not in a pronounced layer form.
