**NATIONAL TRANSPORTATION SAFETY BOARD**

**Attachment 3 –Sitec Aerospace Hydraulic Fire Shut-Off Valves Test Report**

# Engineering Investigation Report

DOC. NO. E03A00-144-02

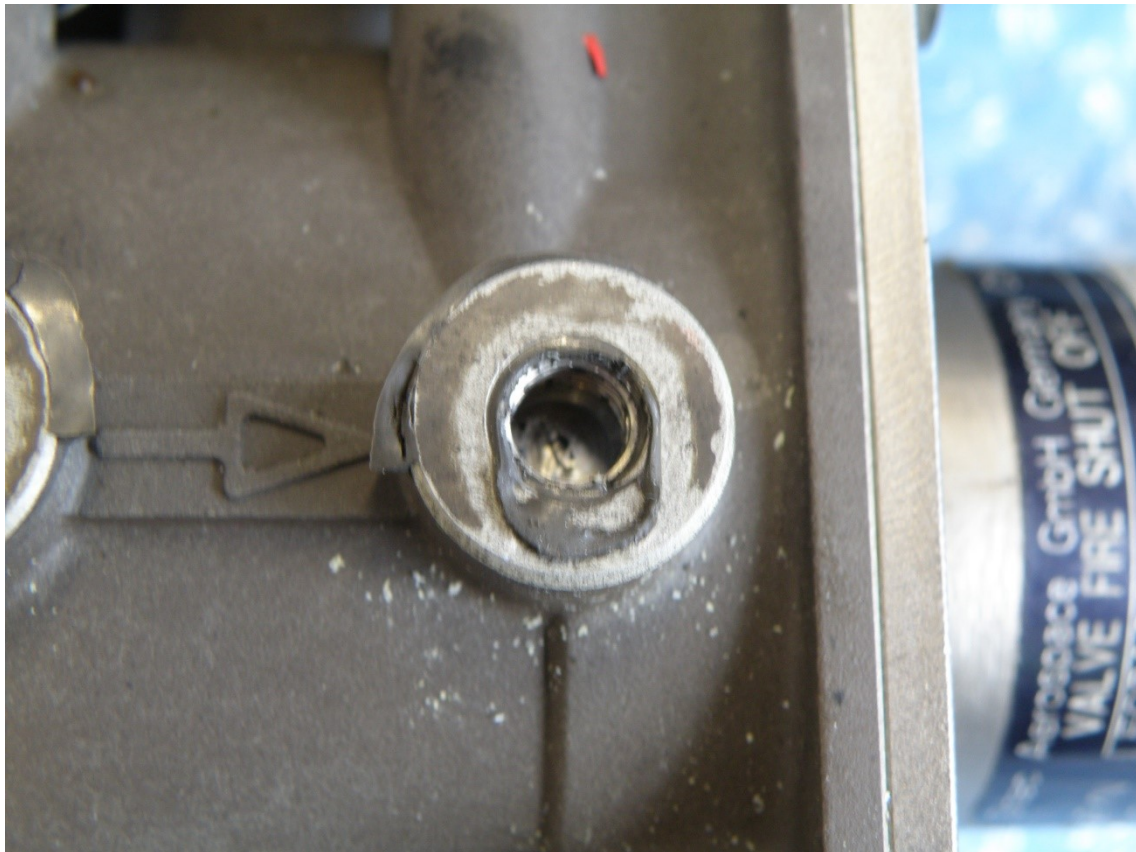
Figure 3: Imprints on mounting hole

- The general external condition was found to be good.
- No sign of heat damage to be found which would have been indicated for example in a change of colour of the locking paint.
- Imprints were found on the bottom of the mounting holes (Figure 3). These imprints do not interfere with the ball movement or function of the FSOV in general.

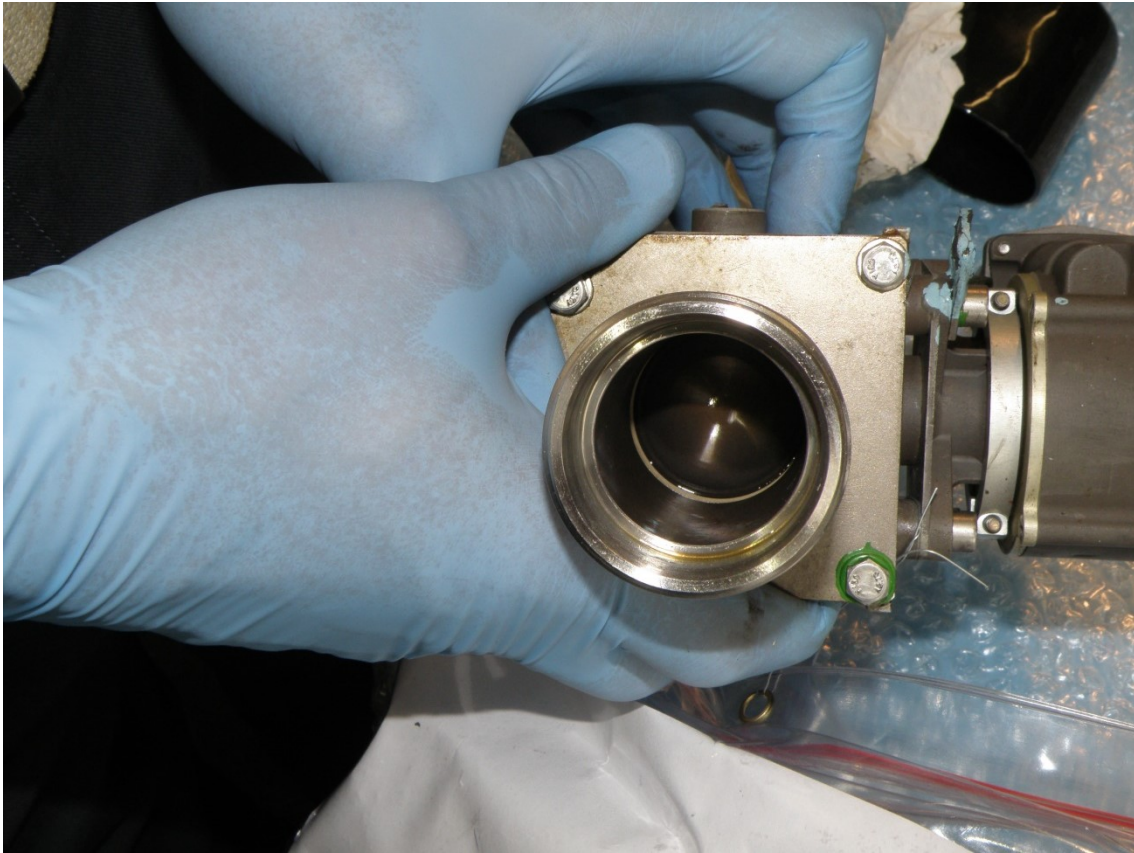
Figure 4: Visual Inspection of Ball Position

- Visually the ball appeared to be closed when looking inside the valve. The cavities and the ball seemed to be in good condition. No deposits or other FOD was found. (Figure 4).

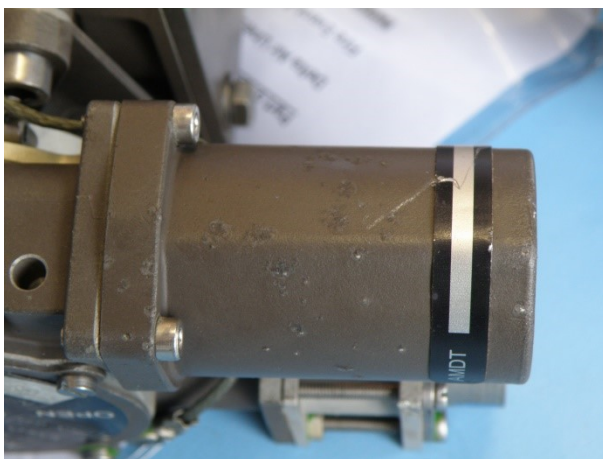
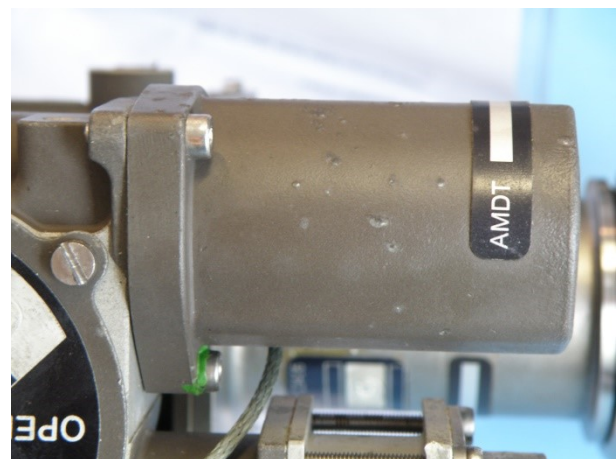
- Motor cover of actuator shows dots and/ or dents and deposits (Figure 5 and Figure 6). The impacts marks do not interfere with the actuator function.

Figure 5: Dents/ Deposits on motor cover 1

Figure 6: Dents/ Deposits on motor cover 2

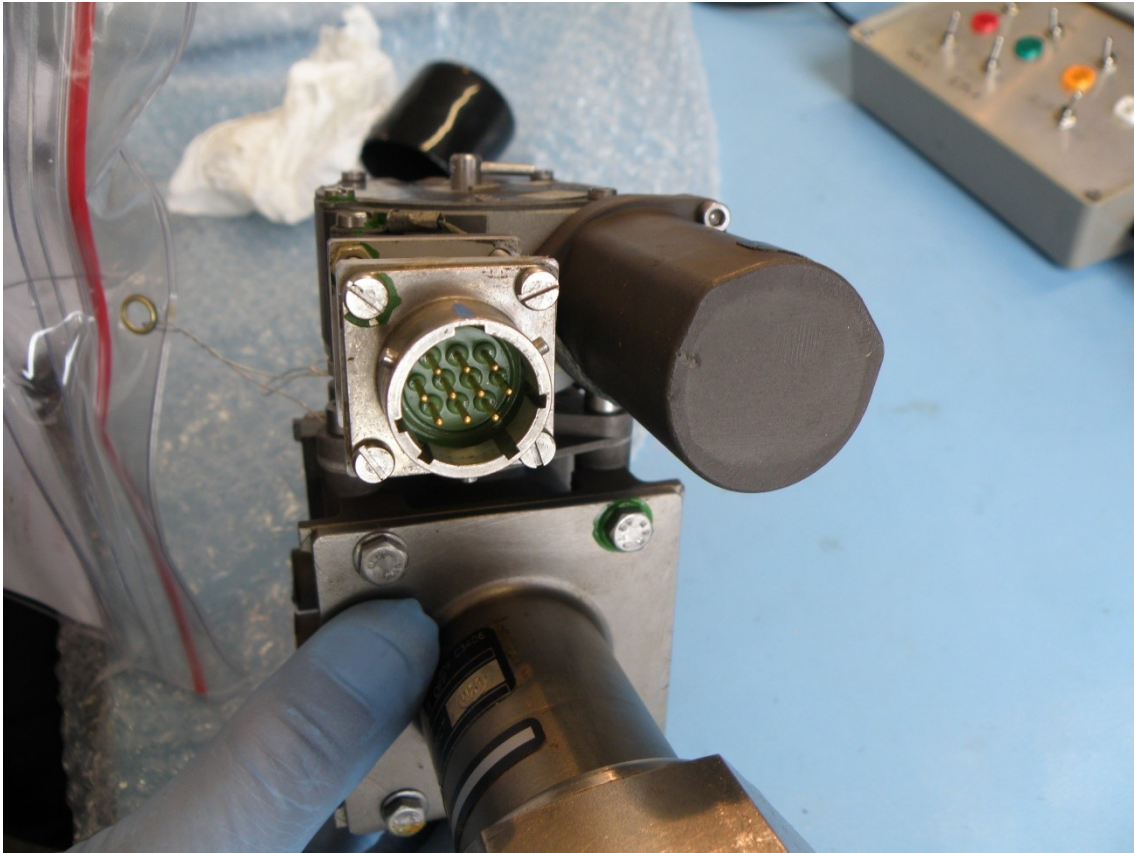
Figure 7: Connector pins

- Connector of actuator seemed to be in good condition, no bent or missing pins, no FOD inside connector that could cause short circuit (Figure 7).

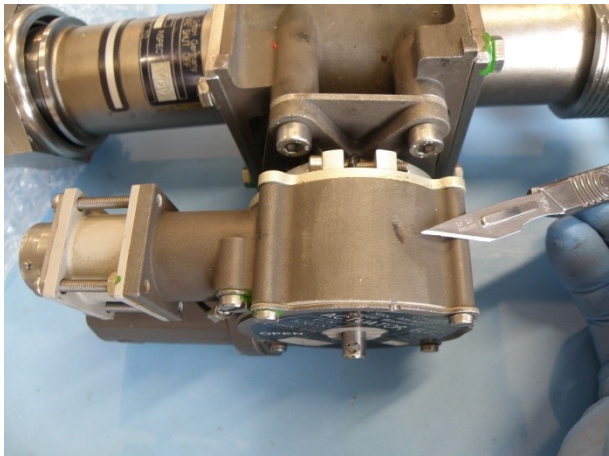
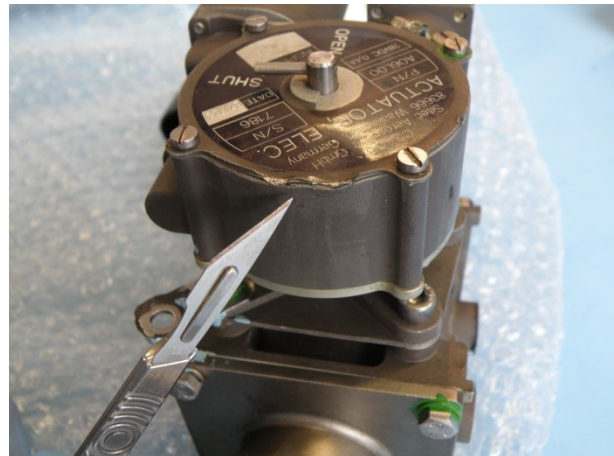
- On actuator housing and cover several impact marks were found ( Figure 8 and Figure 9).

Figure 8: Impact mark on actuator housing

Figure 9: Impact mark on actuator cover

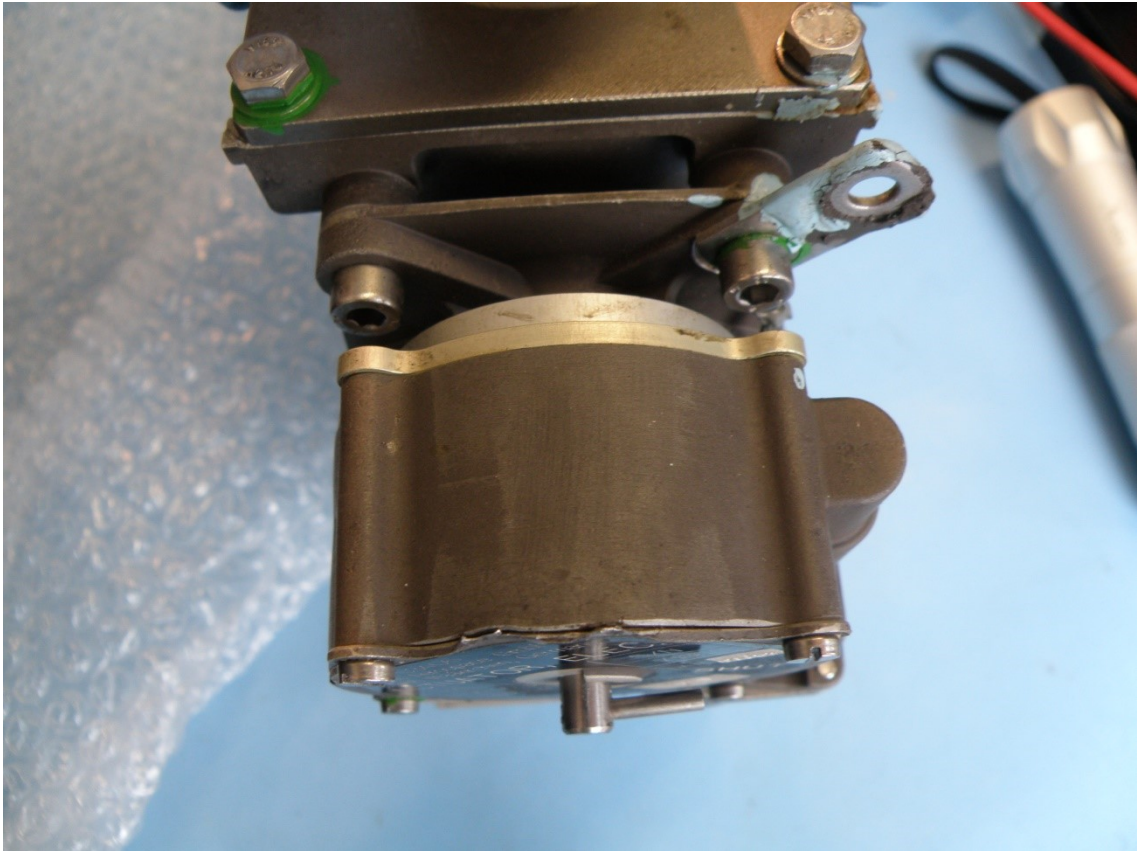
Figure 10: Refurbished actuator surface

- Two surfaces of the actuator housing seem to be refurbished. This doesn't interfere with the function of the valve (Figure 10).

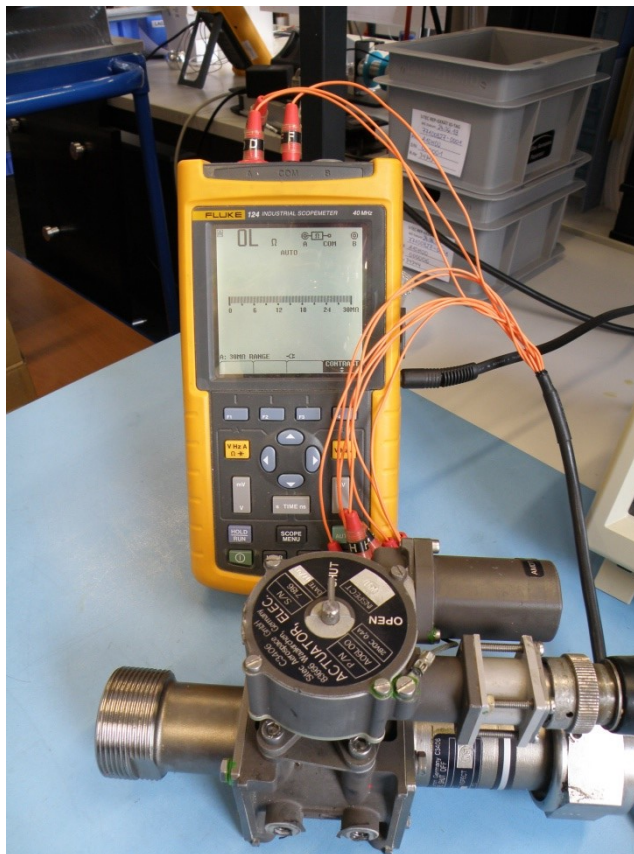
The electrical indication was checked without operating the valve. An Ohm- meter was connected to the unit as per engineering test procedure §2.2. The resistance was measured at 0.5 Ohm indicating that the valve is in closed position.

Additionally the Ohm- meter was connected to the unit to check if the signal for the valve to be open is present which should not be the case. The measured resistance was infinite which proves that the electric indication is functional and indicates that the valve is in closed position.

Figure 11: Electrical Indication Test, infinite resistance

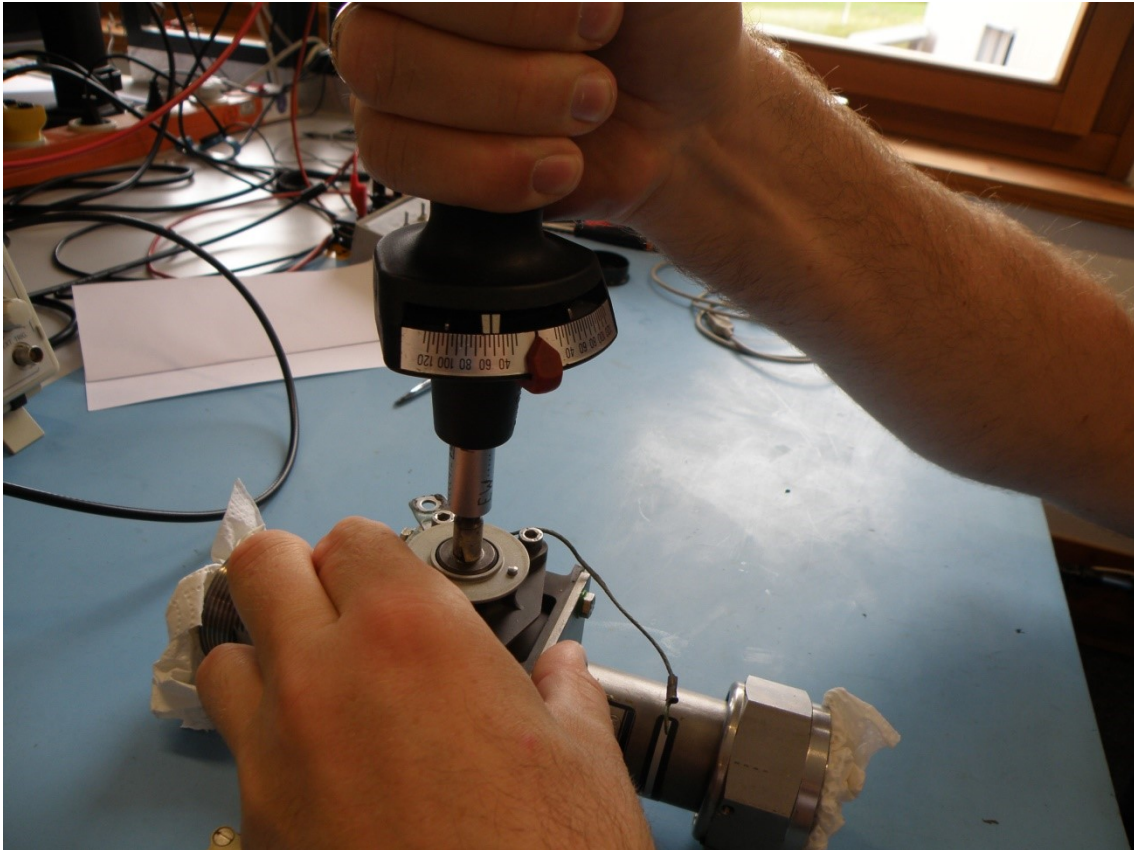
Figure 13: Torque measurement of valve ball

In addition to the test procedures the torque of the valve ball was measured. For this the actuator was disassembled from the valve. Afterwards the torque to move the ball was measured as  $0.7 \pm 0.05$  Nm for both directions of ball movement.

As per drawing of the valve the torque should be between 0.7 Nm and 1.2 Nm. Therefore the measured values are within specification.

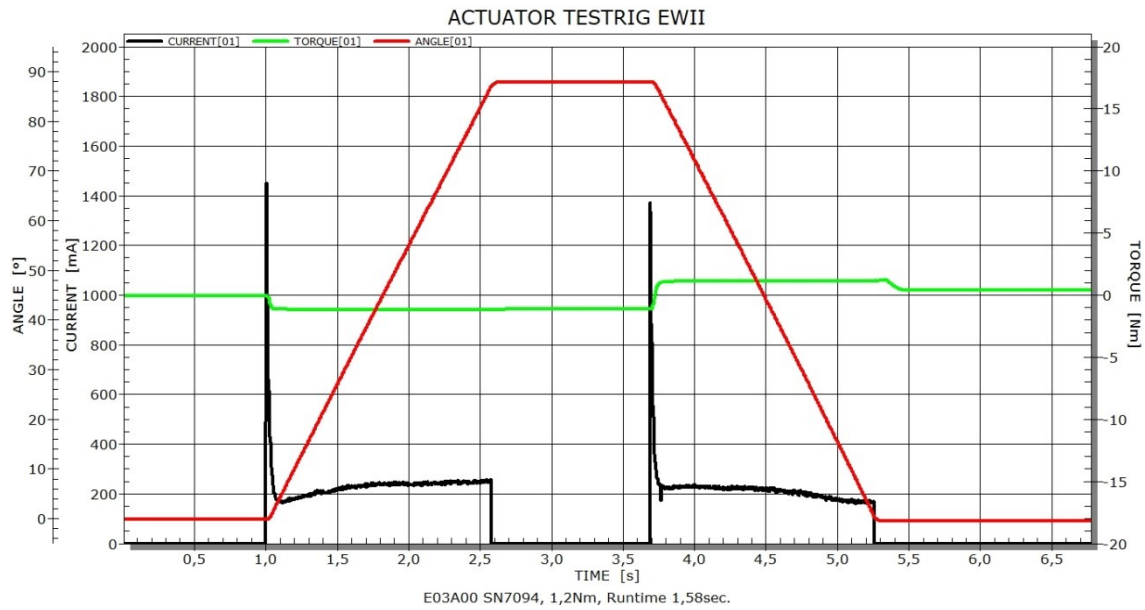
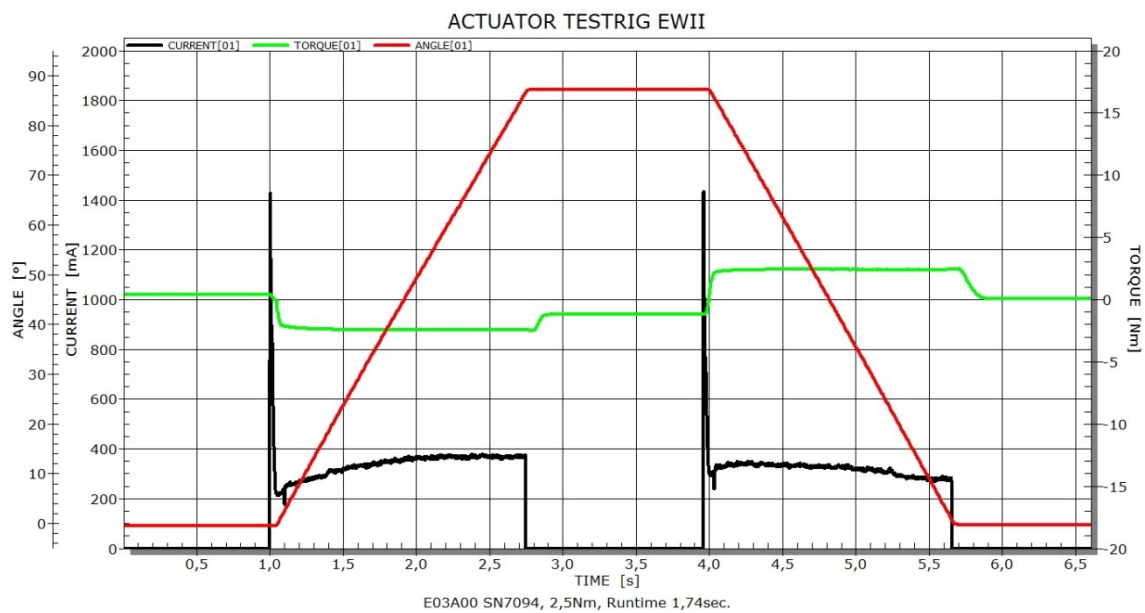
Additionally a load of 1.2 Nm and 2.5 Nm was applied to the actuator and the travel time under these loads was measured. The travel times were measured as 1.58 seconds and 1.74 seconds (Figure 14 and Figure 15). This shows that the actuator is able to move the ball from open to closed position in less than the required 1.8 seconds even with a load that is three times higher than the actual torque of the ball.

Figure 14: Actuator travel time under 1.2 Nm load

Figure 15: Actuator travel time under 2.5 Nm load

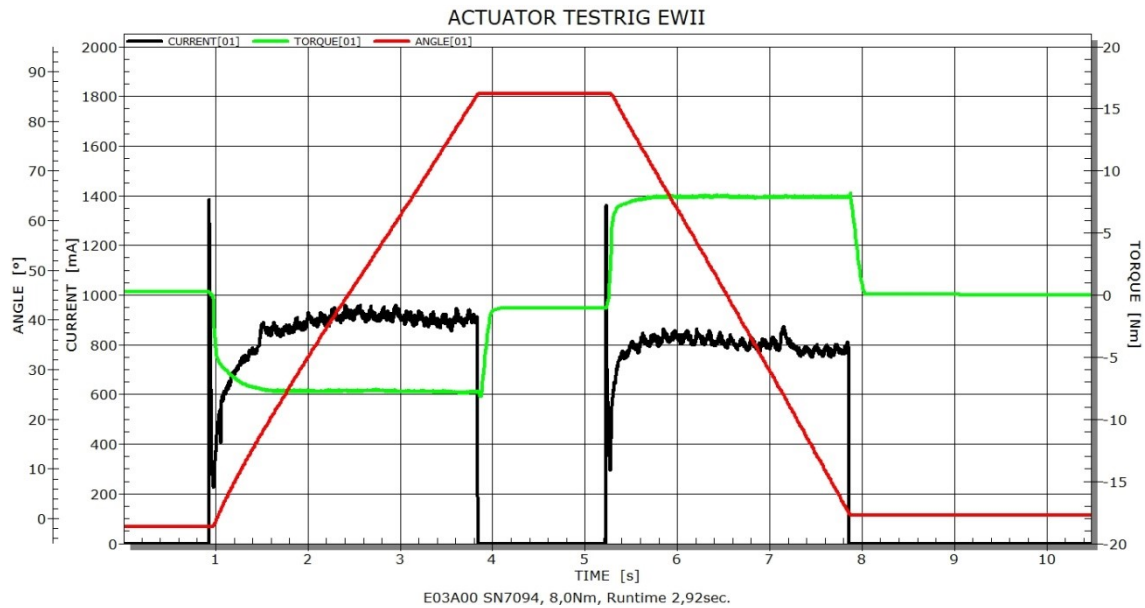
Afterwards a load of 8 Nm was applied to the actuator which is more than 10 times higher than the torque needed to turn the ball. Even if the maximum travel time was exceeded (2.92 seconds) the actuator was still able to perform a 90° turn (Figure 16). Therefore it can be concluded that the actuator was operational and was not on the edge of its performance when command to close was given.

Figure 16: Actuator travel time under 8.0 Nm load

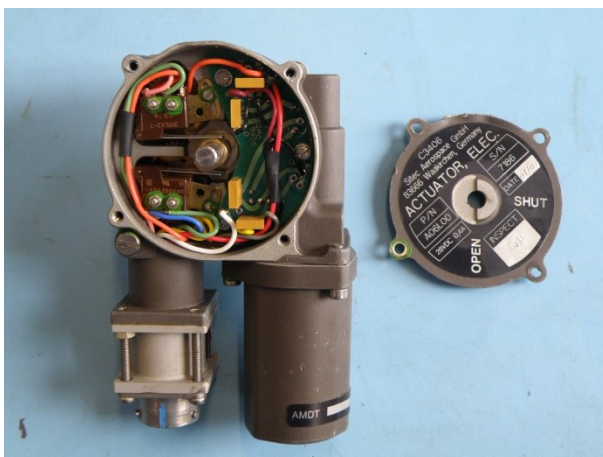
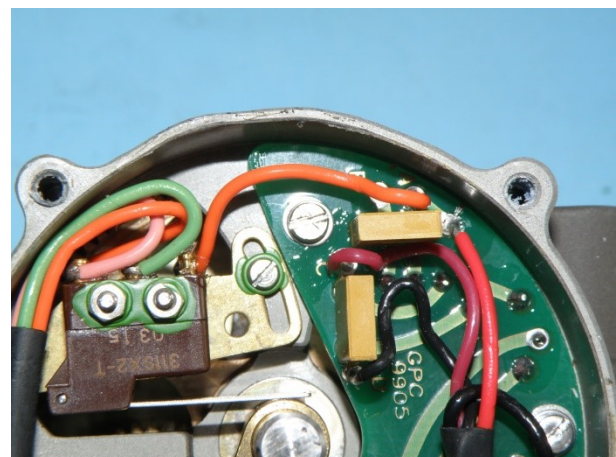
- When the actuator cover was opened all screws were tight still glued with Loctite. No sign of previous opening was found.
- No humidity, excessive dirt or other FOD was found inside the actuator.
- No obvious sign of heat was found, no colour change on the sealant of the screws which would indicate intense heat.

Figure 17: Opened actuator

Figure 18: Opened actuator - detail

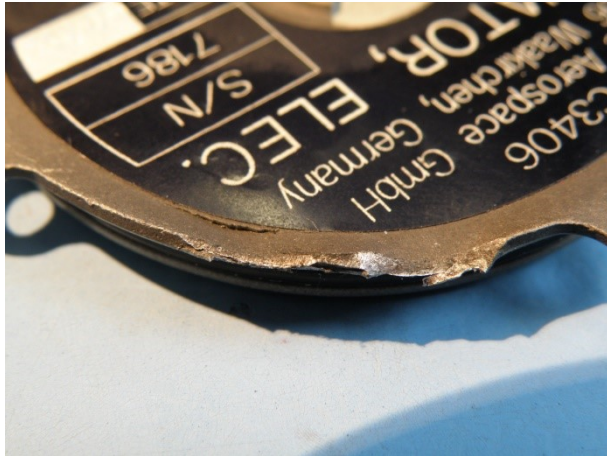
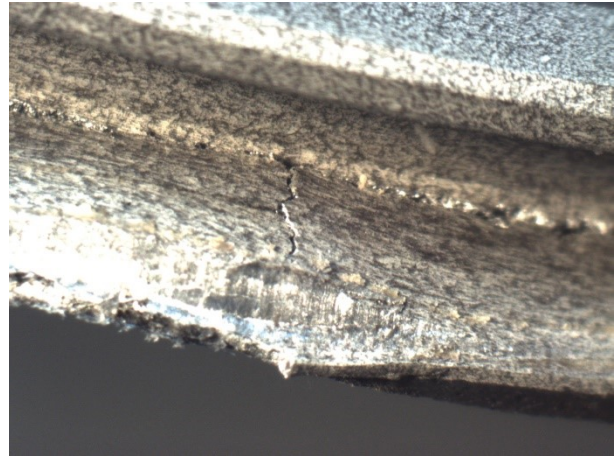
- Soldering points were still in shape. A flattening of these points would have indicated heat exposure.
- The lid of the actuator cover showed signs of impact. A crack that went through the cover into the o- ring groove was found (Figure 19 and Figure 20)

Figure 19: Crack on actuator cover

Figure 20: Crack in o- ring groove

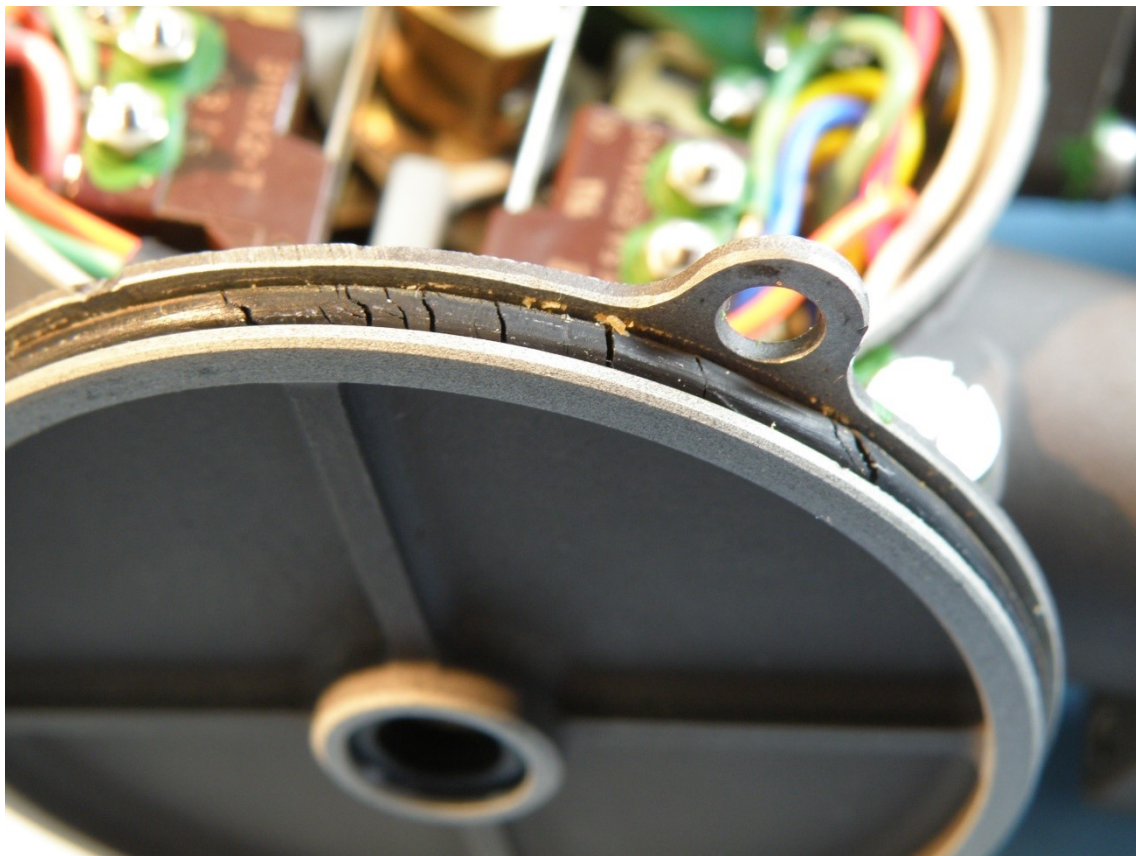
The o- ring inside the groove of the cover was dried and cracked (Figure 21)

Figure 21: Cracked o- ring

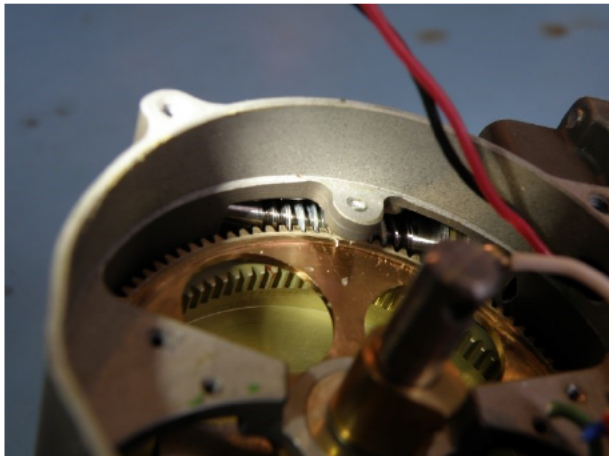
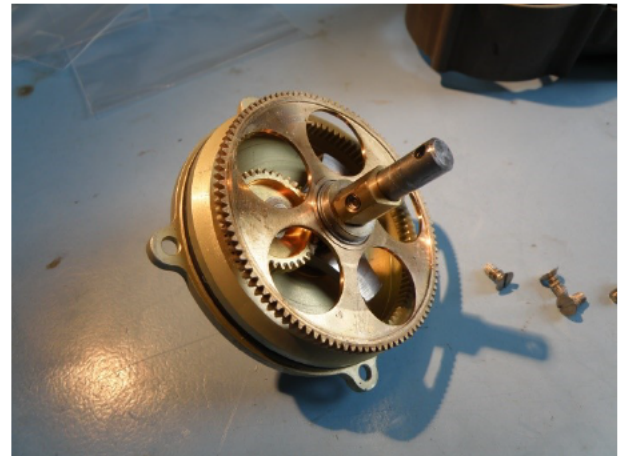
- After removal of the PCB the gear was found in good condition. No signs of obvious wear. No dirt or other FOD was found. Grease was still present and clean. All teeth of the gearwheels were present and in good condition. No wear excessive wear was found.

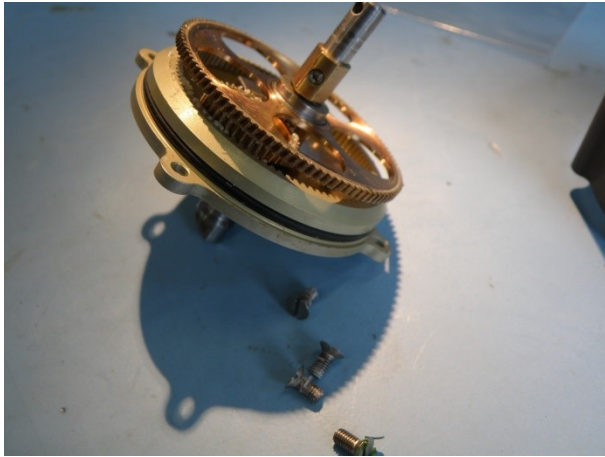
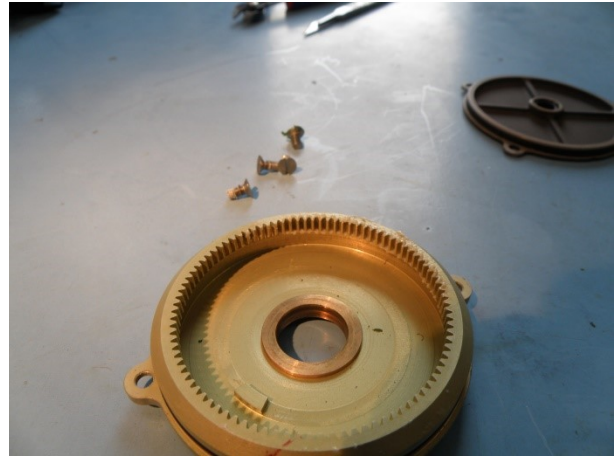
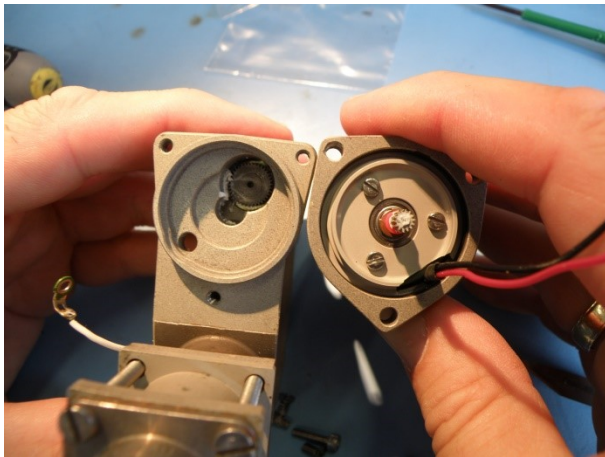
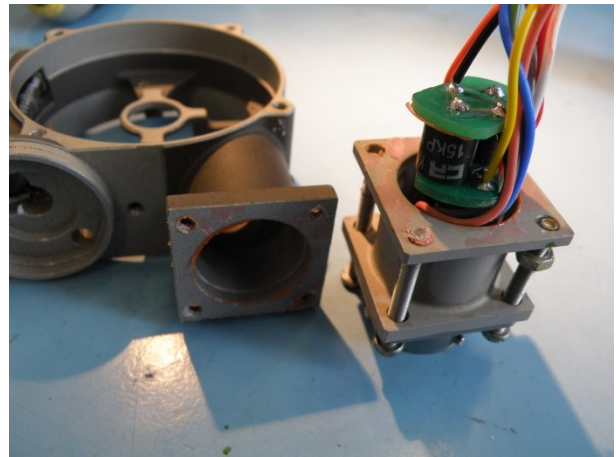
- All screws on the output flange were tight and locked. No sign of previous opening was found.
- The o- ring of the output flange was found in good condition. All teeth were present and in good condition (Figure 26 and Figure 27)
- When motor assembly was opened motor and gear were found in good condition. No dirt or other FOD was found. (Figure 28)
- Lightning protection was found in good condition. All soldering points were still in shape. No sign of heat exposure ( Figure 29)

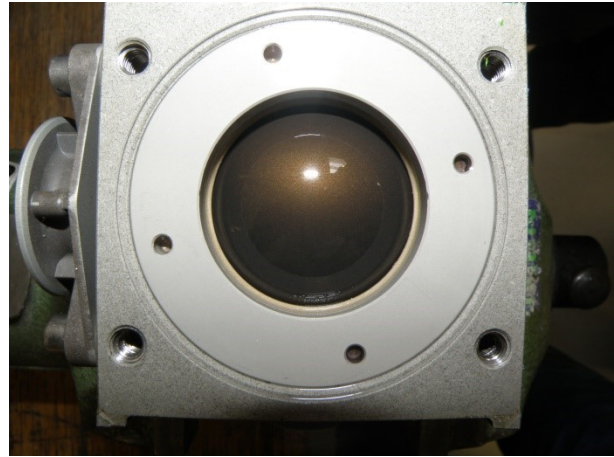
Figure 31: Valve body with ball

- When the flanges were disassembled from the valve body all screws were still tight.
- The o-rings were found to be in good condition. No scratches or dents could be detected on either body or flanges.
- No imperfections of neither ball nor sealings were found. No dirt or other FOD was detected (Figure 31).

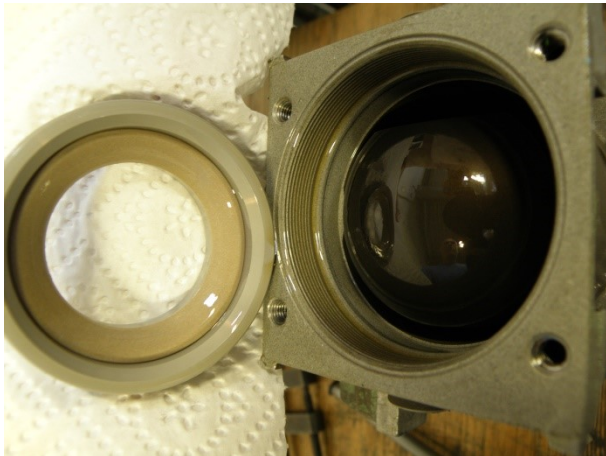
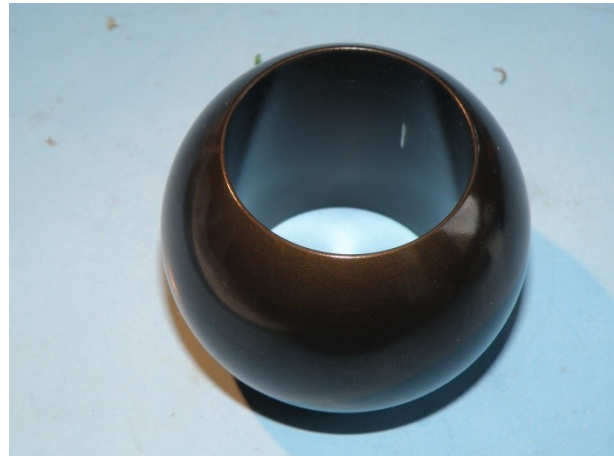
- When sealing ring was removed no dirt or other FOD was detected. No nicks or dents were found on sealing ring (Figure 32).
- Ball was found in good condition. No scratches or similar was detected. Marks from surface treatment were found inside the ball. These marks have no impact on function of the ball (Figure 33).

Figure 32: Valve sealing ring

Figure 33: Valve ball with manufacturing marks inside

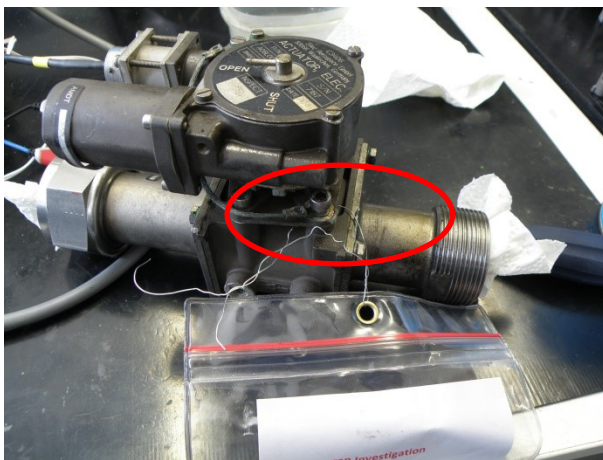
While visual inspection the unit was found in closed position. No obvious sings of heat or damage could be found. The bonding strap of the valve was missing and the screw holding the bonding lead and strap was found loose. Probably the bonding leash was disassembled by Delta Airlines when removing the FSOV from the hydraulic system.

Figure 34: Green FSOV with missing bonding strap

The acceptance test procedure was carried out in accordance with E03A00-05 issue 01 on the ATP test stand. All electrical values and leakage rates were in tolerance. The travel time was in tolerance. The bonding measurement failed due to the loose screw holding the bonding leash. The ATR can be found in Appendix C.

While inspection of green FSOV S/N7095 no sign of malfunction could be detected. All test values were in tolerance. After replacing the missing bonding leash the unit is serviceable.
