PRELIMINARY REPORT

Delray Beach, Florida

HWY19FH008

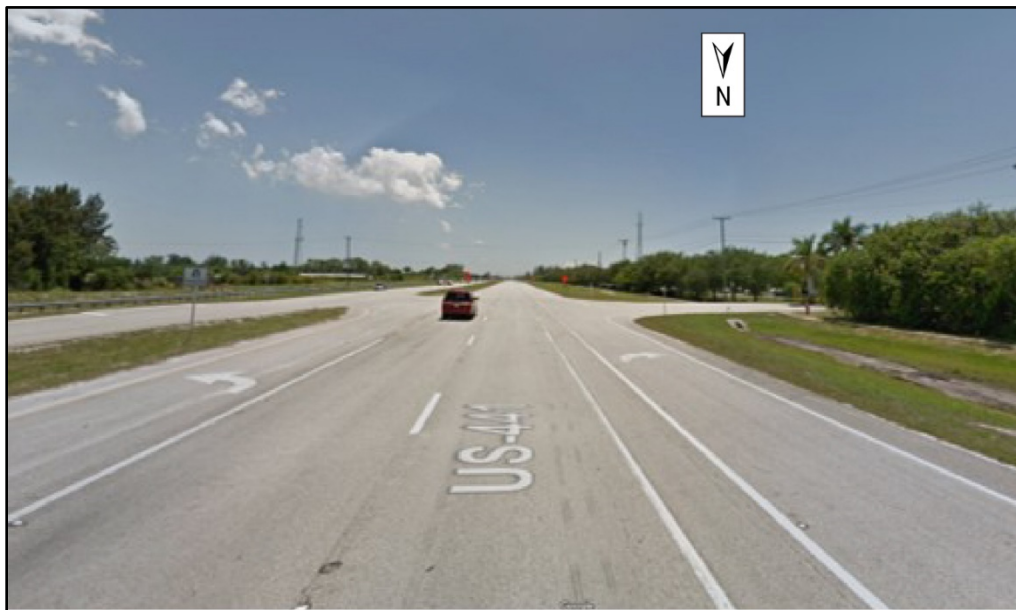
Figure 1. Southbound view of crash intersection. Private driveway into agricultural facility is visible on right side of image. (Source: Google Maps)
