PRELIMINARY REPORT

Enbridge Inc. Natural Gas Pipeline Rupture and Fire

Danville, Kentucky
August 1, 2019
PLD19FR002

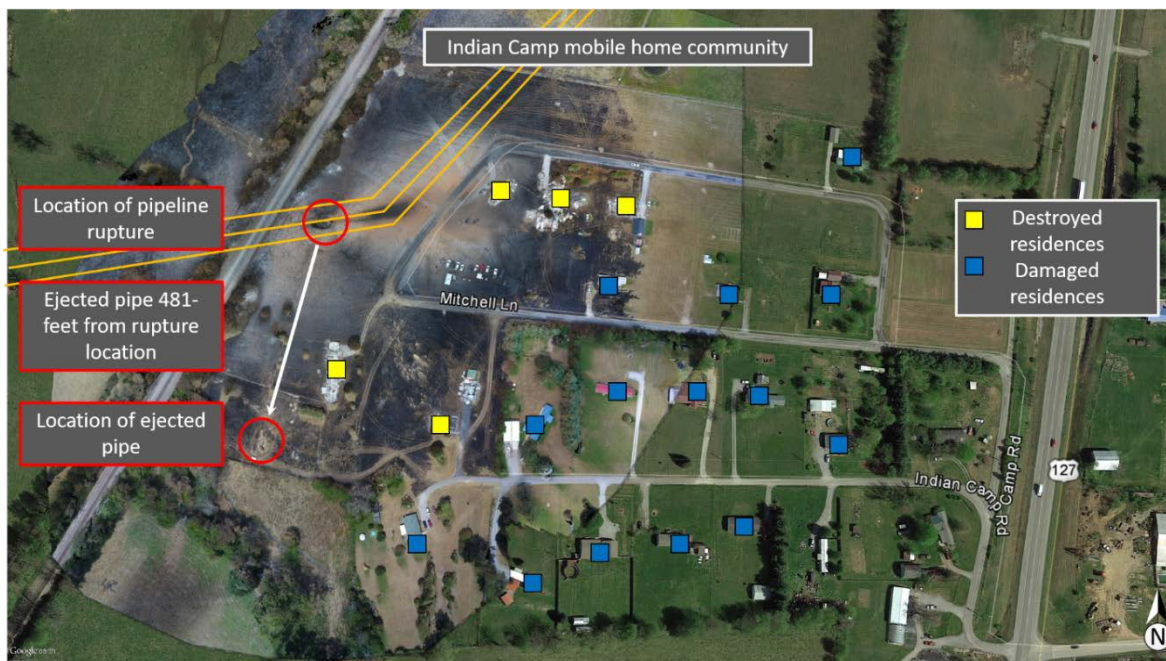
On August 1, 2019, at 1:23 a.m. local time, a 30-inch-diameter natural gas transmission pipeline owned and operated by Enbridge Inc. (Enbridge) ruptured near Danville, Lincoln County, Kentucky, about 35 miles southwest of Lexington, Kentucky. The rupture released about 66 million cubic feet of natural gas which ignited, resulting in the death of 1 person, the hospitalization of 6 people and the evacuation of 75 residents from the Indian Camp mobile home park. The fire destroyed 5 nearby residences, damaged 14 other residences, and burned about 30 acres of land including railroad tracks owned and operated by Norfolk Southern Corporation. (See figure.) As a result of the explosion, a 33.2-foot-long section of the pipeline was ejected and landed about 481 feet southwest of the rupture site.

Figure 1. Postrupture aerial view of the accident area. (Photo overlaid on Google Earth image.)
