**Principal Investigators** Alvaro Rodriguez  
**Senior Accident Investigator** Gregory Ochs  
**Accident Investigation Director** Peter Katchmar  
**Date of Report** November 10, 2020  
**Subject** Failure Investigation Report: Panhandle Eastern Pipeline Co.,  
Incorrect Operation

**Date of Failure** March 26, 2020  
**Commodity Released** Natural Gas  
**City, County, State** Meade, Meade, Kansas  
**OpID and Operator Name** 15105, Panhandle Eastern Pipeline Co.  
**Unit # & Unit Name** 1083, Liberal  
**WMS Activity ID** 20-178587  
**Milepost (MP) / Location** Borchers – North Station  
**Type of Failure** Incorrect Operation  
**Fatalities** One  
**Injuries** None  
**Description of Impacted Area** Class 1, Rural Area  
**Total Costs** \$21,139

## Failure Investigation Report – Panhandle Eastern Pipeline Co.

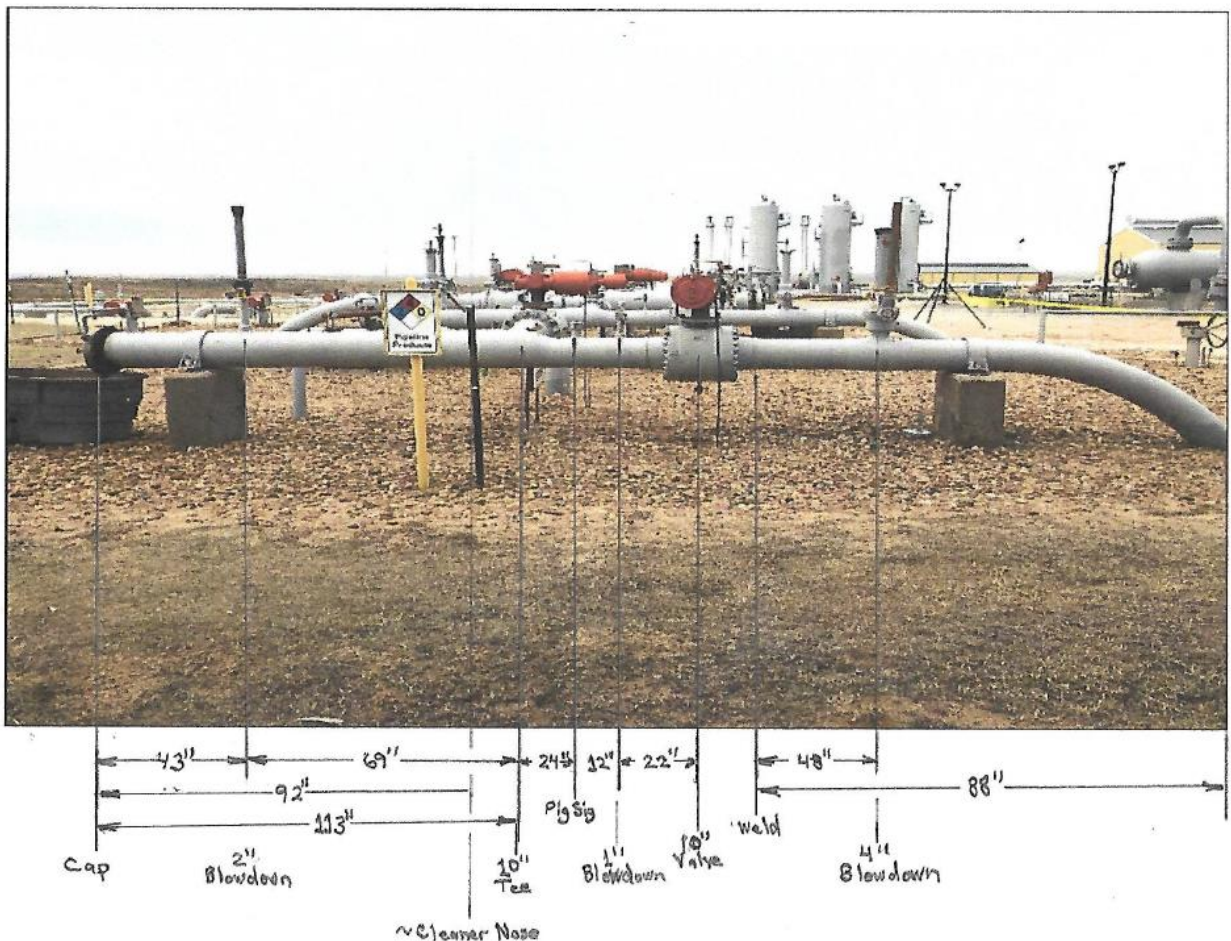
Figure 1. East 10" Pig Receiver Sketch, G. Ochs (04/03/2020) Photograph Taken on March 28, 2020

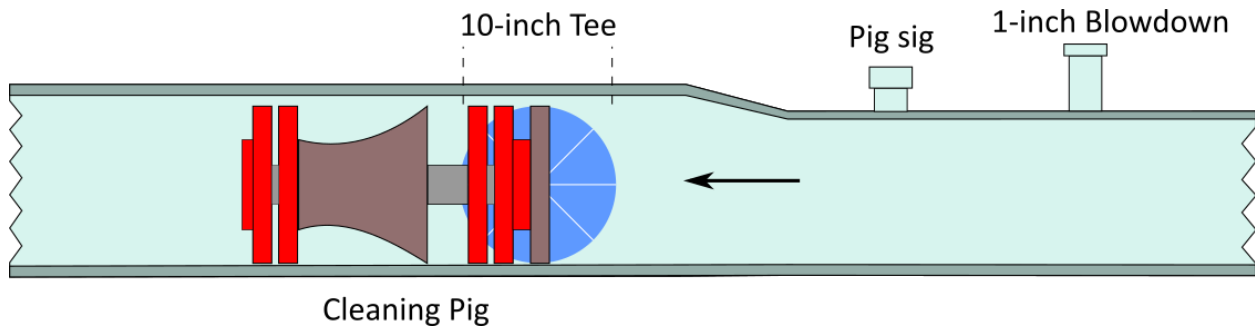
Figure 2. Sketch of Approximate Location of Stuck Cleaning Pig Inside the East 10" Receiving Barrel

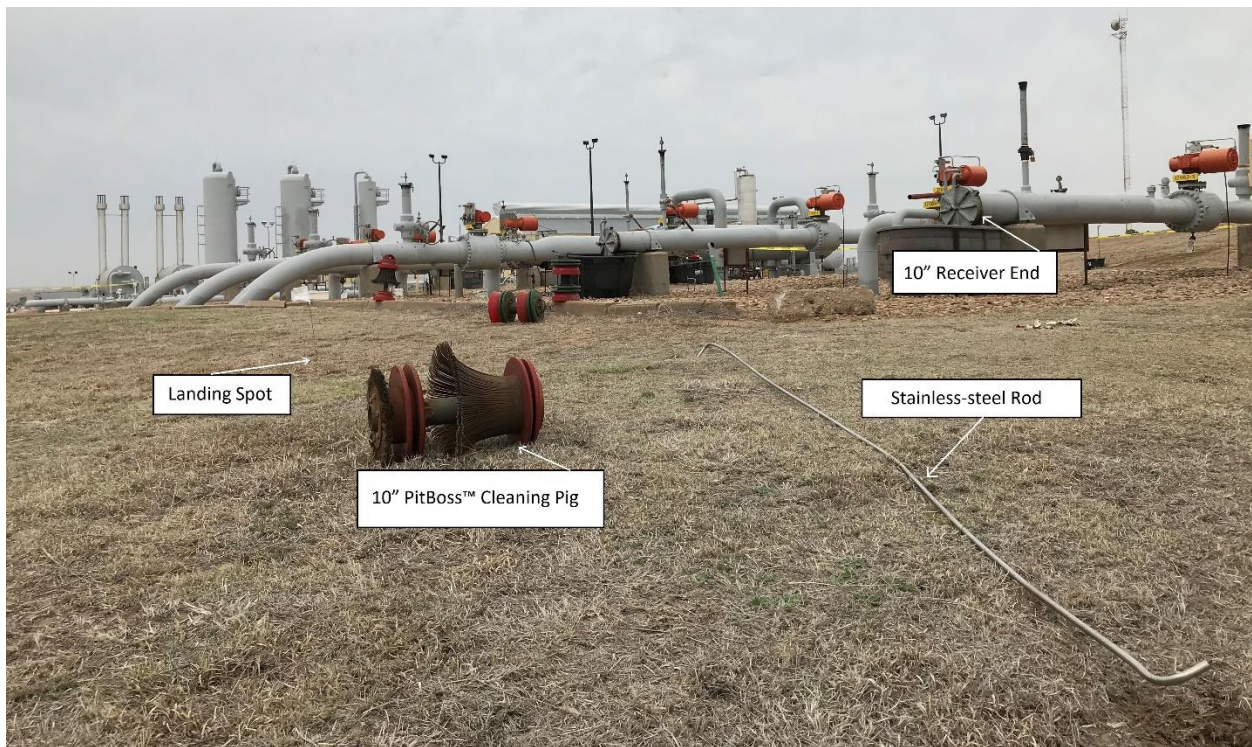
Figure 3. Photograph of the Incident Scene as it was Left - The Landing Spot of Technician 1 is Marked with a White Flag (Approximately 22 Feet from the 10" Receiver End) Rodriguez, March 28, 2020

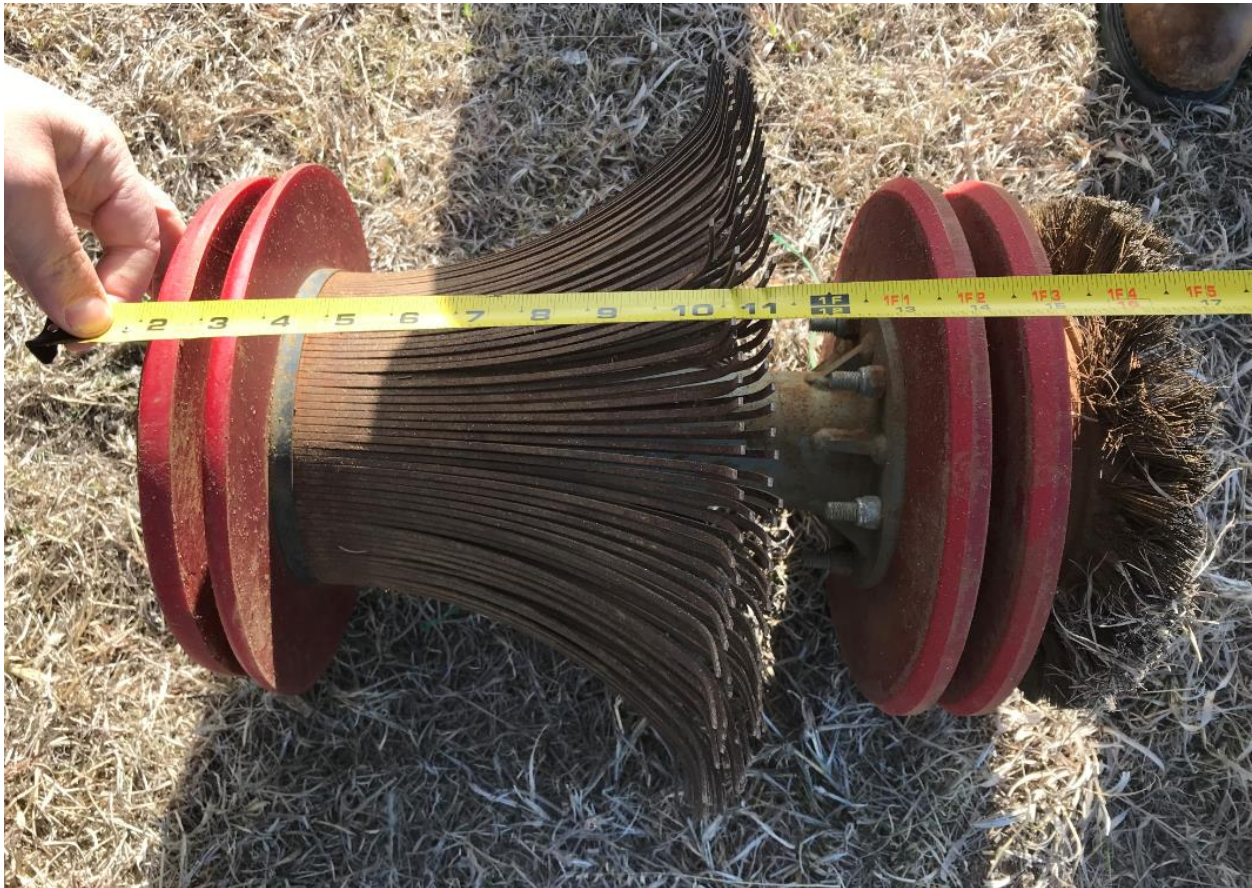
Figure 4. Photograph of the 10-inch PitBoss™ Cleaning Pig that Impacted Technician 1 Rodriguez, March 28, 2020

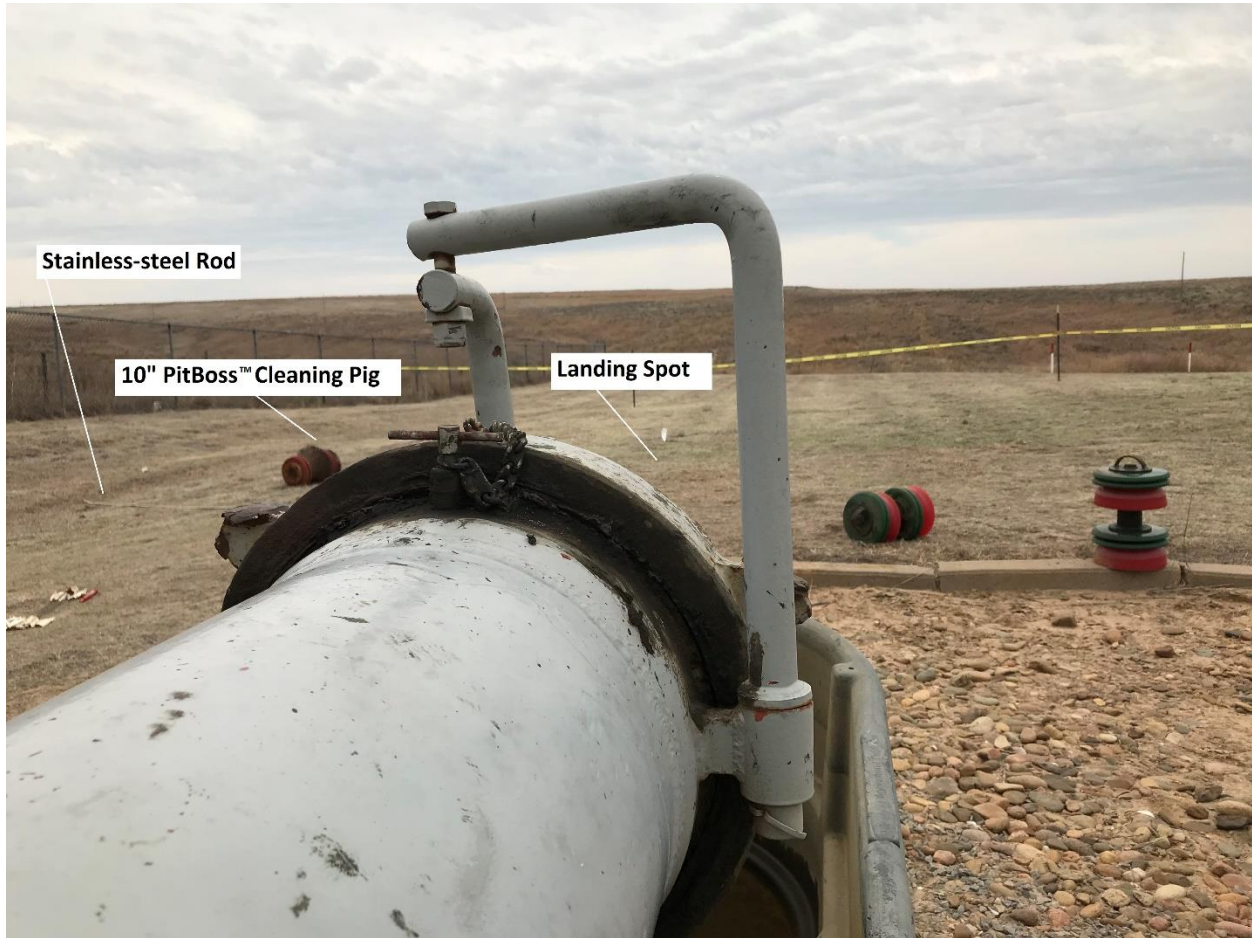
Figure 6. Photograph of End of East 10" Receiver Facing South  
Please Note the Flag where Technician 1 Landed and the Position of the 10-inch PitBoss™ Cleaning Pig  
Rodriguez, March 28, 2020

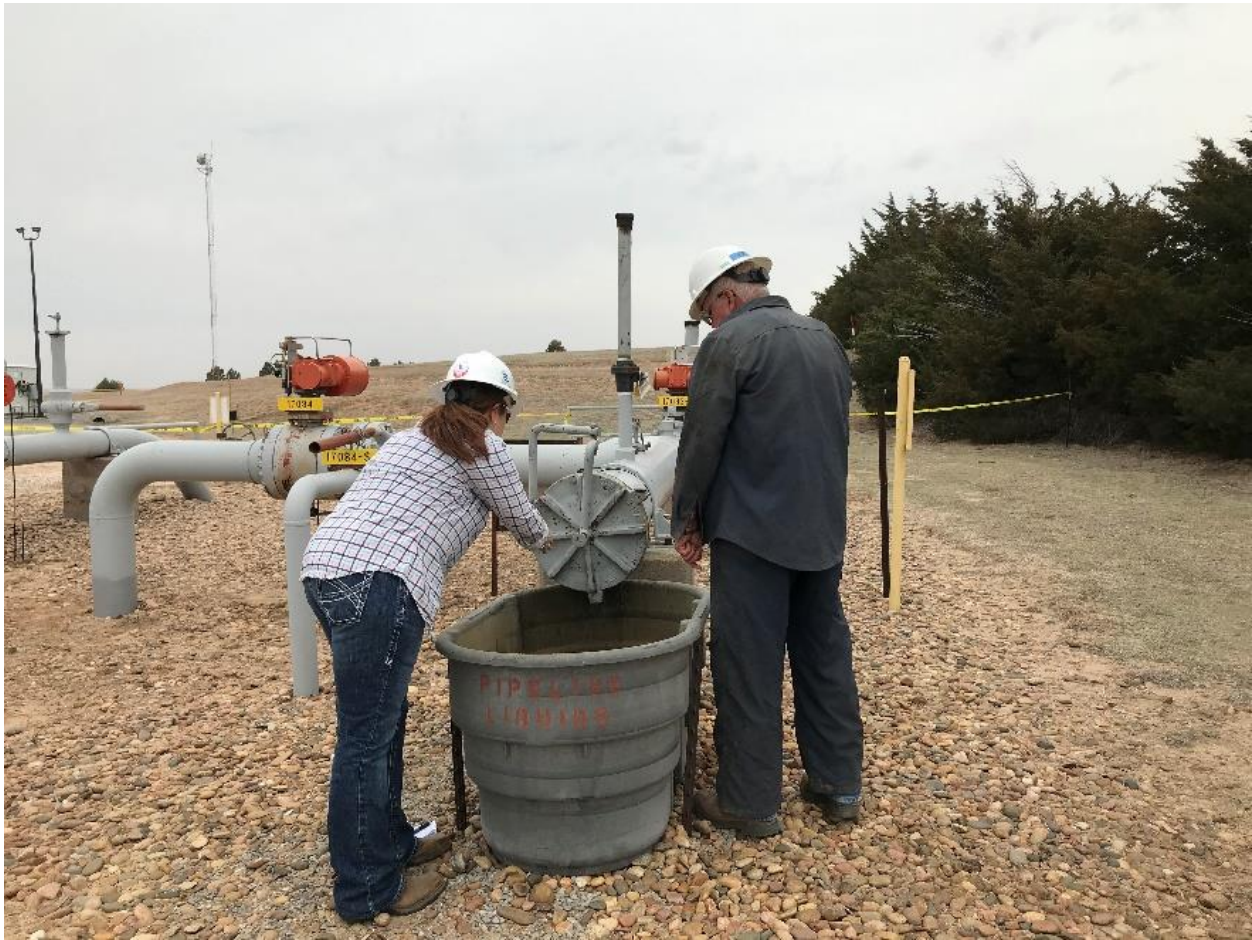
Figure 7. Photograph of the Re-enacted Incident at the East 10" Receiver Facing North Rodriguez, March 28, 2020
