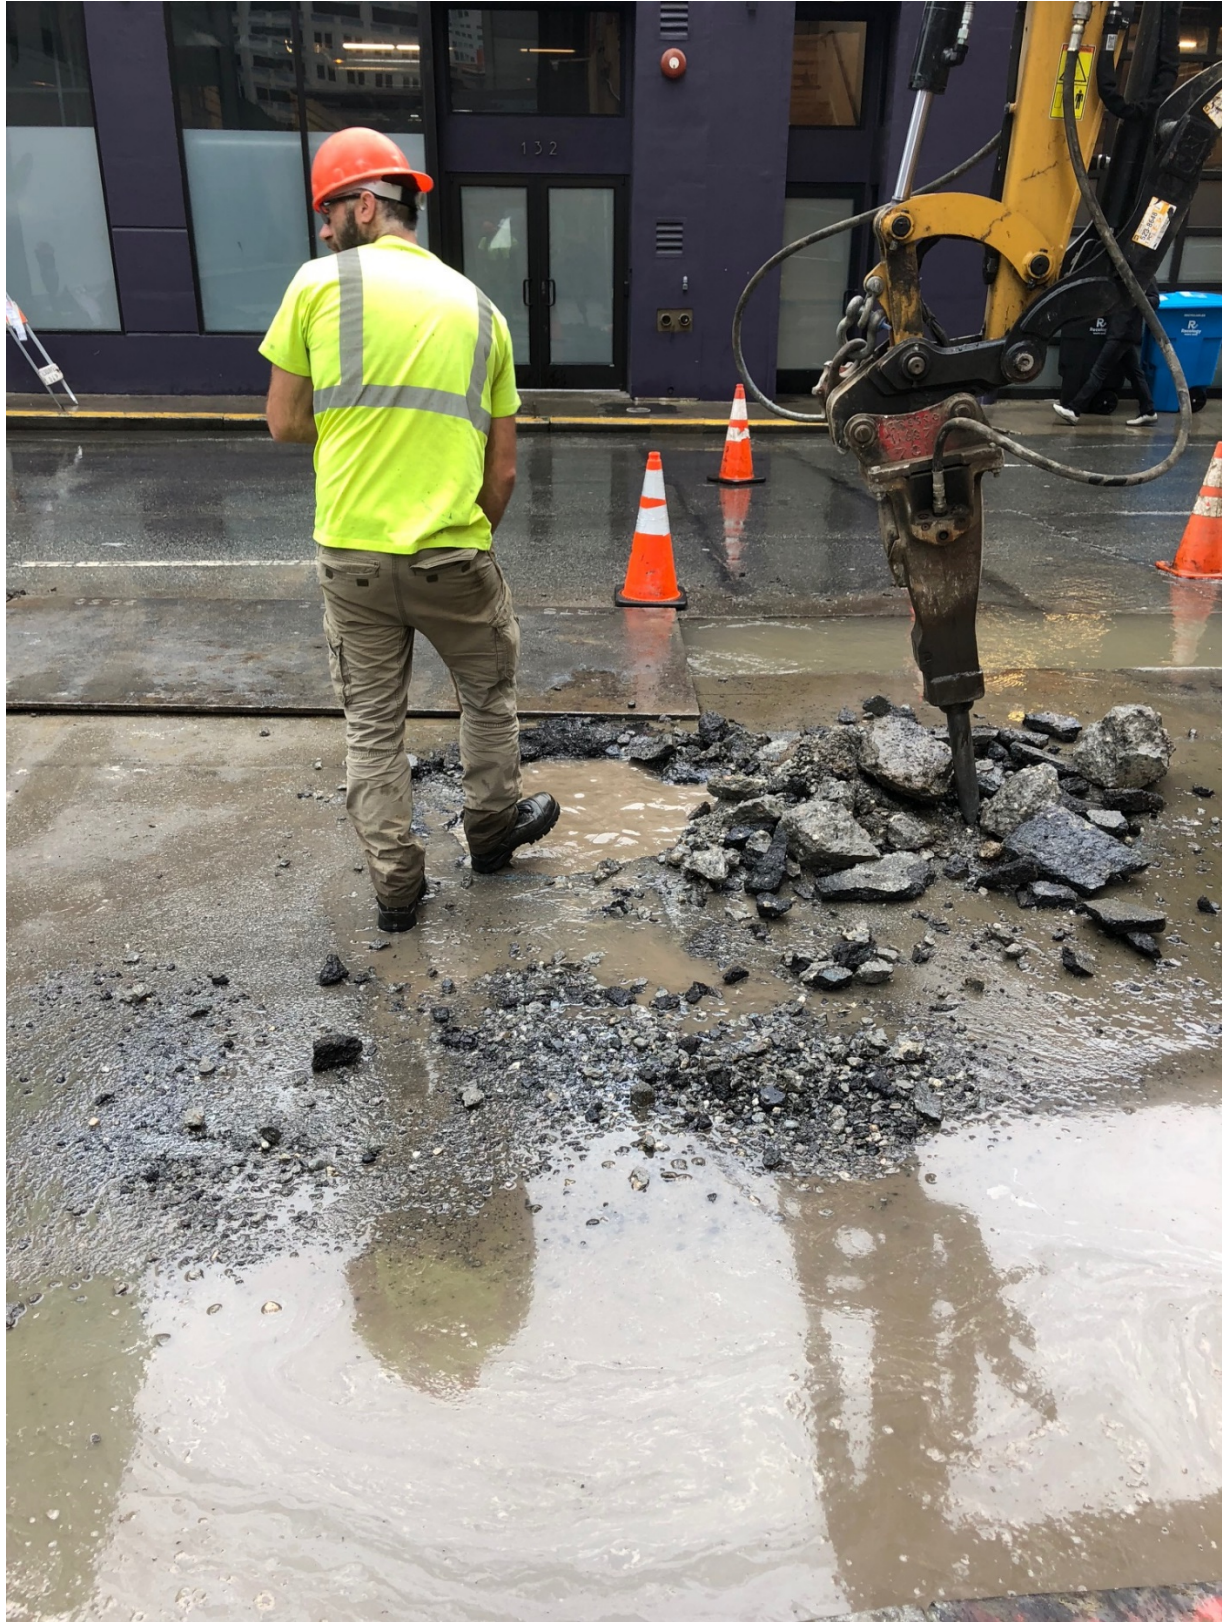
*Figure 1. Hawthorne Street after water main damaged. CAT 305 E2 excavator on right with jackhammer attachment. View facing southwest. Photograph courtesy of Kilford Engineering, Inc.*

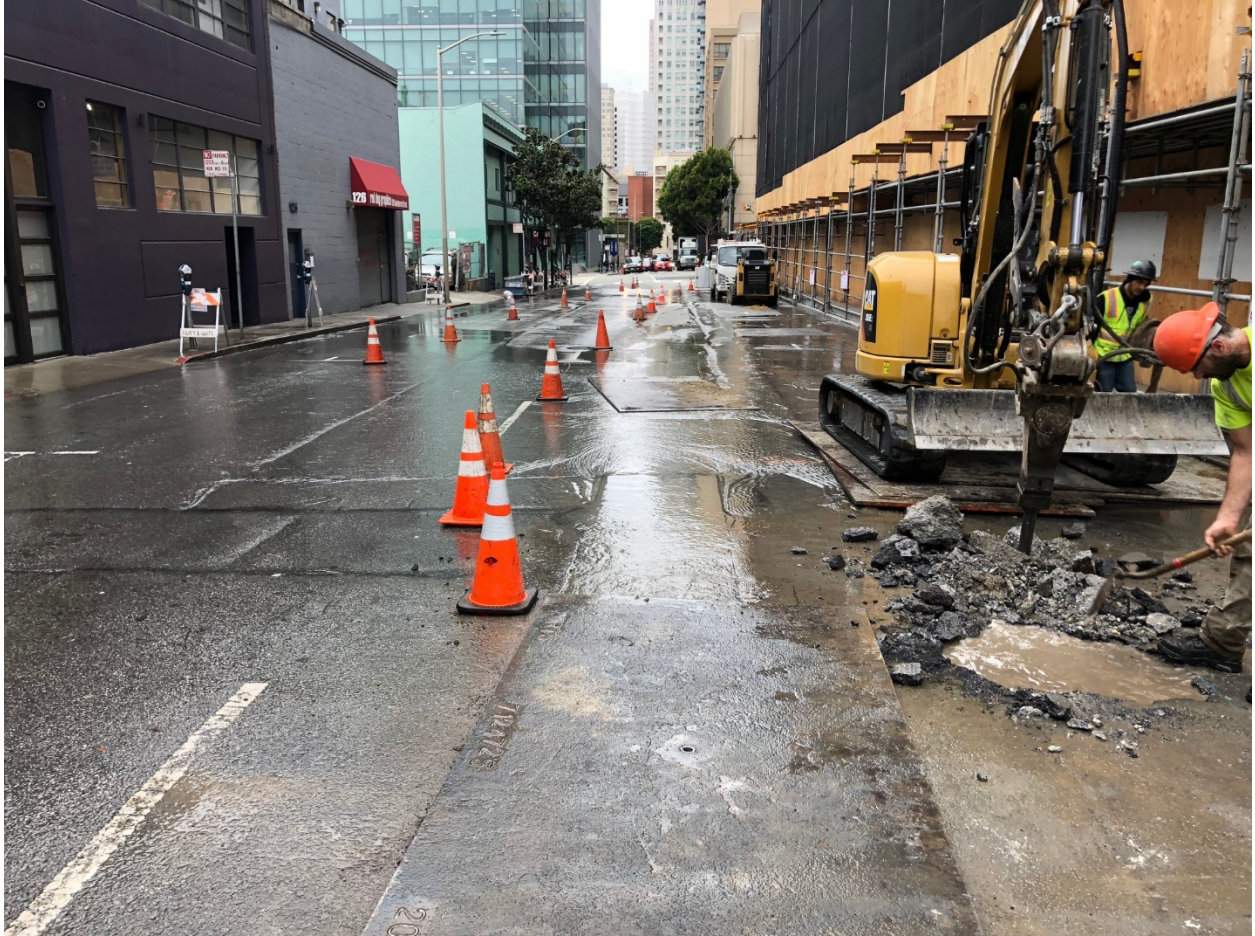
*Figure 2. Hawthorne Street after water main damaged. CAT 305 E2 excavator on right with jackhammer attachment. View facing northwest. Photograph courtesy of Kilford Engineering, Inc.*

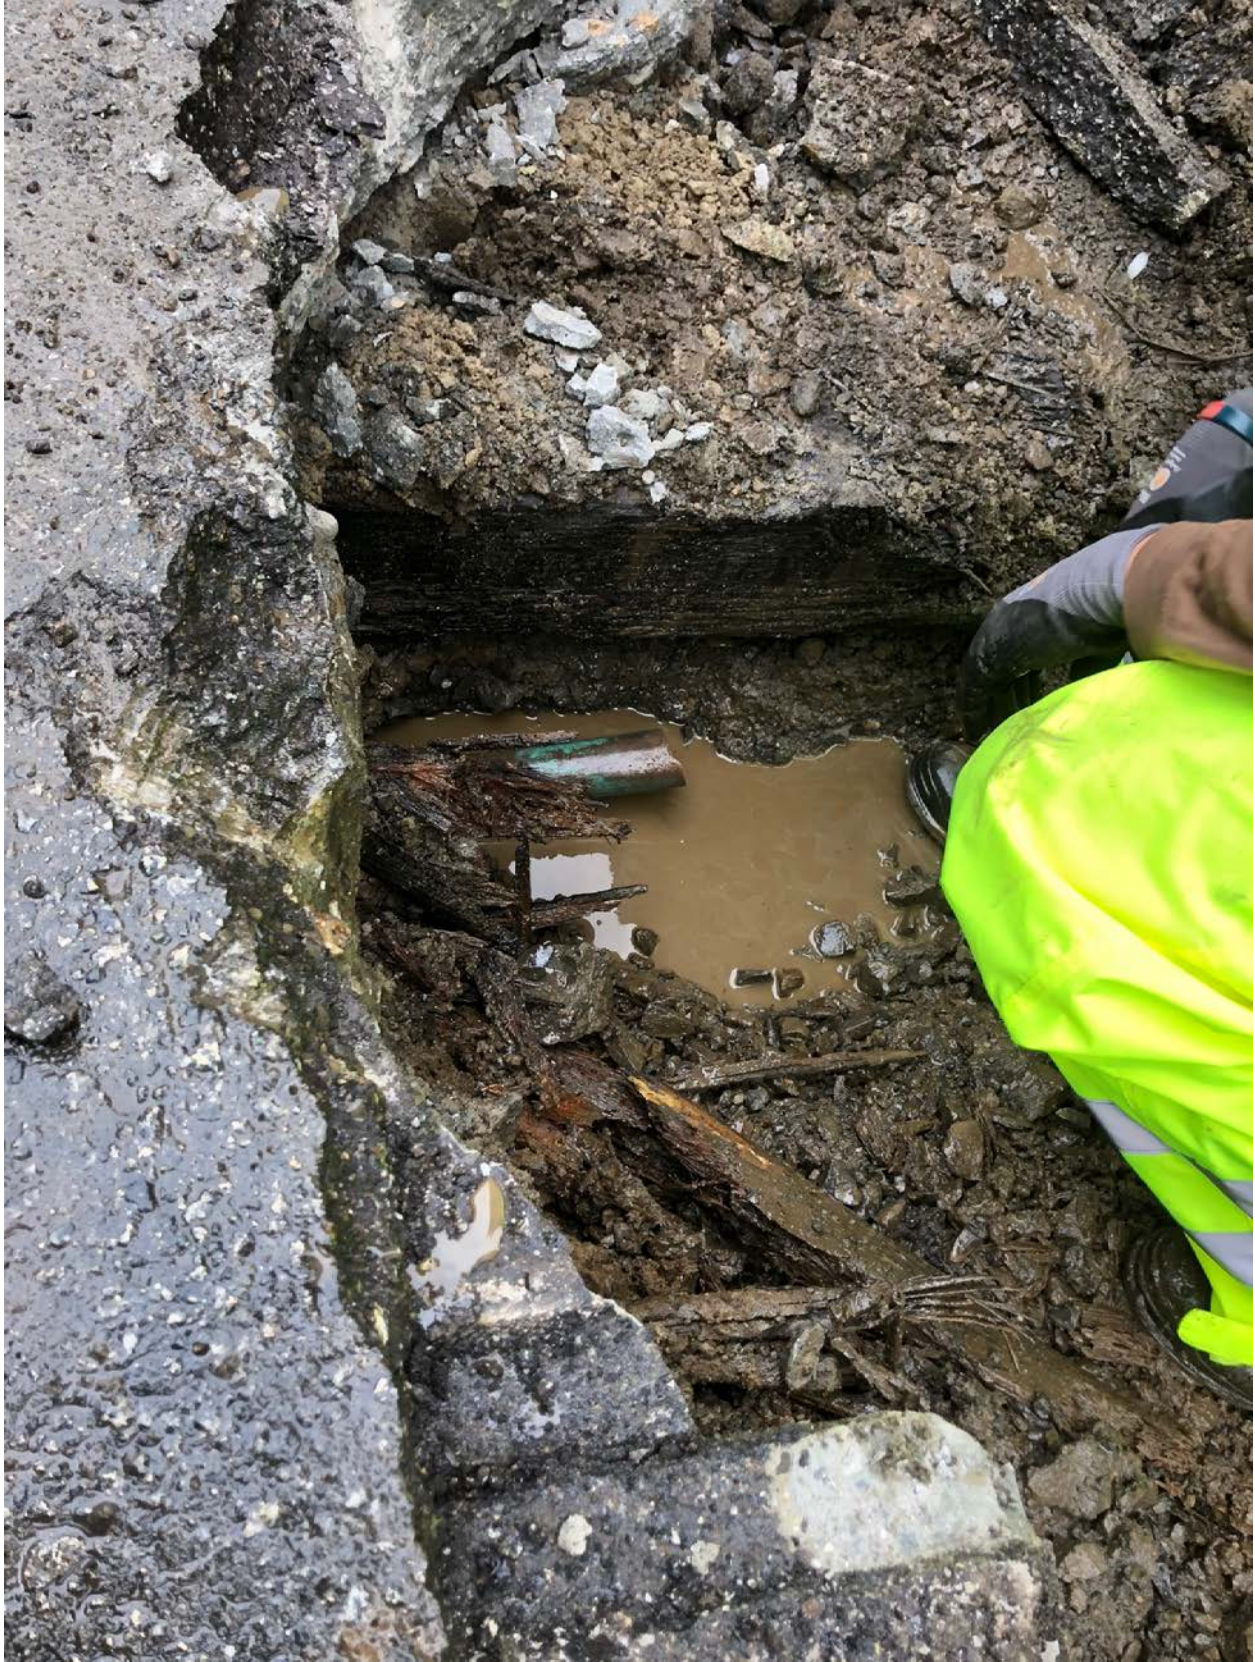
Figure 3. Damaged water main on Hawthorne Street. Photograph courtesy of Kilford Engineering, Inc.

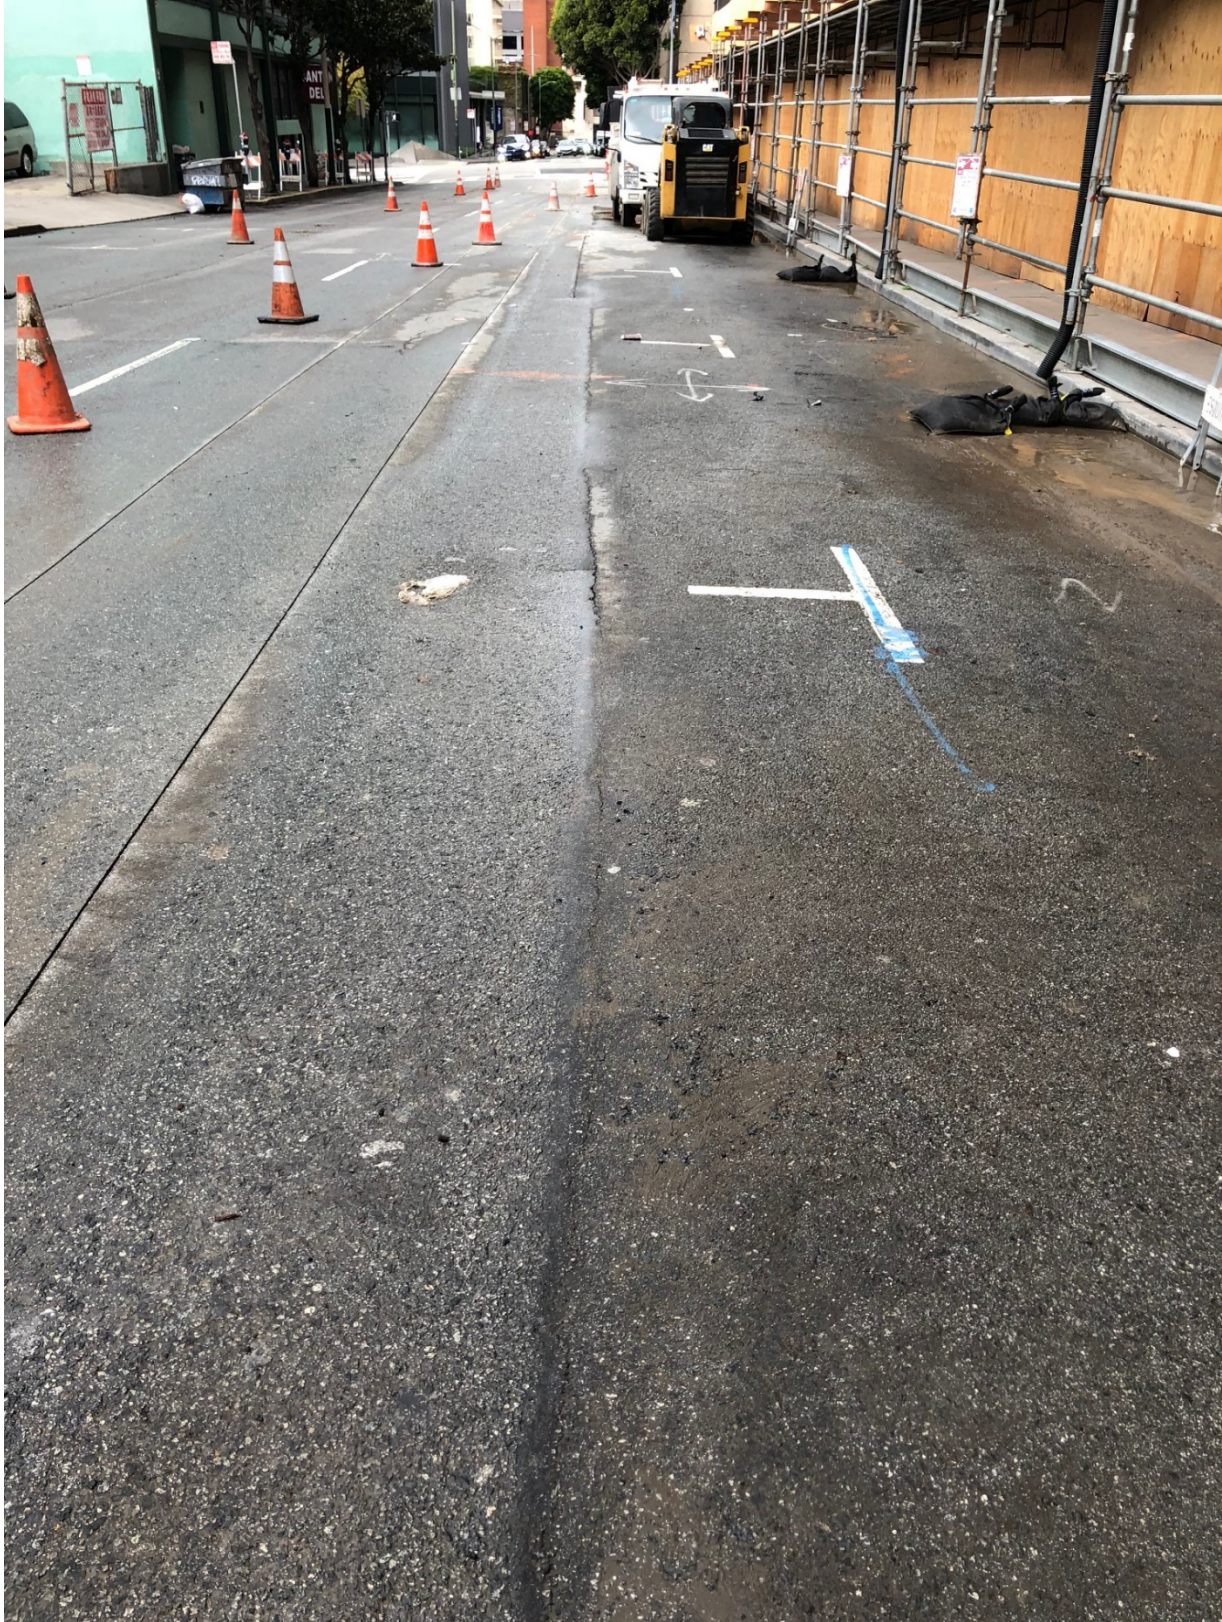
Figure 4. Hawthorne Street prior to excavation work, showing one-call markings and evidence of saw-cutting. Photograph courtesy of Kilford Engineering, Inc.
