# *Proassist III*

Starboard side deckhouse weathertight door

Photographs are screen shots from underwater video taken on  
January 2, 2021.

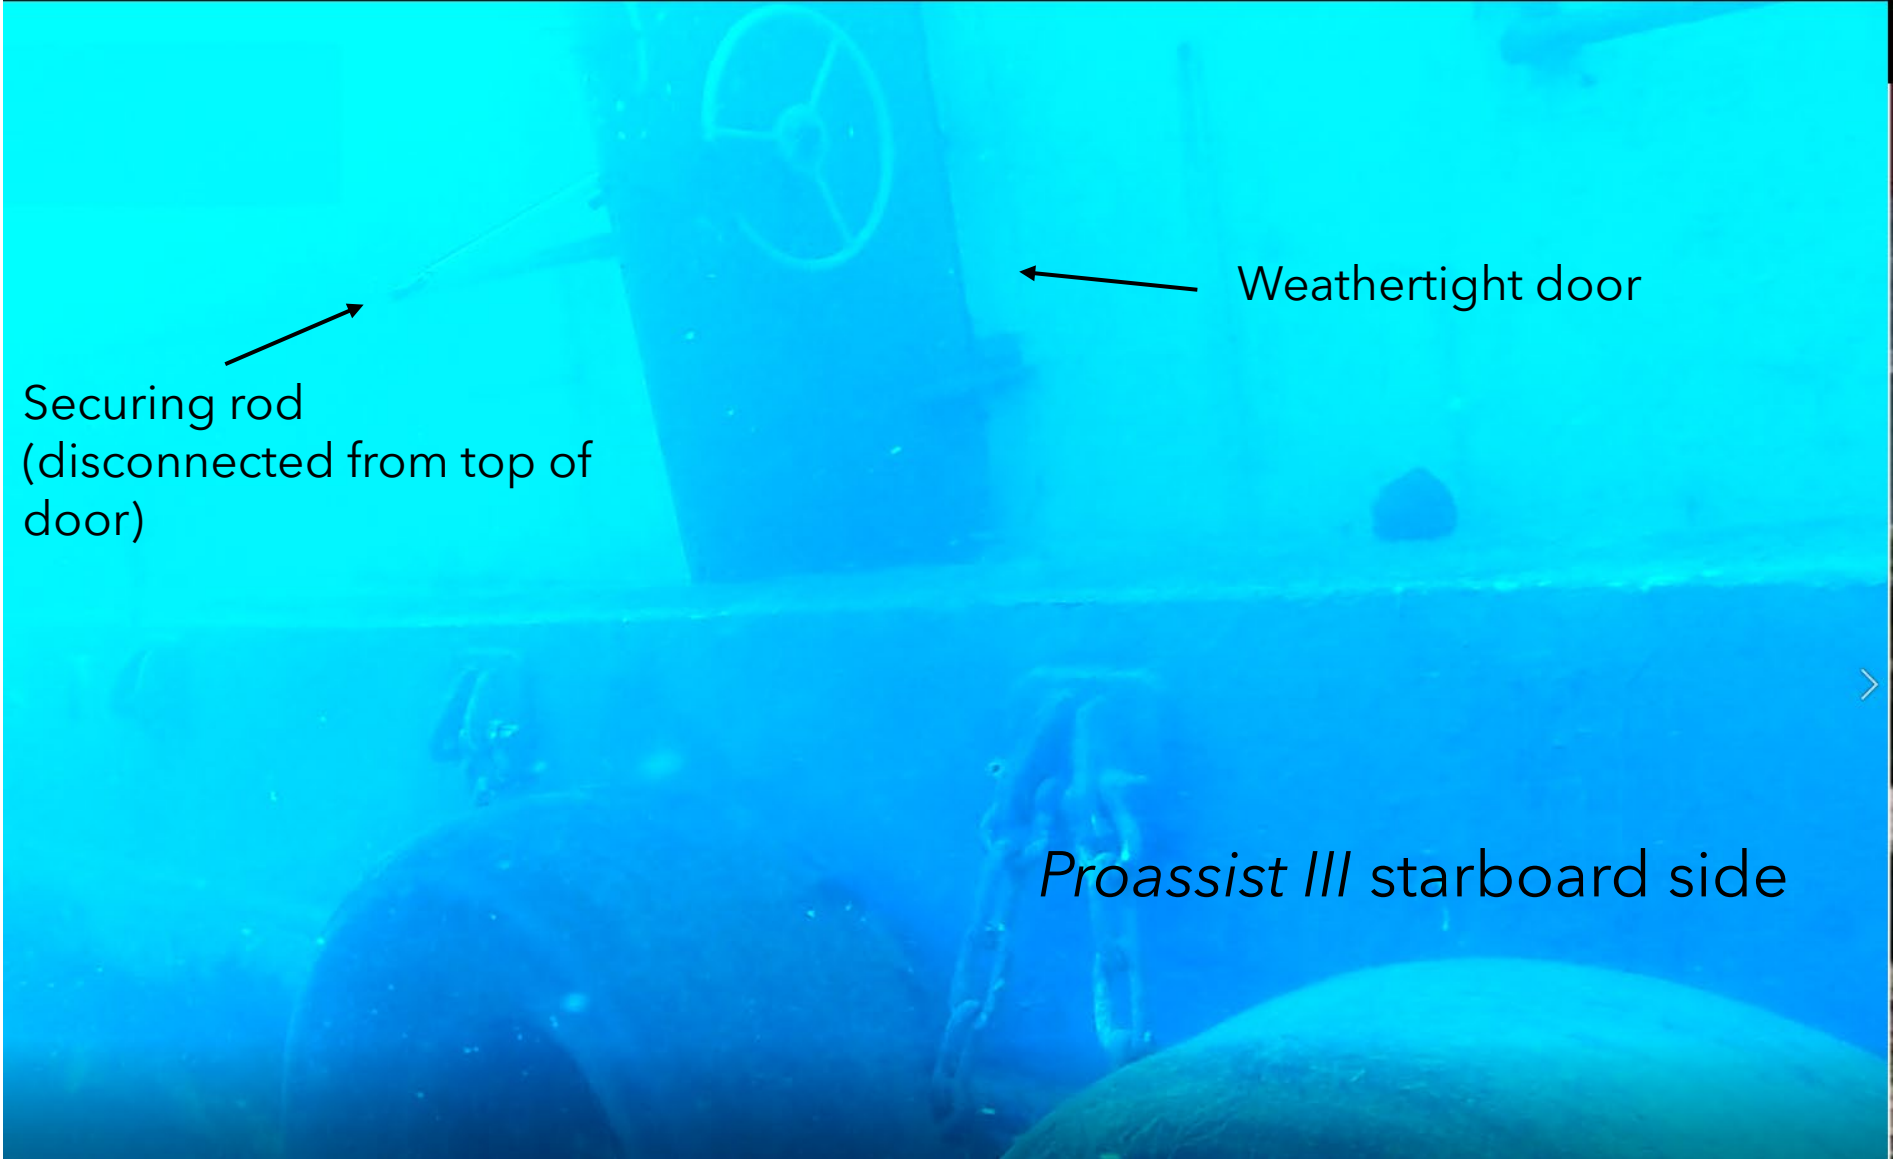
*Proassist III* starboard side

Securing rod  
(disconnected from top of  
door)

Weathertight door
