National Transportation Safety Board

ERA23FA033

PROPELLER EXAMINATION SUMMARY

Location: Keene, New Hampshire
Date: October 21, 2022
Time: 1845 EDT
2245 coordinated universal time (UTC)
Airplane: N8020R, Beech A24R

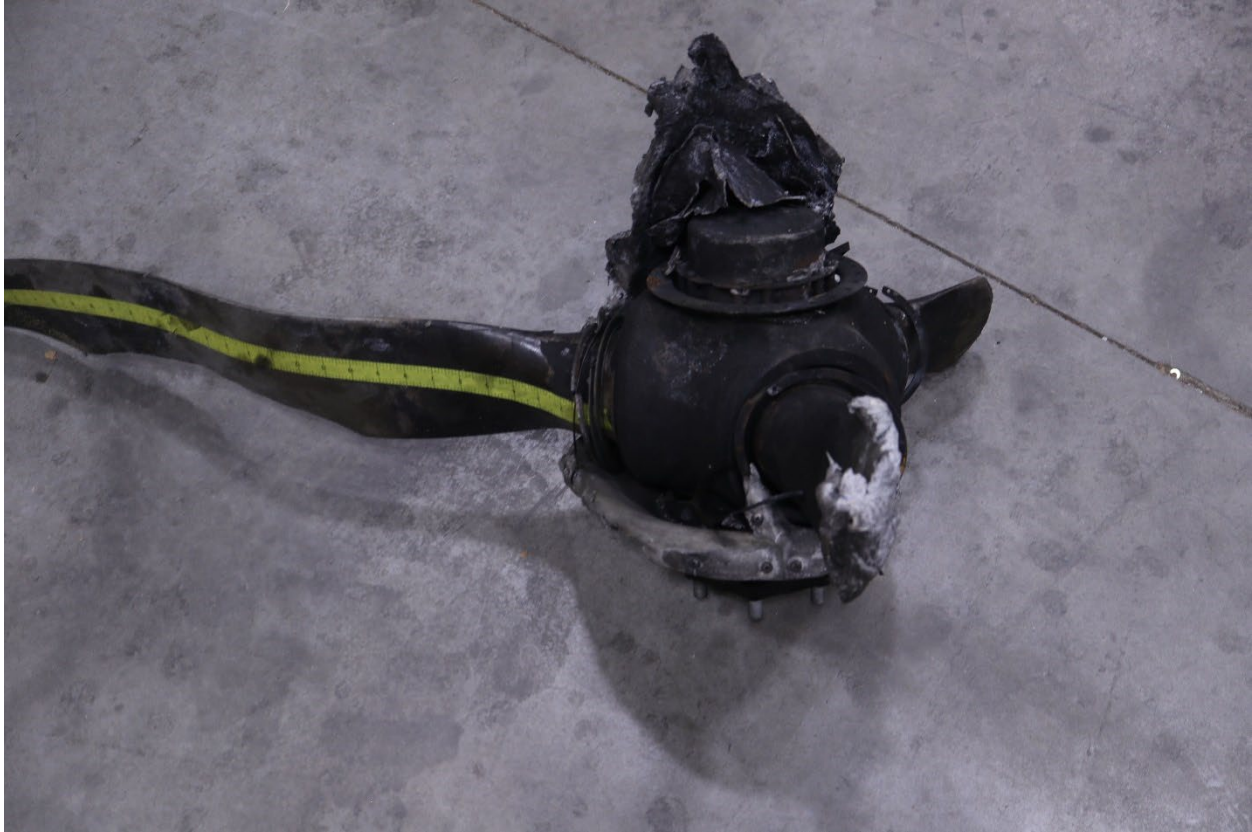
Examination of the propeller revealed all blades were free to rotate in the propeller hub and all retaining rings were dislodged. Examination of the propeller blades revealed the following observations.

Figure 2: View of the Propeller At Inspection.

No. 1 Blade - Free to Rotate in the Propeller Hub. The leading edge was rotated 180° from the normal orientation. Extensively heat damaged.

No. 2 Blade - Free to Rotate in the Propeller Hub. Extensively heat damaged.

No. 3 Blade - Free to Rotate in the Propeller Hub. The leading edge was past the high pitch stop. Appeared to be full span. Heat damaged.

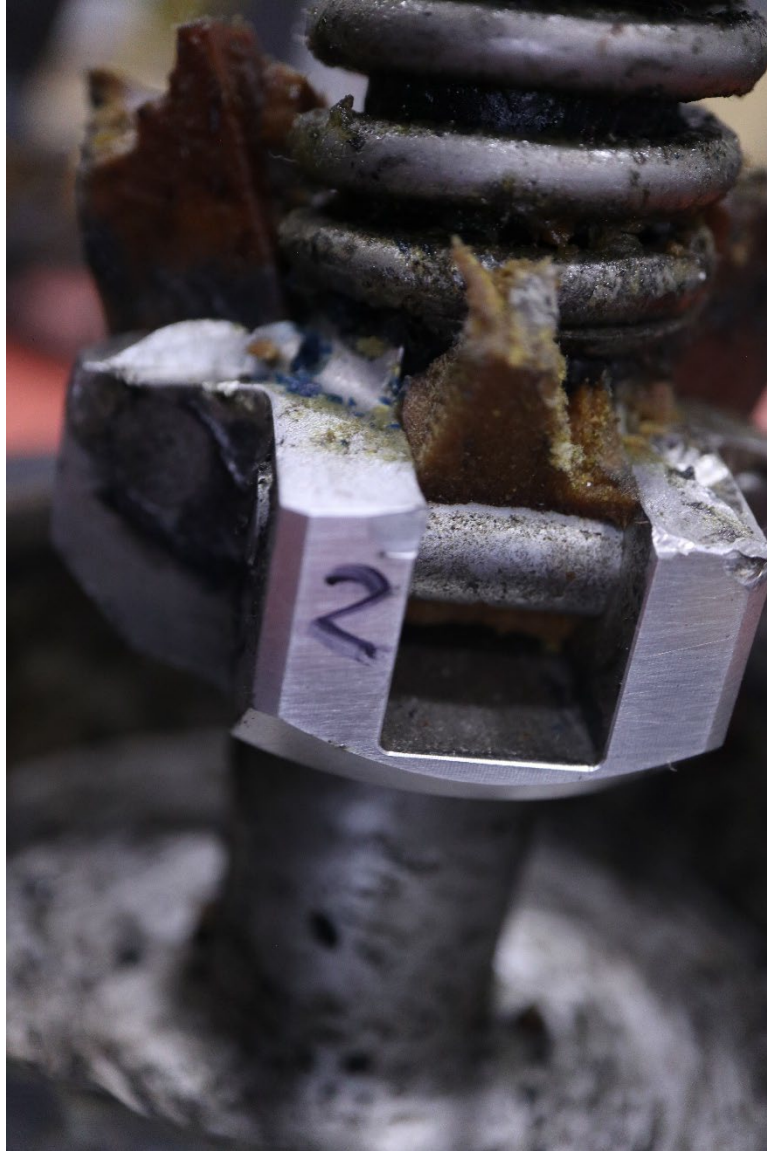
All three of the A-4577 phenolic blade actuating links were fractured at varying locations, but still connected to the C-4784 piston of blades No. 1, 2, and 3. The phenolic blade actuating link for the No. 2 blade was fractured at the attach point at the piston but a section of block remained.

Figure 3. View of the Fractured Phenolic Blade Actuating Link for the No. 2 Propeller Blade.

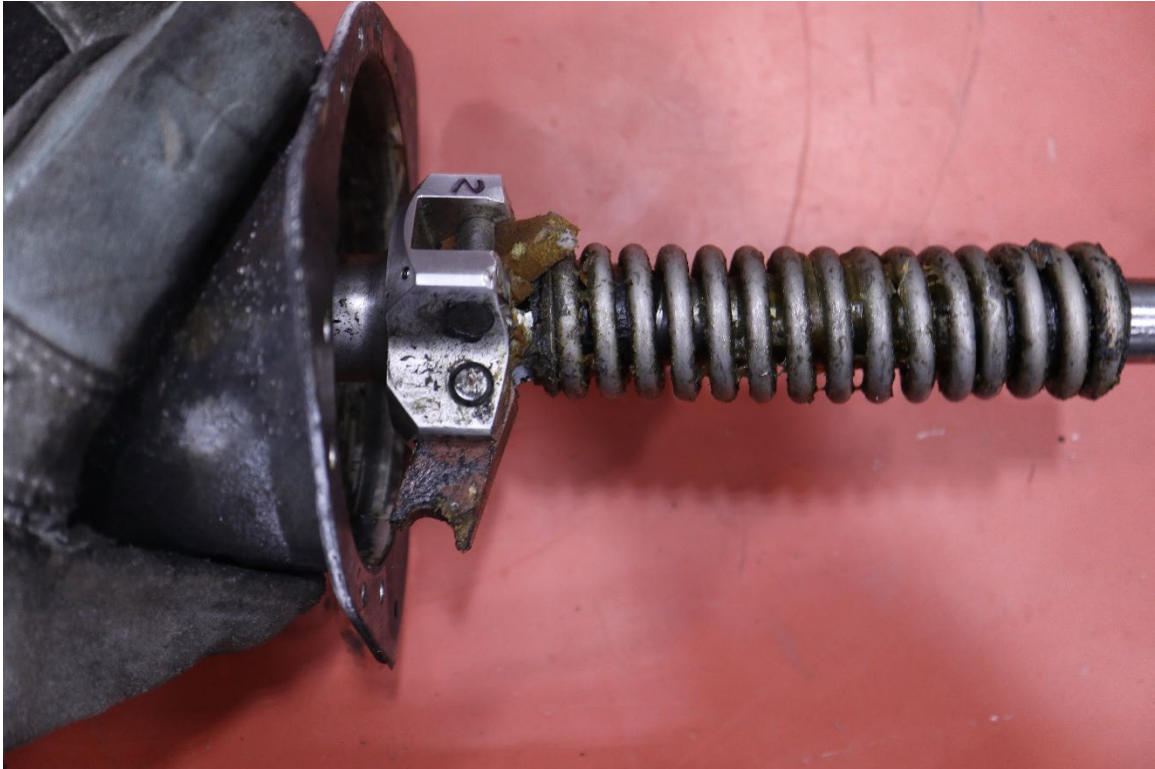
The spring was intact, and it and the piston were at low pitch.

Figure 4: View showing the spring and piston on the low Pitch.

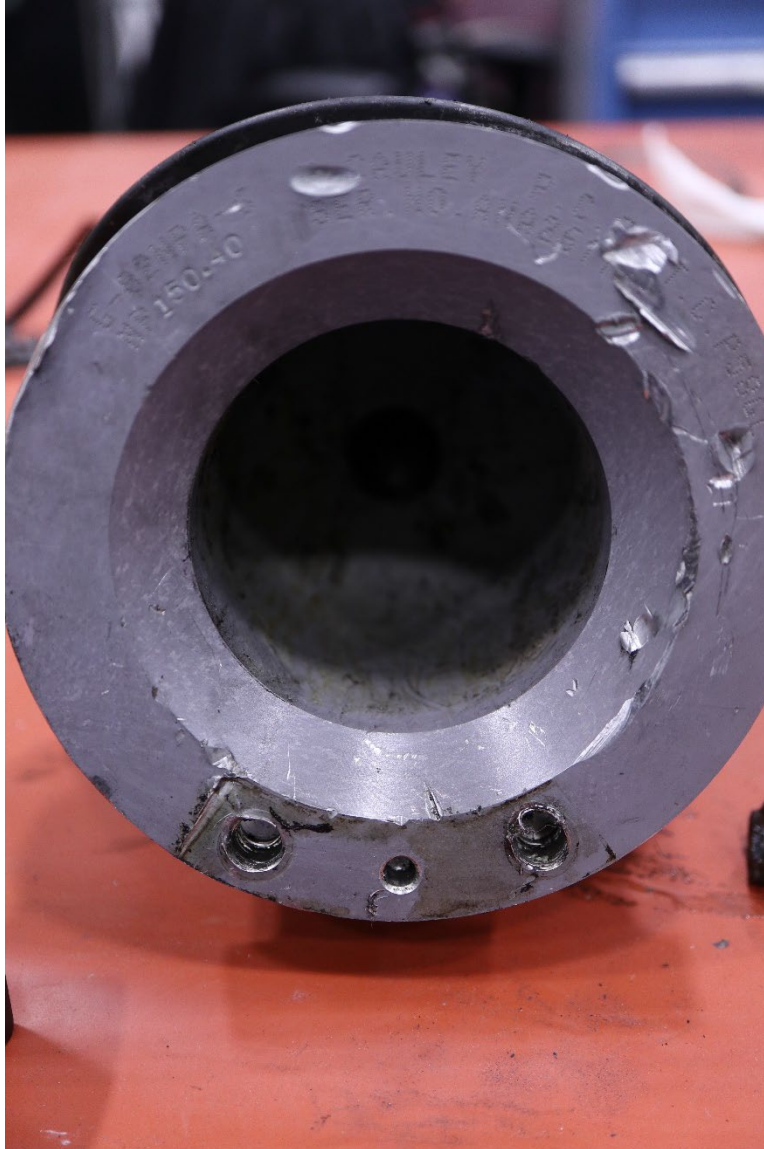
No. 1 Blade - Pitch pin was separated from the butt end of the blade. The threads in the holes that attach the pitch pin were damaged.

Figure 5: View of the Butt End of the No. 1 Propeller Blade. Note the Damaged Bolt Holes.

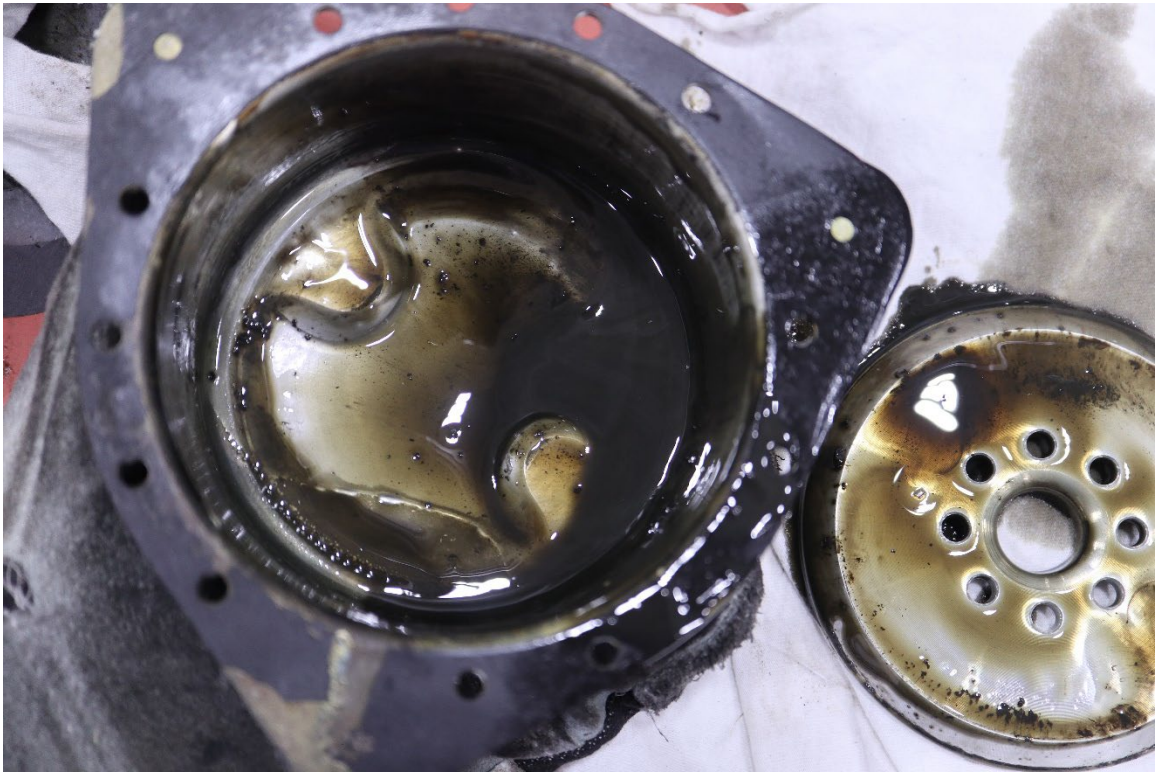
Residual oil was noted in the cylinder (normal).

Figure 6: View of the Residual Oil in the Cylinder.

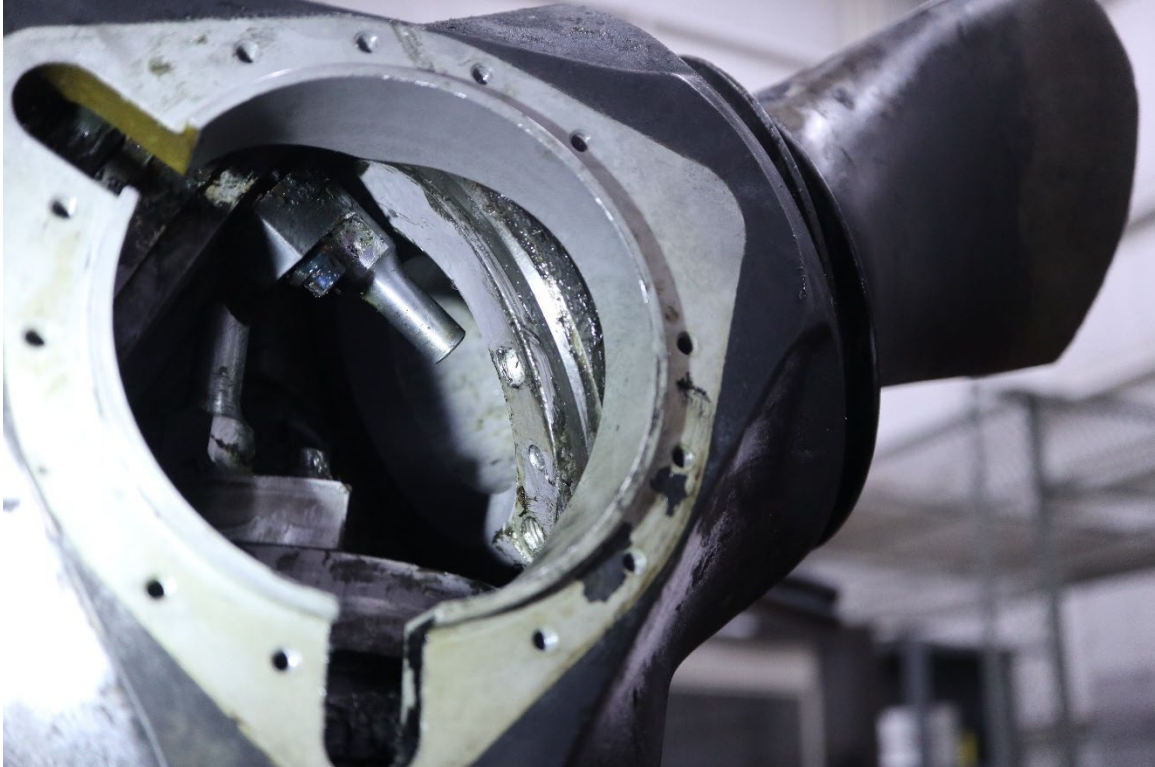
Because of the propeller design, the exact propeller blade angle at impact could not be determined, but, based on the impact marks on the butt end of the No. 1 blade by the corresponding pitch pin from the No. 3 blade, the propeller blade angle was at or near the low pitch stop.

Figure 7: View of Inside the Propeller Hub With the Butt End of the No. 1 Blade and the Pitch Pin from the No. 3 Blade Noting the Impact Damage. The Correlation of the two was used to Derive Approximate Blade Angle at Impact.
