Railroad Accident Brief: RAB-21/08

Southeastern Pennsylvania Transportation Authority Light Rail Vehicle Collision

Upper Darby, PA
August 22, 2017

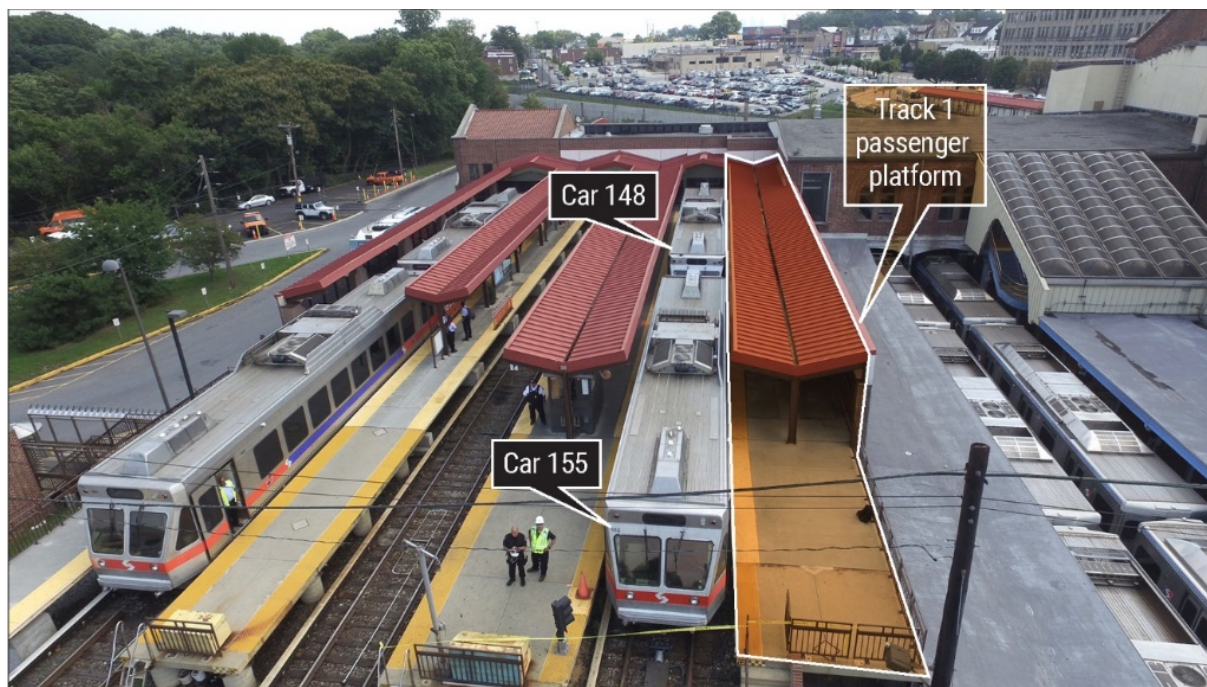
Figure 1. Aerial view of accident location looking southeast on the morning after the collision. (Source: SEPTA)

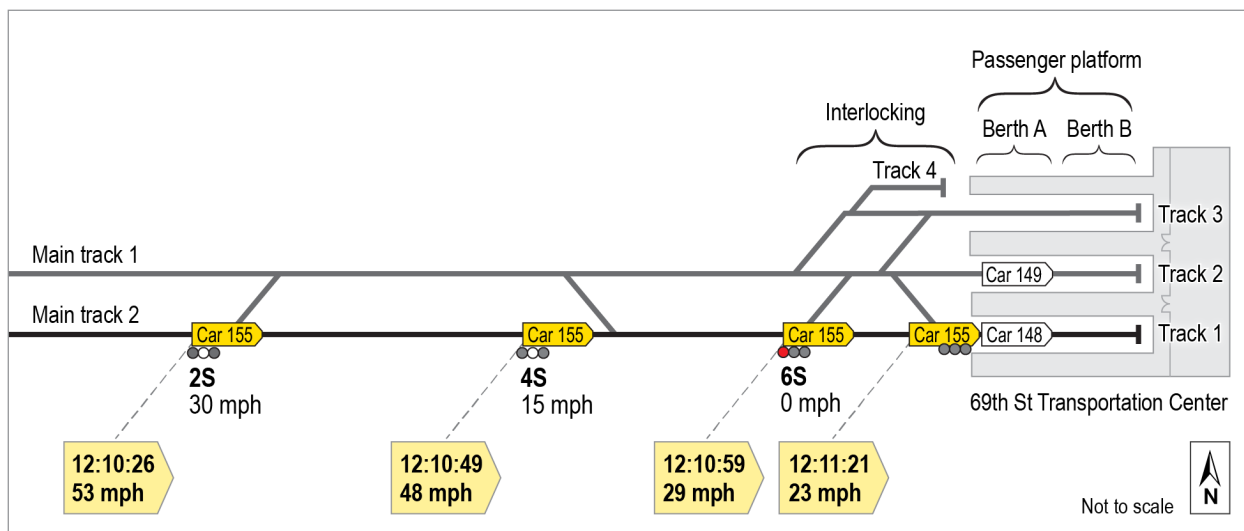
At 12:10:26 a.m., after departing Township Line Road station, car 155 reached signal 2S, the first of three wayside signals, along the approach into the 69th Street station. (See figure 2.) Car 155 passed signal 2S traveling at 53 mph even though the onboard cab signal indicated a maximum allowable speed of 30 mph.² The operator

At 12:10:49 a.m., car 155 passed signal 4S at 48 mph while the onboard cab signal indicated a maximum allowable speed of 15 mph. At 12:10:59 a.m., car 155 passed signal 6S at 29 mph as the onboard cab signal indicated a maximum allowable speed of 0 mph. At 12:11:21 a.m., traveling at 23 mph, car 155 struck the rear of car 148 on station track 1.

Figure 2. Diagram of car 155's approach to the 69th Street Transportation Center.

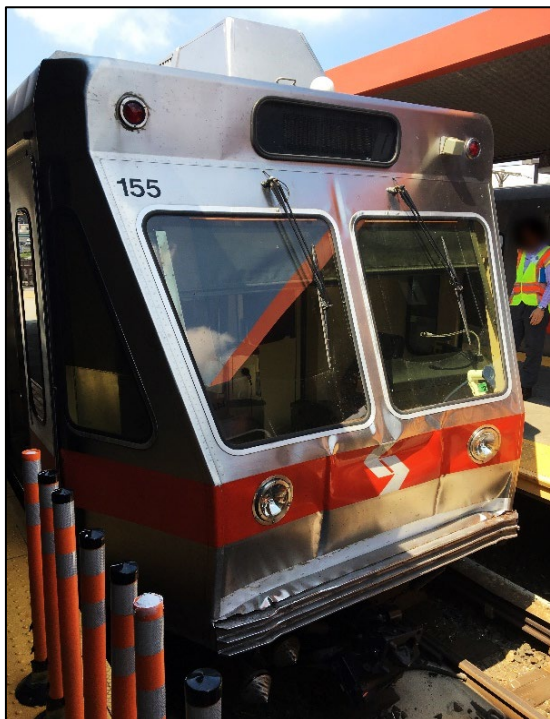
Figure 3. Postaccident collision damage to car 155.

Car 155 sustained exterior damage on the striking end of the coupler and front bulkhead panel and adjacent sidewall structure.⁴ (See figure 3.) On car 148's exterior, the struck end coupler, front bulkhead, and adjacent sidewall structure were damaged. The collision damage on both cars did not extend into the interior occupant space; only localized minor frame buckling was found. In addition, minor floor panel buckling, a broken door panel window, wall and ceiling panel cracks, dislodged seat cushions, and a misaligned door panel were noted on each car.
