National Transportation Safety Board
Railroad Accident Brief
CSX Transportation Freight Train Derailment and
Bridge Collapse
Alexandria, Virginia
May 19, 2018

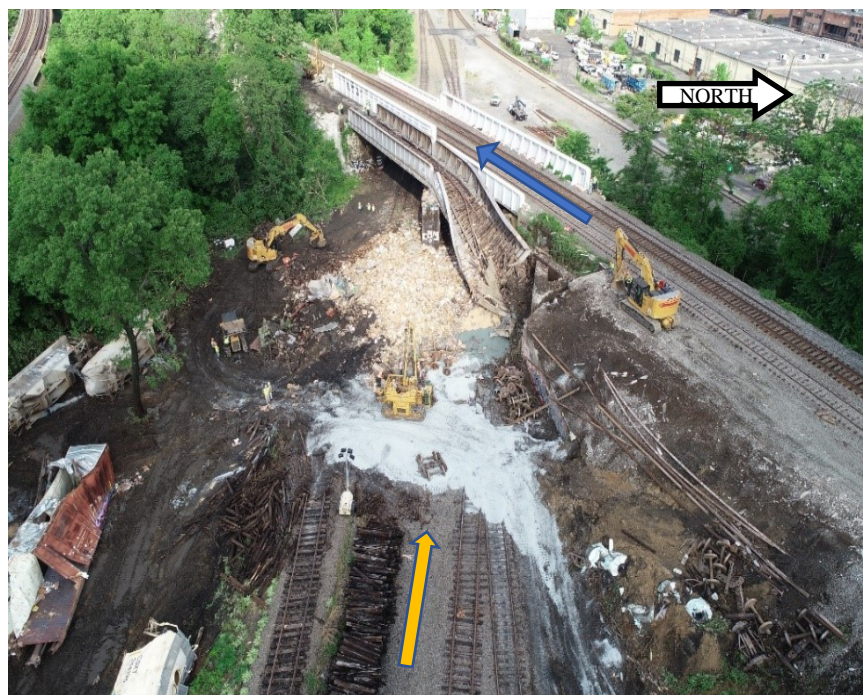
On May 19, 2018, at 7:02 a.m. local time, southbound CSX Transportation (CSX) freight train X41518 derailed near milepost (MP) 102.9 as it approached a bridge overpass in Alexandria, Virginia.¹ The train had been traveling on main track one of the RF&P subdivision.² As a result of the derailment, the CSX bridge supporting main track one was extensively damaged and collapsed at the approaching abutment wall. The bridge structure and 8 of the 31 derailed railcars fell upon the tracks below, owned by Norfolk Southern Railways (NS). (See figure 1.) The CSX bridge for main tracks two and three was not involved and remained in service throughout the investigation.³

Figure 1. The damaged bridge. The blue arrow indicates the direction of travel on the CSX track and the yellow arrow indicates the NS tracks.

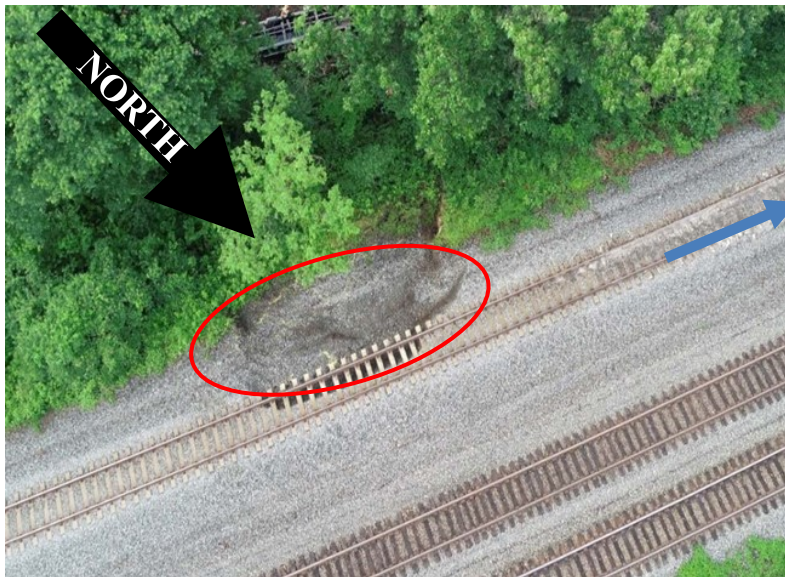
The investigation revealed an area in a curve at MP 102.9 where the subgrade fill subsided from the track structure on main track one, about 500 feet before the bridge spanning the NS tracks.⁶ Upon their arrival on scene, CSX personnel discovered that the subgrade fill and track ballast had subsided for about 26 feet in length, and at a depth of about 18 inches below the top surface of the cross-ties. Figure 2 shows the POD, circled in red, and the subgrade fill failure. Main track one is at the top, main track two is in the middle, and main track three is at the bottom of the figure.

Figure 2. The POD location and the subgrade fill failure indicated with the red circle. The blue arrow indicates the direction of train travel.

These findings were consistent with the on-scene observations of NTSB investigators. The weak and saturated soil, combined with the heavy rains that impacted the area, caused the subgrade fill to subside in the area of the POD.

The National Transportation Safety Board determines that the probable cause of the CSX Transportation train derailment and subsequent bridge collapse on May 19, 2018, was a subgrade fill failure of the track structure that displaced a large area of ballast under the low rail of the track near milepost CFP 102.9, resulting in a cross-level deviation of the track significant enough to allow a wheel climb derailment.

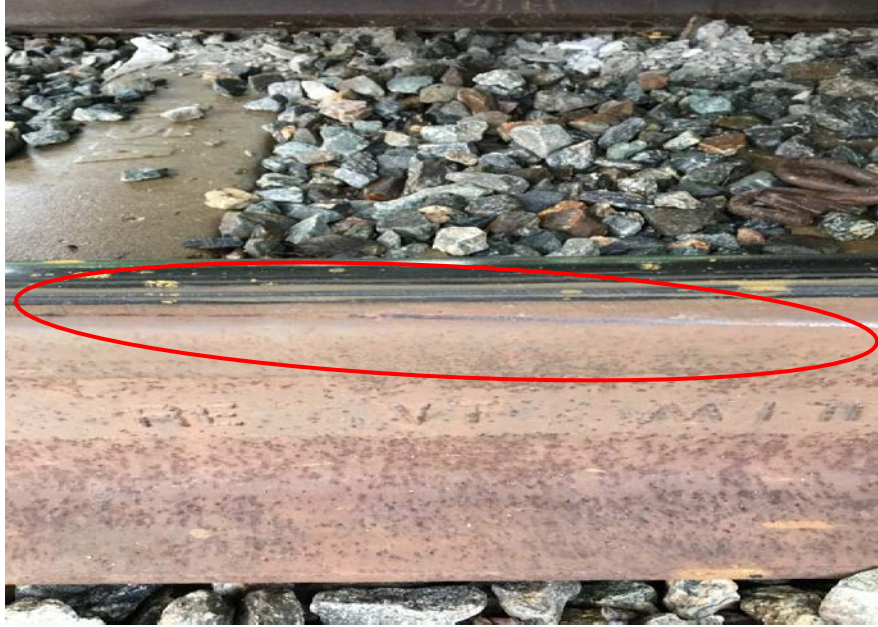
NTSB investigators identified a flange mark, consistent with a departure from the normal wheel rail interface, traversing the top of the high rail at MP CFP 102.9. At this location there was an irregular cross-level deviation between the high and low rail due to subgrade fill failure.⁷ (See figure 3.) The resulting cross-level deviation was enough to allow a wheel climb derailment.

Figure 3. High rail with the flange mark circled in red.
